Details of Proposed Work

Drumin Castle: Location and remedial work

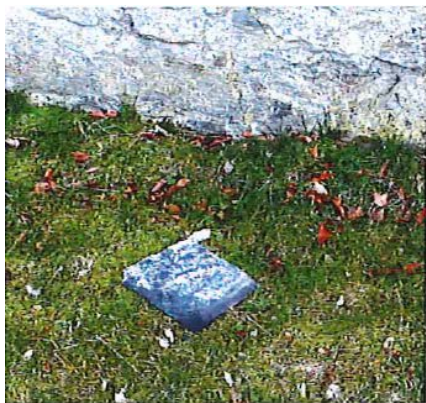
Fallen slate a base of West wall

- Slates: Re-fixed in robust long term method to stand up to exposure. Long term damage to the structure may accrue from water penetration so these will need to be fitted in a safe and secure manner.

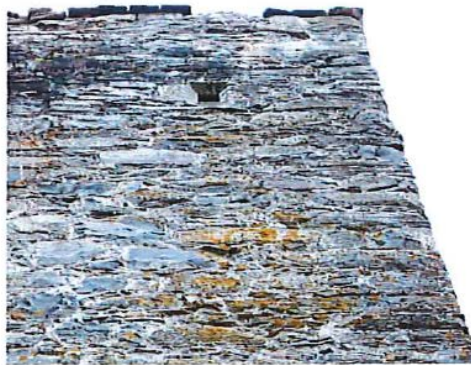
West wall with missing slate copes

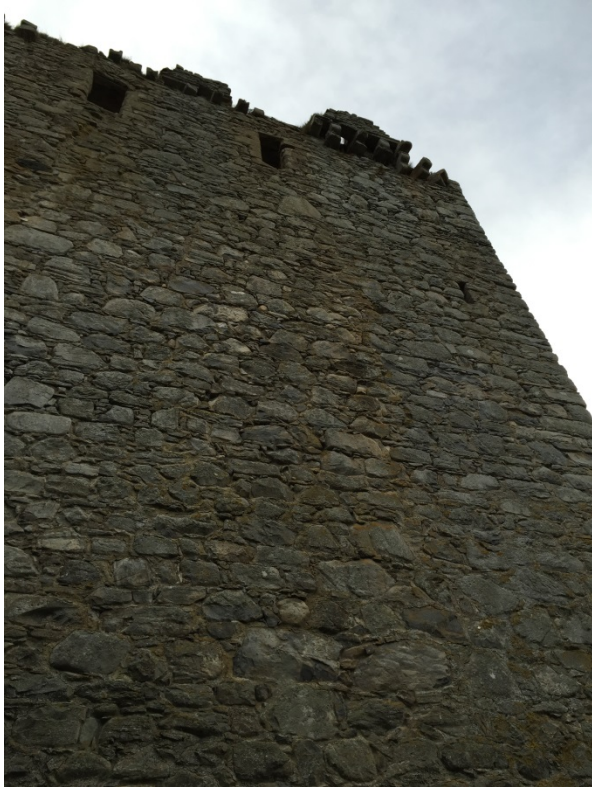
Visible growth on wall heads and slates missing.

- Wall heads (Unclear how consolidated during last work): If nothing already in place to prevent water penetrating into wall core then vegetation should be removed and wall will be consolidated. Any work will use NHL 5.0 hydraulic lime mortar, using sharp sand sourced following analysis of the original mortar.

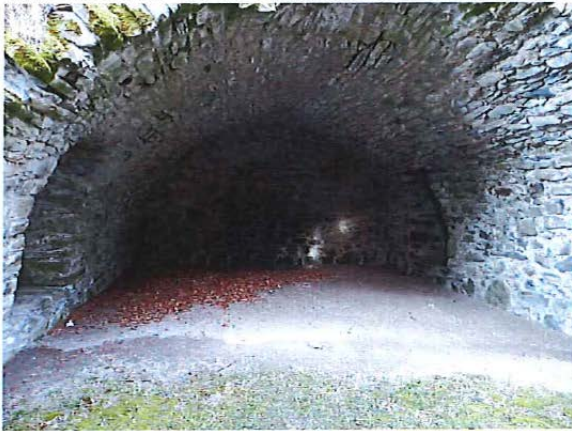
Undercroft

The interior of the undercroft is sound with no obvious sign of unstable masonry.

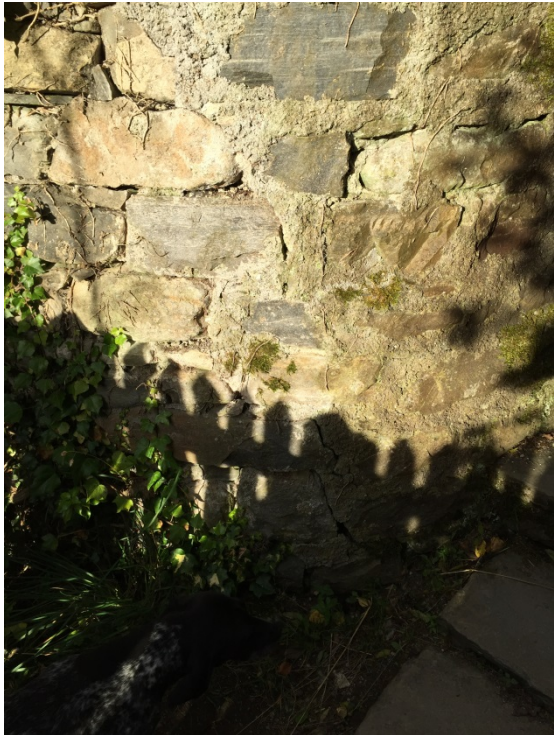
South east internal wall, bottom of staircase, Old Portland Cement visibly cracking.

- OPC pointing to staircase: The wall will be raked out and repointed using an NHL 3.5 hydraulic lime mortar; using sharp sand sourced following analysis of the original mortar. To ensure the correct sand is used a sample has been taken from Drumin Castle and sent to the Scottish Lime Centre.

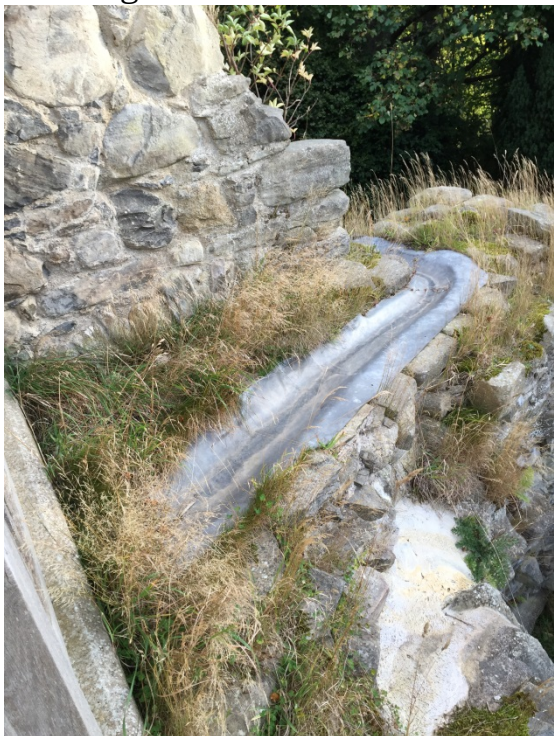
Lead gutter overgrown.

- Lead gutter:
 - Debris and vegetation will be removed. This will be done by hand and a suitable herbicide used to inhibit future growth.
 - Once this has been completed the area will be checked to ensure there are no further leaks and appropriately sealed.

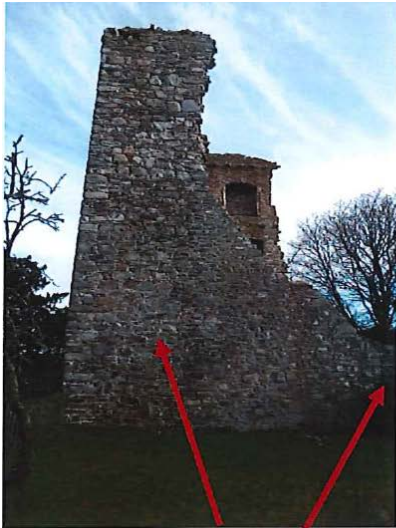
South wall - bulge area - crack

- Bulge at the base of the southern wall will be measured and then assessed for any movement in the future.
- Joints to some areas have opened and will require old portland cement raking out and replaced with a lime mortar. This will allow the pointing to breath and release any water that is absorbed through the wall heads. The original portland cement that has been used for pointing in the past will not allow this and may be a contributing factor to other cracking in the wall and the bulging in the southern wall.

Remedial work not considered for bulge in this job. Continual assessment will be undertaken to gauge whether there is any movement. In the future.

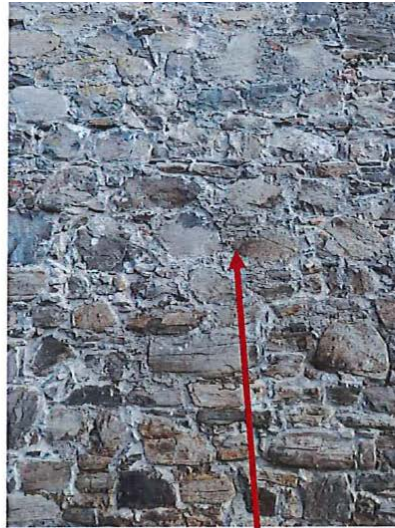
bulge area with minor crack
