Military Prison - South Elevation

MILITARY PRISON CONSERVATION WORKS SOUTH ELEVATION

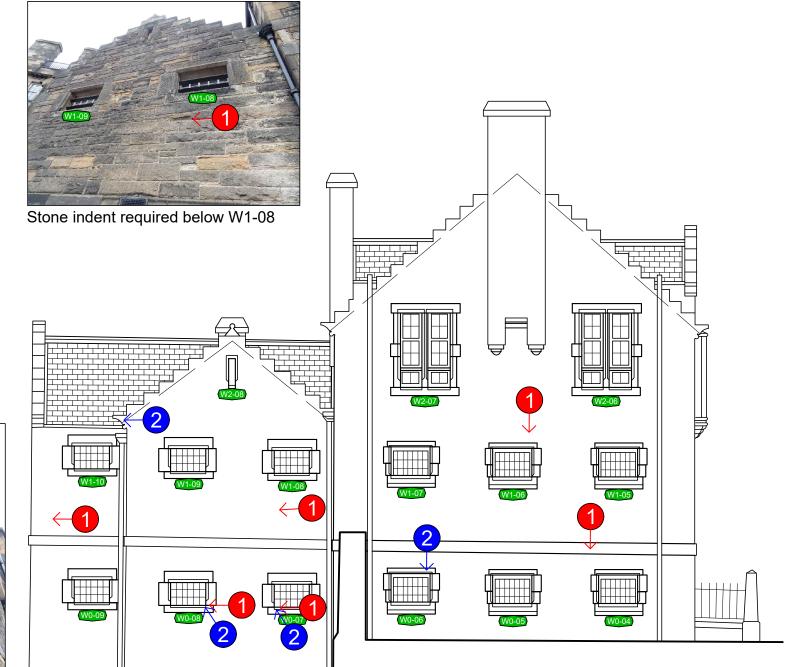
Location of stone indent required

on the stepped gable

below W1-10, and fractured stone

South elevation with location of stone indent required above W1-06

Indent required above W0-04 on string course

Fractured stone and indent required at both W0-08 and W0-07

Fractured cill at W0-07

Masonry to be inspected from scaffold and any defects reported to the DA for further instruction. It is anticipated that a maximum of 60% of the facade areas will need repointing. Mortar mix to match existing, based on mortar analysis.
