# Clach Toll Broch, Assynt Conservation Management Plan

AOC 20867  
March 2009

## Clach Toll Broch, Assynt, Sutherland Conservation Management Plan

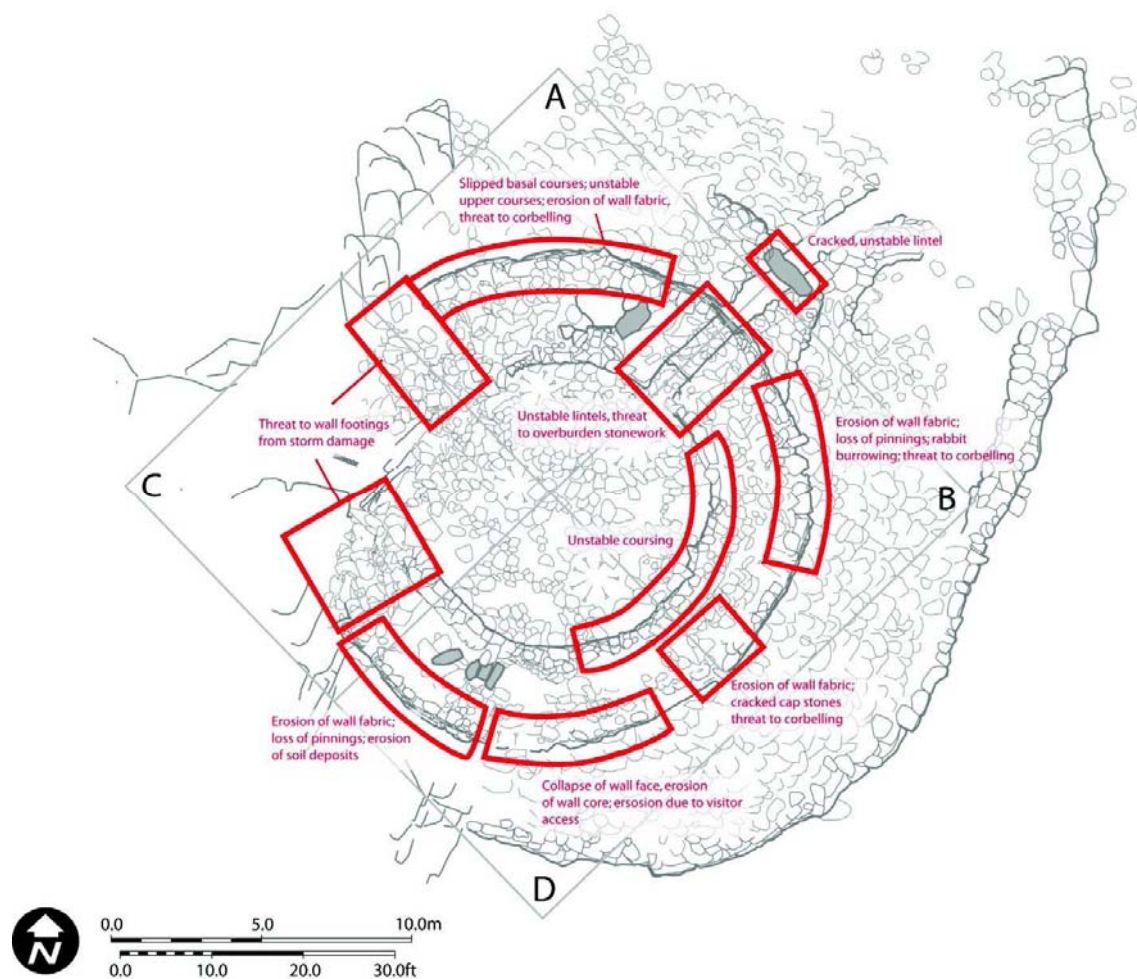
Figure 21: Summary of the treats to the monument identified and their locations

48. Several areas of the structure give cause for immediate concern. In area 101/B, for example, rabbits are burrowing into the wall core, removing the brash and inorganic soils of the wall around cell 2 and serving to destabilize areas of masonry above. Just as importantly, weathering of the mineral soils around the foundation courses of the broch is potentially undermining the stonework supporting the surviving broch wall. This process is illustrated particularly clearly by photographs

49. The erosion of the site is being further accelerated by damage caused by visitors accessing the monument over the damaged parts on the seaward side. Several pathways have formed leading into the site over the rubble mound and over the walls, and these correlate with areas of unstable stonework, clearly disturbed recently. Management of visitor access and its restriction to routes safe enough to accommodate safe access.

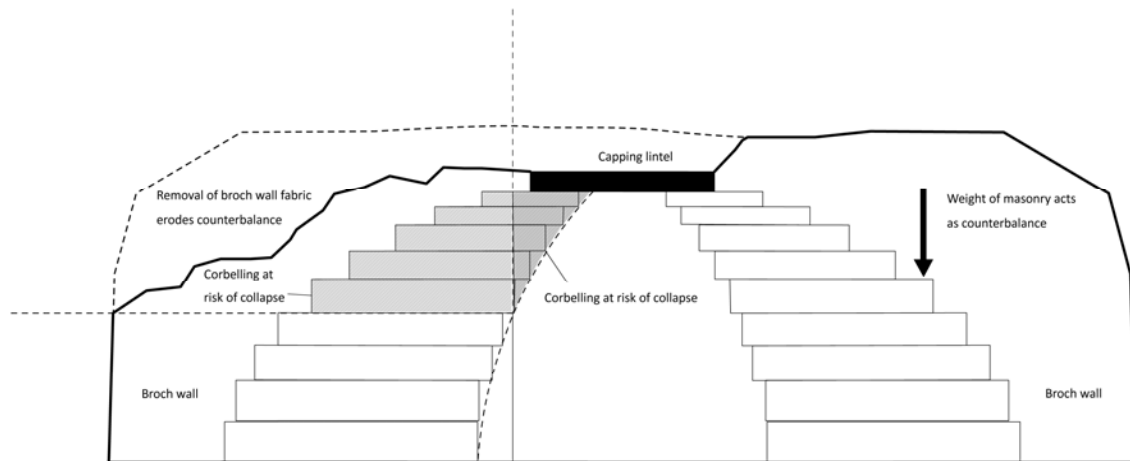
Figure 22: Schematic representation of intramural corbelling and its destabilisation

69. The intramural chambers survive in various degrees of preservation. Cells 1 and 2 are linked with the entrance passage through a narrow path (filled with debris) and access depends on the integrity of the orthostats that frame the entrance opening. Their walls appear to be geometrically undistorted, though several of the capping lintels in Cell 1 are missing. Cell 3 is in a very good condition but the opening giving access to the interior is filled with debris, and although its lintel still functions it is cracked vertically. Cell 4 is almost completely filled with debris and many of its lintels are out of place. The lintel over the internal opening has cracked and only a supporting block takes the weight of the remaining upper structure.
