**St Comghan's Church, Kilchoan**

**STRUCTURAL SURVEY REPORT**

Prepared by B J Smith  
Technical Director

4<sup>th</sup> June, 2015

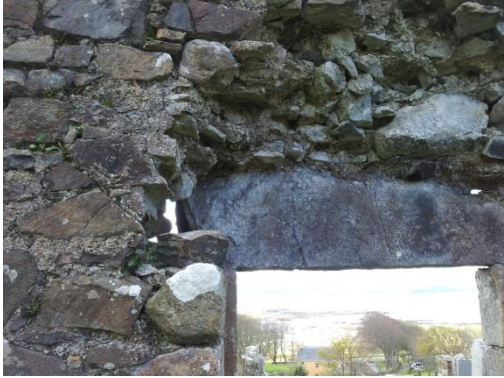
Picture 9

There is a void behind the lintel internally and the expectation is that an inner timber lintel has deteriorated and fallen away/or been removed. The void expands above the opening where part of the inner stonework has collapsed.

In our opinion the external stone lintel has reached the end of its serviceable life. As a result of cracking, and weathering/freeze/thaw action of laminates, the stone mass of the lintel will suffer from progressive disintegration leading to inevitable collapse. It is difficult to predict a timescale for decay, but it is clear to us that there is a limited window of opportunity to arrest the decay and stabilise/repair/otherwise support the lintel intact. This may include the reinstatement of the internal timber lintel and reconstruction of the collapsed inner stonework. Invasive techniques to improve the stone fabric of the lintel are not only undesirable, but they may prove to be damaging. Therefore, some sort of secondary support to the soffit, leaving the lintel itself free of the burden of supporting the stonework above may be the best option.

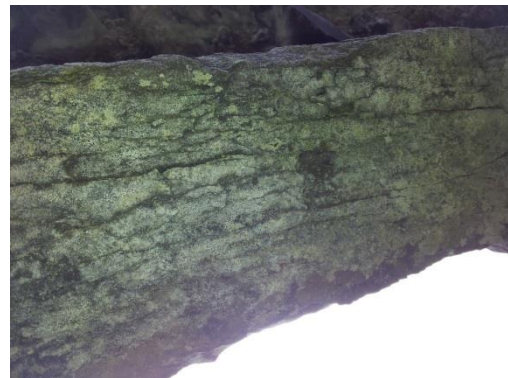
Picture 12

The stone lintel over the current entrance is framed with a deep but uneven block of finely laminated rock. There are two distinct cracks running vertically through the lintel at approximately 1/3<sup>rd</sup> points, visible internal and external.

Photograph 12 shows fine vertical laminations and photograph 14 shows spalling at the centre of the front face.

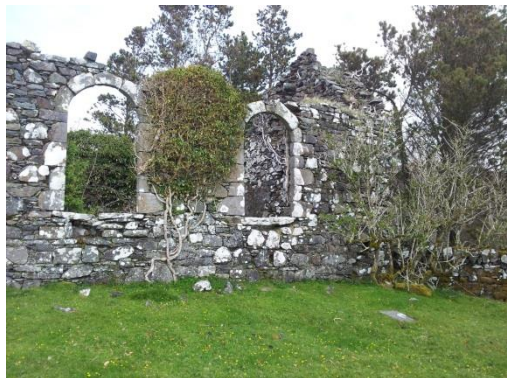
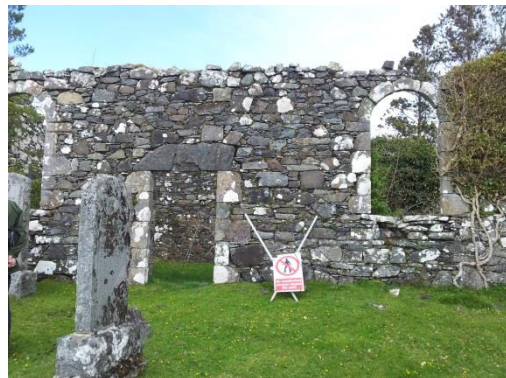
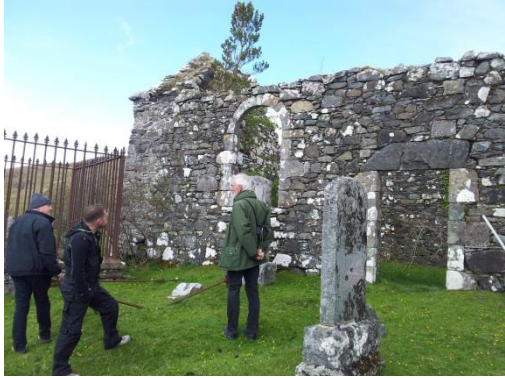
The three stone arches have all deteriorated to a similar degree. They lack the vertical load from collapsed stonework above which creates compression and stability. The arch keystones and springers have been tidily cut so that the bearings are flat. However, there are occasional gaps, and as the modest amount of lime mortar used in their construction has weathered away, they are now effectively un-cemented.

The structure of the inner leaf is now absent/collapsed/removed, so the arch stone themselves are found to be free of any form of lateral restraint.

In our opinion, whilst the arches are currently intact, they are finely balanced with no restraint which means that they will inevitably be susceptible to deterioration due to weathering of joints and the effects of high winds. In engineering terms we therefore consider them to lack the necessary degree of safety required to ensure stability and we should therefore advise that they are classified as UNSAFE STRUCTURES.

Because the arch profiles remain intact, and despite of the potential instability it is clear to us that there is a limited window of opportunity to arrest the decay and to stabilise/repair/otherwise support and conserve the arches as they stand. In simple terms this would probably involve the reinstatement of the timber backing lintel, and the reconstruction of the stone walling to reinstate up to the original eaves level. Repointing of the arch stone joints will also contribute to the overall structural integrity.

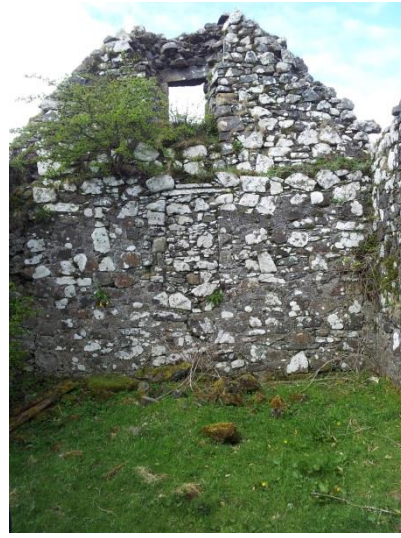
Picture 30

On the inner elevation, above the high level window opening there is a precarious section of overhanging stonework which remains stable due to intact lime mortar joints. This will deteriorate due to weathering over time, and it is therefore recommended that measures are taken to reinstate the support of the inner leaf. This may involve temporary support measures; ideally it would involve reinstatement of the inner timber lintel and reconstruction of the stonework which has collapsed.

Deterioration due to weathering of joints and occasional invasion by vegetation and the roots of small shrubs will cause an accelerated decay. The solution would be to consolidate the stonework by appropriate repointing work and reconstruction of loose stone blocks in accordance with recognised conservation practices.

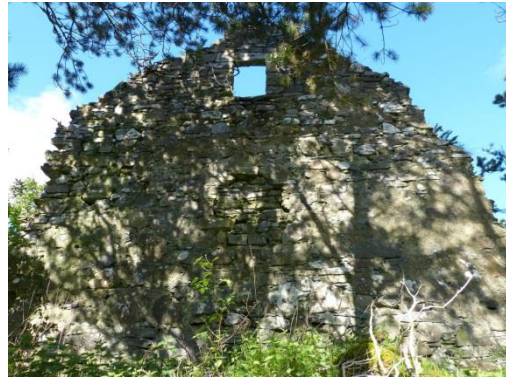
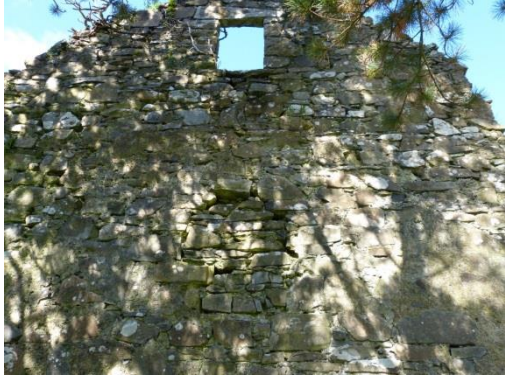
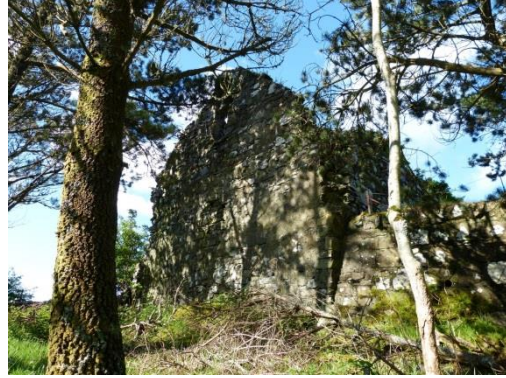
Whilst the gable verge stonework appears to be uneven with occasional loose stone blocks, the general impression is that the gable wall remains generally true to line and intact.

On the inner elevation, above the high level window opening there is a localised section of collapsed stonework associated with the absence of inner timber lintel. The remaining stonework peak appears to remain intact, but a closer inspection would be advisable to check its stability/safety.

Deterioration due to weathering of joints and occasional invasion by vegetation will cause an accelerated decay. The solution would be to consolidate the stonework by appropriate repointing work and occasional careful dismantling and reconstruction of loose stone blocks in accordance with recognised conservation practices.
