# Myrton Castle

Monreith, by Port William, Wigtownshire

*Archaeological Evaluation : August 2015*

Job number AA 2037.00

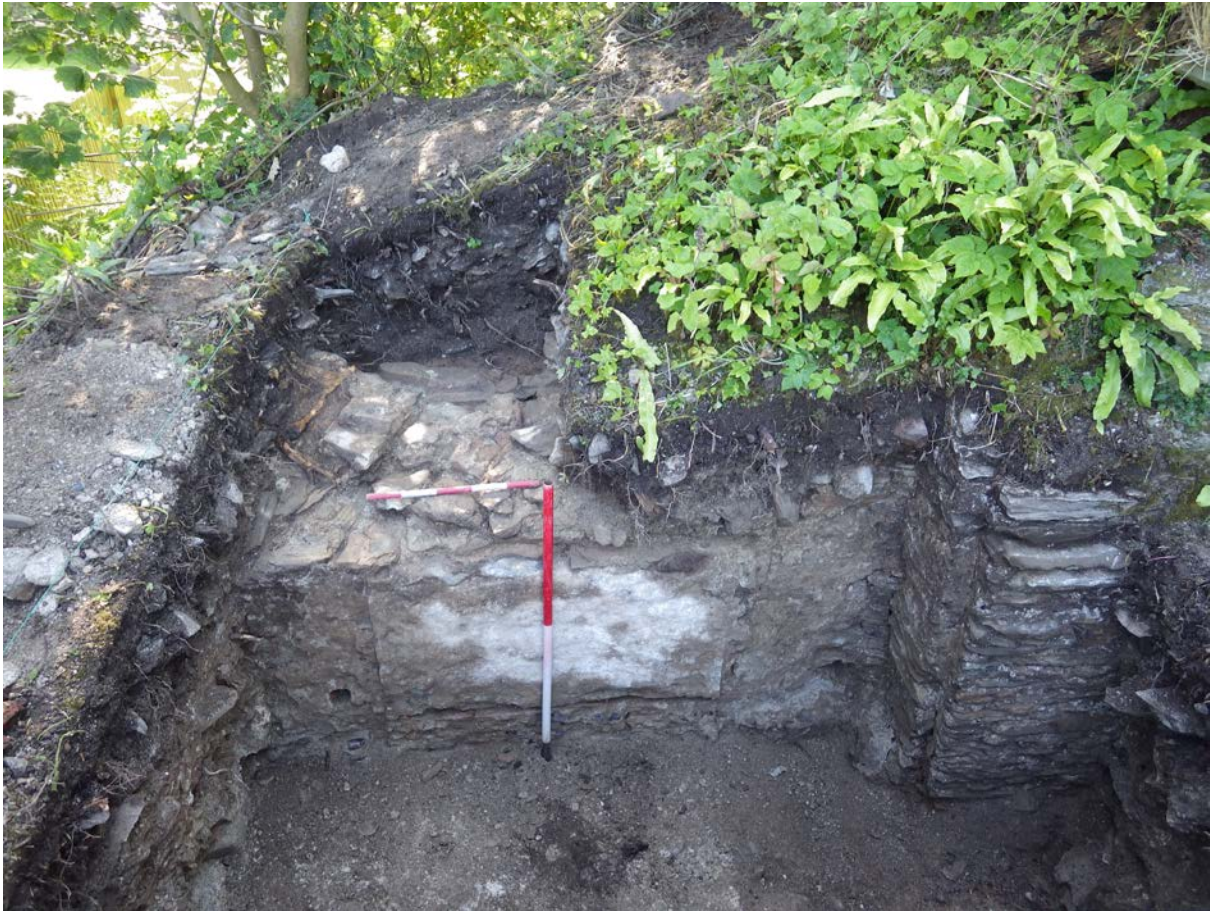
Plate 2 West (interior) face of wall [104], joined to wall [108] by slate pinnings; wall plaster relating to the later press can be seen behind the vertical scale

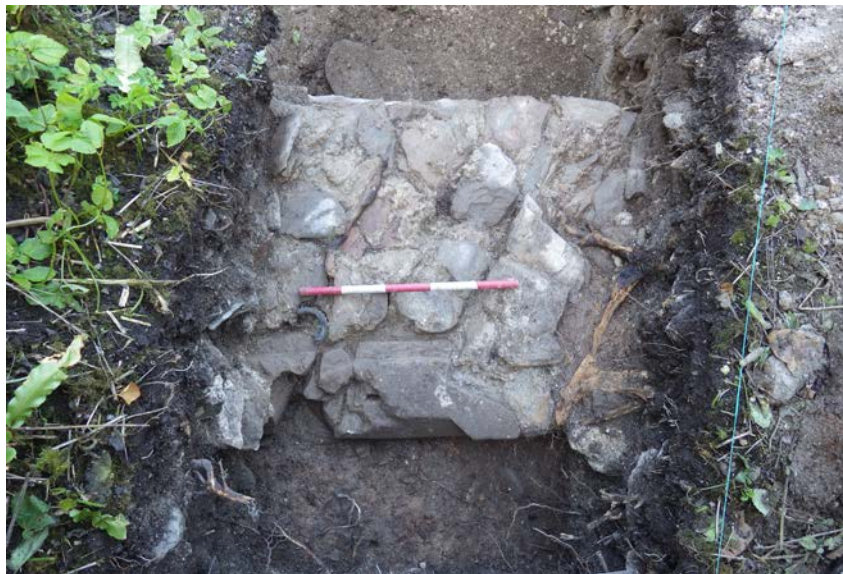
In the 18<sup>th</sup> century modifications were made to the buildings. The window was blocked with mortared rubble and a timber press or shelving built against the interior (western) wall face, the extent of which was silhouetted by plaster applied to the wall face. Sockets for shelving also survived. A hole to the left of the cupboard may have been for associated fixtures (*figure 3; plate 2*). Fine pale grey plaster fragments [112], of the same material as the plaster covering the wall were found adhering to the base of wall [104]. This plaster contained embedded fragments of bottle glass dating to the later 18<sup>th</sup> century. Fragments of similar glass were found within the mortar of the infilled window, suggesting the window was infilled at the same date; similar material was also found in trench 2.

Plate 3 Wall [104] showing infilled window and chamfered stone (at bottom of photo)

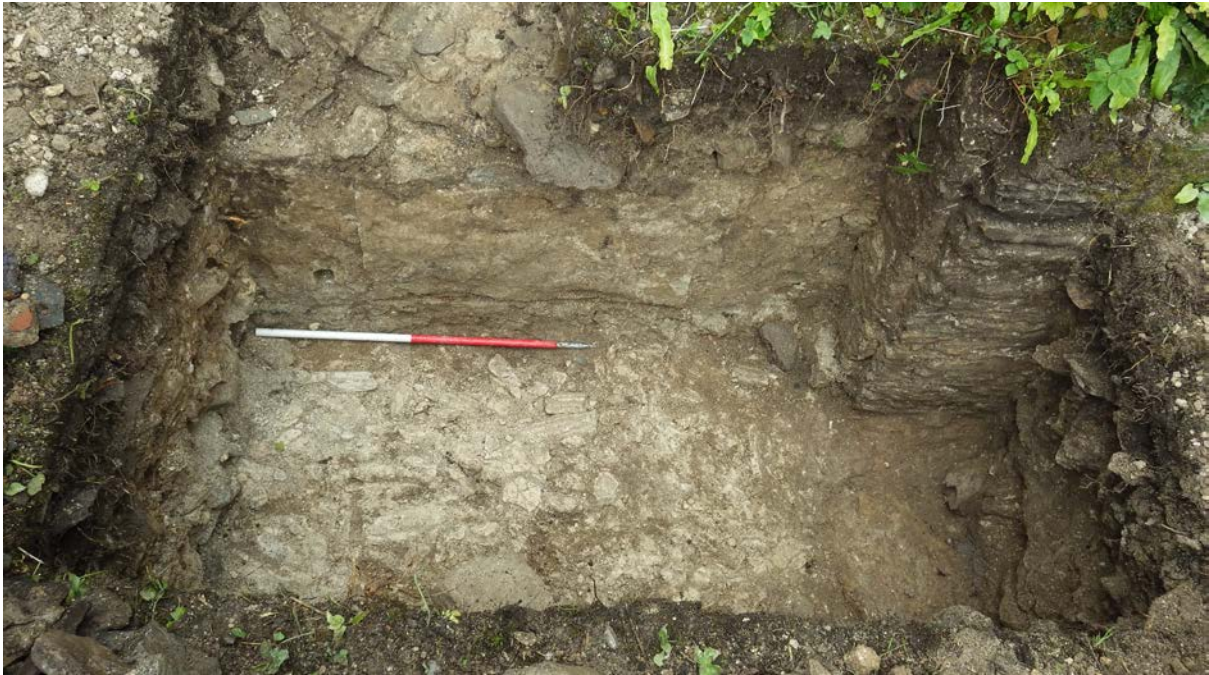
root disturbance in this layer, which was 0.02m thick and was confined to the northern part of the trench, suggesting the ceiling in the former room by the earlier tower was not plastered (*plate 4*).

*Plate 4 Plaster deposit [107] in Trench 1, confined to N of tower wall [108], looking east*

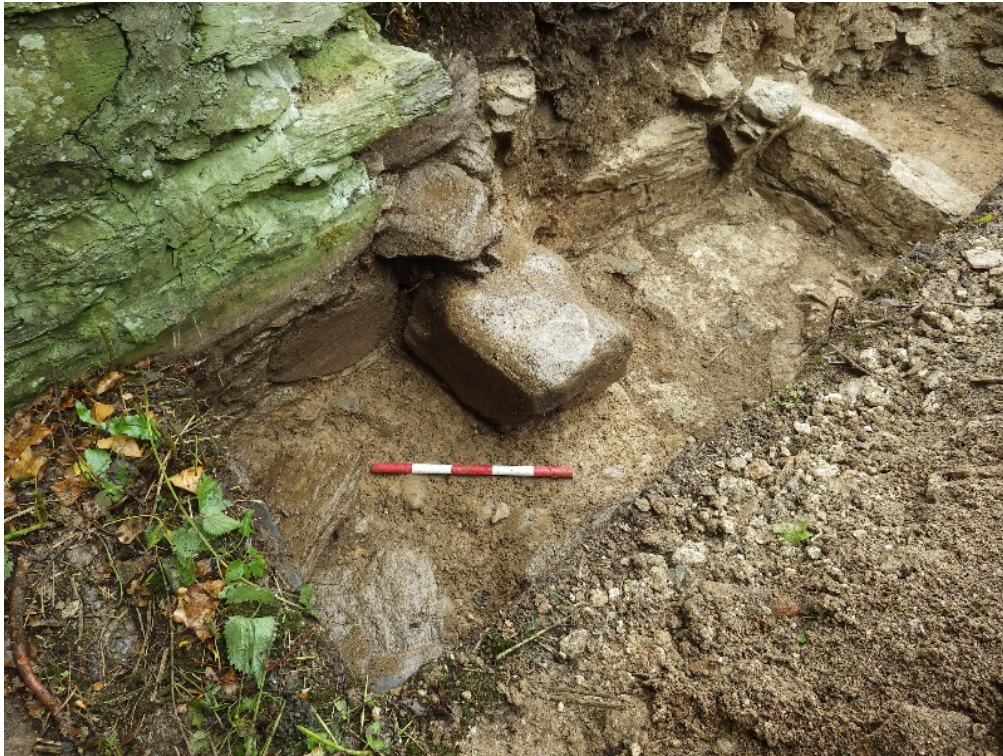
*Plate 7 The projecting stub of wall [208] as initially revealed; the distorted section of walling at top right [211] lies on the line of the north exterior wall face of the early tower; looking northwest*

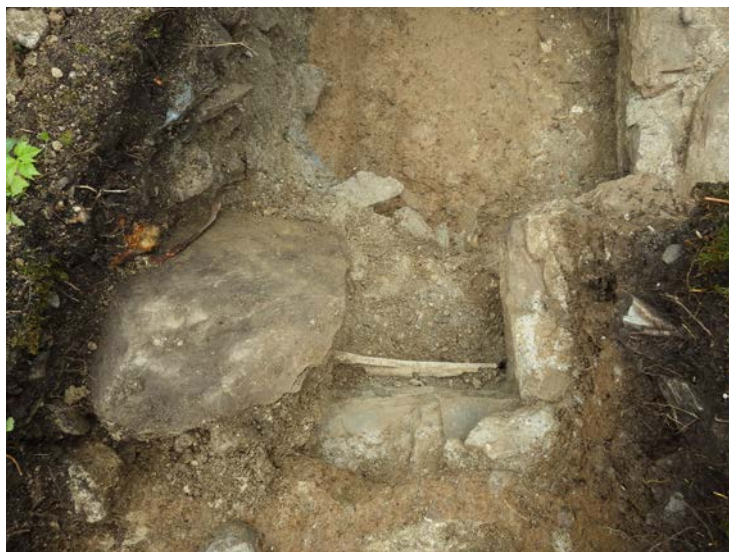
Plate 8 Window recess [213] with internal partition wall [211] to right, looking east

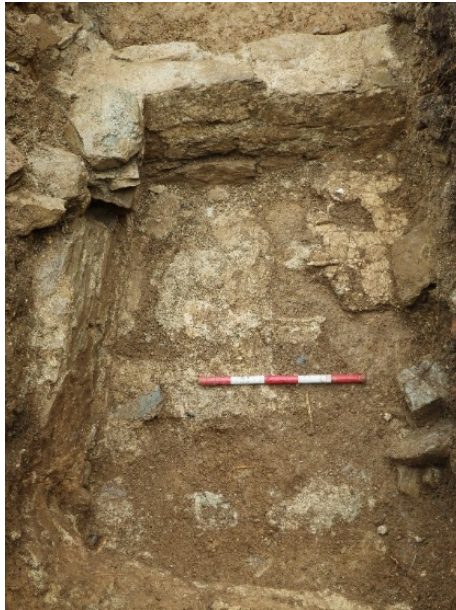
The plaster was only noted between walls [211] and [208] and not within the chambers to the north or south. The plaster lay on the bare clay [216] of the motte core, this showing that any floor surfacing that may have existed had been robbed prior to the ceiling coming down.

*Plate 9 collapsed plaster ceiling [204]*

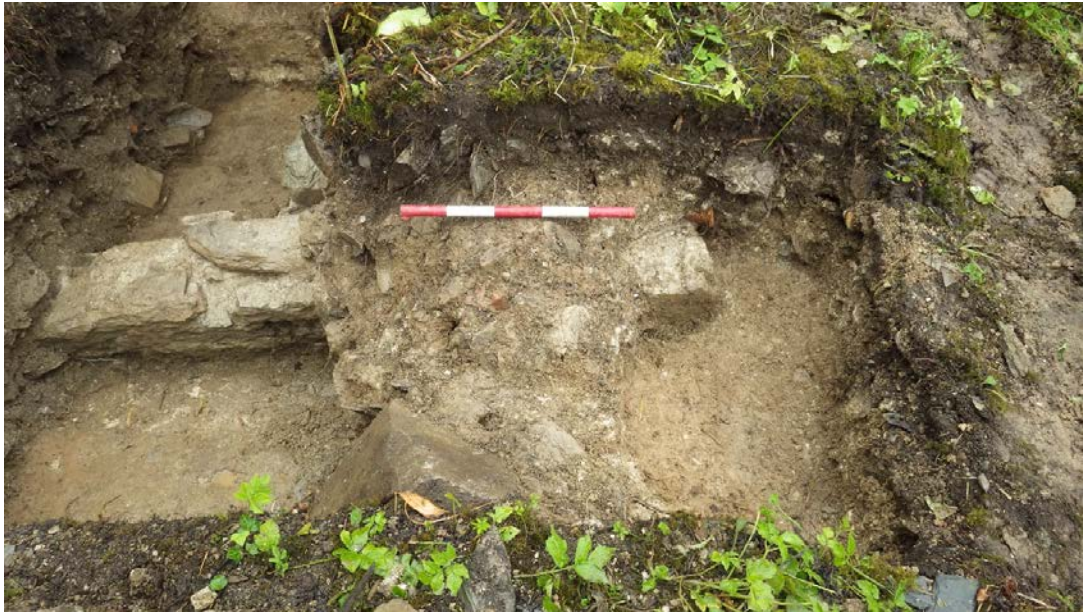
This clay capping was in part buried beneath some crushed lime mortar of [202] (see below) indicating that robbing or at least works on the ruins continued after the landscaping.

*Plate 10 clay capping [207] enhancing ruined castle walls (50 cm scale)*

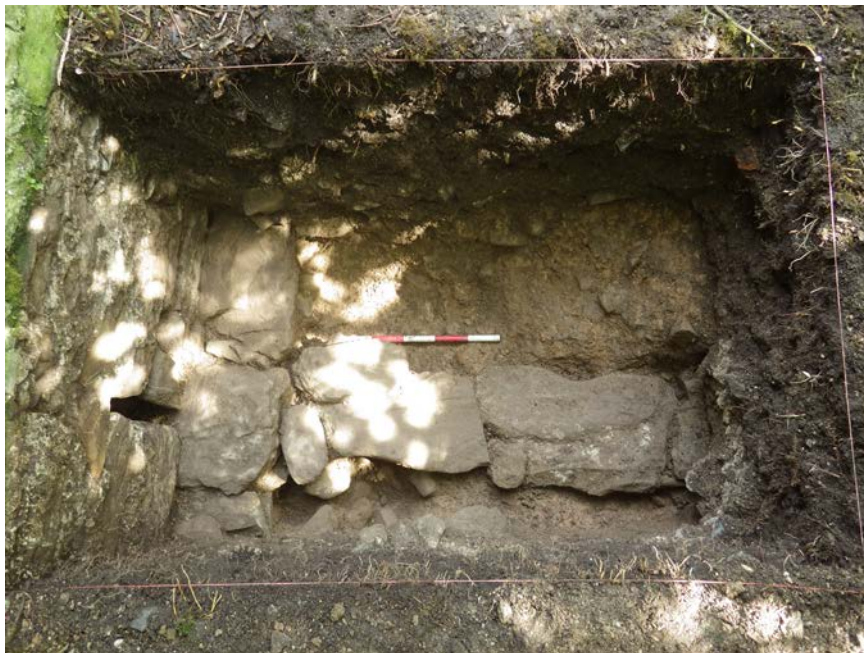
The tower foundations [305] consist of a single course of large, flat stones 0.40-0.50m in width, and 0.10-0.20m in thickness, placed end-to-end (*figure 9; plate 13*). The foundations protruded 0.30m from beneath the wall face. The loop [306] was a narrow opening 0.05-0.08m in width by 0.35m in height built into the wall as part of the tower's construction. The top and sides of the gun loop were formed within the rubblework of the surrounding wall [302], while its sill was formed by the projecting foundation structure [305].

Plate 13 Trench 3 post-ex, looking north; showing tower foundations [305] (on left) and drain [308]

The tower foundation contained a small, narrow outlet beneath the loop, this seemingly to lead into the drain (*plate 13*). From this outlet, the drain sloped eastwards at approximately a 23° angle for 0.50m before levelling out to a shallower gradient. The drain ran eastwards from the loop and was generally un-lined on the sides and base with a stone capping [308]. However stones lining the sides were visible in the west facing section (*plate 14*). The channel thus formed was 0.3m in width and up to 0.26m deep, with steep sides and a flat base. The fill of the drain [311] comprised water-sorted friable brown-grey gritty silt, rich in shell fragments. The drain cut was filled with light brown silt [310] and contained a Cu alloy coin (SF059) tentatively identified as a 17<sup>th</sup> century Dutch *zeelandia duit*.

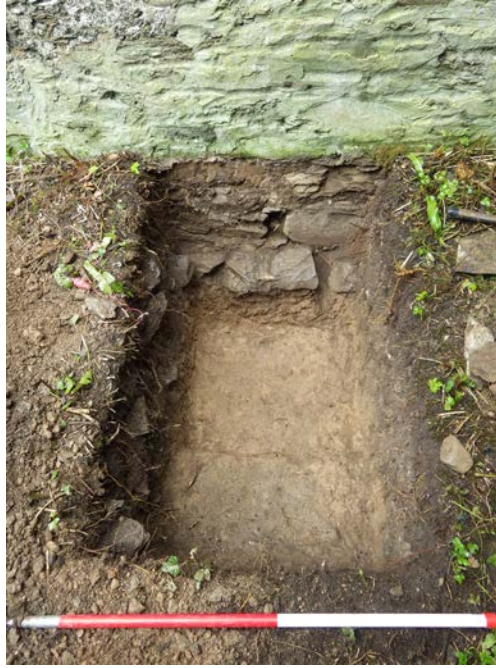
The wall of the tower [403] was built above the foundation course. There was some possible suggestion of a shallow footing trench [407] cut into the top of the motte; however this was poorly defined and mainly suggested in the east section – see *plate 16* below. The gun loop [405] within the wall was low and narrow and had been simply formed by rubble stone, without dressings (*plate 17*).

The tower's exterior footing structure was built directly upon the level surface of clay deposit. The footing itself consisted of a single projecting base course of large stone slabs. The interior of the wall extended down in to the motte top to a considerably greater depth.

Plate 17 Post-excavation view of Trench 4 (2015) looking north

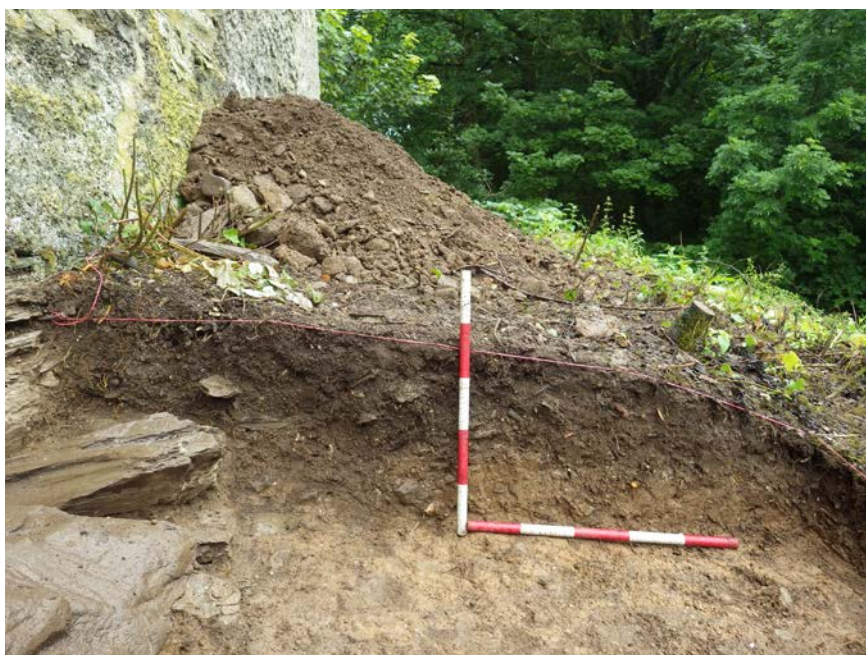
The castle foundation trench [506] was a north-south orientated linear cut with a 45° sloping side and flat base cut into the clay motte surface. The foundation trench was filled by mid to grey brown gritty silty clay [507] with mortar flecks and angular stone and pebble inclusions, surviving to a depth of 0.15m. The foundation trench and fill are most visible in the north facing section (*plate 19*), and it is within this fill [507] that the castle foundations [503] are set.

*Plate 19 Post-excavation south section of Trench 5, showing cut [506] and fill (507)*

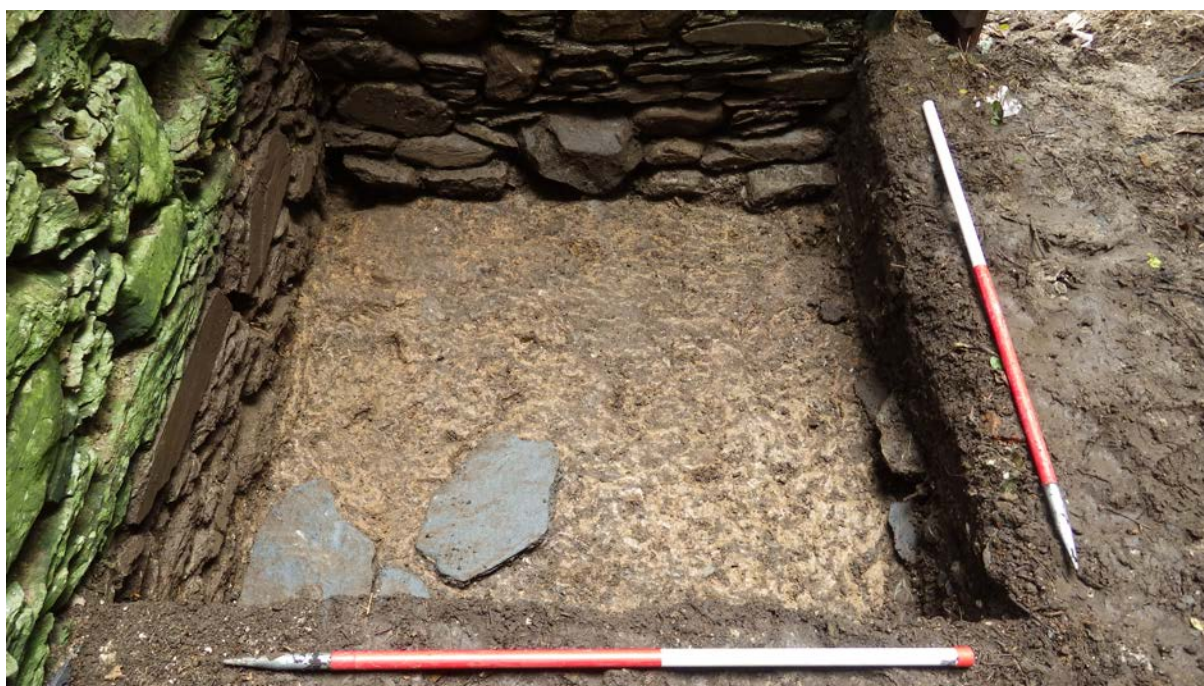
Plate 22 Post-excavation view of Trench 6 with (602) in the SE corner and the motte top (604) across the bottom of the trench, looking north (014)

The base of the original tower wall [605] was constructed on the surface of [604], within a foundation cut, which was not seen. The northern doocot wall [606] appeared to have been constructed directly upon the levelled surface of the motte (*plate 22*). Both walls were of rubble construction with lime and mortar bonding.

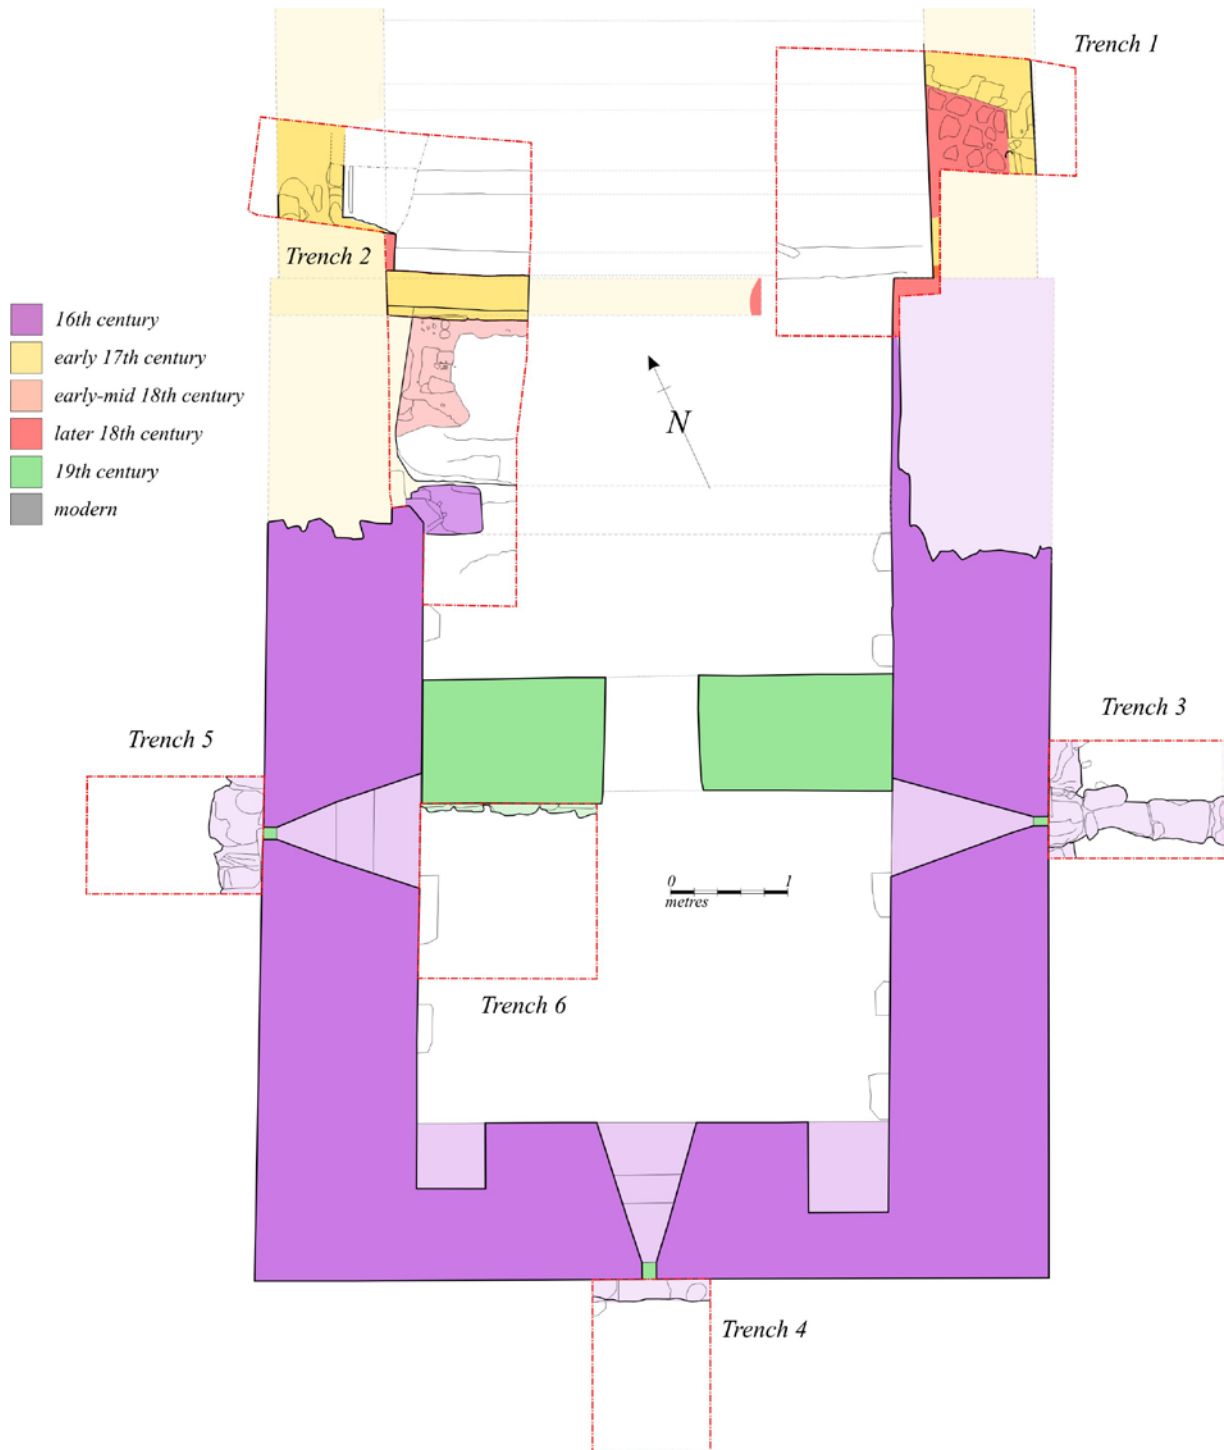
Figure 15 Plan of the tower showing excavated remains, phasing, etc

These trenches revealed a footing structure that was consistent for each side, comprising a solitary projecting footing course formed of individual large blocks of stone. The footing had been built within a very shallow foundation trench cut dug directly into the clay. These footings were originally not deeply buried, and their upper parts may even have been visible.

The excavation of trenches 1 and 2 confirmed the position of the lost north wall of the tower. Overall the tower had measured 8.60m by 6.80m. Probable evidence was found for the position of a stone turnpike stair at the NW angle that may have been accessed by an exterior entrance at the north end of the west wall (a small trench excavation in this area would probably provide more definitive evidence). Almost nothing of the north wall itself survived. However the probable points of its return were visible internally, particularly within trench 1 on the east side, and could be deduced for the west side. It is possible that the base course(s) of the external angles of the tower may still remain *in situ* – however these points lay beyond the edges of the two evaluation trenches. The north wall was of similar thickness to the surviving walls.

The primary reason for the evaluation exercise was to investigate whether the existing tower and the ground on its north side is capable of supporting new construction. From an archaeologist-observer's perspective the surviving three walls of the tower would seem to be structurally stable and solidly founded; this in spite of the slight nature of the footing structure to the exterior. Clearly the interior footings of the tower extend to greater depth and are bedded down in to the core of the summit of the motte mound.
