# **SURVEY OF ENTRANCE PANELS - BALVAIRD CASTLE**

April 2012

## INTRODUCTION

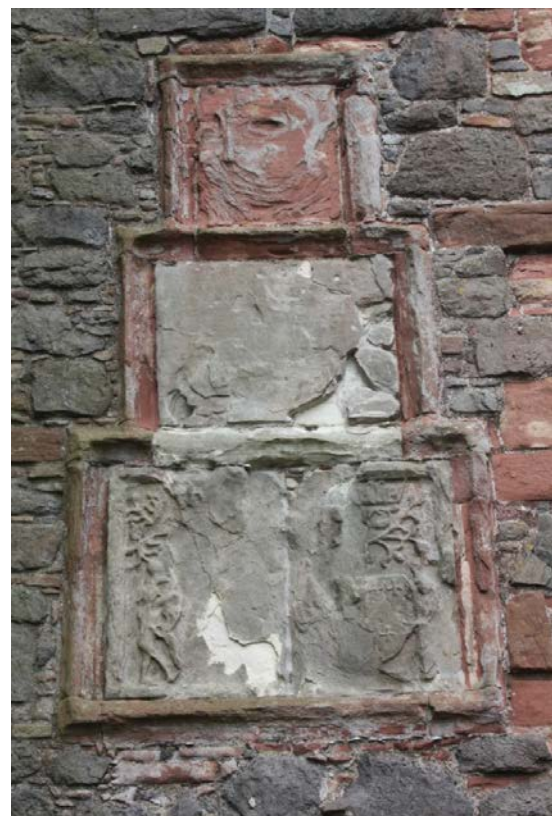
Heraldic panels above doorway

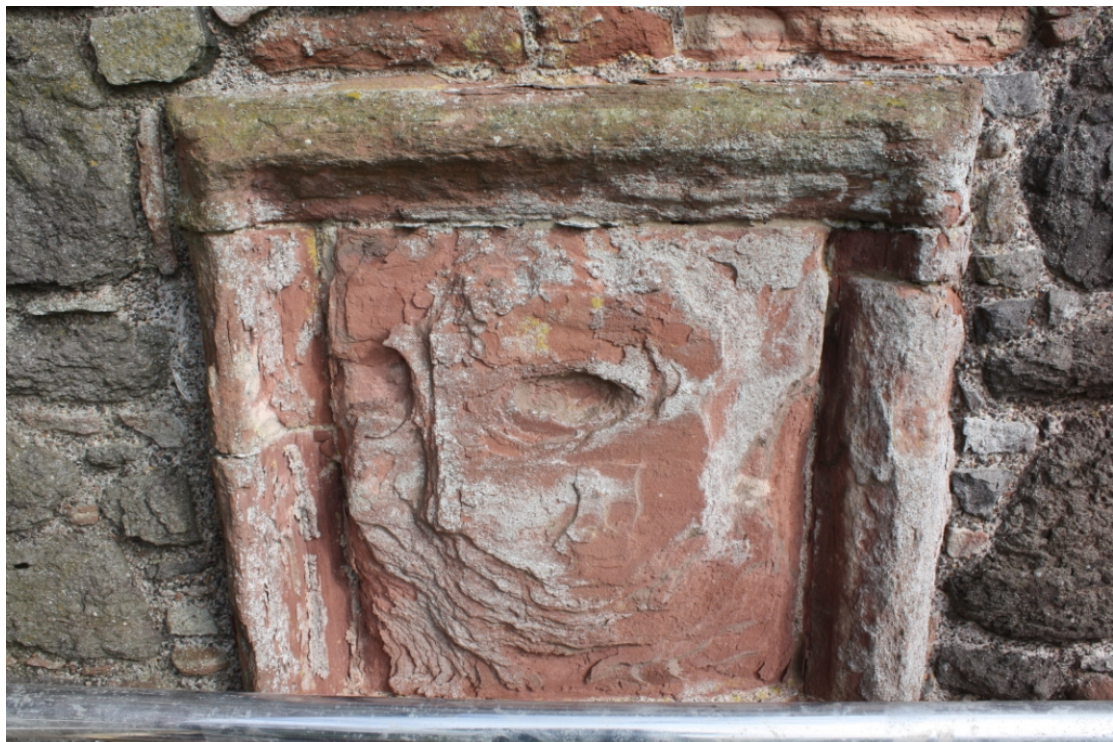
The face-bedded panel has lost all carved detail and is delaminating severely. In places, it is eroded by up to a depth of approx. 80mm. The left side (towards the return corner of the south tower, west of the entrance) of the panel is worst affected by this. Subsurface hollowness was noted in almost all areas. Freshly exposed surfaces are disaggregating

All frame components are delaminating and display open bedding planes. While the upper architrave retains traces of moulded detail, the left (western) upright is particularly eroded and fragile.

White lichen covers many surface areas while algae has also colonised the upper architrave surface. Old resin repair mortars remain visible in the centre and on the right (eastern) side of the panel.

**The overall condition of the panel is very fragile and severely decayed.**

**Upper panel**

The upper two panels and sill stones should be removed and replaced with blank stones of the same petrology and similar or higher porosity than the original stones so as not to shed excessive amount of water onto the stones below. Stone matching analysis needs to be carried out for this purpose.

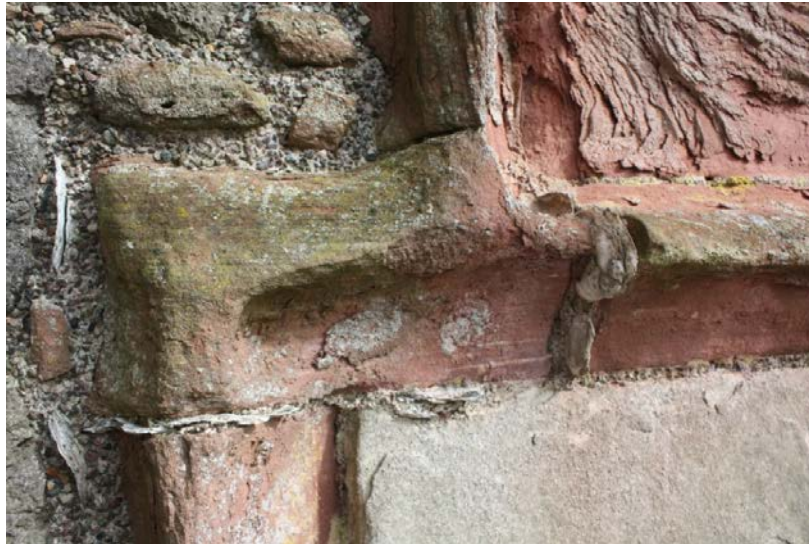
The panel is pointed with soft lime mortar and pinned with shells which often protrude from the joints by several cm, illustrating the extent of erosion. The surrounding masonry appears to be cement pointed.

**Eroded moulding with protruding shell pinning**

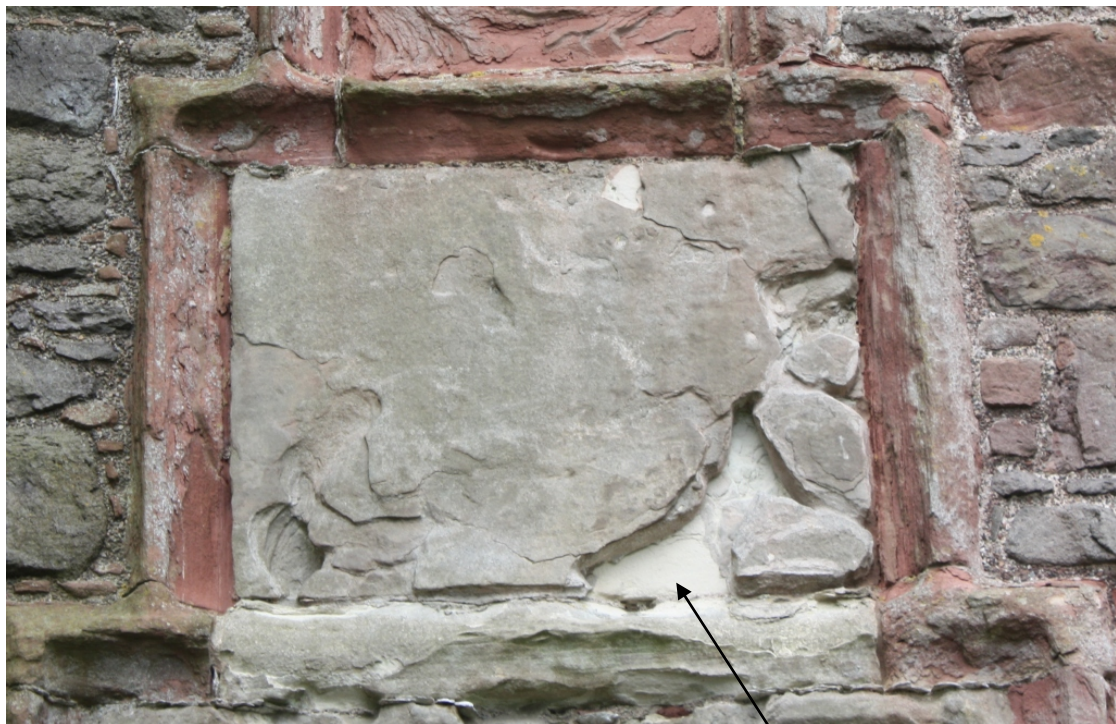
**Middle panel with area of recent loss**

A section of several cm thickness was recently lost from the lower edge of the panel. The exposed fresh surface is very soft and powdery. The older surface is hard (possibly due to previous alkoxy silane treatment) but sub-surface hollowness could be detected over the whole panel. Edge pointing remains visible along areas of decay on the right (eastern) side of the panel.

Fragile areas at imminent risk of delamination and loss were noted along the central – right top edge, central bottom edge, bottom left corner and central left edge.

Judging by the protrusion of the shell pinnings, the top moulding (sill of top panel) has eroded by at least two cm. The upright frame members like the top and sill moulding are delaminating along open bedding planes. The left upright member is again more eroded than the one on the right. The sill is delaminating and disaggregating. It has lost all detail and moulded shape.

**The overall condition of the middle panel is very fragile with several substantial areas at imminent risk of loss.**

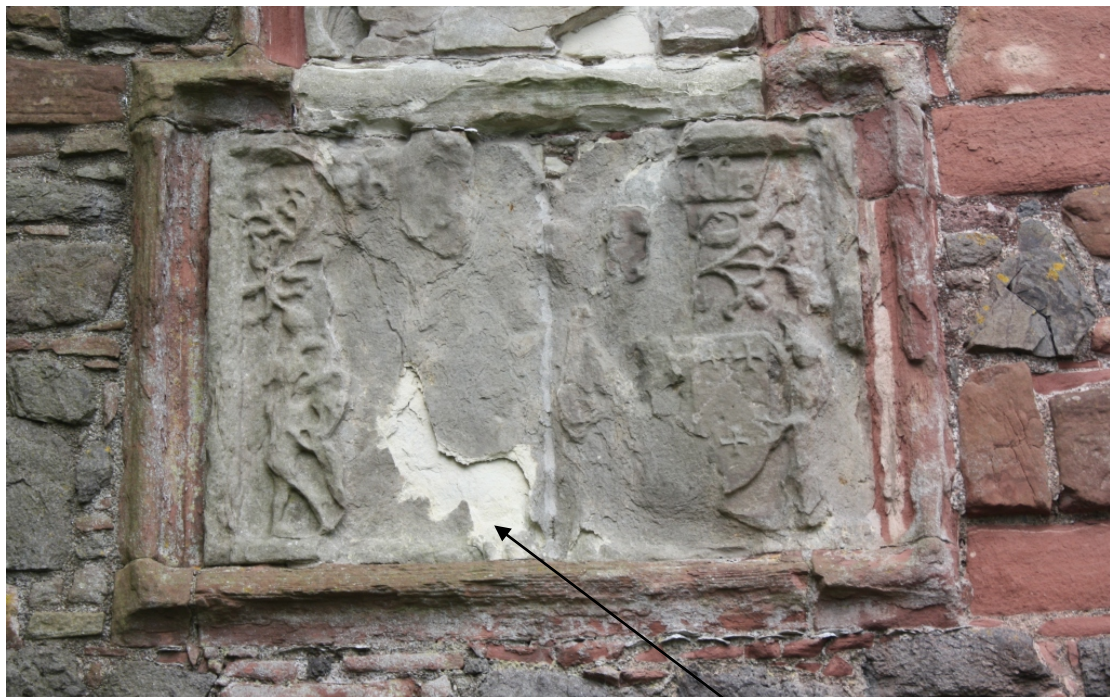
The panel consists of two buff sandstones, both of which retain carved heraldic detail on their outer sides. All carved detail has been lost from the central section where the stonework is very fragile.

Sub surface hollowness was detected in the central areas and on outer panel edges. Surface blistering occurs on the lower outer edge of the right panel. Previous resin pointing is visible here and the outside edge of the left panel

**Lower panel with recent loss**

The central top edge is delaminating and at risk of loss, previous repairs are visible but failing. A large surface area has been lost recently in the central lower area. The exposed aggregate is soft and powdery.

**The lower panel is very fragile with further areas at risk of loss.**

The delamination edges of the lower panel should be consolidated with lime mortar pointing so as not to cause any further moisture barriers.

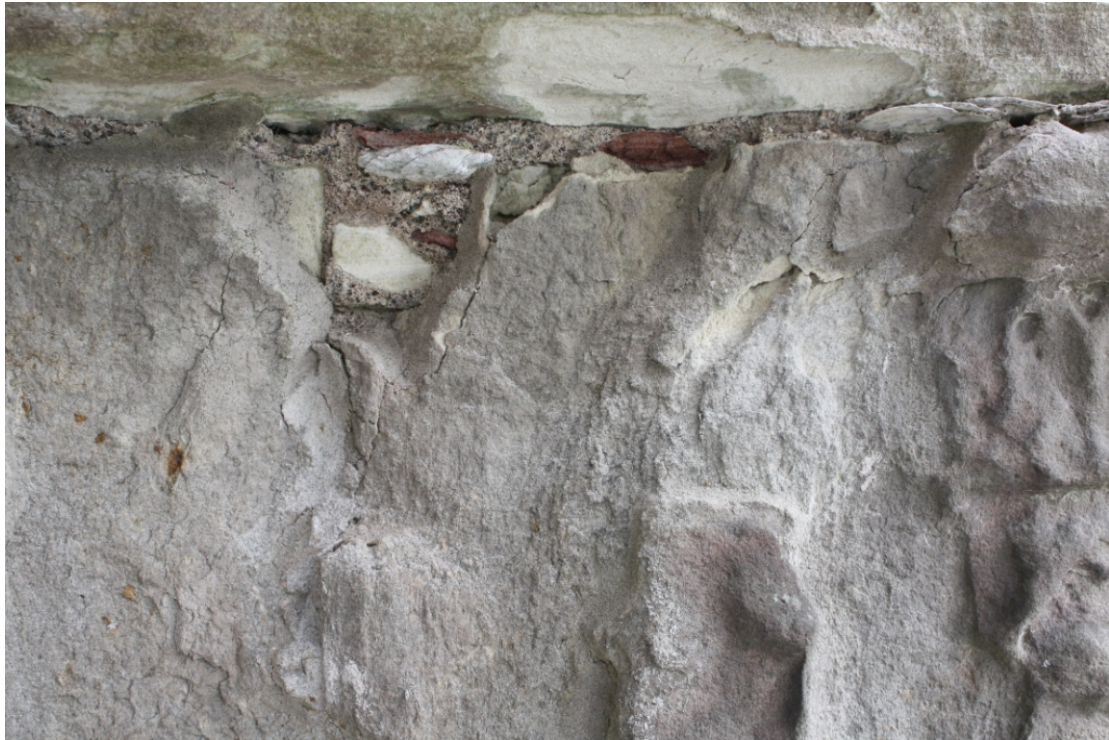
**Failing resin repairs and surface delamination at centre of top edge**

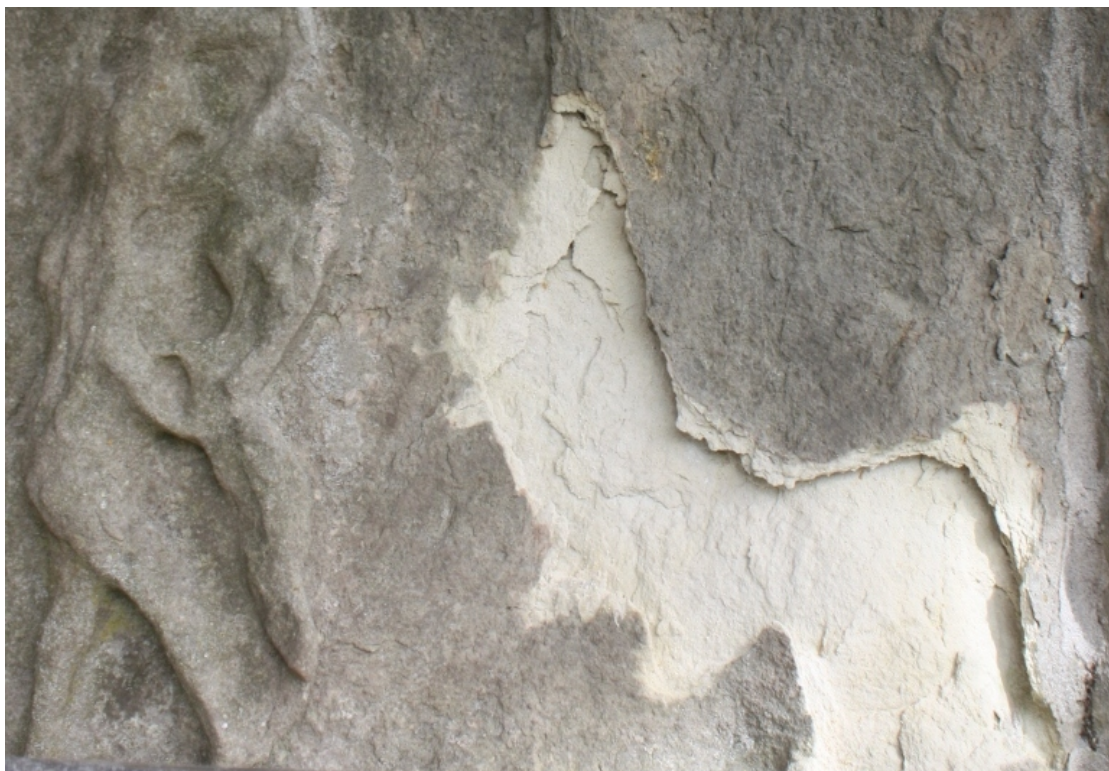
**Area of recent loss from surface delamination with exposed disaggregated substrate**
