| MONUMENT | BOTHWELL CASTLE |
| PROJECT | LATRINE TOWER CONSOLIDATION WORKS<br>SHAFT AND INTERIOR CONSOLIDATION DETAILS |

| PROJECT DRAWING NUMBER | | 90038-150714-003B | |

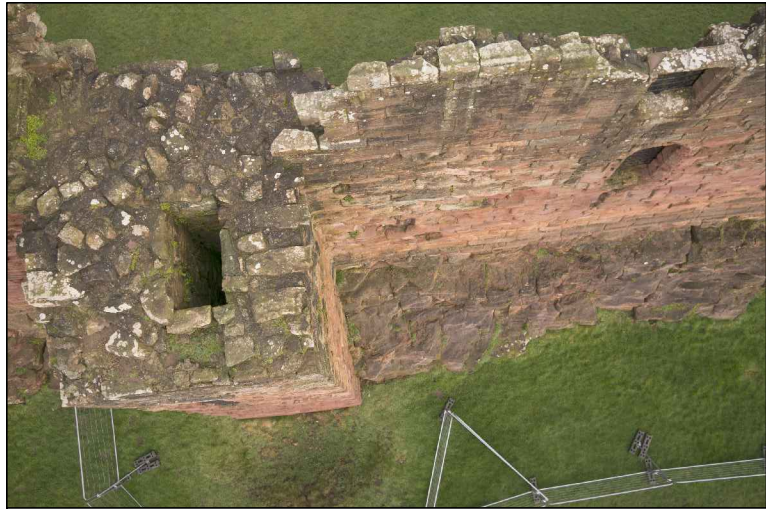
ROUGH RACKED WALLHEAD TO LATRINE TOWER: photographed 13th March 2015

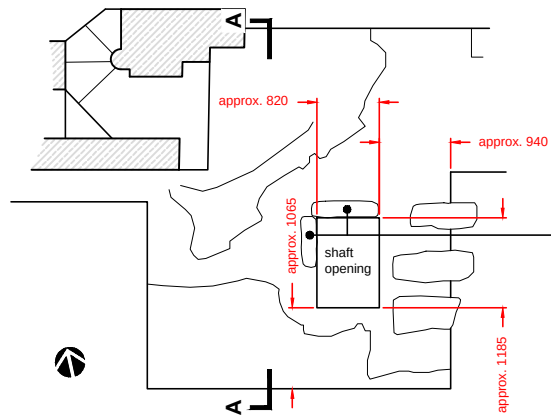
1:50 LATRINE TOWER ROUGH RACKED WALLHEAD:  
extracted from archive drawing 188/038/005 (date unknown).

Worked larger stones to edges of shaft which may be original, likely reset in recent past.

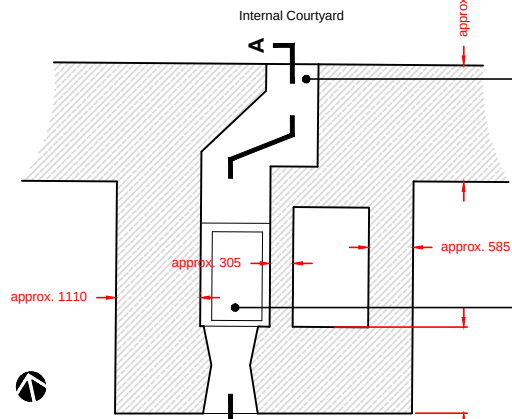
1:50 LATRINE TOWER AT INTERNAL COURTYARD LEVEL:  
extracted from archive drawing 188/038/018 (circa 1924).

Existing modern yett to latrine shaft with defective fixings. Cut out corroded fixings and re-new into stonework joints.

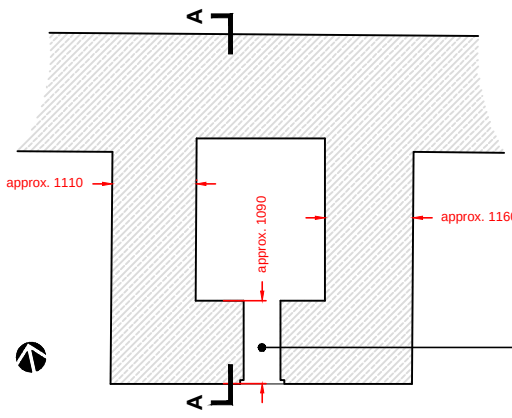
1:50 LATRINE TOWER AT BASE:  
extracted from archive drawing 188/038/018 (circa 1924).

Low level opening in depression at external ground level.

Low level outlet at external ground level. Provisionally open up outlet opening by removing modern metal plate/modern stone infill to allow access.

Provisionally allow for removing turf to open up at outlet.

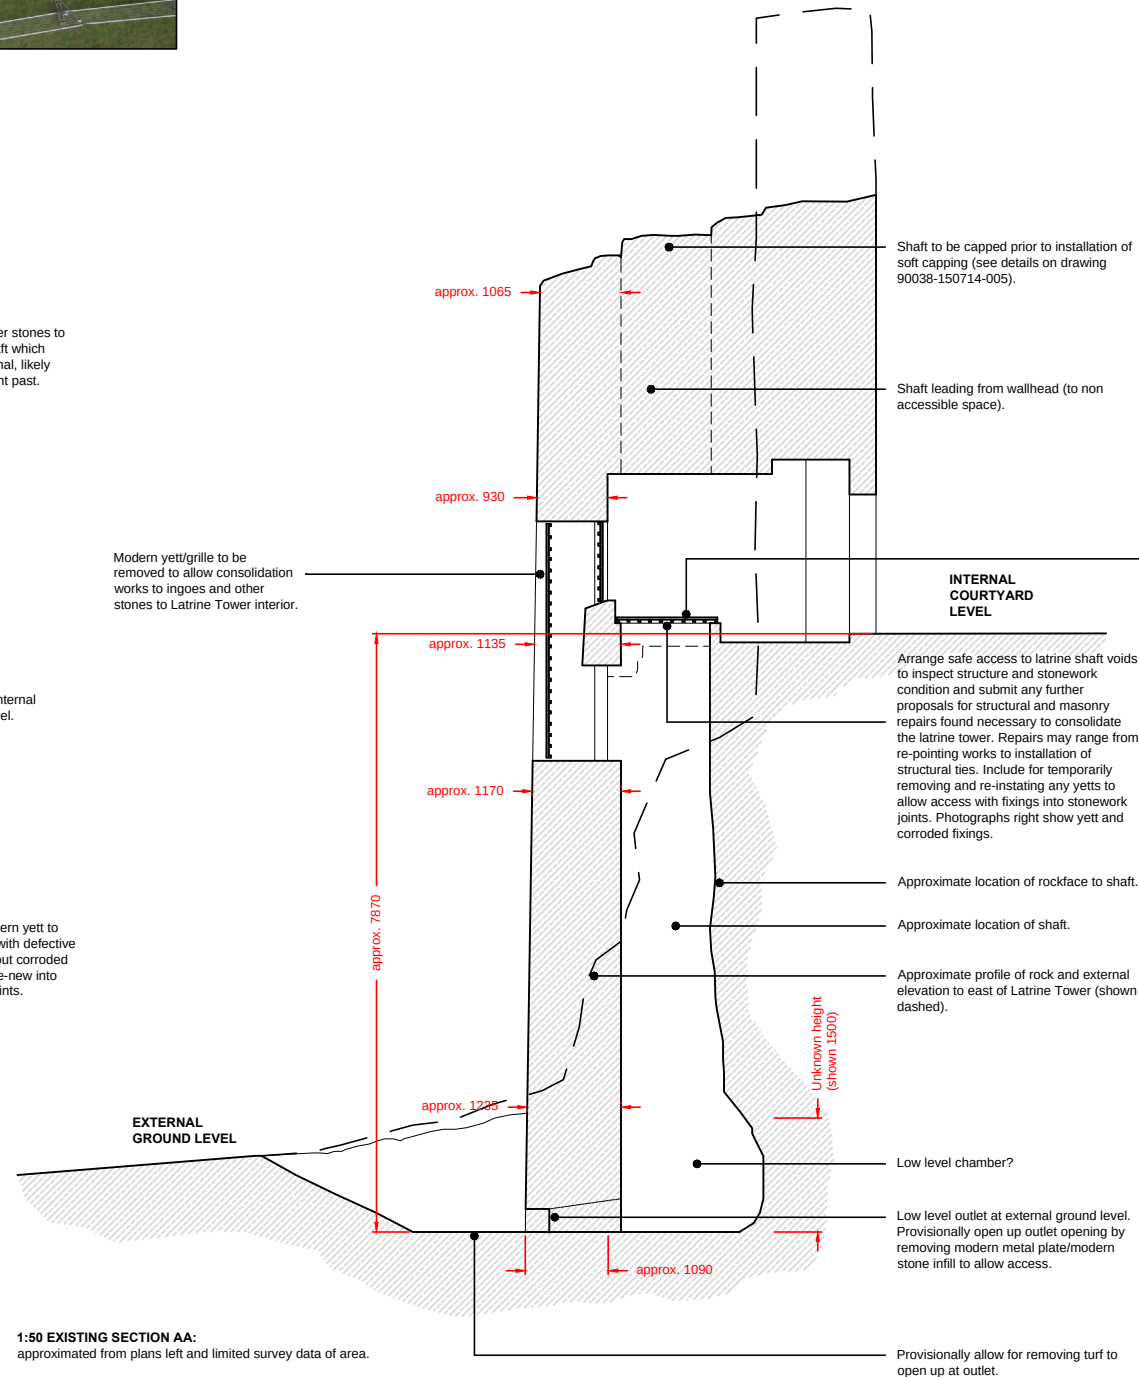
1:50 EXISTING SECTION AA:  
approximated from plans left and limited survey data of area.

Shaft leading from wallhead (to non accessible space).

Low level chamber?

Shaft to be capped prior to installation of soft capping (see details on drawing 90038-150714-005).

Arrange safe access to latrine shaft voids to inspect structure and stonework condition and submit any further proposals for structural and masonry repairs found necessary to consolidate the latrine tower. Repairs may range from re-pointing works to installation of structural ties. Include for temporarily removing and re-instating any yetts to allow access with fixings into stonework joints. Photographs right show yett and corroded fixings.

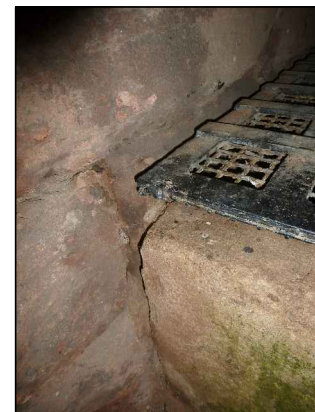
Defective and corroded yett fixings. Fixings to be cut out to allow removal of yett, with new fixings into stonework joints being used to re-install yett once condition inspection of shaft and any necessary repairs have been completed.
