| MONUMENT | BOTHWELL CASTLE |
| PROJECT | LATRINE TOWER CONSOLIDATION WORKS<br>PROPOSED EXTERNAL ELEVATIONS WORKS |

| PROJECT DRAWING NUMBER | 90038-150714-004B |

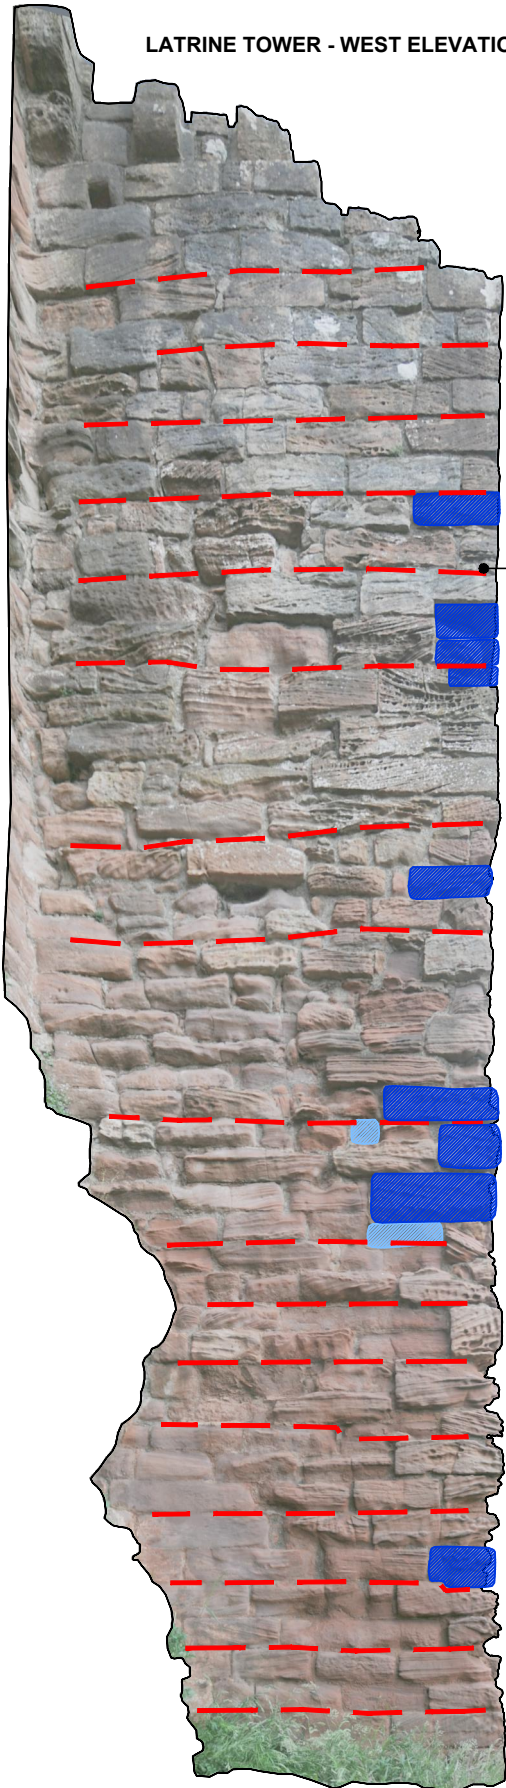
## LATRINE TOWER - WEST ELEVATION

Opening previously consolidated as large vertical opening with yett which appears not to be historically correct. Pay particular regard to opening west jamb stones when carrying out repairs to ensure all evidence of original build and configuration is retained, or recorded and replicated in indents.

This area to be assessed on site once safe access is available to determine if helical bar reinforcement is required into joints  
\*(provisionally shown helical bars at every second joint below south facing opening).

6mm diameter stainless steel helical bars to be installed at regular intervals (provisionally every 2nd or 3rd bed joint as built permits) and returned 3m on each side. At the opening, helical bars to be returned into interior space as far as possible.

Existing modern yett grille to be removed for works. Assess weight and determine method of removal. Unbolt from existing fixing straps which are to remain in-situ. If operation proves difficult, cut yett to enable removal in preference to damaging fixings. On completion of works allow for re-setting any loose fixing straps into resin and adding additional bronze or stainless steel fixing straps of similar design into joints if required. Repair, overhaul, or replace yett to similar design and re-instate back into opening.

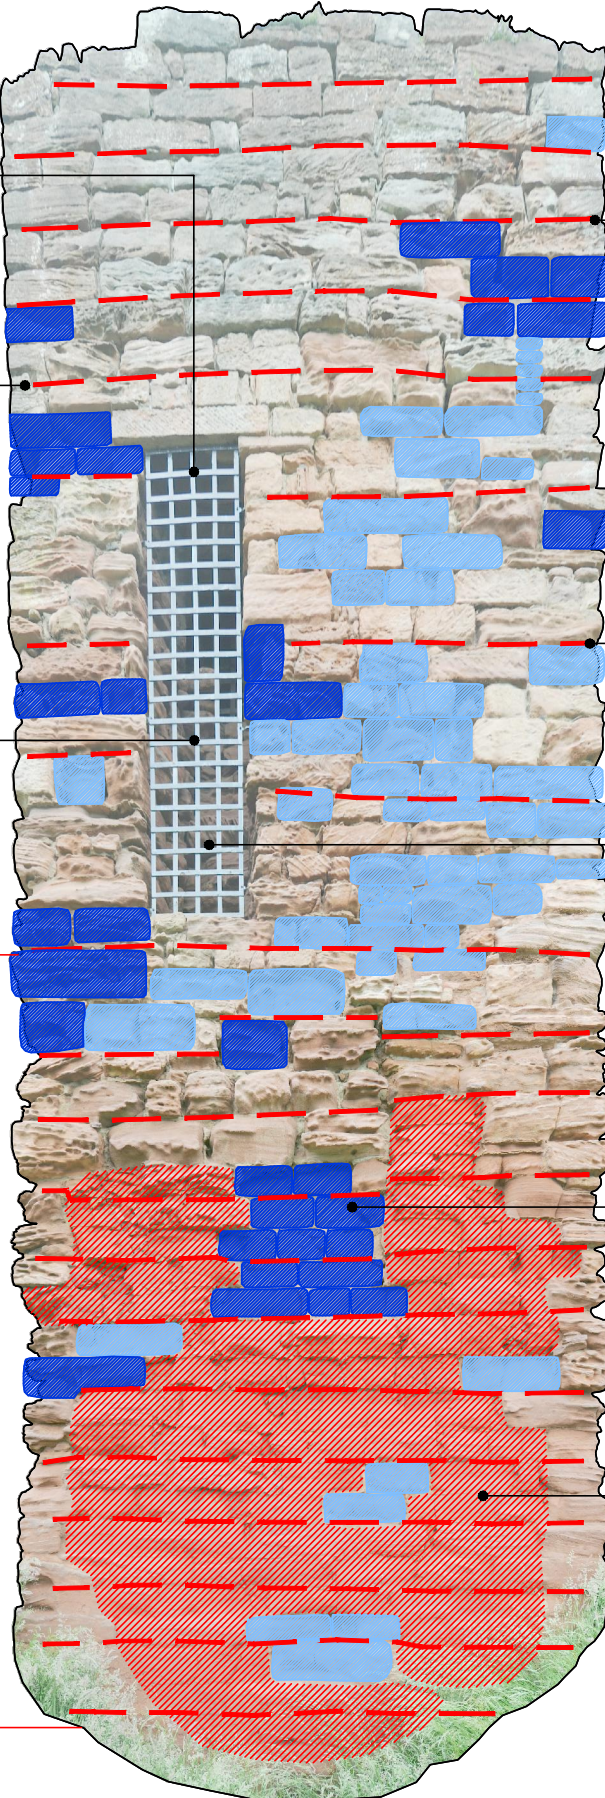
## LATRINE TOWER - SOUTH ELEVATION

To consolidate, restore structural integrity and prevent erosion of core material, re-instate missing area of facework shown to have disappeared since after 1899 archive photo was taken. Prior to carrying out these works, provisionally cut out small area of core and eroded facing stone behind, within shaft, to determine overall thickness of wall, facing stone thicknesses and build quality which will inform stone indent requirements to badly eroded back facework at base.

Within red hatched base area identify severely decayed stones in locations required for structural build/facing thickness investigation to confirm structure is sound. Carefully cut out and open up. From this, determine extent of stone replacement required to maintain across area to ensure structural performance. Note, provisionally allow for 70% indenting here.

6mm diameter stainless steel helical bars to be installed at regular intervals (provisionally every 2nd or 3rd bed joint as built permits) and returned 3m on each side. At the opening, helical bars to be returned into interior space as far as possible.

6mm diameter stainless steel helical bars to be installed provisionally at every fourth joint here and returned 3m on each side. At the opening, helical bars to be returned into interior space as far as possible. See details below right for helical bar installation.

Arrange safe access to latrine shaft voids to inspect structure and stonework condition and submit any further proposals for structural and masonry repairs found necessary to consolidate the latrine tower interior (see drawing 90038-150714-003). Include for temporarily removing and re-instating any yetts to allow access.
