KILLEAN AND KILCHENZIE OLD CHURCHES

KINTYRE

REPORT

I. INTRODUCTION

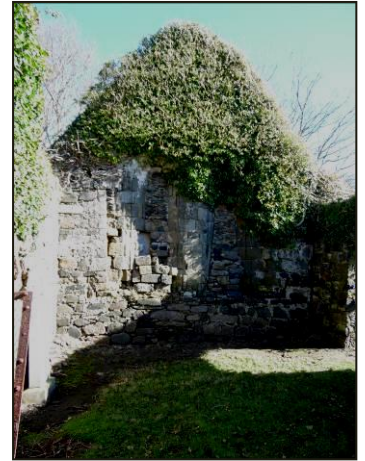
EAST WALL WITH ELABORATE WINDOW OBSCURED BY IVY

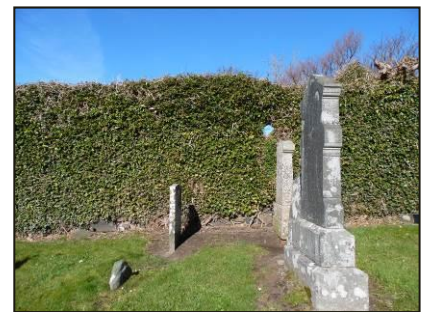
VIEW OF SOUTH WALL COVERED BY IVY

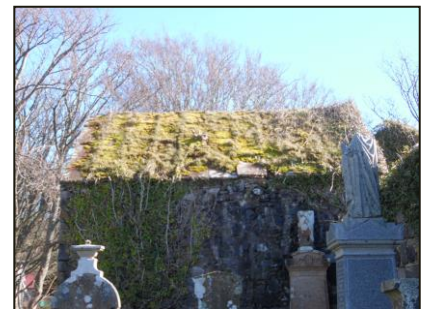
NORTH AISLE COVERED WITH VEGETATION, VISIBLE ORIGINAL ROOFING SLABS

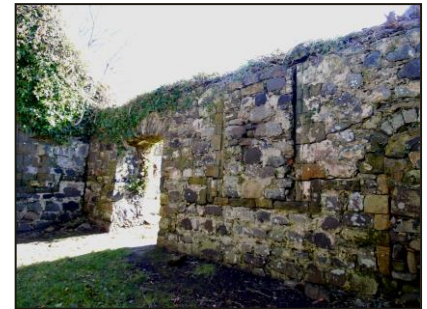
The south wall is leaning outwards relatively consistently from approximately 100mm to the west of the crosswall to some 250mm in the east part. This tilt is historic and due to the burials adjacent to the foundations. Although this distortion might appear to be extensive it is not threatening the stability of the wall itself.

SOUTH WALL INTERNALLY – ABOVE AND BELOW - VISIBLE TILT AND DISTORTIONS AT INFILLS

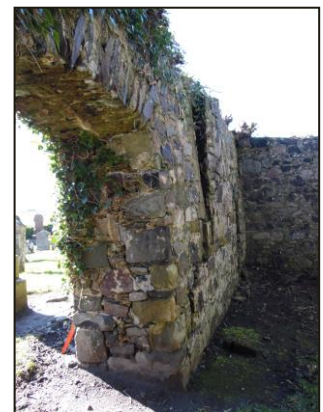
The church has been heavily overgrown with ivy for over 60 years. We can say this on the basis of old photographs. The ivy has been trimmed recently, however, large roots have penetrated the walls and infills splitting them and pushing large lumps of masonry outwards. Our photographs and a sketch are showing this.

SOUTH WALL AT DOOR – NOTE EXTERNAL SECTION OF WALL LIFTED AND PUSHED OUT BY IVY

The purpose of the propping is to hold in those masonry segments which have been wedged out of the wall by roots and other effects. The longstanding historical leaning of the wall has to be accepted for now. It is due to burials and early ground disturbance etc.

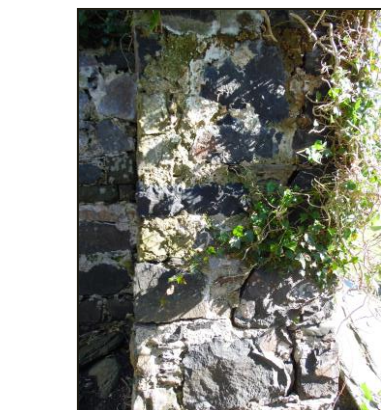
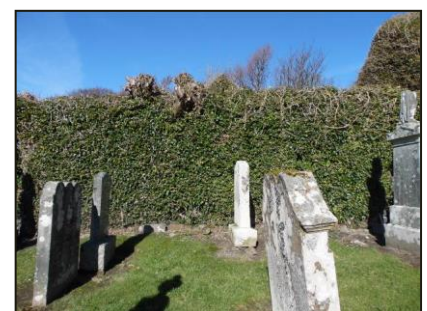
SOUTH WALL – MASSIVE TREE ROOTS IN INFILLED WINDOW AREA

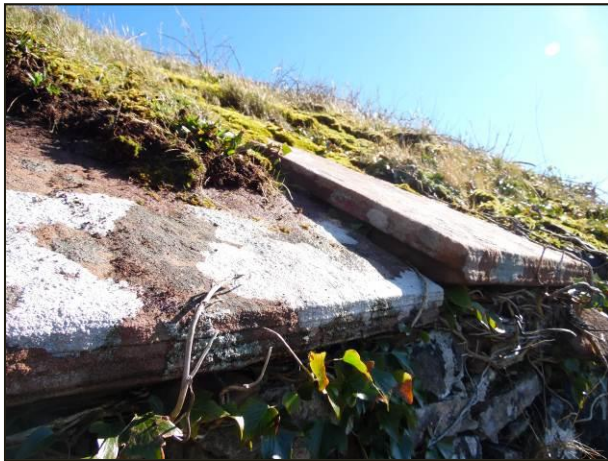
NORTH AISLE - ORIGINAL ROOFING SLABS LIFTED BY ROOTS, LOOSE WALLHEAD STONES HELD BY IVY

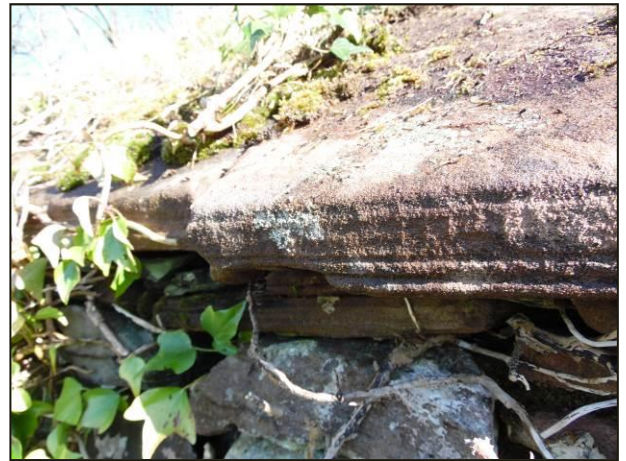
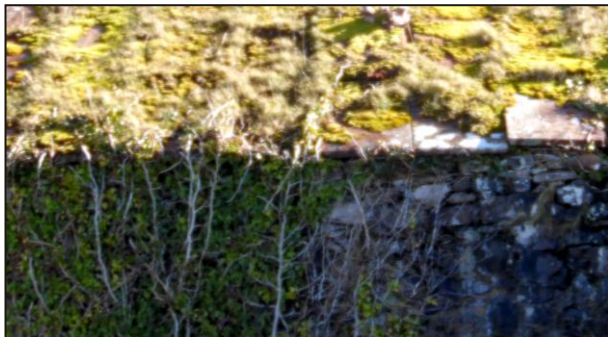
NORTH AISLE WEST WALLHEAD

The walls are covered with ivy but are still in good condition up to some 400mm downwards from the wallhead level. The ivy has penetrated the wallhead however and is now holding the stones and roofing slabs in place. A concern however is the amount of water retained by the ivy in the upper parts of the walls. This must have a detrimental impact on the internal environment of the aisle and its humidity level. We noted some minor salt efflorescence on one of the graveslabs.

IVY RETAINING WATER AND PREVENTING WALL FROM DRYING
NOTE GOOD CONDITION OF WALL FACE SOME 600MM BELOW
WALLHEAD LEVEL

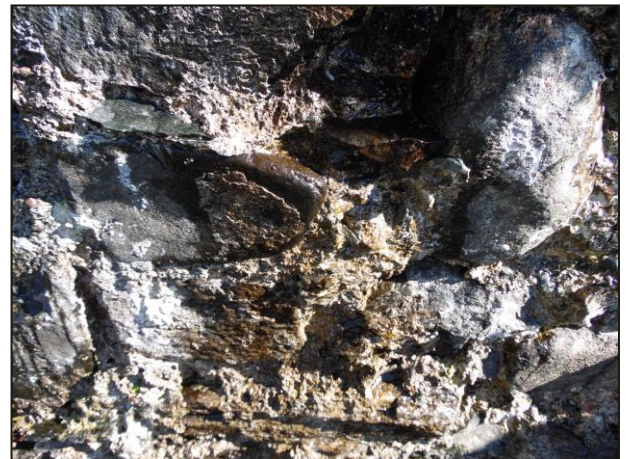
WATER RUNNING ON THE WALL FACE UNDER IVY

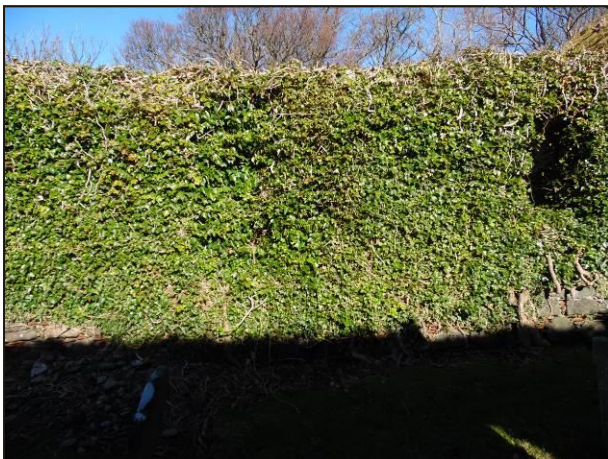
NORTH WALL INTERNALLY - HEAVY
IVY GROWTH

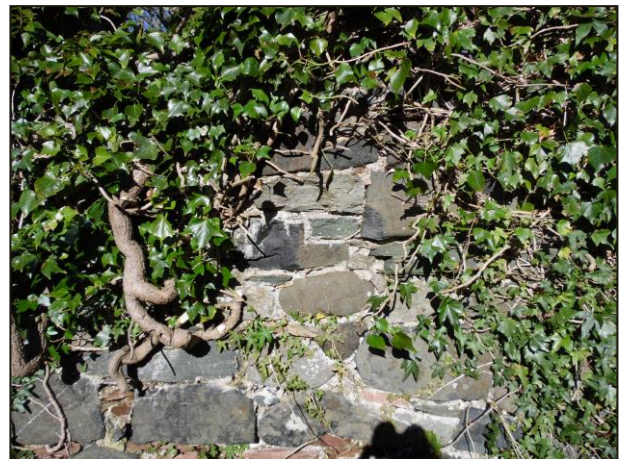
NORTH WALL INTERNALLY - INTACT
UNDER IVY

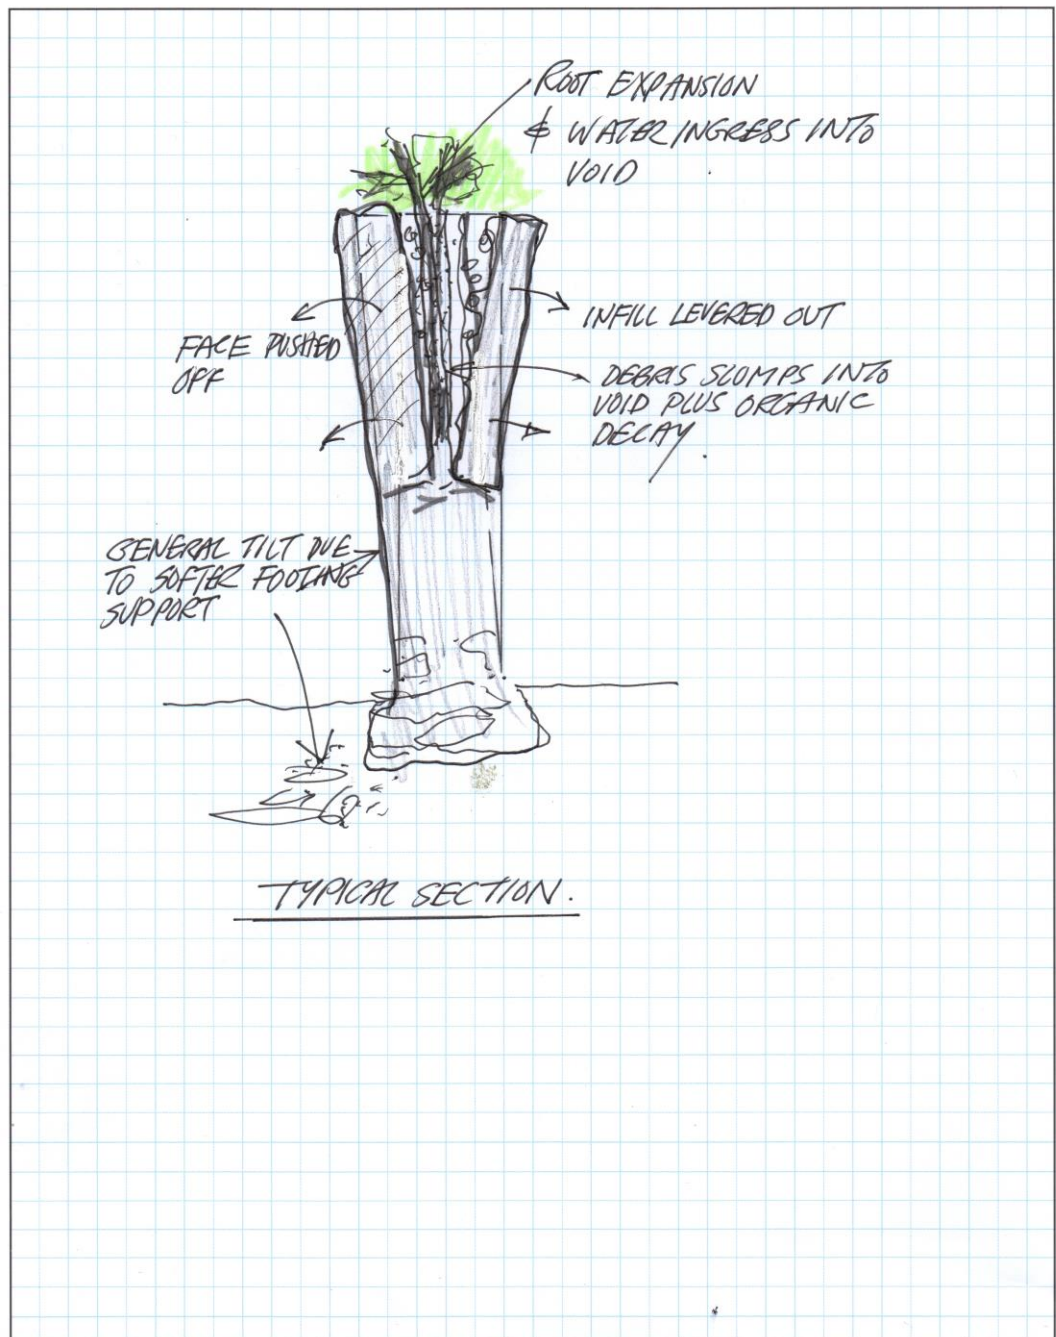
Drg No SK/O Job No 16/821
Rev _____ Scale _____
Drawn by JPA Date MAR16.
Checked by _____ Date _____

EFFECT ON ROOTS & VEGETATION
GROWTH

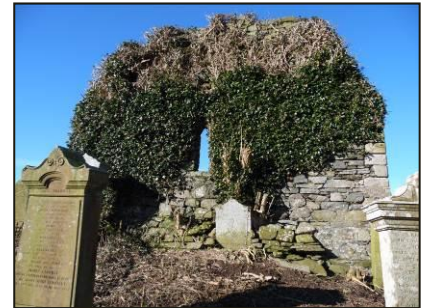
OVERGROWN EAST GABLE

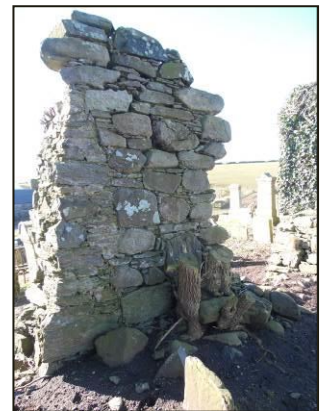
SOUTH WALL STUB – NOTE LARGE TREE ROOT AT THE BASE

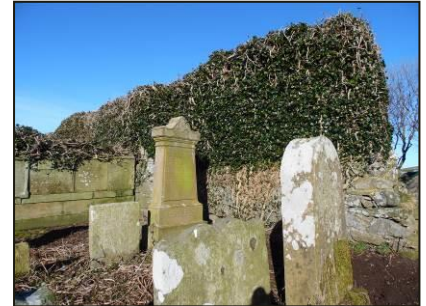
SOUTH WALL OVERGROWN WITH IVY

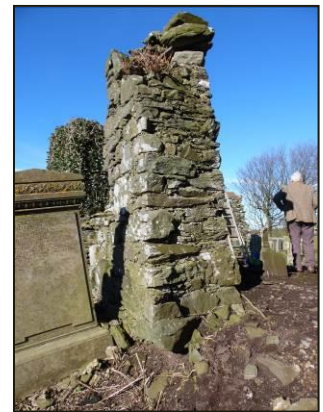
- The stability of the “stub” which lost some of its foundation stones due to the proximity of the graves and erosion
- Loss of support of the original door lintel in west end of the south wall due to erosion of the poor quality masonry infill

“STUB” – PUSHED BY TREE ROOT FROM INSIDE AND WITH VOID AT FOUNDATION LEVEL

- 1) Remove loose earth from the void without excavating
- 2) Line the void with Tyvek or similar separating membrane. This is to ensure that there is no bond between the masonry and lime concrete infill.
- 3) Mix lime concrete in proportion 1 part of hydraulic lime NHL5 to 2 parts of well graded aggregate from 20mm downwards. Mix should be semi-dry. Fill small hessian bags with lime concrete up to one third of bag capacity. This work can be done off site and prepared in bags transported to the churchyard
- 4) Place bags into the void lined with membrane and compact them thoroughly.

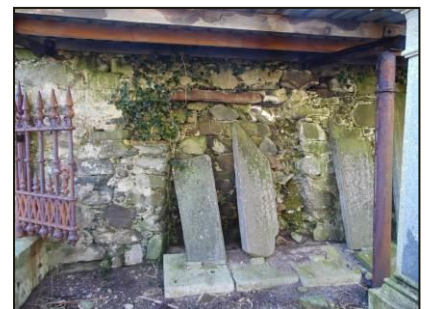
UNSUPPORTED ORIGINAL LINTEL
