BLAIRFINDY CASTLE, GLENLIVET

*REPORT ON CONDITION OF THE RUIN
AND
PROPOSED CONSERVATION WORKS*

APRIL 2016

addison conservation + design

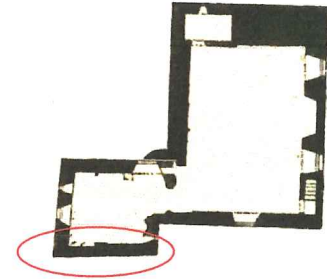
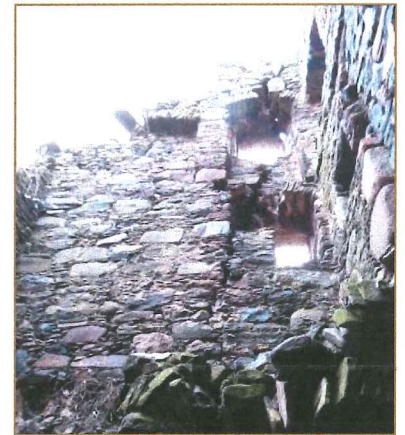
Internally, there are loose stones and missing voussoirs of the upper window arch with a large stone wedged between parts of masonry. This area is particularly vulnerable and the stone is likely to fall if the erosion is allowed to progress further. The lower window was altered and part of the arch was removed or collapsed.

VIEW ON UPPER PARTS OF THE WALL INTERNALLY, VISIBLE DAMAGE TO MASONRY AT THE LOWER WINDOW DUE TO HISTORIC ALTERATION

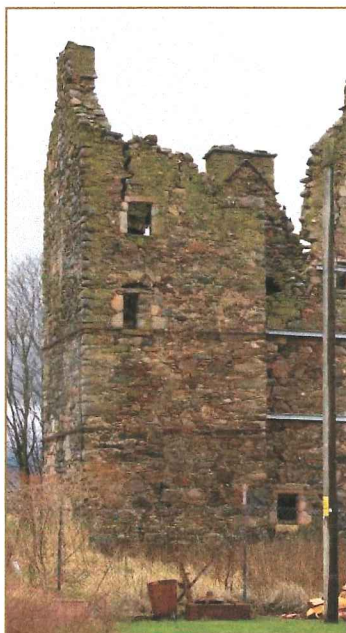
Externally, apart from the wallhead level, the masonry is in good condition. At the wallhead, there are numerous loose stones clearly visible.

SOUTH WALL OF TOWER EXTERNALLY

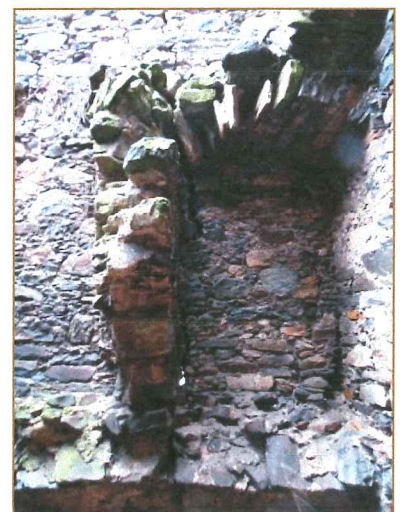
Some of the springer stones of the ground floor vaults and of the recess are loose.

OVERHANGING REMAINING PARTS OF VAULT AND RECESS UNDER STAIRS WITH VISIBLE CRACK

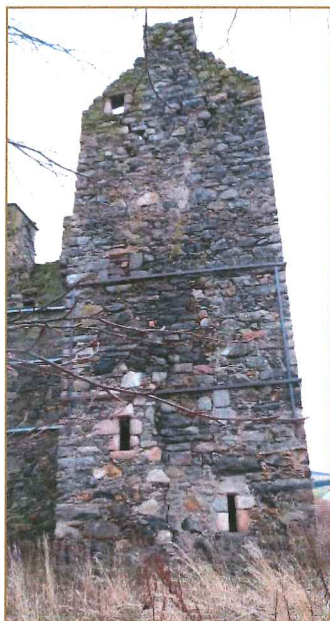
The wall is clamped with a steel ties at its lower part, where there is a vertical crack through the wall on the line of an old flue. At the upper level, the crack splits into two, one leading towards the cill a small window and another one following the flue line. Probably, the crack initiated as part of the foundation settlement recorded elsewhere. However its erosion over time and the corresponding weaker parts of the masonry initiated further movements.

ELEVATION – NOTE FRAGILE AND ERODED MASONRY ALONG THE FLUE LINE AND AT THE WALLHEAD

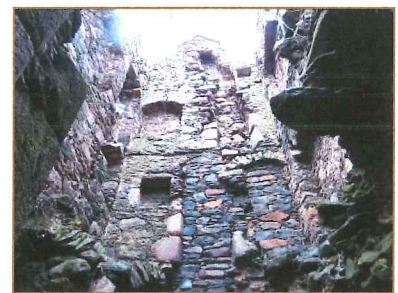
VIEW ON UPPER PARTS OF THE WALL. NOTE LINE OF THE FLUE TWICE CHANGING IN DIRECTION. THE MAIN CRACK FOLLOWS THIS LINE. ALSO, NOTE THE ERODED AND OVERHANGING STONES AROUND THE FLUE AT THE TOP FLOOR AND SPLIT ARCH OF THE RECESS

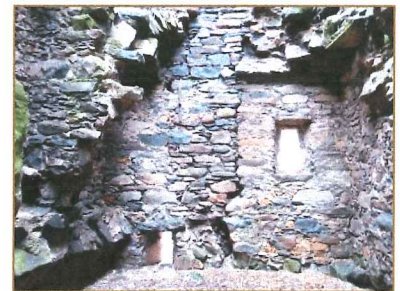
THE FLUE STARTS JUST ABOVE THE GROUND FLOOR VAULTS; NOTE LOOSE AND ERODED MASONRY AROUND.

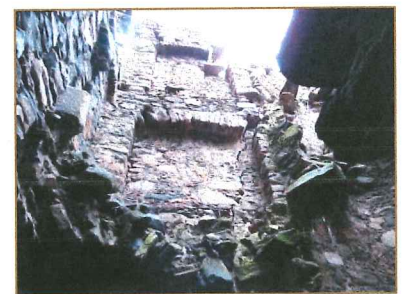
There is an instability of a large part of the masonry above the small top floor window. This area has separated from the corner with the north wall by a distinctive cracking of geotechnical origin, and internally corresponds with the thick area of masonry above the top floor arched recess. The arch is shallow and unresolved due to missing springers and cracking.

NORTH WALL OF TOWER INTERNALLY
VIEW ON UPPER LEVELS SHOWING
UNRESOLVED ARCHES AND PARTIALLY
COLLAPSED PASSAGE

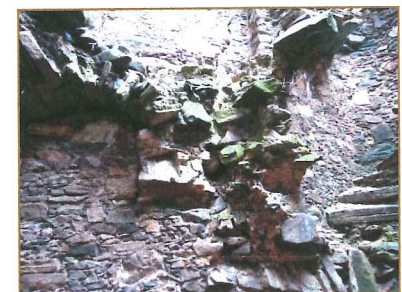
JUNCTION AT THE BEGINNING OF
CIRCULAR STAIRS AT FIRST FLOOR

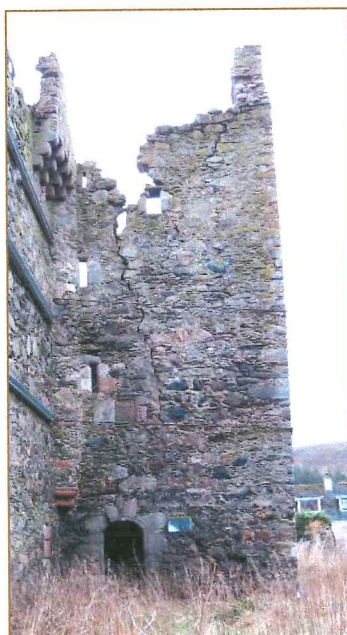
NORTH WALL OF TOWER
EXTERNALLY; NOTE INSTABILITIES
AT THE UPPER LEVEL

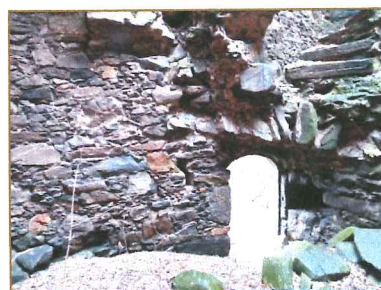
ERODED VAULT AND STAIR REMAINS
ABOVE THE DOOR

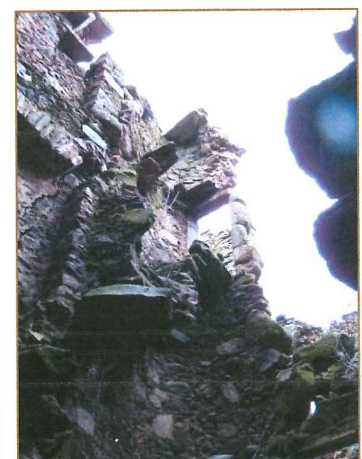
Another line of significant cracking follows the junction with the circular stairs. There are numerous overhanging stones in this area and a block of masonry is fragilely supported on a door lintel and jamb stones. This area however has not separated cleanly from the main wall so there is some relatively effective corbelling there. This cannot be relied on for much longer, however.

JUNCTION WITH THE CIRCULAR
STAIRS WITH A LARGE CORBELLING
CHUNK OF MASONRY ABOVE LINTEL

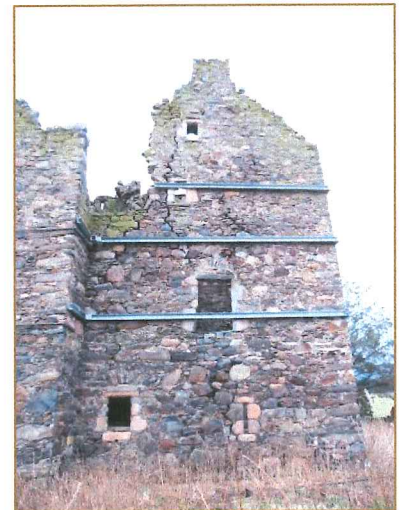
However, a particularly vulnerable area exists at the junction with the Tower. Although it is not obvious from ground level, this area would possibly have had a bartisan type feature which collapsed a long time ago. Such a feature was common for this type of castle and could have accommodate a stair to the attic floor or communication passage to the Tower.

Regardless of the source, the severe undercut of the masonry at the top steel channel, internally and externally, and its relation with the cracks radiating from this point suggests an instability which should be addressed very soon. In this case, the connection of the steel channel to the masonry is proving to have a negative impact.

SOUTH WALL ELEVATION – NOTE EXTENSIVE CRACKING AND INSTABILITY AT THE JUNCTION WITH TOWER.

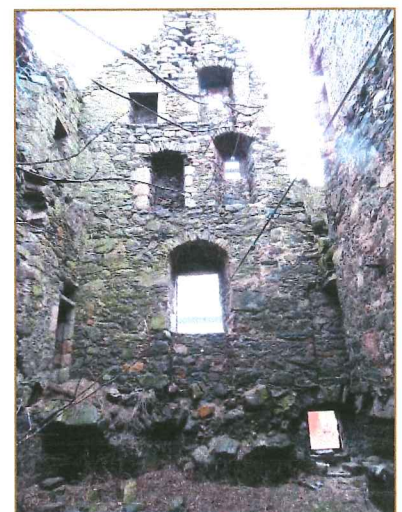
INTERNAL VIEW OF THE SOUTH WALL – NOTE UNDERCUT PIER OF THE TOP FLOOR WINDOW AND EROSION OF THE CHIMNEY

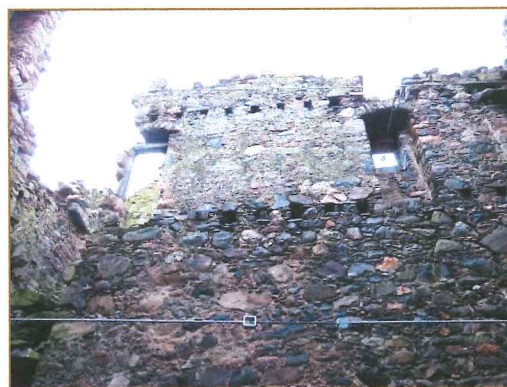
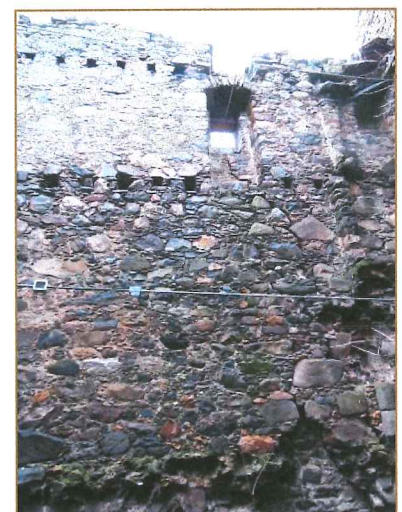
WEST WALL INTERNALLY - NOTE CORBELLING OVERHANG AND EXPOSED TO EROSION UPPER WINDOW ARCH; OTHERWISE, APART FROM USUAL EROSION THE WALL IS IN RELATIVELY GOOD CONDITION

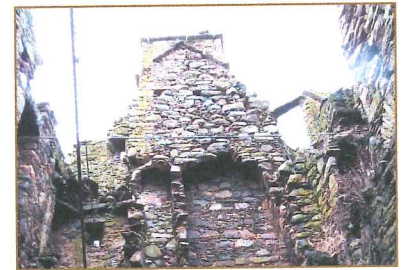
Almost all of the internal face of the main and secondary flues have disappeared leaving exposed and heavily eroded feathery. At the top level, the masonry has created a natural arch supporting the chimney but this is a very fragile and has unreliable stability.

CHIMNEY SUPPORTED BY ARCHING MASONRY; THE ARCH SPANS BETWEEN TWO DELICATE AND HEAVILY ERODED PIERS

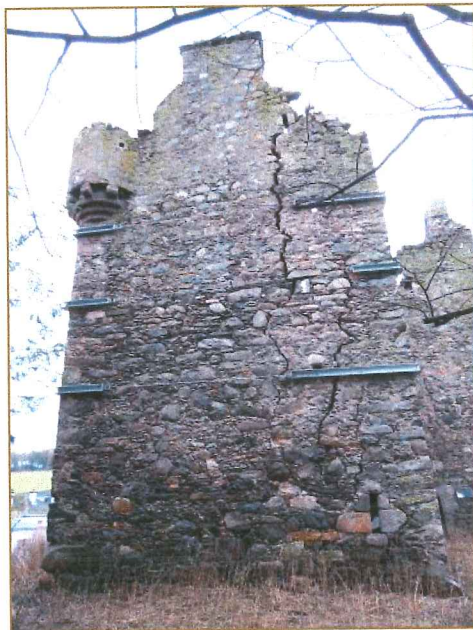
This wall displays severe cracking and separation of the north west corner arising from geotechnical origins but is exacerbated by the masonry weakened by a combination of flues and recesses which reduce the overall robustness of the wall.

EXTERNAL FACE OF THE NORTH WALL
VISIBLE LARGE CRACKS

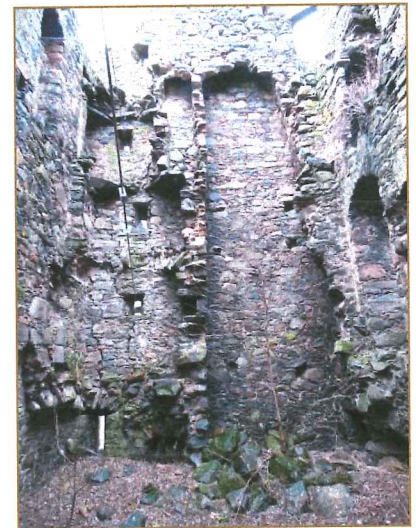
INTERNAL VIEW OF THE NORTH WALL.
VISIBLE ERODED AND FRAGILE FLUE
FEATHERS AND RECESSES

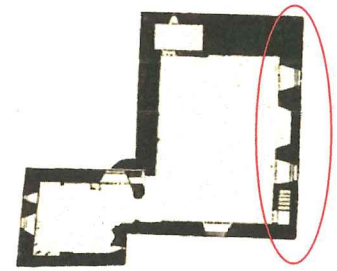
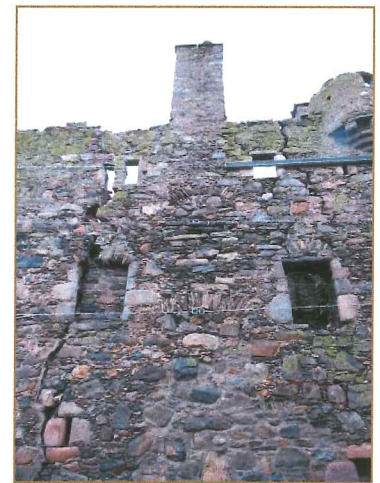
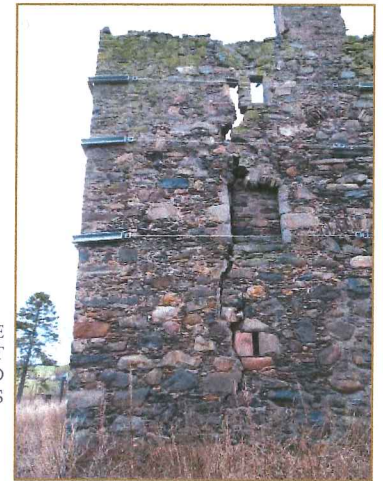
East Wall has similar complexity. In its centre there is a large fireplace of the original great hall and its massive flue, the weight of which was meant to be spread through two relieving arches on the external elevation. The main, most likely highly decorative, lintel of the main fireplace is missing. The fireplace was flanked by two large windows, one of which was built up at a later date. Further, the wall was weakened by a stair carved into the south east corner.

The initial cracking of the castle due to soil consolidation has been increased by erosion and weathering causing localised collapsing of parts of masonry and further secondary cracking.

TWO PHOTOGRAPHS SHOWING THE EXTERNAL ELEVATION OF THE EAST WALL WITH ITS CRACKING AND LOCALISED INSTABILITIES

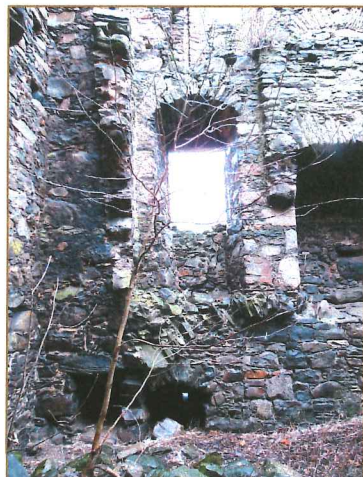
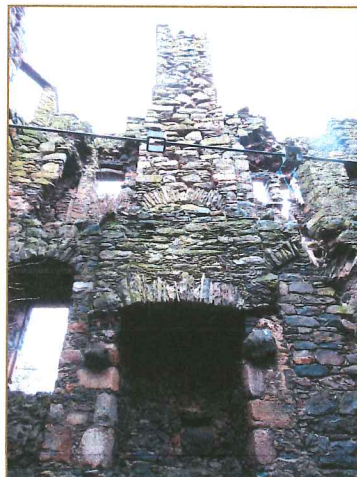
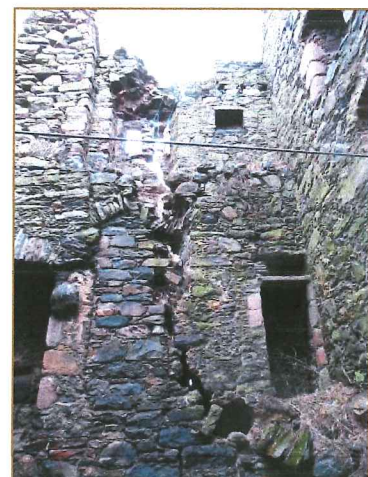
There are many areas of overhanging corbelling masonry, unstable piers and unresolved arches. To the south of the chimney, there is a very distorted part of wall which appears to be "tied" with some ropes to the lintels below.

There is also extensive erosion of the flue masonry with the back of the main fireplace having been consolidated relatively recently with cementitious mortars.

THREE PHOTOGRAPHS BELOW SHOW THE CONDITION OF THE EAST WALL INTERNALLY

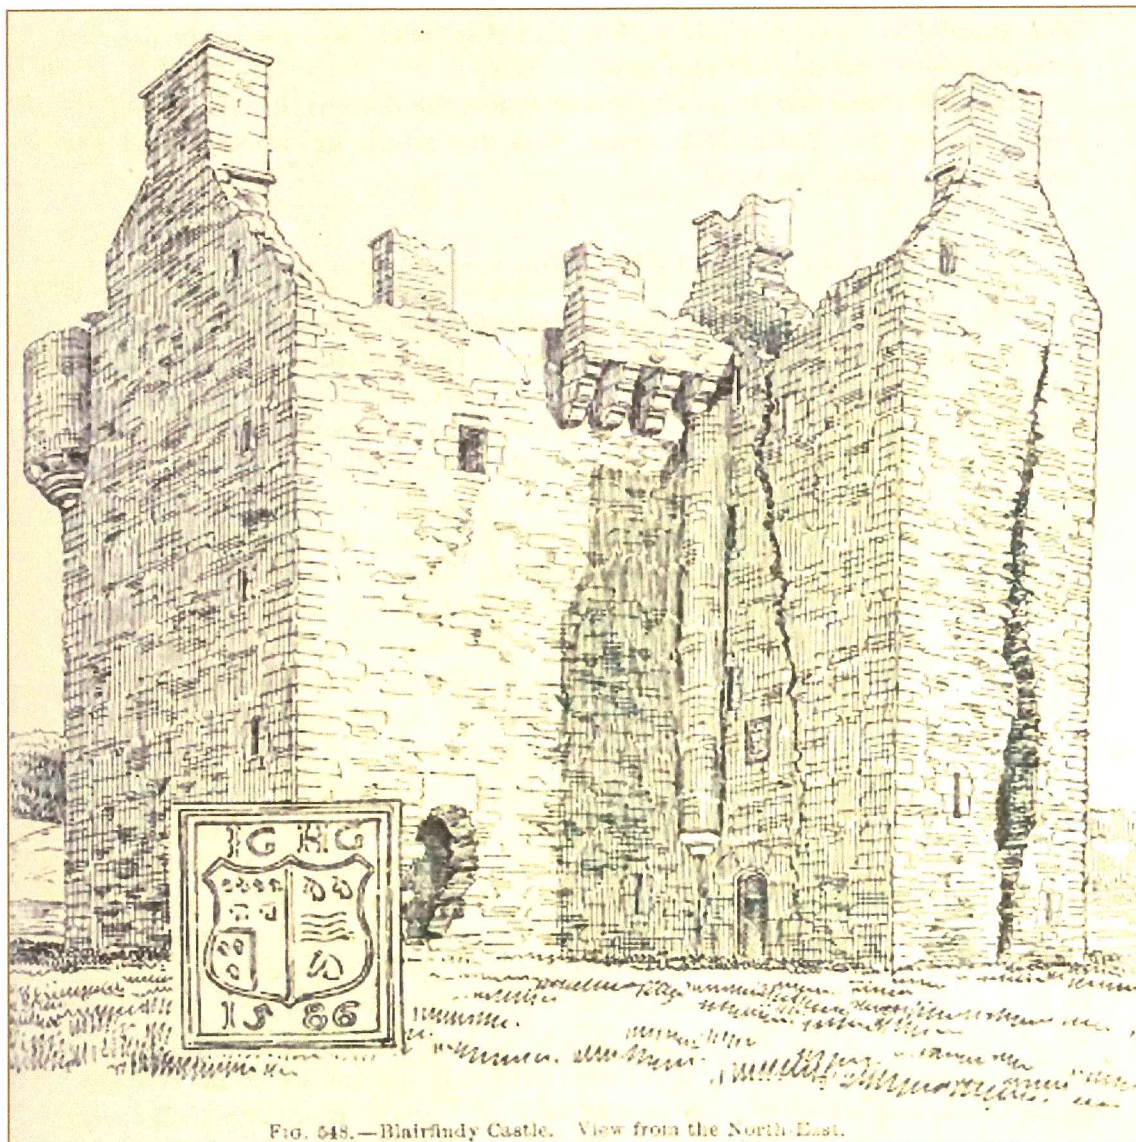
FIG. 548.—Blairfindy Castle. View from the North-East.

NOTE SEVERE CRACKING AND LOSS OF MASONRY
