Kincardine O'Neil Auld Kirk Photographs

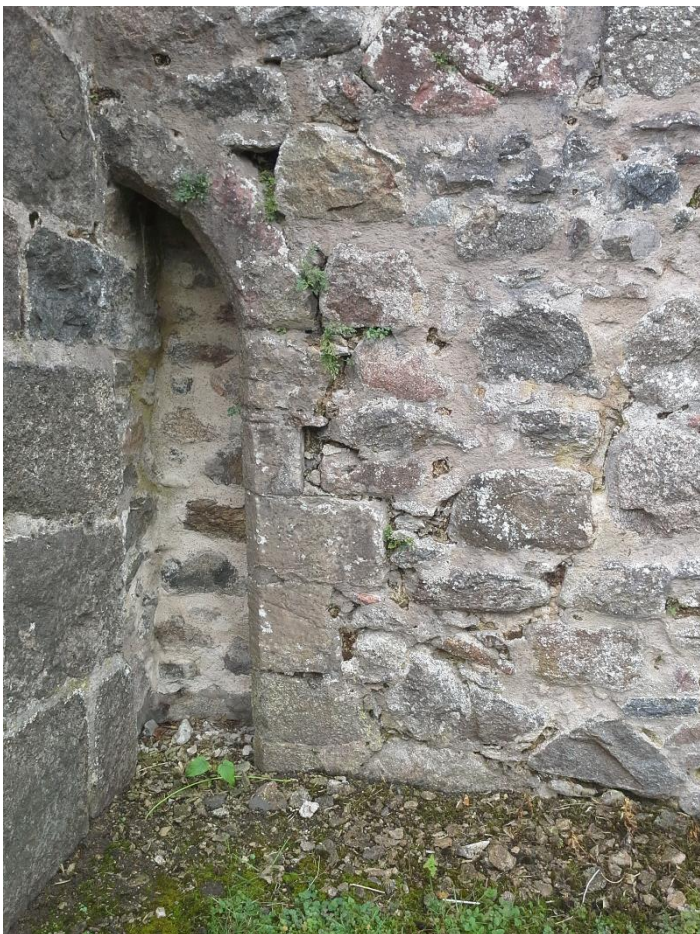
Photo 1: Deteriorated recent attempts of re-pointing using cement

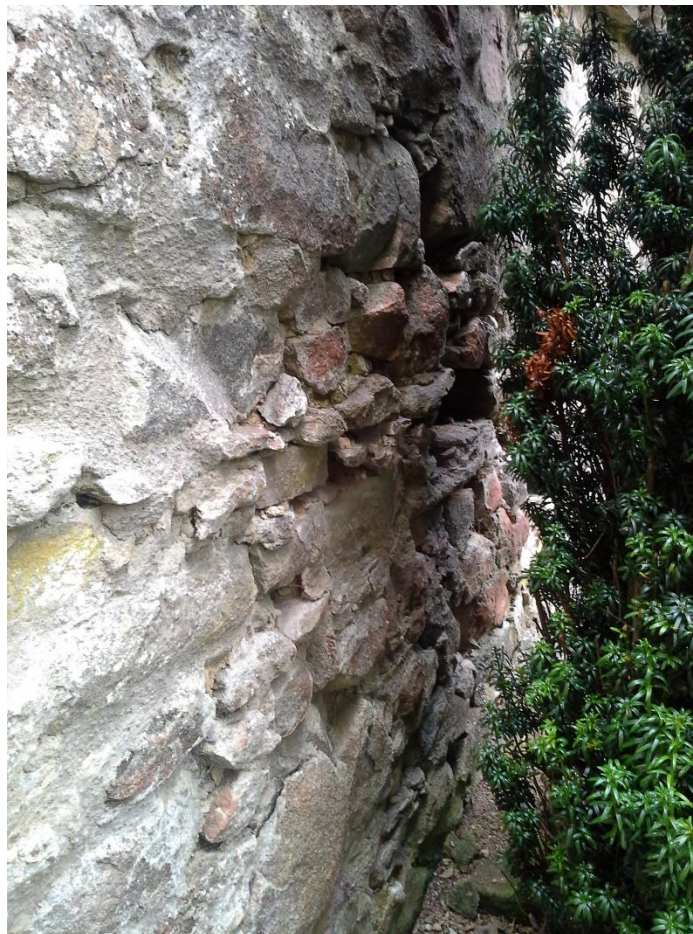
Photo 2: Eroded pointing behind yew tree

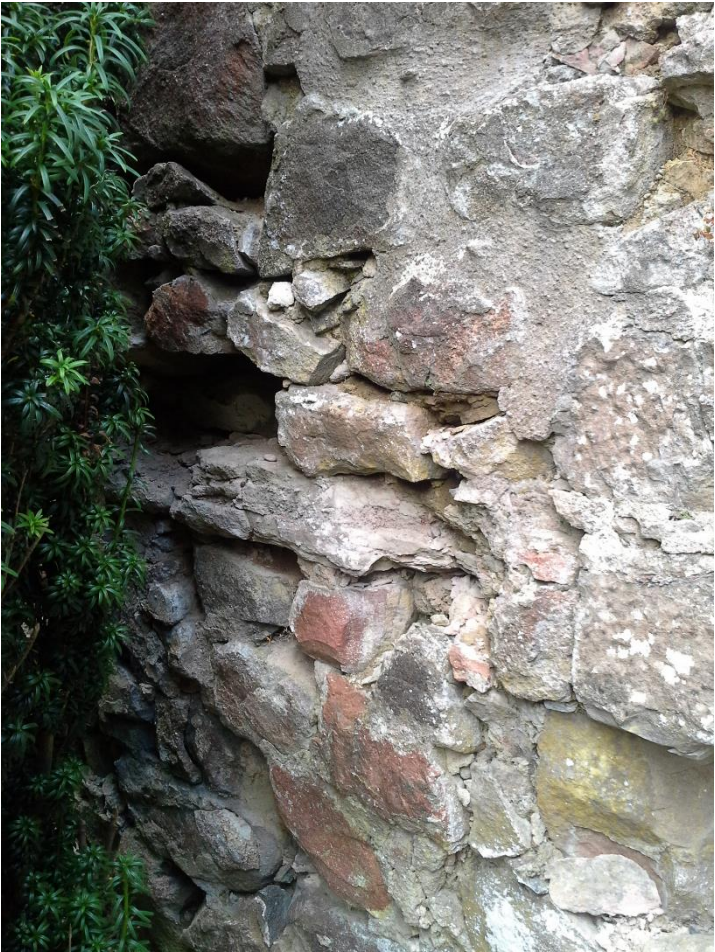
Photo 3: Large area of eroded pointing behind yew tree

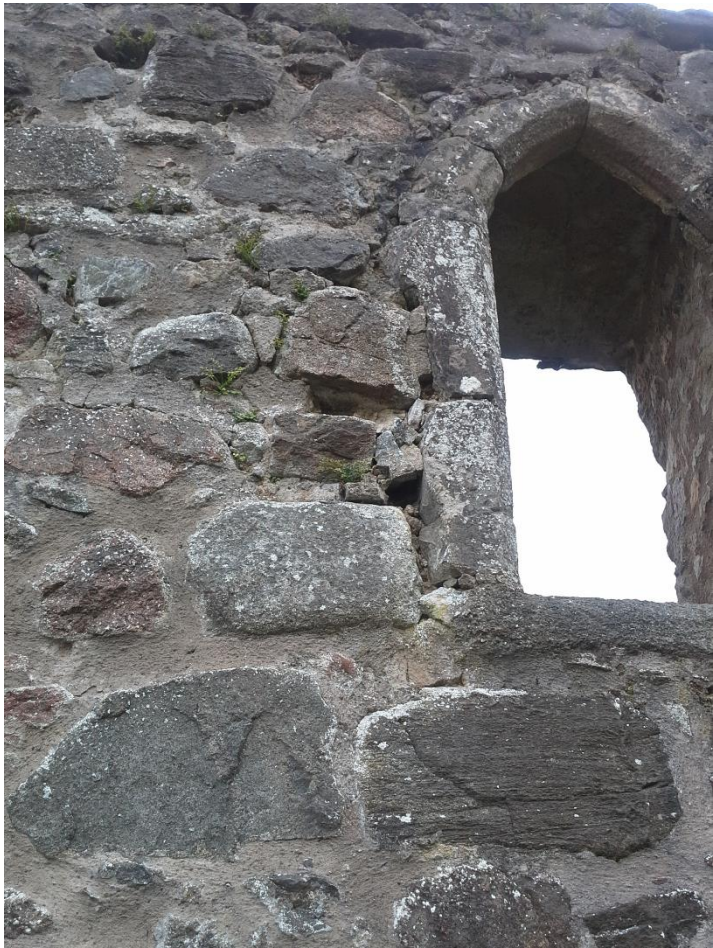
Photo 4: Deterioration of pointing around window on east gable

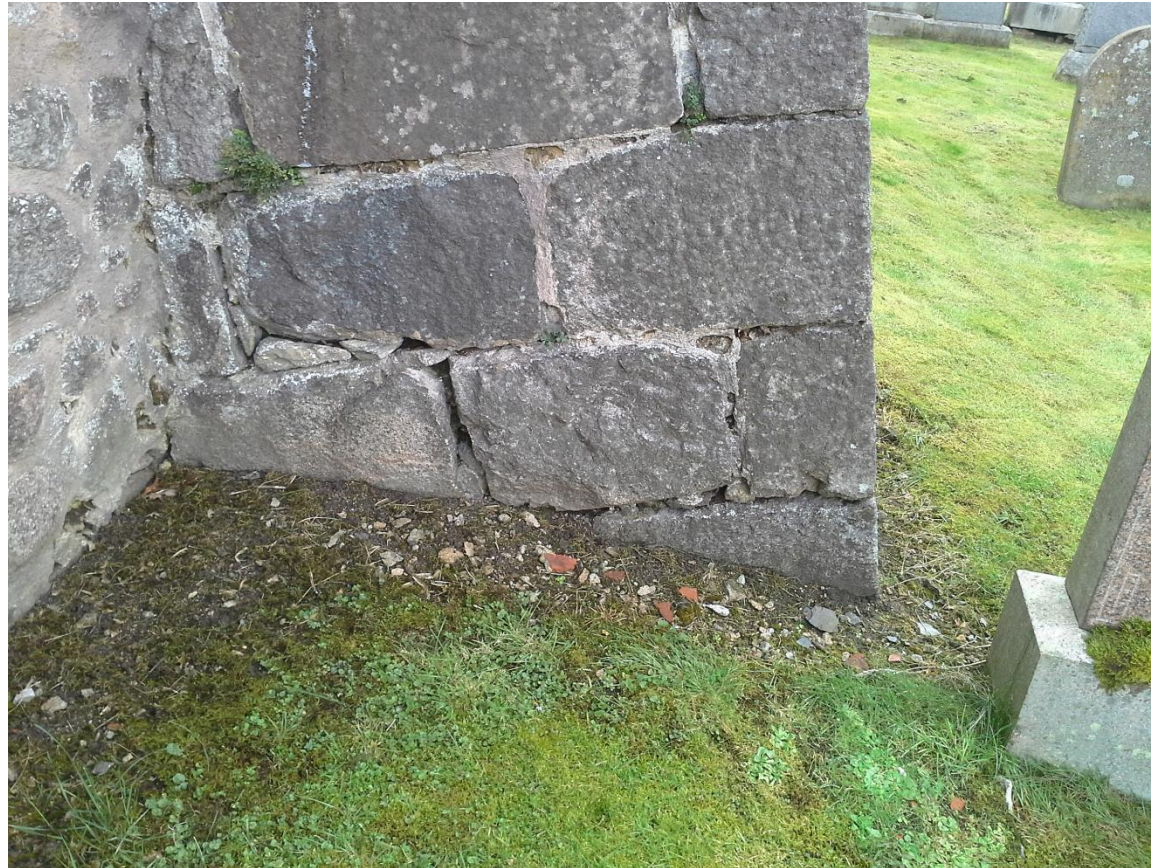
Photo 5: Deteriorated mortar in joints of granite buttress

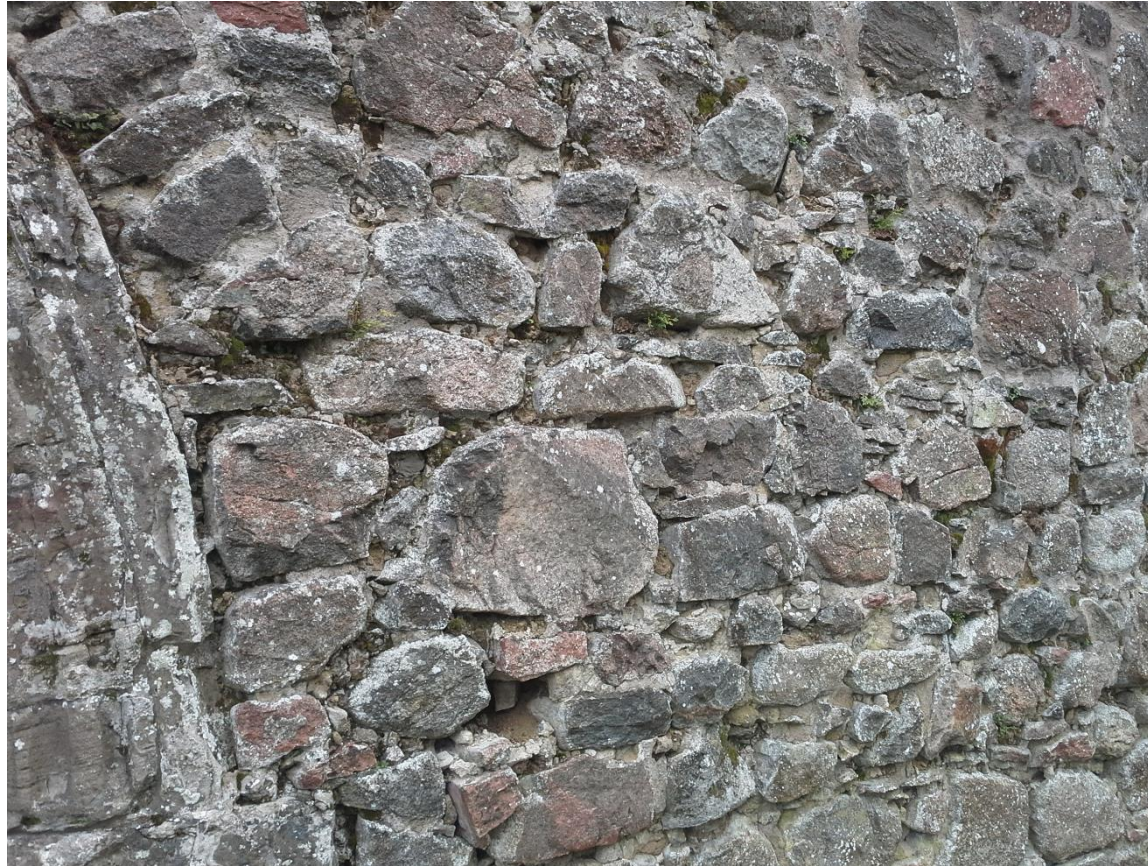
Photo 6: Areas of eroded pointing on elevations

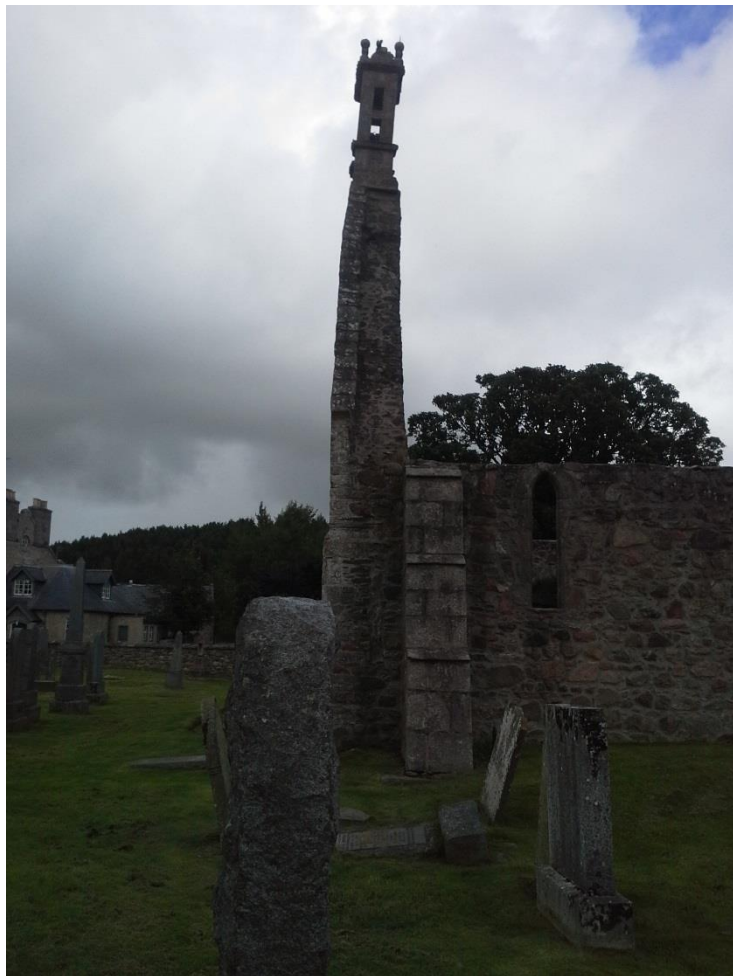
Photo 7: Lean on west gable of auld kirk
