Ash Trees

MONUMENT	Palace of Holyroodhouse
PROJECT	Damaged Tree Removal Location Plan

PROJECT DRAWING NUMBER		2016-05-(90)-001A	
SCALE	1:200	ARCHITECT	Karen Willisamson
DATE	26/2/2016	DRAWN BY	John Crae
ARCHIVE NUMBER

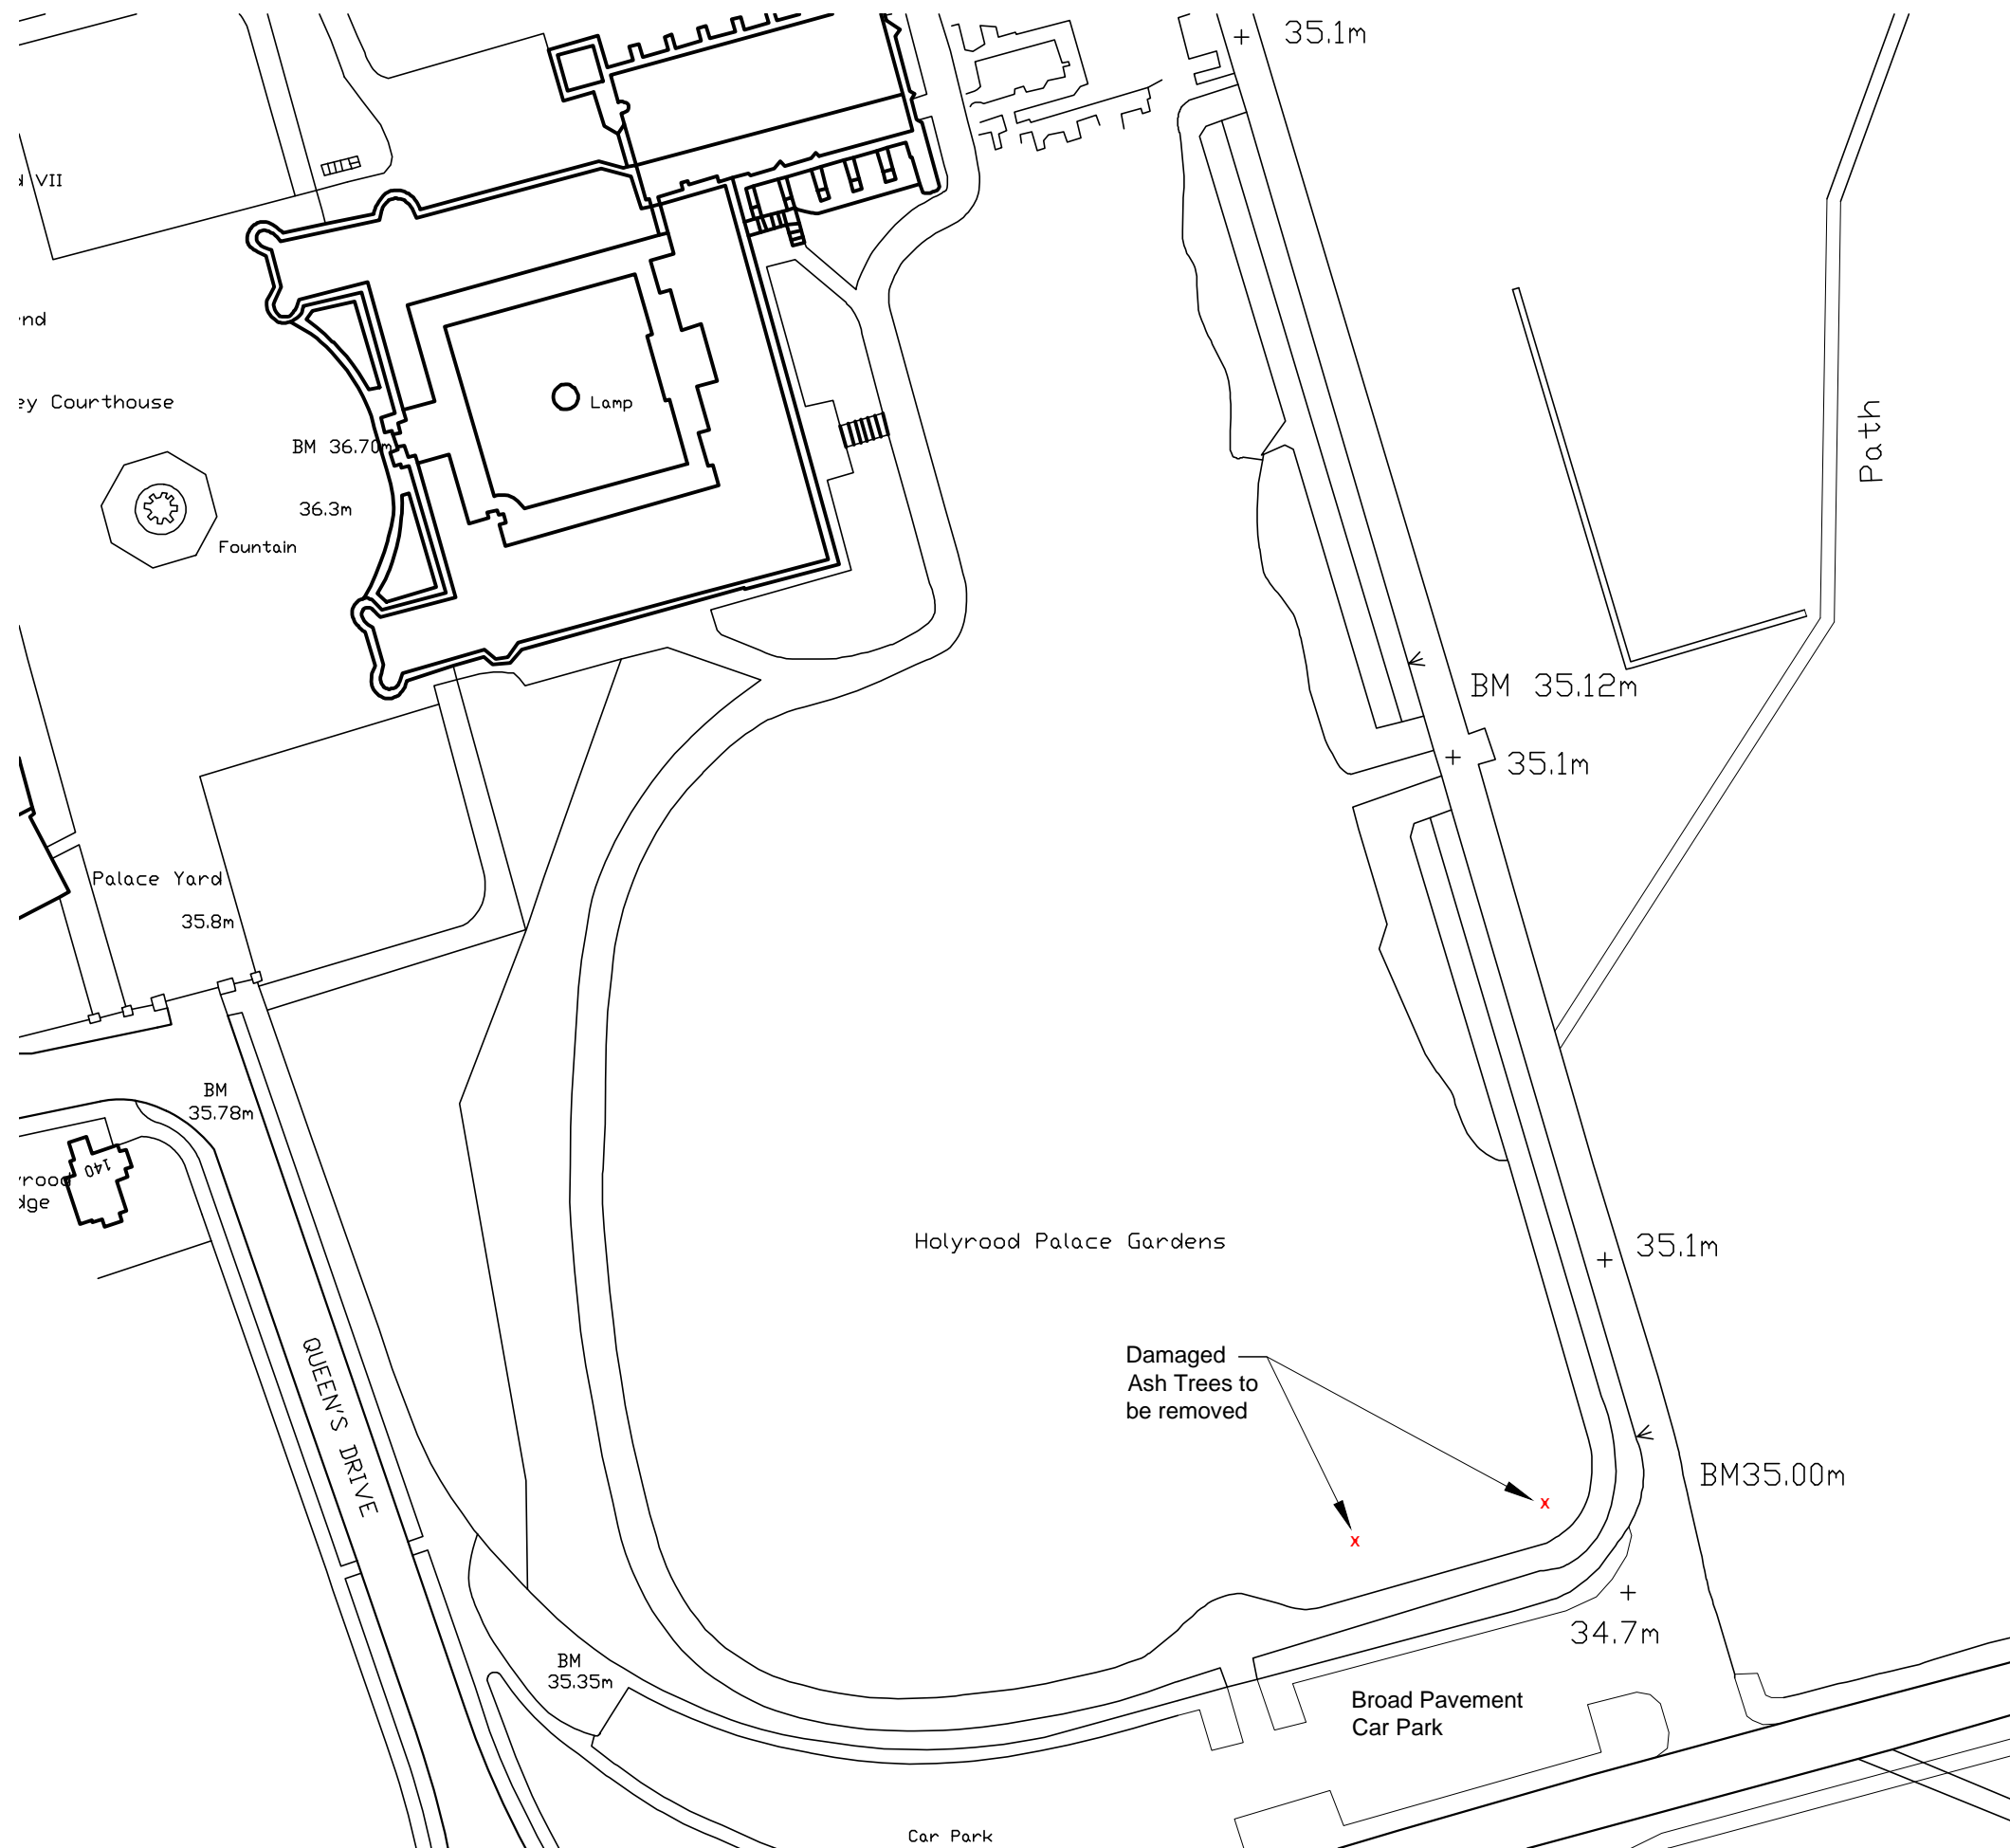
Tree assessment ref -0194 noted tree (ASH 39) diseased and required monitoring. Badly damaged, at risk of full fall in stormy weather.

Tree assessment ref -0191 noted tree (ASH 35) diseased and required monitoring. Badly damaged, at risk of full fall in stormy weather.

1. Agreed MCU to cordon off area during storm warnings.
2. HES Works Manager to get contractors' method statement and costs for safe limb removal (this may not be possible given diseased condition of trees).
3. HES Works Manager to contact Cultural and Natural Resources (Bob Tevendale, Natural Heritage Advisor) to arrange for bat assessment.
4. Tree to be section felled to avoid damage to underlying archaeology.
4. Stumps to be cut to 100mm above ground level, and ground down to 100 mm below existing ground level.
