## DALLAS DHU DRY ROT WORKS

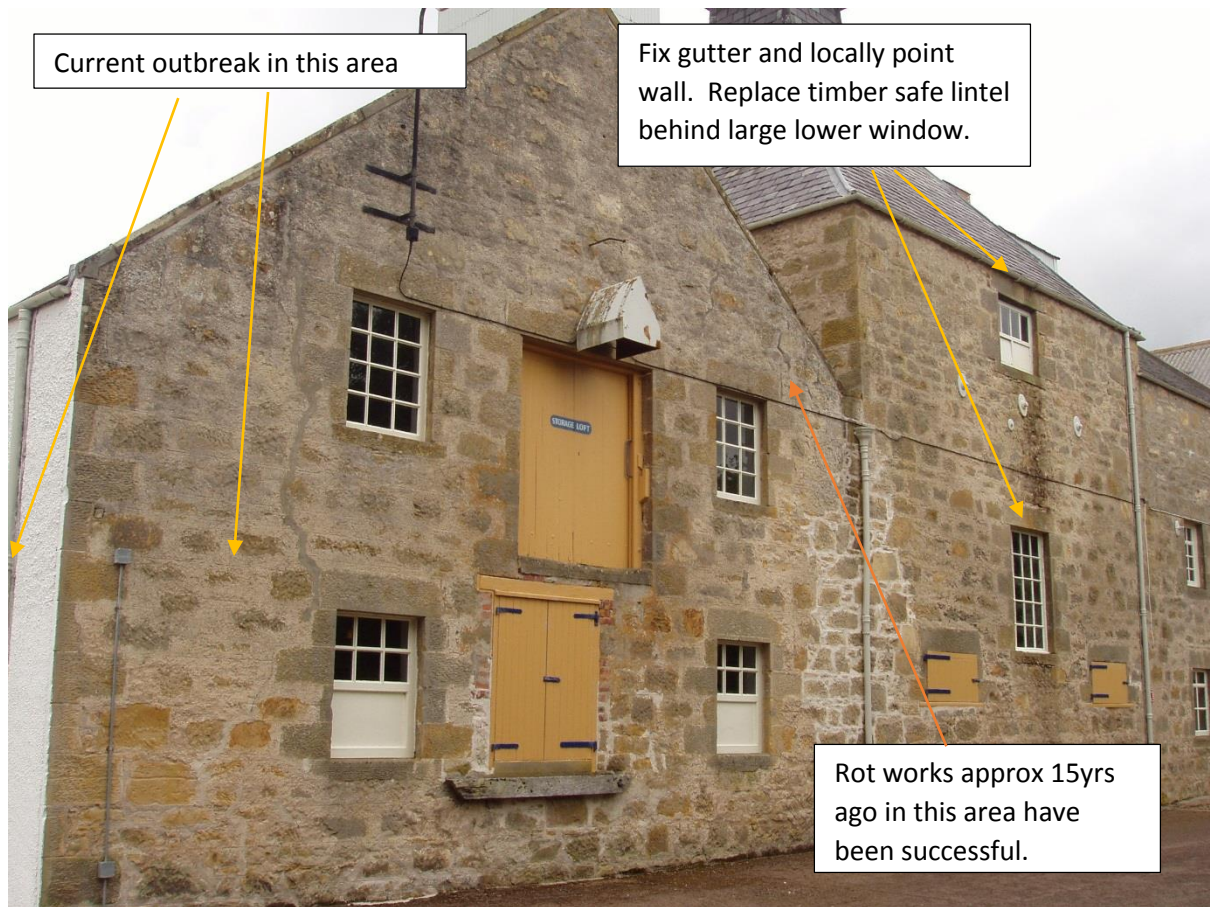
Kiln and Malting floor gable end.

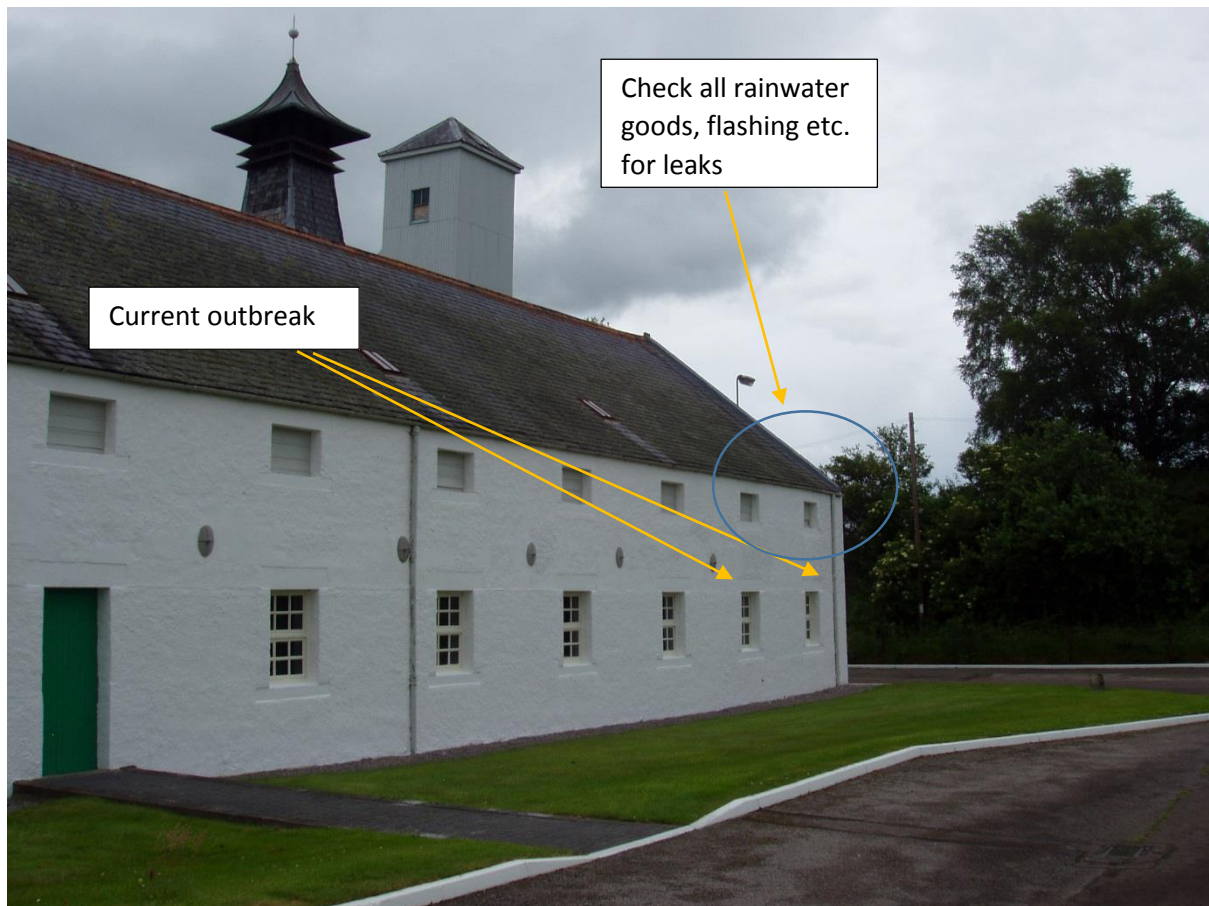
Malting floor outbreak

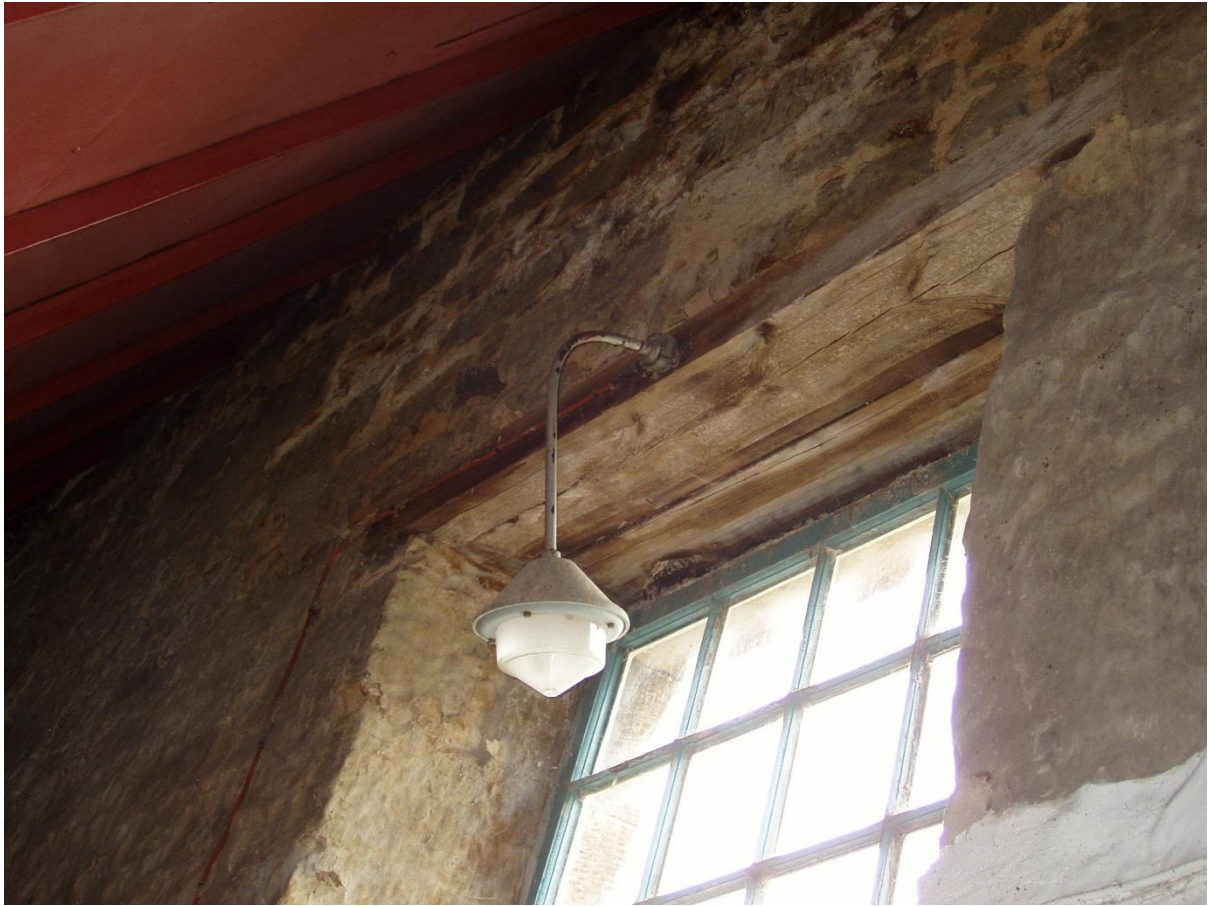
Lintel of large kiln window (note old fruiting body). Break out rotten lintel and reinstate with treated timber coated with Boron, locally rebuild masonry and slaister to match as required.

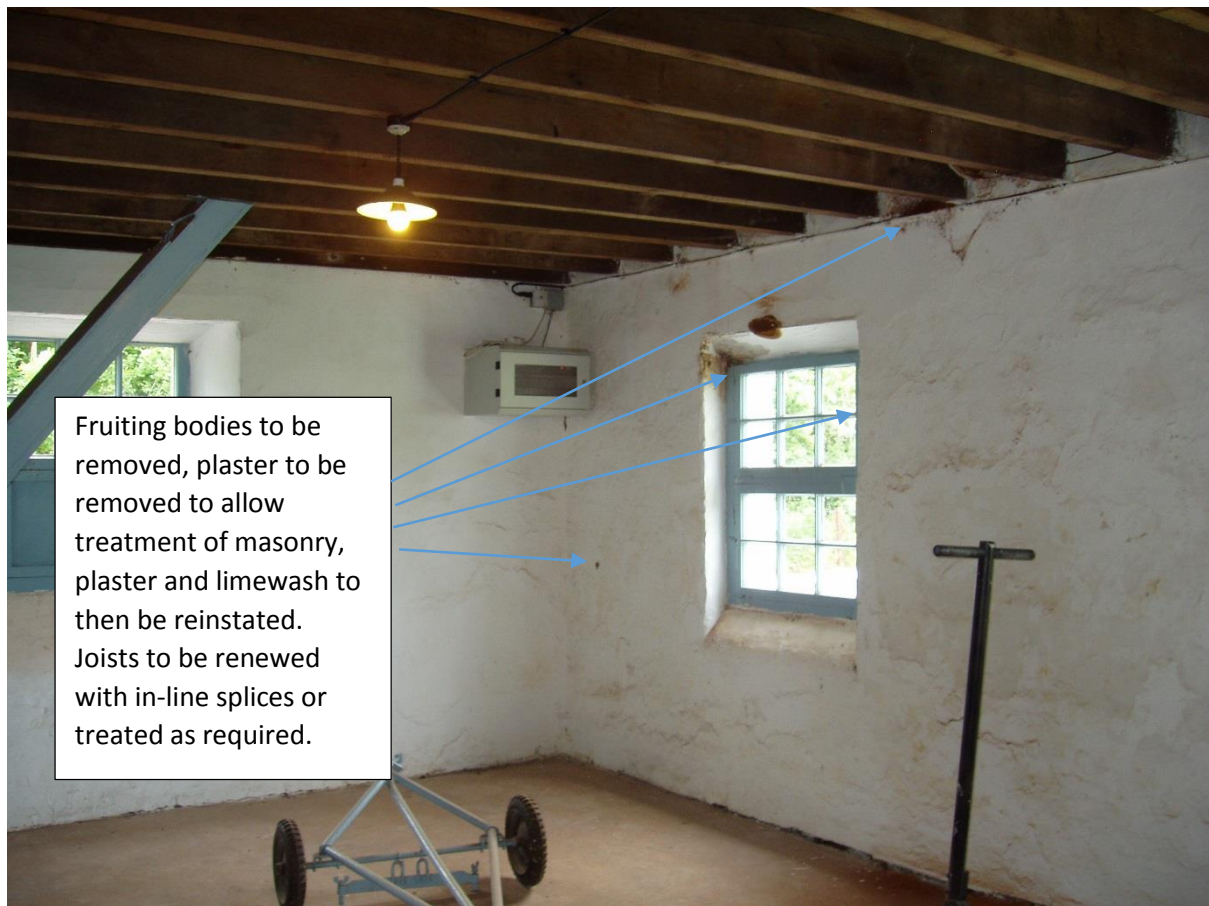
Fruiting bodies to be removed, plaster to be removed to allow treatment of masonry, plaster and limewash to then be reinstated. Joists to be renewed with in-line splices or treated as required.

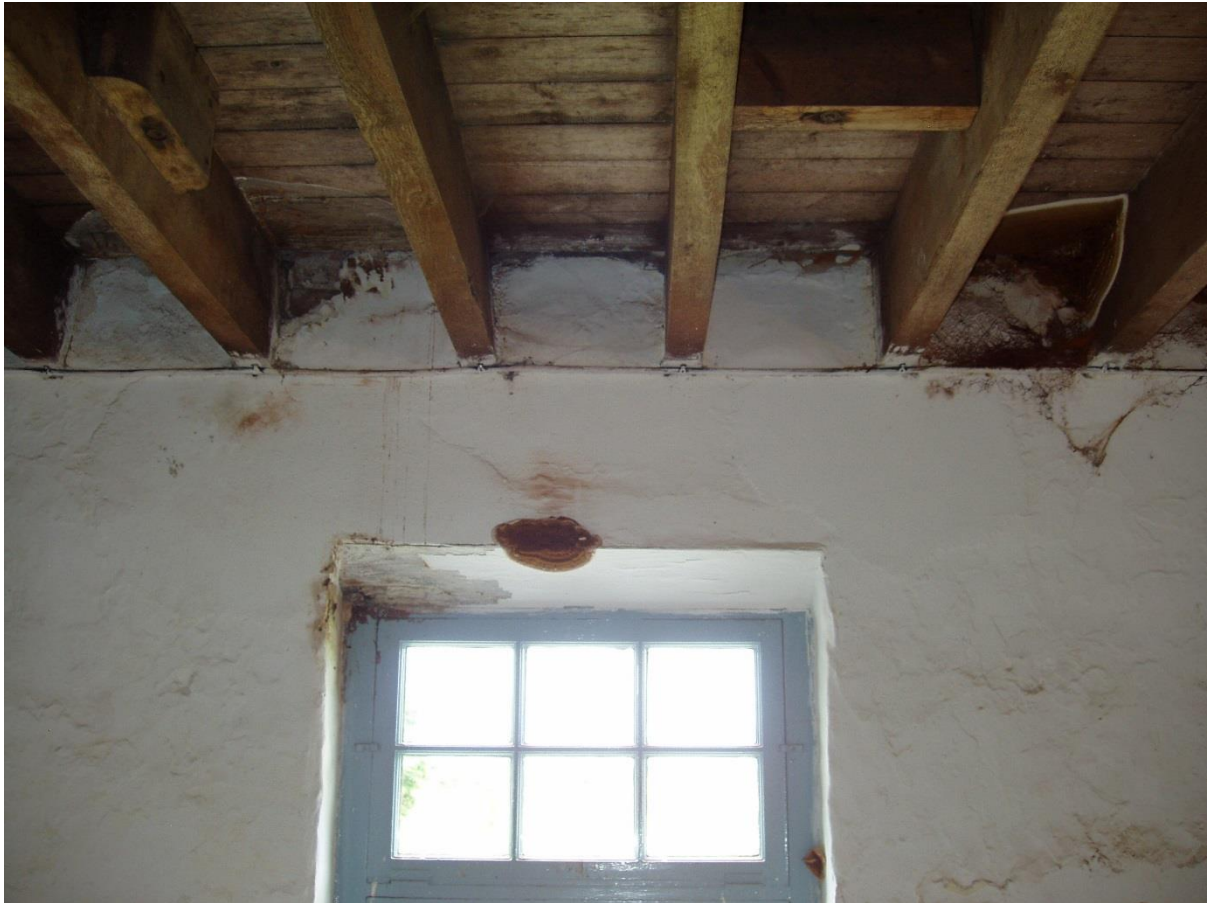
Malting floor fruiting bodies. Plaster needs to be removed to allow access to replace timbers as required and treat masonry, then Lime plaster will be re-applied and limewashed.

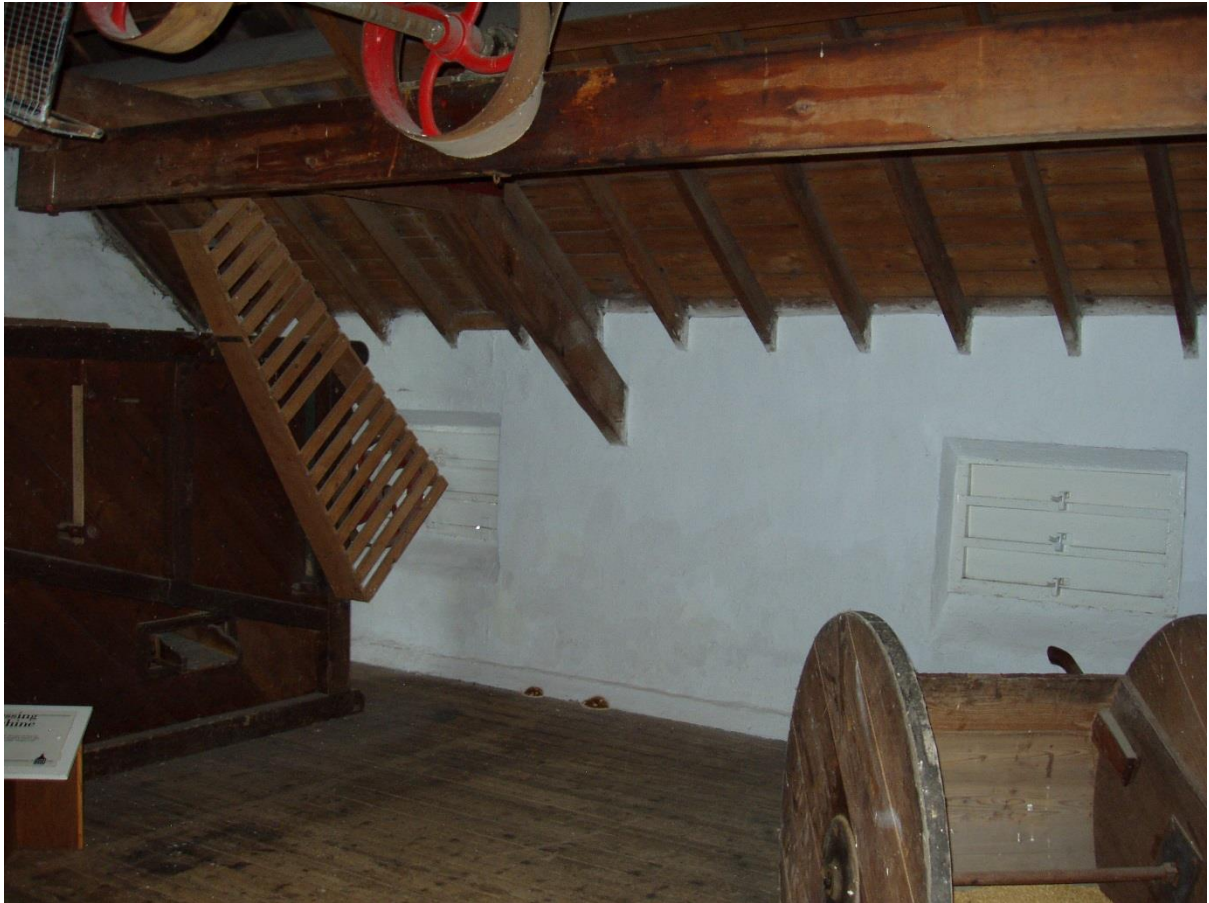
Barley Loft above malting floor. Plaster to be removed to allow access to rafters for treatment or renewal (in line splice). Louvred vent frames can hopefully be treated and retained. MCU to re-plaster and limewash on completion.
