# Survey Report

Dallas Dhu Distillery  
Forres  
IV36 2RR

Barley loft, Malting Floor and Kiln  
Room

NL/AL/SCO1241.3

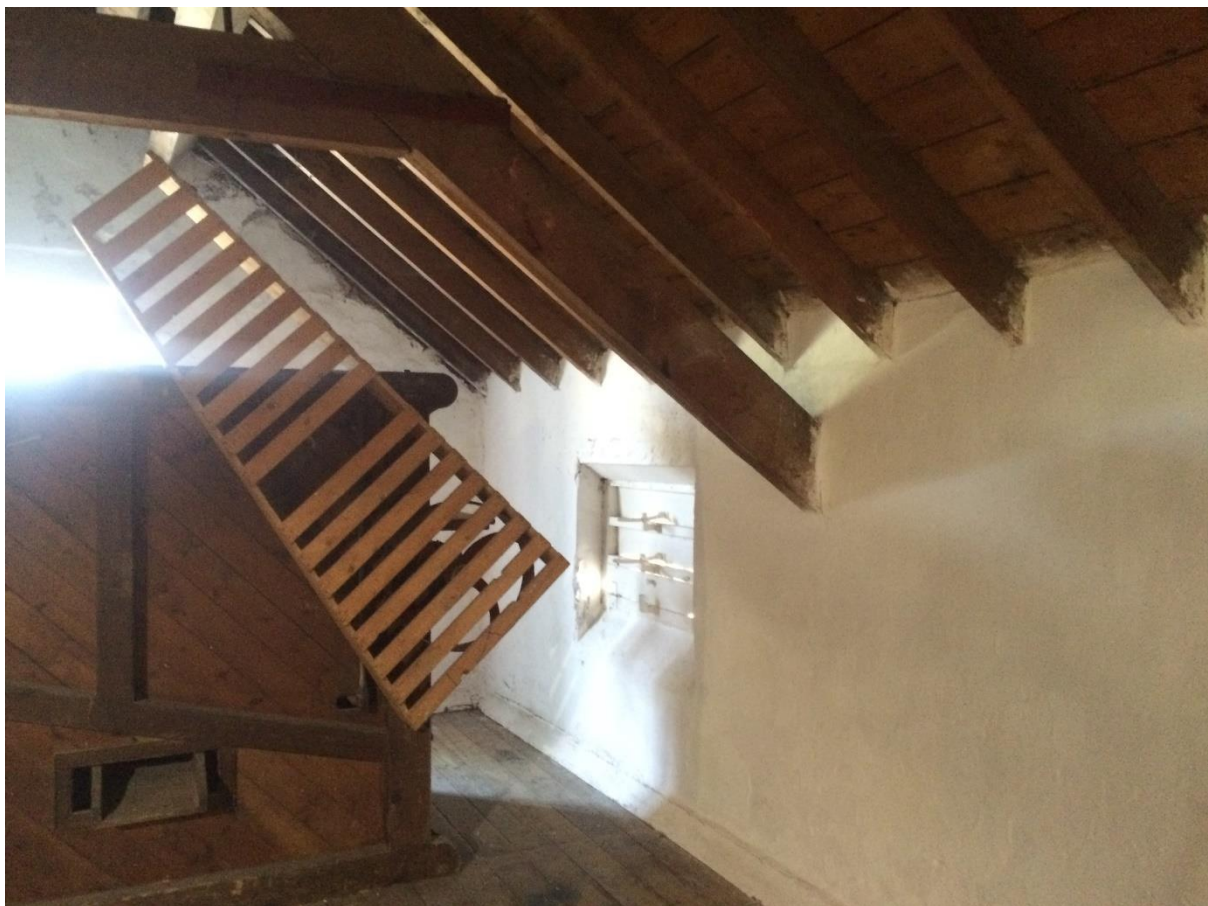
Area of inspection

#### *Front elevation*

A rafter feet inspection along this elevation was carried out with a steel probe.

Many rafters were found to be decayed with *Coniophora puteana* (a wet rot) and to an extent that repairs are required. The main purlin adjacent to the rafters was also inspected and probed. This similarly requires attention.

The left hand window vent had a sporophore on the top left corner. Decay was clearly visible along the top and side rails. This window would need to be removed and repairs carried out. Although a distance away, the other window might need minor repairs.

The timber floor boards below the decayed window are showing severe signs of decay. Structural breakdown of the timbers is in evidence adjacent to the wall and undoubtedly there will be decay to the built in joist ends below here.

Although no inspection of the stonework below the plaster was inspected, there will certainly be mycelium and strands below here which if not exposed, could cause extensive problems at a later stage.

Remove slates up 1m from gutter level, up the rake of the roof. Remove slates from gable end and in as far for repairs to 15 no rafter ends can be carried out.

Remove sarking boards to gain access to the rafter feet. Keep as much of the original sarking as possible but discard any decayed boards.

Suitably support rafters with Acro props and spreader batons. Carry out repairs to rafter feet by cutting away decayed timbers and fitting TRS beams to the same dimensions. These bespoke beam kits are made from kiln dried C24 timber and fitted with zinc plated 8.8 grade high tensile bar. More details can be forwarded along with specification if required.

Refit sarking, incorporating new boards as necessary. Felt roof with Rubberoid Roofshield breather membrane and refit slates.

Suitably support the principle rafter with an Acro prop. Carry out a repair to the principle rafter by cutting away the decayed timber and fitting a TRS beam.

Replace the damaged timber floor boards with timbers to match the same dimensions. An allowance of 2m<sup>2</sup> has been allowed.

Remove the timber window and carry out repairs to the decayed and damaged timbers. Prime, undercoat and paint the window before refitting.

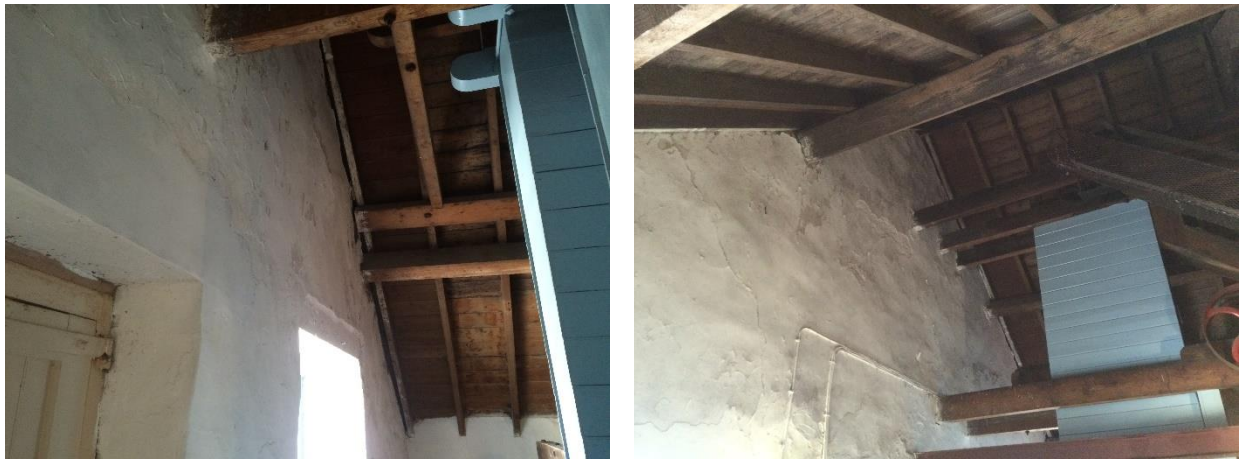
#### *Gable elevation*

The gable wall was inspected from floor board level.

The window adjacent to the front elevation was found to have a timber lintel supporting the stone work above. It should be noted that the remaining window and door both have concrete lintels. I would suspect that this wall has been wet for many years and continuing problems exist on this elevation. There has been work carried out externally to the skews on both roof elevations and indeed sarking and timber repairs have already been carried out to the opposite site to the front elevation. Due to the possible condition of this wall, this lintel should be replaced.

There is a total of 8 no built in timbers ranging from purlins to joists. The remaining purlins have been wrapped in some form of dpc. These timbers could be at risk especially as the lintels have already been replaced.

For the purpose of this report an allowance for carrying out repairs to all built-in timbers on this elevation has been allowed.

Replace the two timber lintels above the windows on the front elevation and replace the timber lintel above the window on the gable end. These lintels should be replaced in concrete.

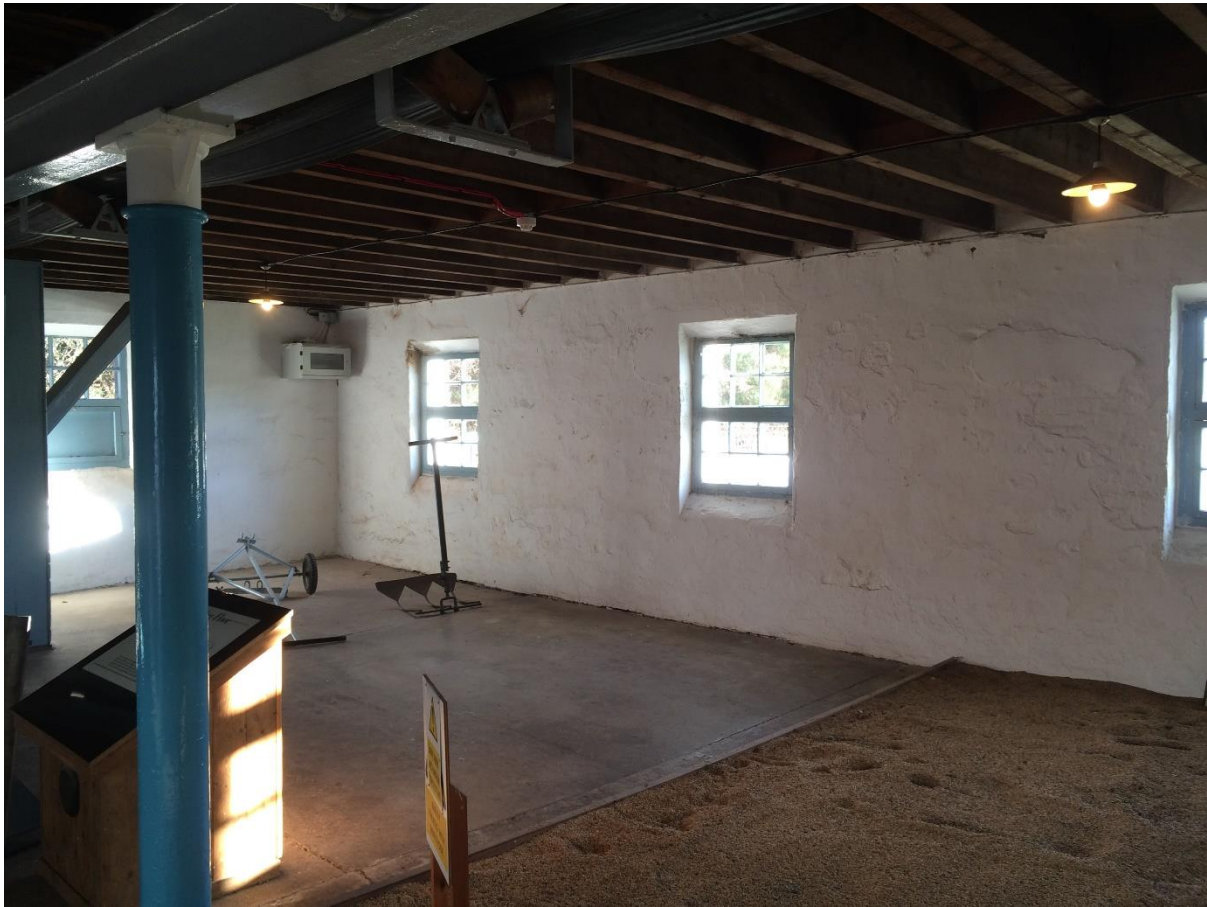
Dry rot sporophore were in evidence in numerous places on the front wall and on surrounding timbers. This is due to moisture traveling from the upper level and down into the timbers on the ground floor.

Decay was evident in a number of built-in joist ends and to at least one number timber lintel and once again the plaster is very damp which is an ideal breeding ground for the dry rot to move between areas. Damp staining carried along from the corner to at least 6m.

The concrete floor in this area has dropped by at least 25mm. There is no obvious cause for this and it appears the entire floor slab has dropped in unison rather than crack into smaller parts. The only way for this to drop is for the sub-base to be loose or washed away by excess water penetration under the concrete. Or the slab had initially settled in this position after being laid.

The soakaways should be checked or the underground drainage investigated to make sure no cracked or broken pipes are letting water spill into the ground near here.

The floor could be monitored for the foreseeable future to make sure movement has indeed stopped.

Suitably support first floor joists with Acro props and spreader batons. Carry out repairs to joist ends by cutting away decayed timbers and fitting TRS beams to the same dimensions. These bespoke beam kits are made from kiln dried C24 timber and fitted with zinc plated 8.8 grade high tensile bar. More details can be forwarded along with specification if required.

An allowance for 14 no joist ends has been allowed. Note joists will be cut back 150mm from the wall for 13no and 450mm for 1no.

Remove the timber window and carry out repairs to the decayed and damaged timbers. Prime, undercoat and paint the window before refitting.

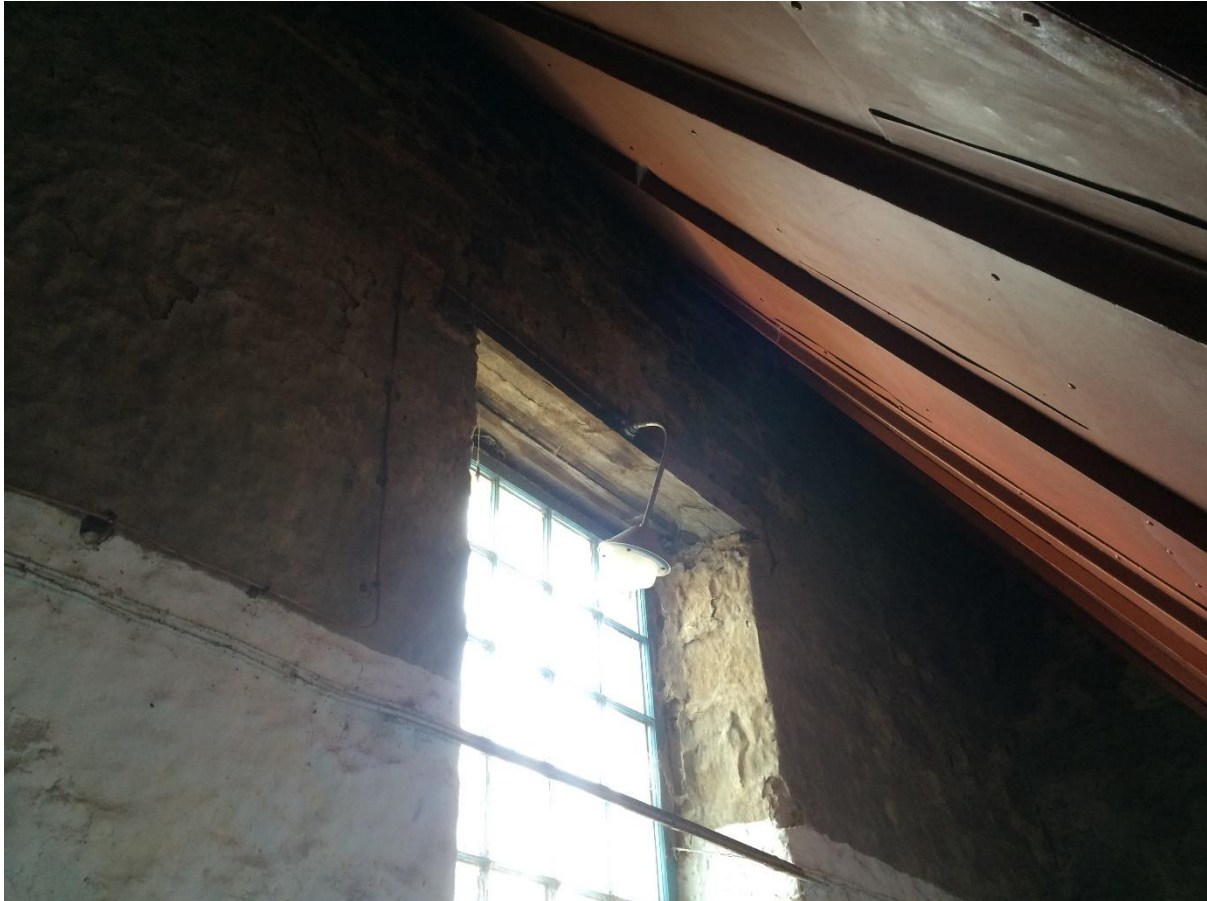
An inspection of the kiln room was carried out from ground level.

A large dry rot sporophore was in evidence in the timber lintel above the large window and where seen, the ends of the lintel appear decayed with severe water staining also in evidence.

The upper section of this window appeared to be decayed and will need to be removed and repaired. At the very least, the top rail of the frame will need to be replaced.

Suitably support the masonry above the centre window timber lintel.

Remove the decayed lintels and treat the masonry with fungicide.

Install precast/pre-stressed concrete lintels with a minimum 150mm bearing at each end.

Remove the timber window and remove from site. Carry out repairs to the top and side rails. Prime, undercoat and paint the window before refitting.

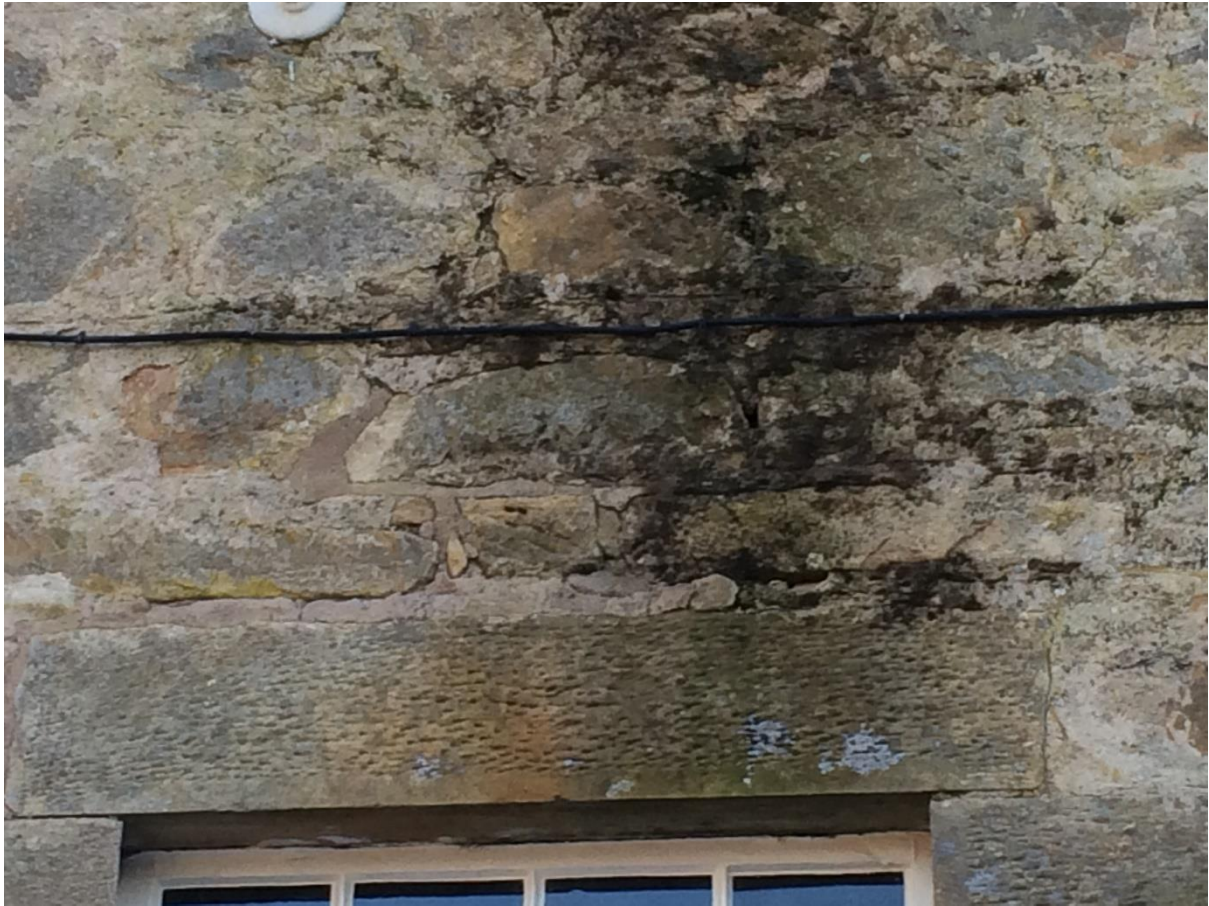
On inspection externally, it was found the gutter above the window area is cracked at the cast gutter joint. Water has been spilling from here for what appears to be a length of time, as the wall is marked with water staining.

Water staining to the external kiln wall

Replace cracked section of cast guttering and reseal all joints in this vicinity. Paint cast to match as near as possible with coloured Hammerite paint.
