| MONUMENT | SWEETHEART ABBEY |
| PROJECT | SOUTH AISLE WALL MASONRY CONSOLIDATION - PROPOSALS |

| PROJECT DRAWING NUMBER | | 90293-150904-001B | |

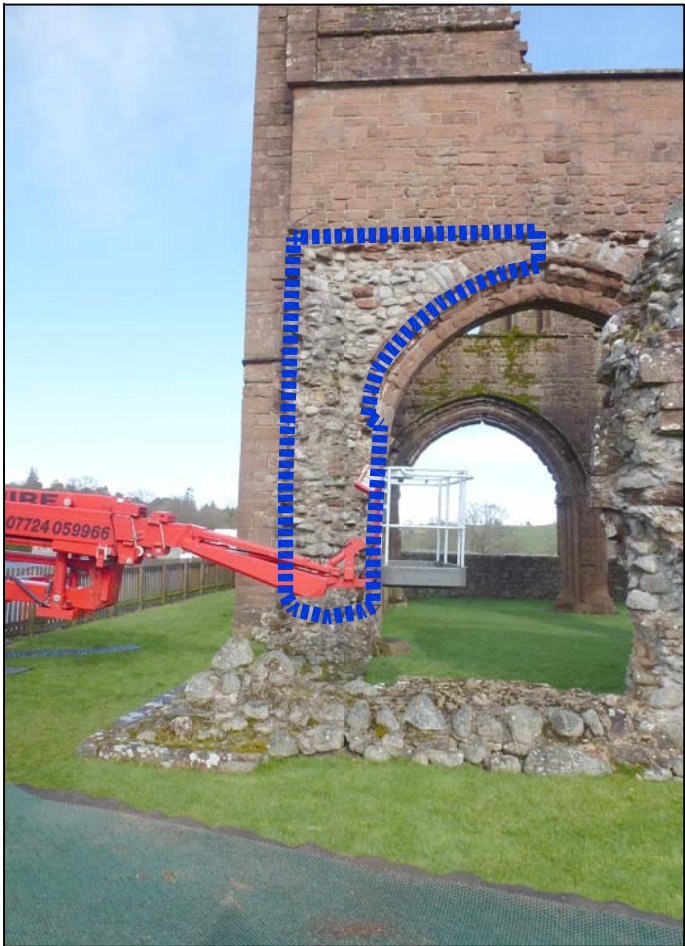
Core to South Aisle wall to be consolidated. Adjacent decayed dressed sandstone to be brushed back and repointed.

Consolidation Works to South Aisle Arcade and West wall remains: Problematic areas consist mainly of core material from ground floor level to location of the vault to the south aisle. There are also decaying facework stones at the junction to the buttress to the south side of the west end, along with arch stones to adjacent bay and arcade. The consolidation works are concentrated on the fragile matrix of granite, sandstone, original lime mortar and modern cementitious mortar in areas of core material which, though consolidated in the past by rough racking, has inevitably been weakened by exposure to weather. As well as continuing erosion of fabric, the risk of lumps of mortar and particularly of larger stones detaching and falling presents a potential health and safety risk. Recent high level survey operations have identified loose material and the core area requires thorough consolidation.

Brush back superficially decayed and powdering, delaminating or contour scaling surfaces of deteriorated adjacent masonry to a sound surface using a non-metallic brush. Remove loose detaching fragments careful by hand to address the risk of falling masonry. Cut out failing cementitious mortar where this can be achieved with minimum damage to dressed stones and re-point in lime mortar.

Once access is available and limited opening up investigation of core / rough racking can commence, assess condition to determine level of intervention required to make safe, particularly at mid to higher level. Agree works and extent with District Architect who will agree detail with HES HMD - this is likely to include:

- removal of vegetation including roots.
- removal of badly decayed detaching sections of core material and brushing back to sound surfaces.
- localised lime mortar grouting where cracks are opening up behind otherwise sound sections of core material.

- localised slaister application of lime mortar to consolidate disintegrating rough racking face and to fill voids, incorporating stones within the application in order to support sections above.

- ensuring larger stones are well anchored within the core material and that individual stones do not cantilever out unduly. Drilling and incorporating stainless steel rods resin grouted back into the wall structure and concealed behind larger rough racking stones is likely to be required.

- At higher level if investigation of condition of core material dictates, cutting back of rough racking and exposed core and installation of stainless steel mesh to secure core material fixed by M20 threaded stainless steel rods resin anchored into the original wall core material and left projecting outwards. Locations and spacing of rods to be the minimum necessary commensurate with structural requirements for securing rough racked face. This metalwork is then to be concealed behind a reformed rough racked face formed by drilling larger stones and setting them onto the ends of the rods. The area in between these stones is to be infilled by slaister mortar and pinnings over the mesh to entirely hide it from view. All to strive to recapture the existing exposed core / rough racked appearance.
