## Jarlshof – Selectively repoint sea wall

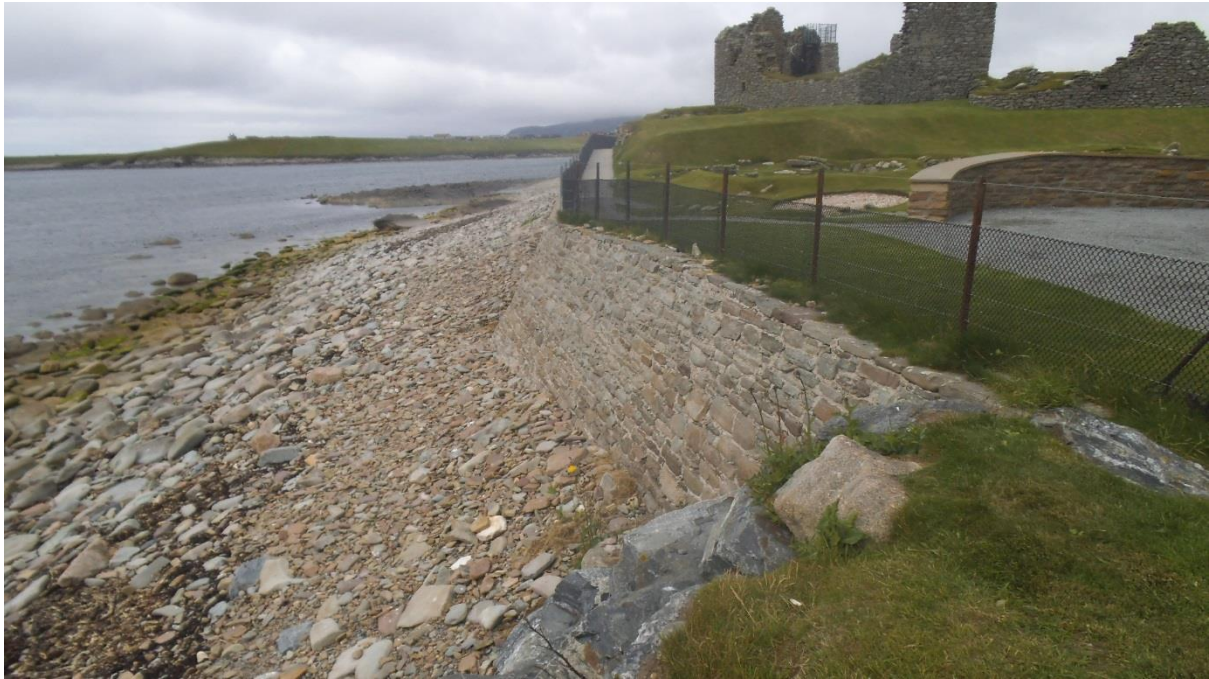
1. Start of sea wall adjacent to Visitor Centre

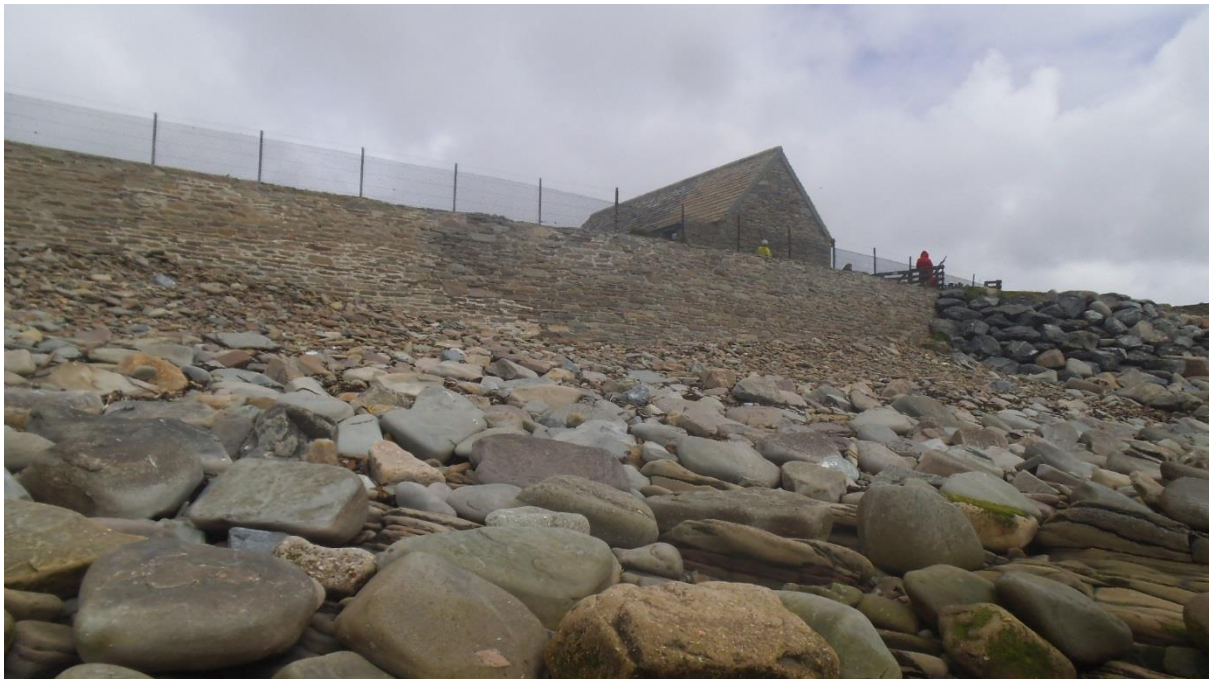
2. Wall showing pointing patches from previous works

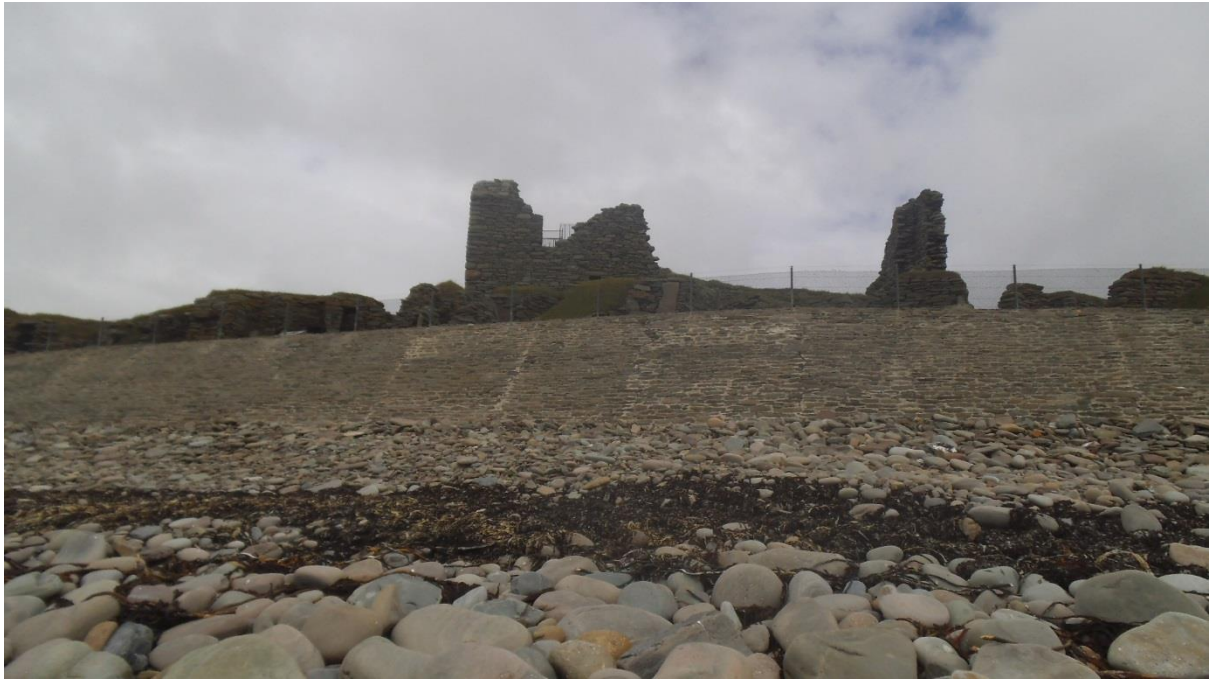
3. Regular lines where pointing is failing at wall panel joints

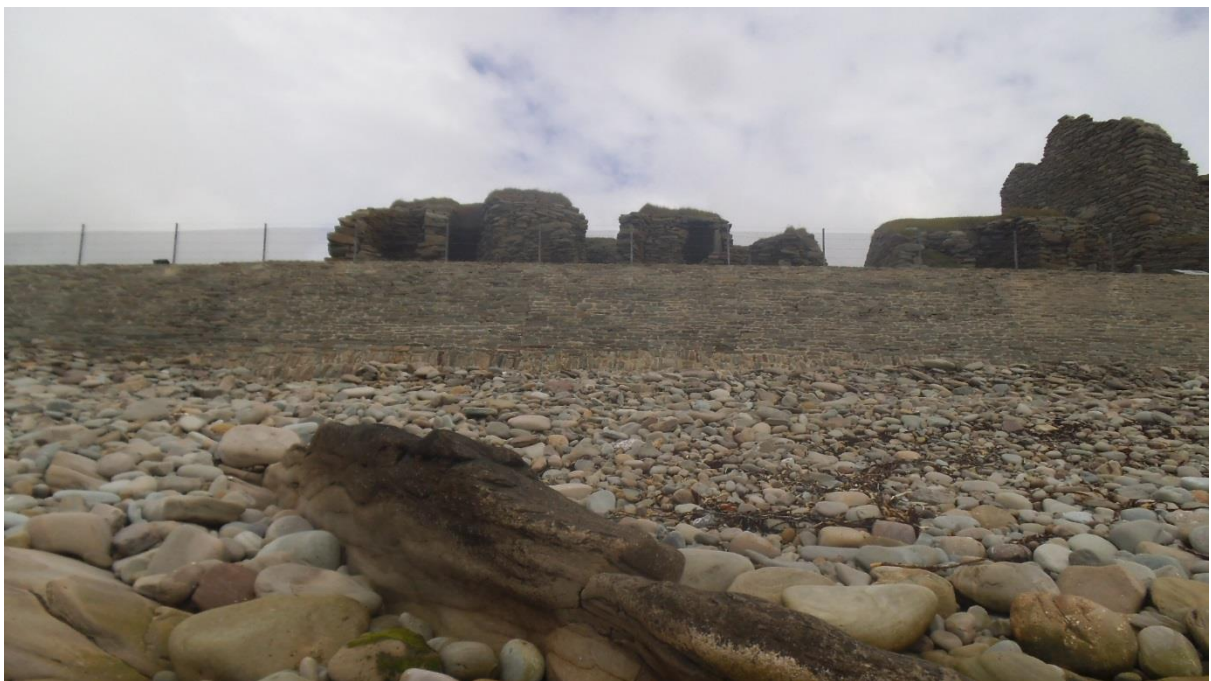
4. Patches of previous repair, dark spots where mortar is missing, regular decay lines relate to wall construction bays

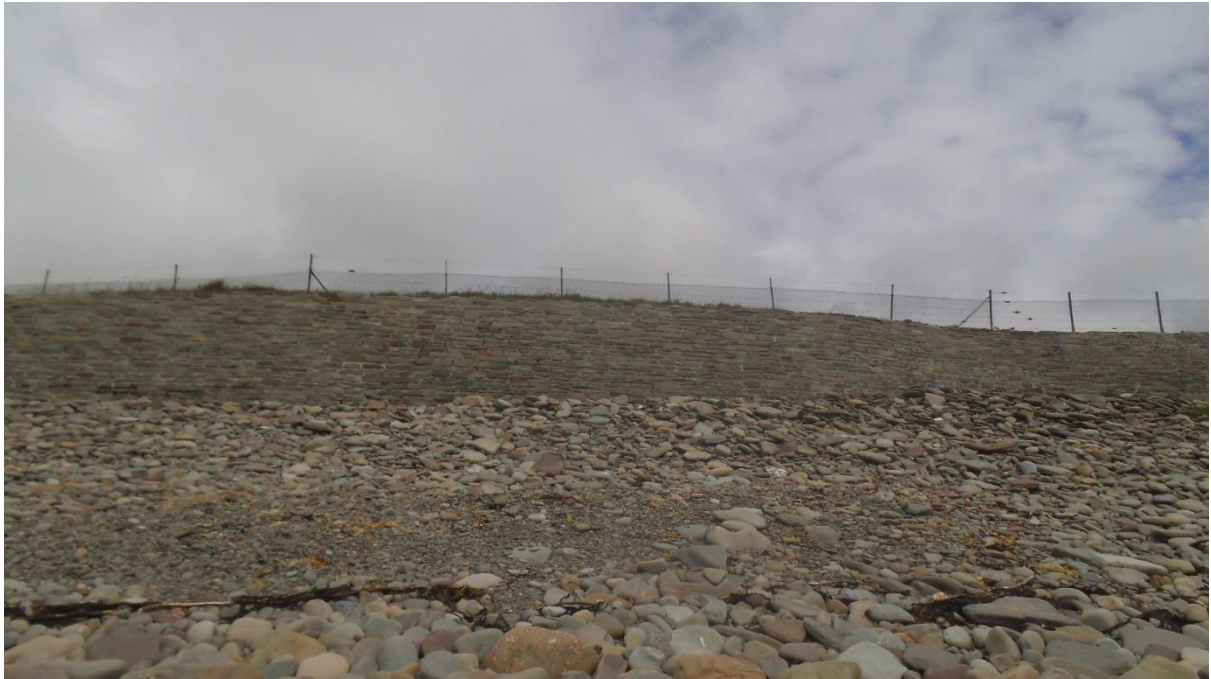
5. Less work appear required towards the west end of the wall (but see below)

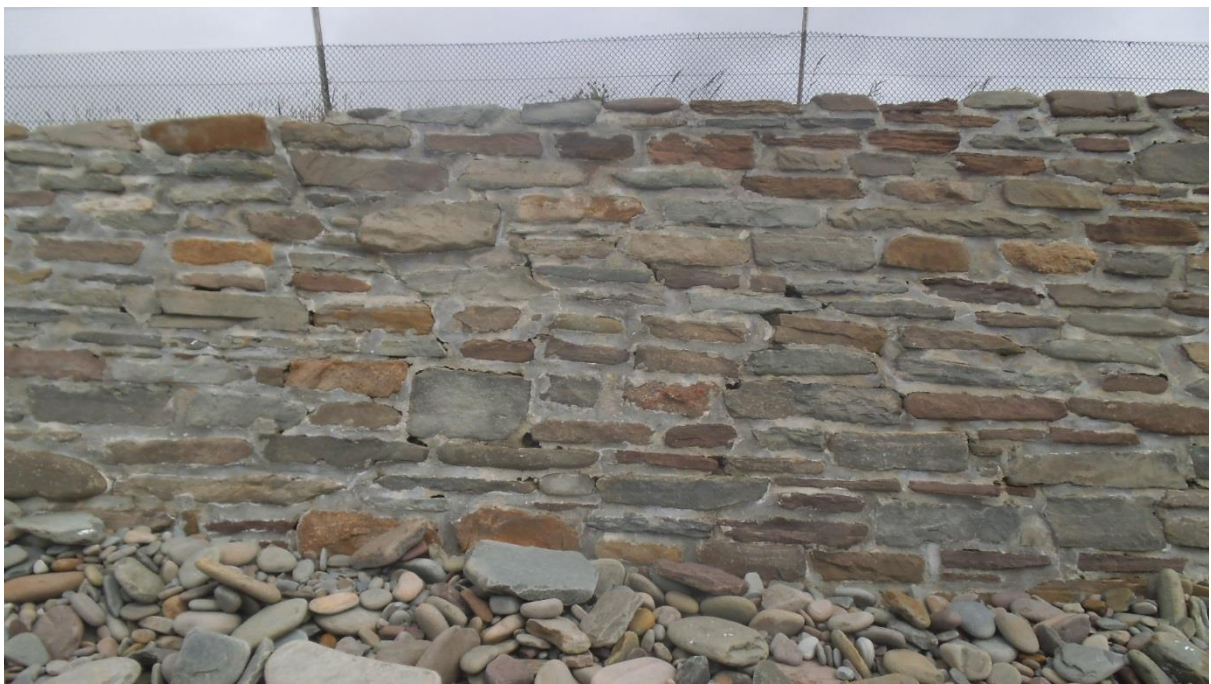
6. Voids behind strong cement mortar in western region of wall

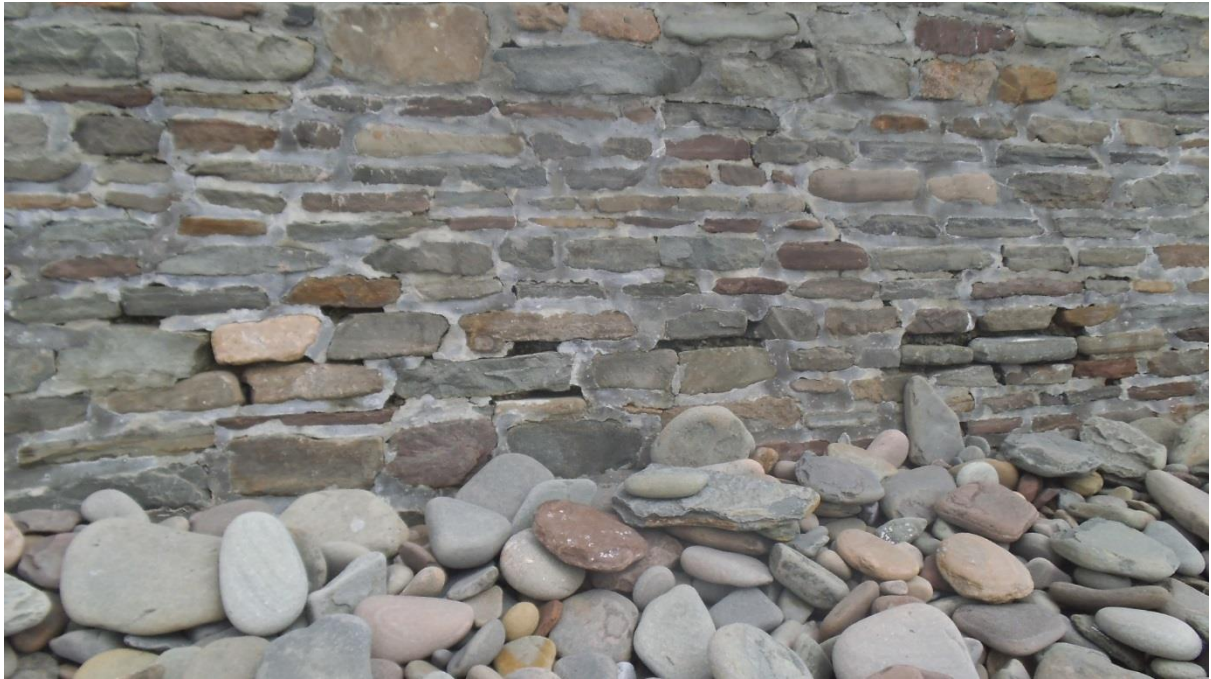
7. Voids being formed at wall base behind hard cement pointing, typical to whole wall

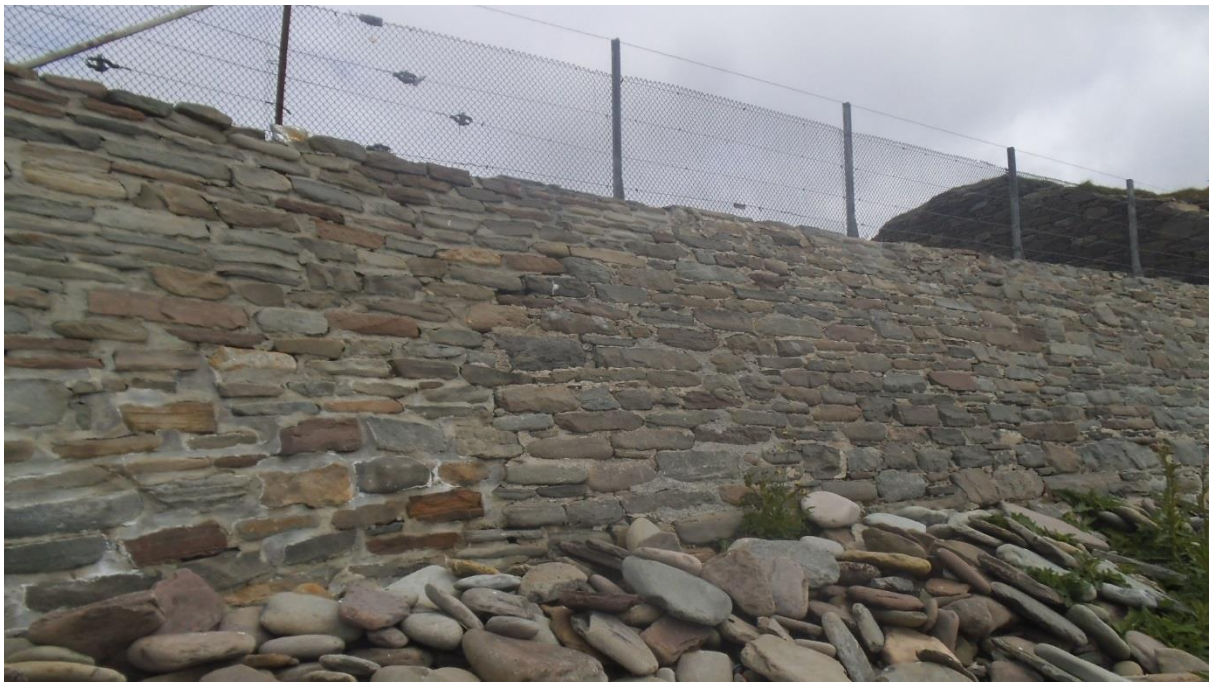
8. Hard pointing losing hold on stones, voids forming behind, wall top stones becoming loose/dislodged

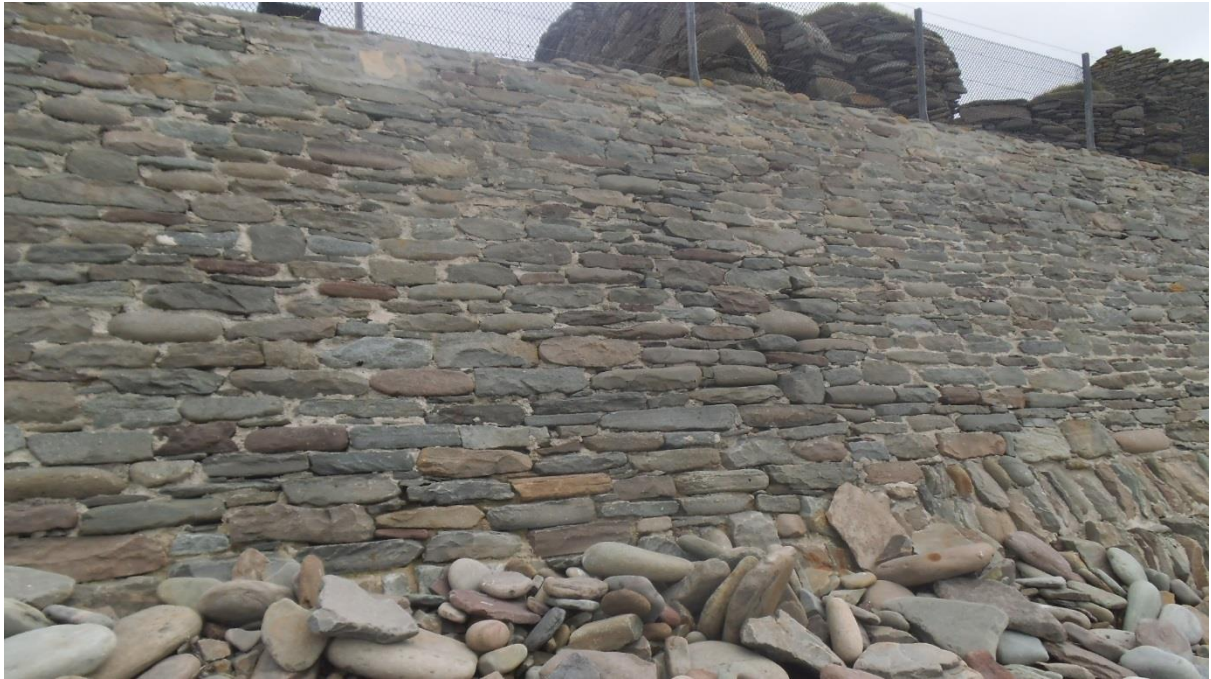
9. Much previous patch mortar, voids evident where hard pointing has fallen away

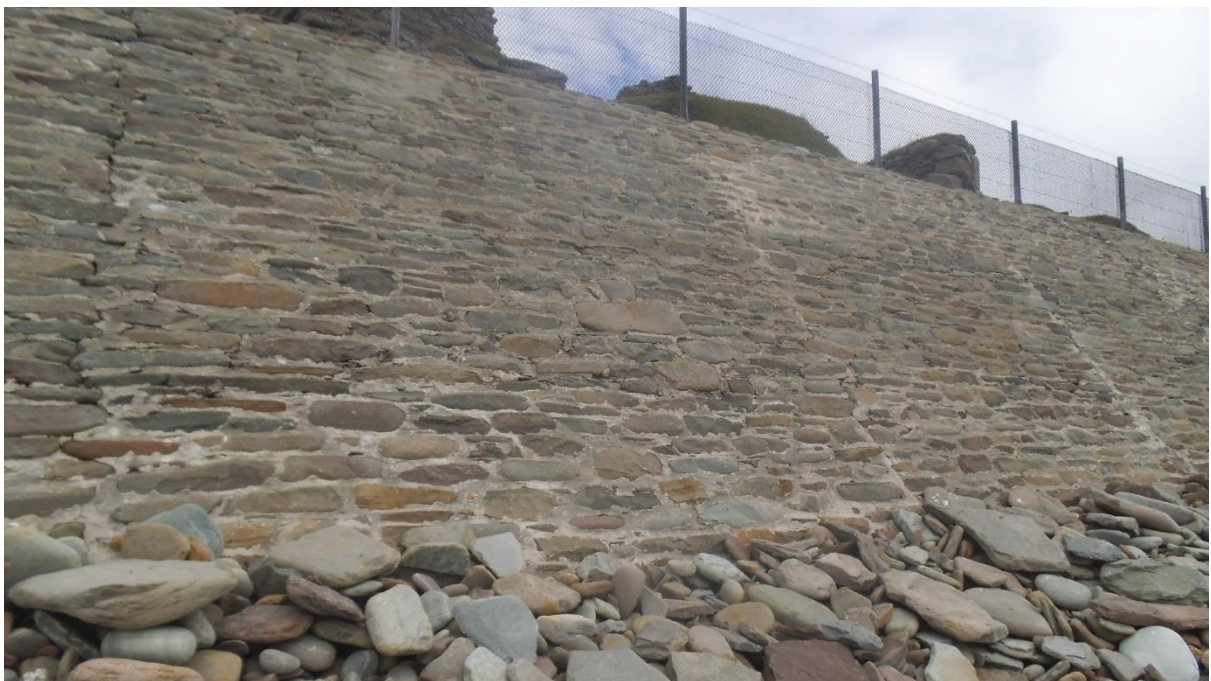
10. A typical mid-wall section showing the regular bay/failure/expansion pattern in addition to the general decay of the previous pointing
