# Blackhouse H: Method statement for the repair of collapse on the south gable

16<sup>th</sup> August 2016  
Supported by:

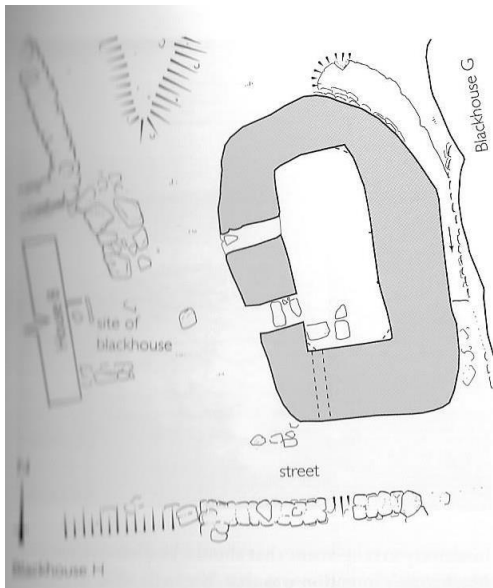
Figure 4 Blackhouse H as surveyed by RCAHMS (scanned image from Gannon & Geddes, p101)

There are also some unknowns in regard to the fabric of the blackhouse structure. Johnstone and the RCAHMS plan above record the line of a drain under the south gable – the condition of this feature and its impact on the structural integrity of the building are not known. There is also a lack of knowledge regarding the extent of previous work party repairs to the structure – if these are indeed present, it is likely that this will become quickly apparent. If areas of 1980's repair for example can be identified, there will be less onus to repair the structure stone for stone, and instead it may be more appropriate to repair the structure in such a way as to improve structural stability whilst also maintaining a 'St Kildan' vernacular style to the stonework, this will of course be subject to consent and advice from the St Kilda Archaeologist. With these points in mind the basic 'steps' to be followed during the repair are listed below.

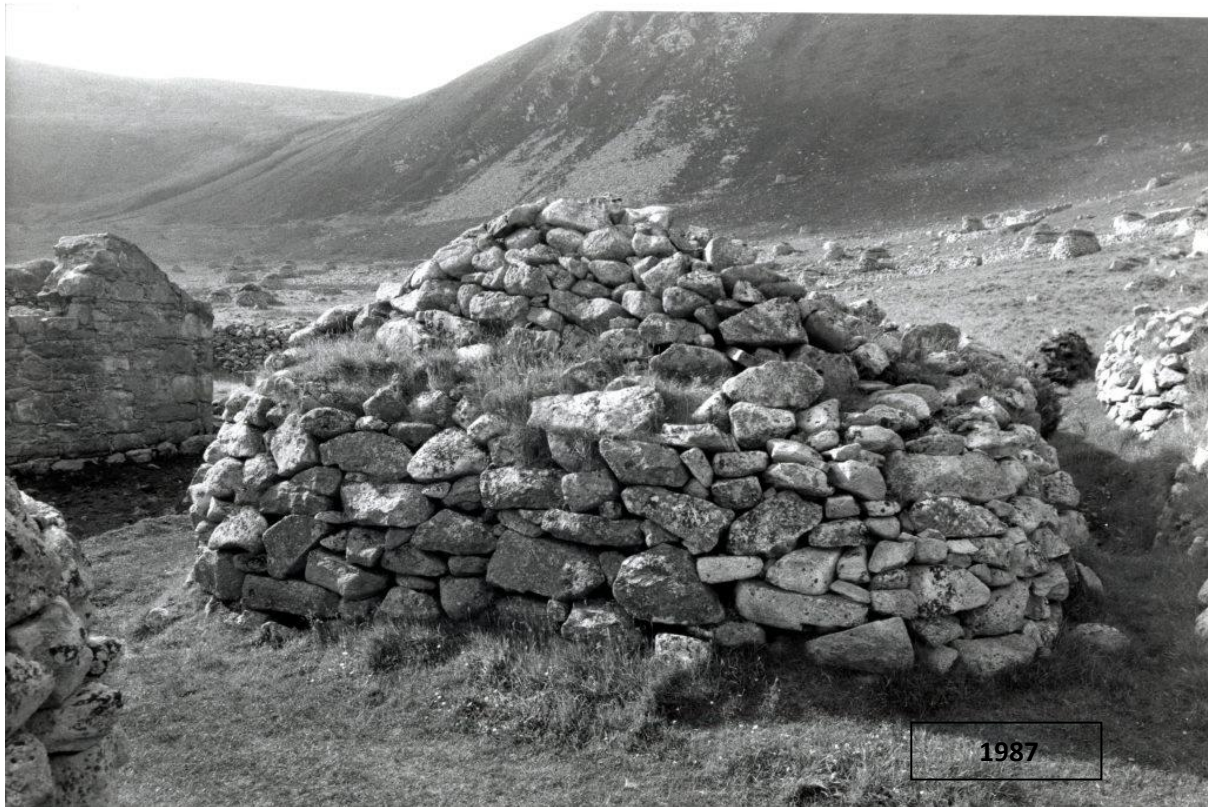
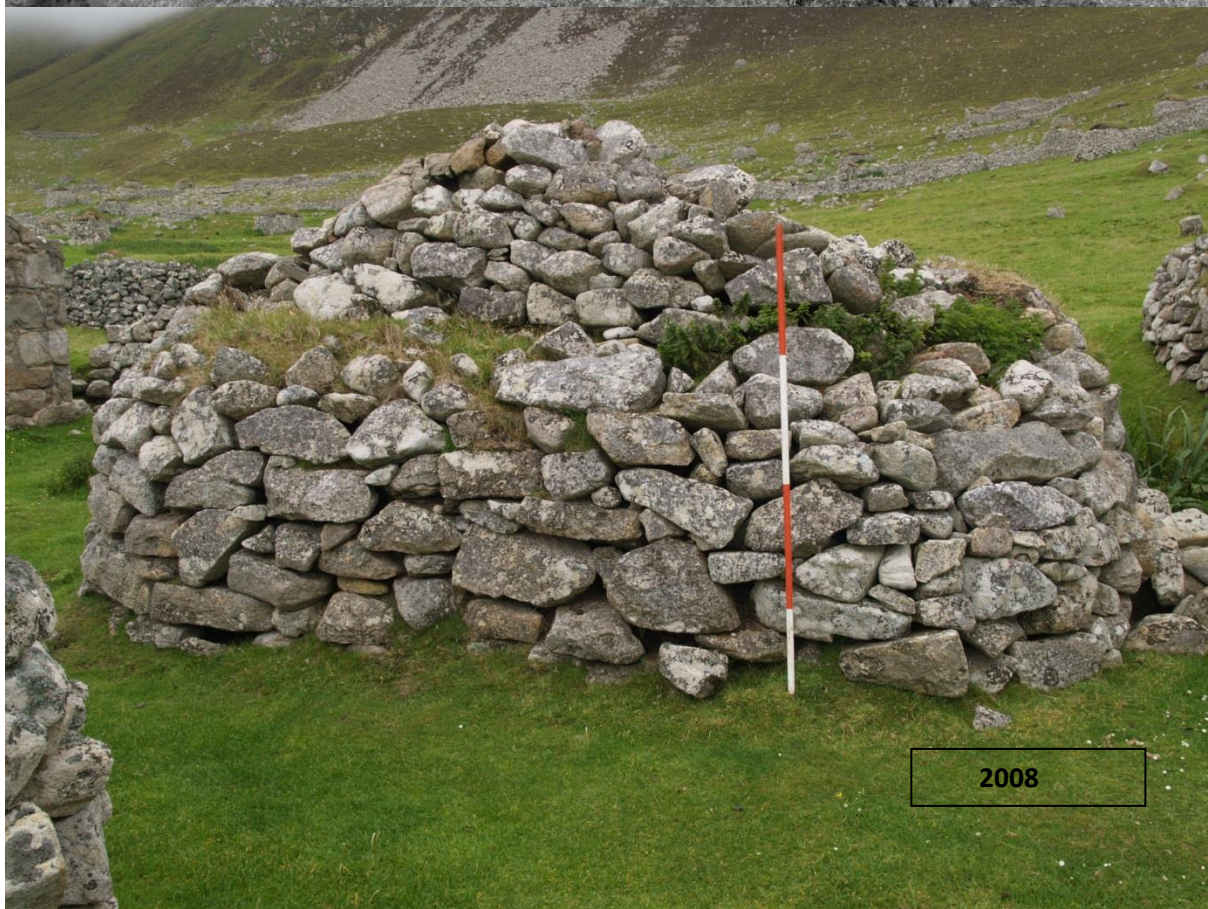
There are no records of repair or reconstruction works carried out to blackhouse H since the National Trust for Scotland's ownership (1957), although detailed recording did not occur until the late 1990s. However a monitoring photograph taken in 1987 (fig7), appears identical to one taken in 2008 and so it is assumed that no works have taken place since at least 1987, however the presence of squared timbers in the collapse may indicate intervention in the late 20<sup>th</sup> century

Figure 7 *Blackhouse H west gable as surviving in 1987 & 2008*

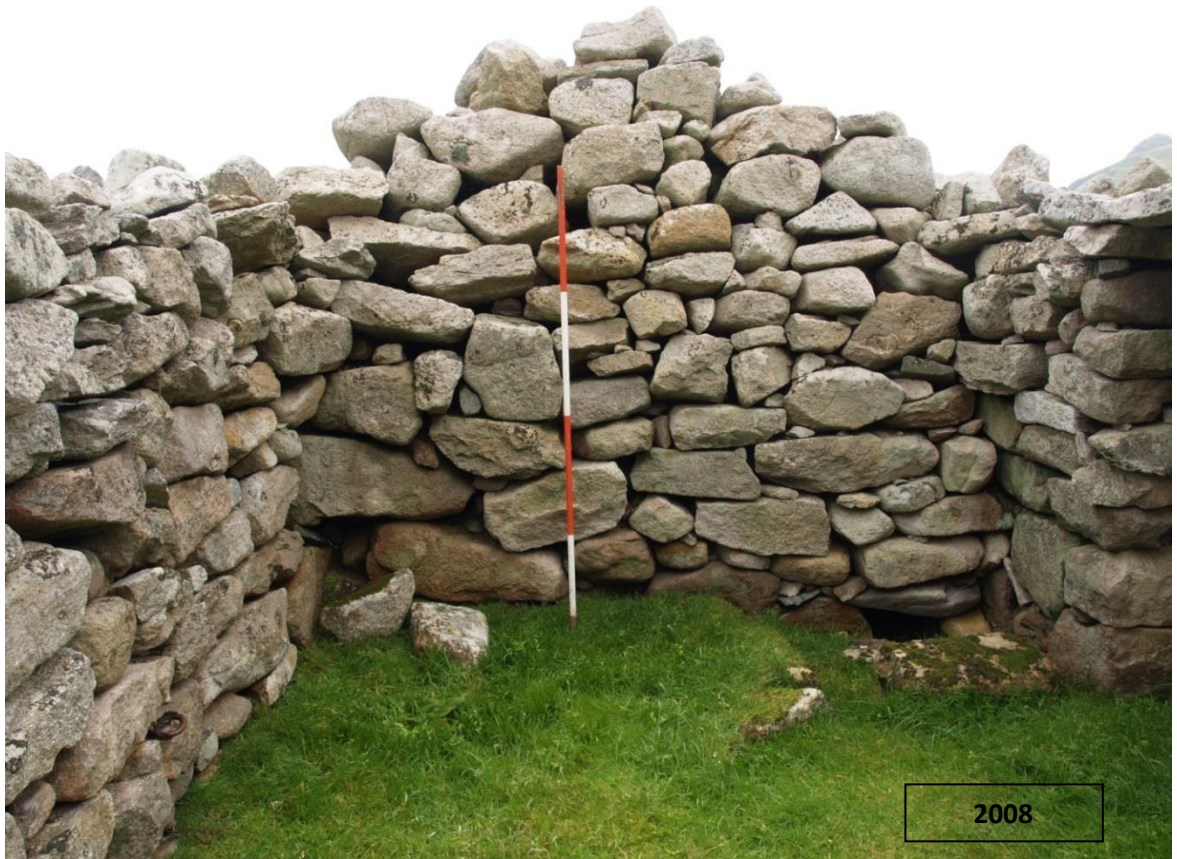
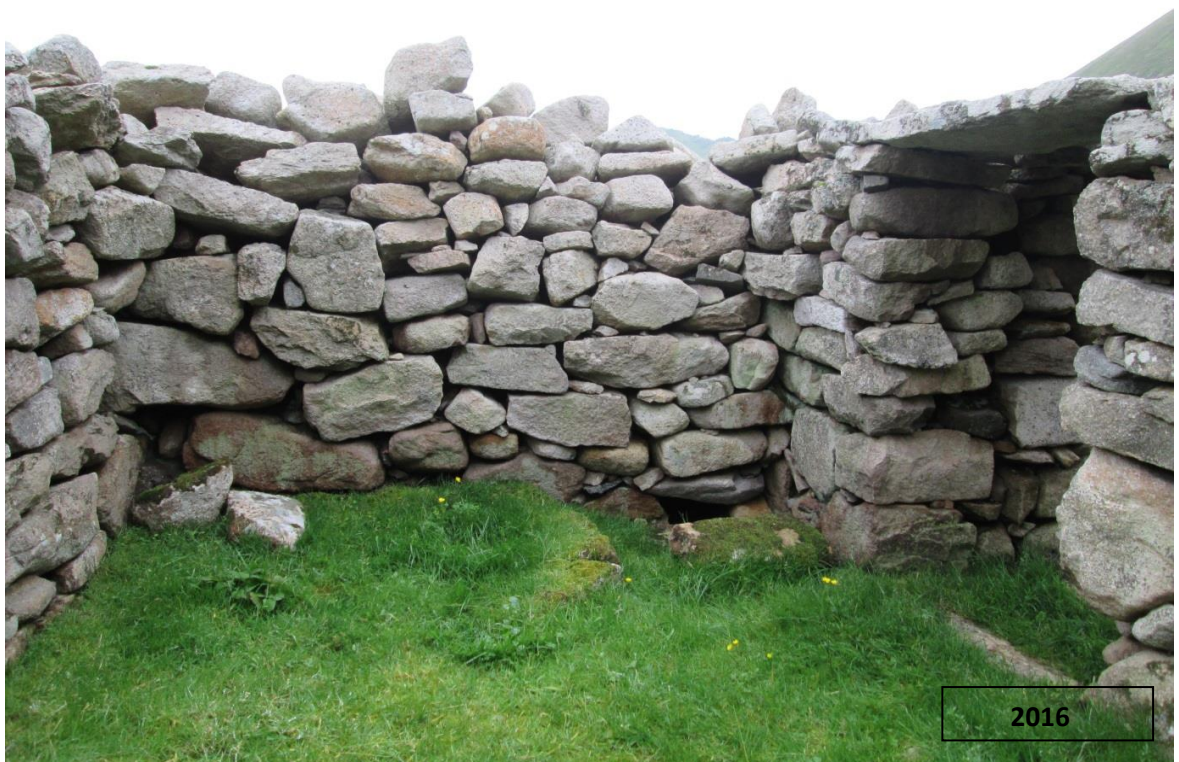
The southern gable end of this building collapsed on the 23<sup>rd</sup> July 2016 following a period of heavy rain. In the absence of the St Kilda Archaeologist, the site was made safe by the St Kilda Ranger, Kirsten Dallas and the appropriate authorities, including Historic Environment Scotland, informed. There had been no prior suggestion that this wall was any more unstable than others along the street, but given that the adjoining southern gable of blackhouse G collapsed in 2014 and that of blackhouse B in 2011, this collapse is not unexpected. The clean interior of the blackhouse and presence of two squared timbers, respectively 1.10m by 120mm by 60mm and 0.40m+ (one end being buried in the stone tumble) by 100mm by 70mm, within the collapsed stone suggests this gable of the blackhouse has already been altered by NTS work parties. It is probable that these timbers originally formed part of the roof framework, as the larger piece has a fragment of tarred felt adhering to it.

Figure 8 *Blackhouse H interior view of south gable as surviving in 2008 and August 2016*

**1. Clearance of rubble.** Rubble to be sorted and laid out to allow for identification of stones to allow for stone-for-stone repair.

**2. Stabilising of collapse.** Further removal of stones may be necessary to create a stable foundation for repair

**3. Rebuild of collapse to main body of blackhouse.** This will be undertaken using a stone-for-stone rebuilt where possible. Any additional material such as core material will be sourced locally and will be made visually unobtrusive.

**4. Assessment of stability of main structure.** Contractor will assess the structure to decide if it is structurally stable enough to take the weight of the gable. **If the structure is suitably stable then 5a, if not 5b.**

**5a. Rebuild of gable.** Following stone-for-stone method where possible, any changes or addition of material needed will be completed using locally sourced materials and will be visually unobtrusive.

**5b. Store stone for gable appropriately.** The gable stones will be stored nearby, lichen-face up, to preserve lichen patina and ensure stone is kept collated and can be easily identified at a later date. Suggestions for making the structure more stable will be discussed with partners to allow for full repair.

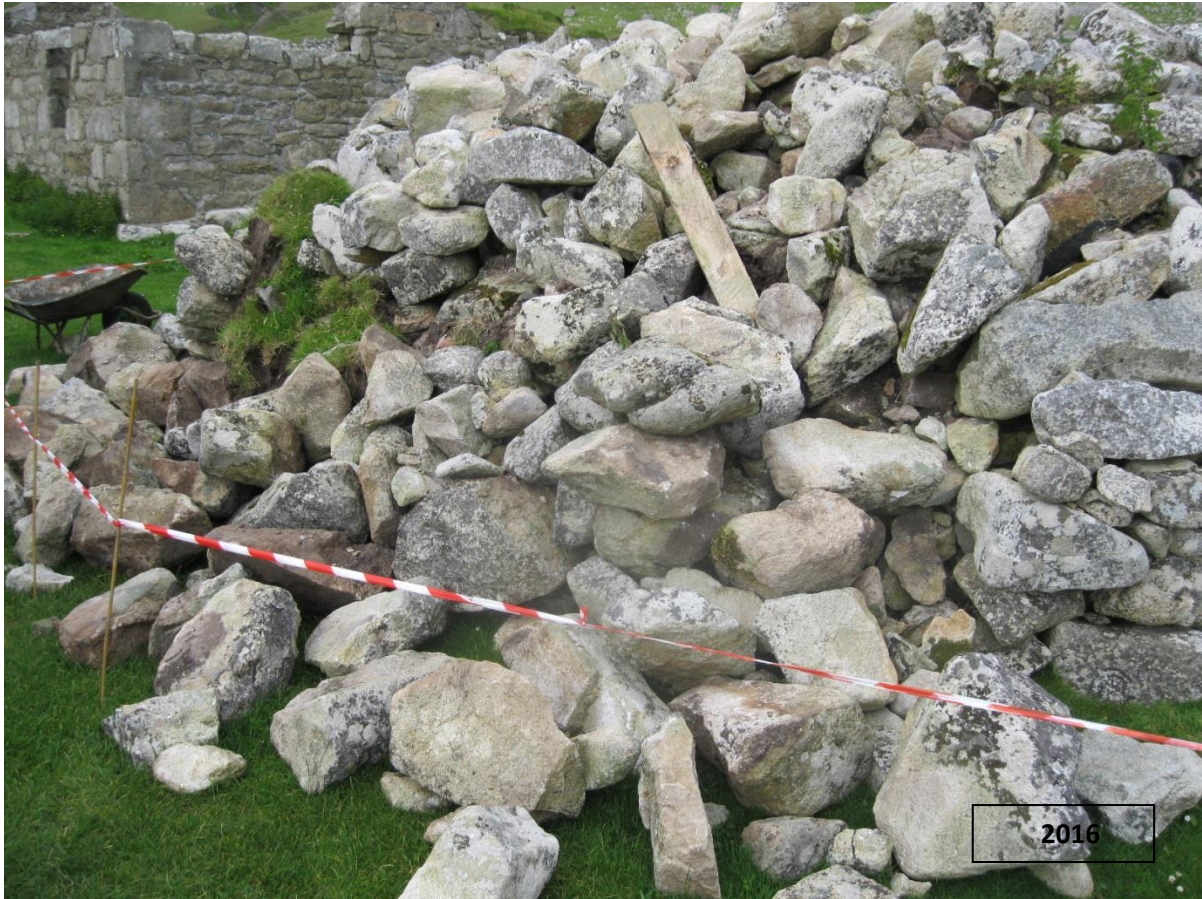
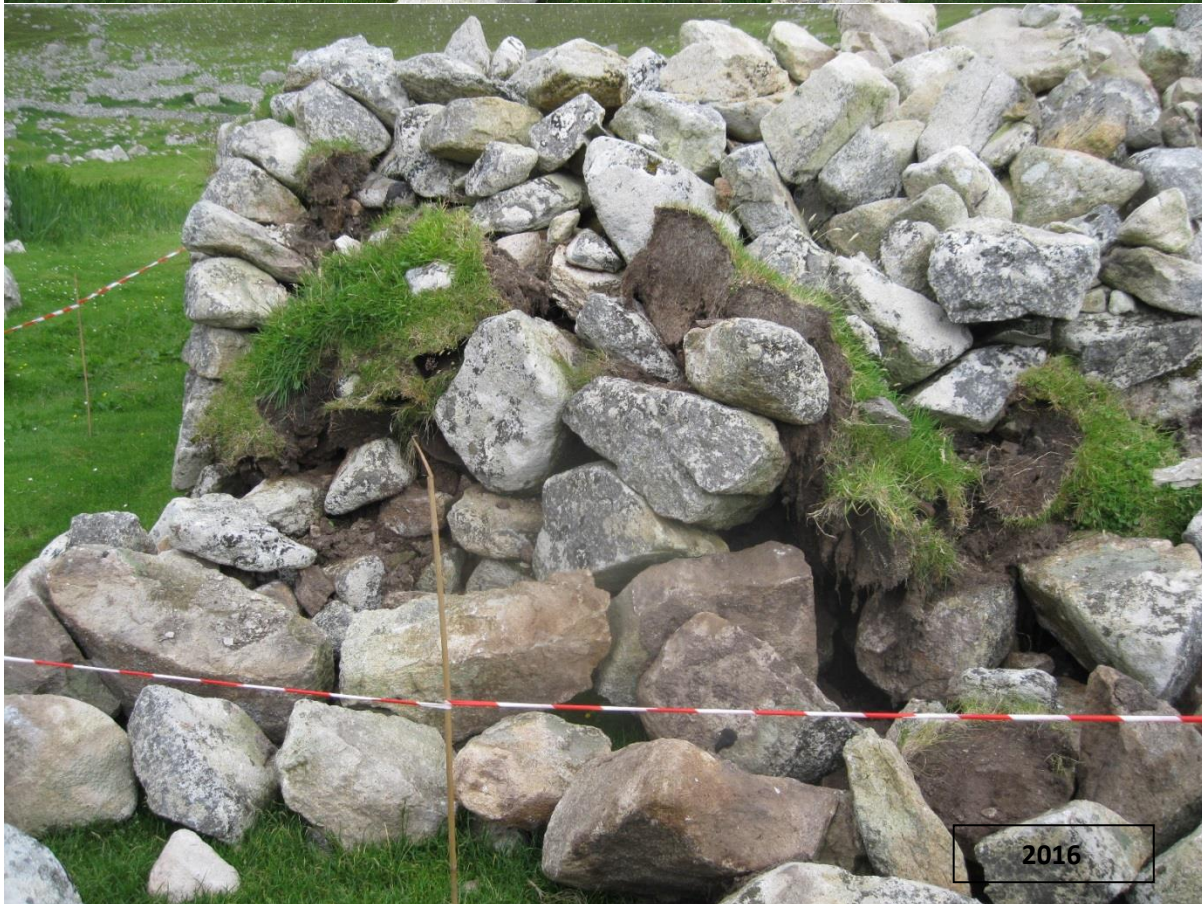
There are several areas of concern regarding the repairs. Innes Watson, the contractor, has concerns that the collapse was partially caused by the added weight of the dry stone upper gable resting on top of the end-wall of the blackhouse. This structure is possibly a later addition and is in some ways contrary to the blackhouse building tradition (Walker and McGregor 1996), although certainly it is within the a vernacular tradition of drystone building on St Kilda. As a result of the concerns from the contractor, it is intended that there will be a concerted attempt to strengthen the load-bearing capacity of the main body of the blackhouse wall during repairs. This may be undertaken by giving the infill of the wall a

Figure 9 Detail of collapsed stonework of south gable of blackhouse H in July 2016

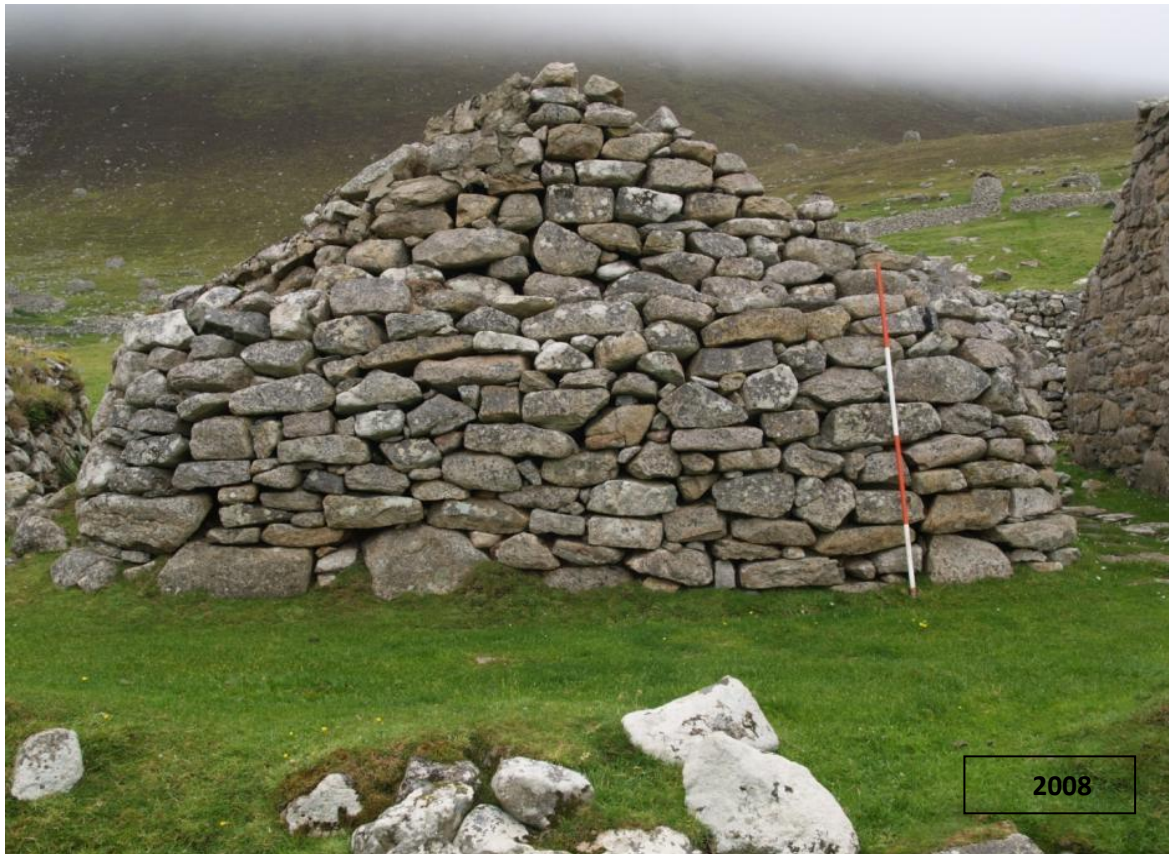
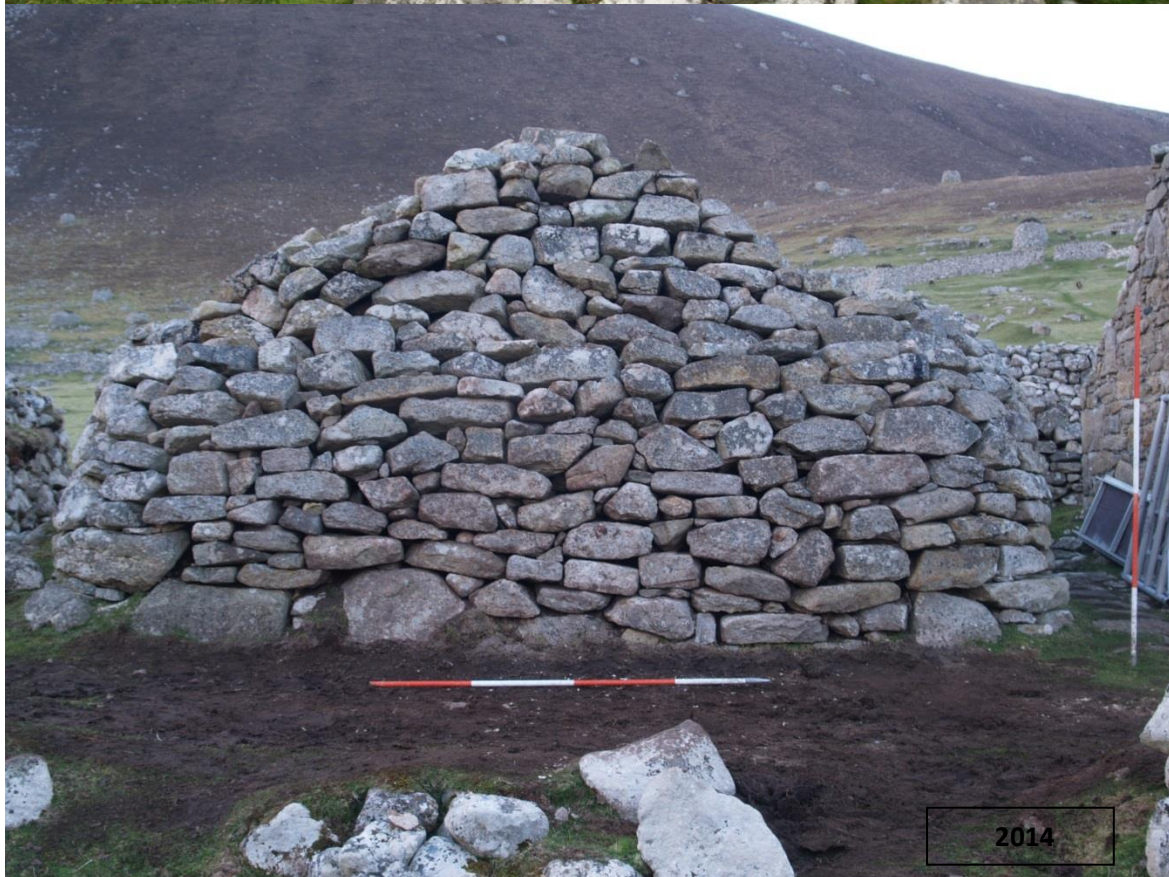
Figure 10 South gable of blackhouse G, as reconstructed in 2014 after its collapse, with image from 2008 above of gable before its collapse

higher component of rubble or a greater number of packing stones than would originally have been utilised. If this is the case, the materials will be locally sourced and the change will not be visible externally. This has proved a satisfactory process for the reconstruction of blackhouse G.
