HUNTLY CASTLE

Survey of stone frieze and other ornamental stone

September 2015

Applied Conservation - Stone
Conservation Group
7 South Gyle Crescent
Edinburgh EH12 9EB
Tel: 0131-334 6367
Fax: 0131-334 6810

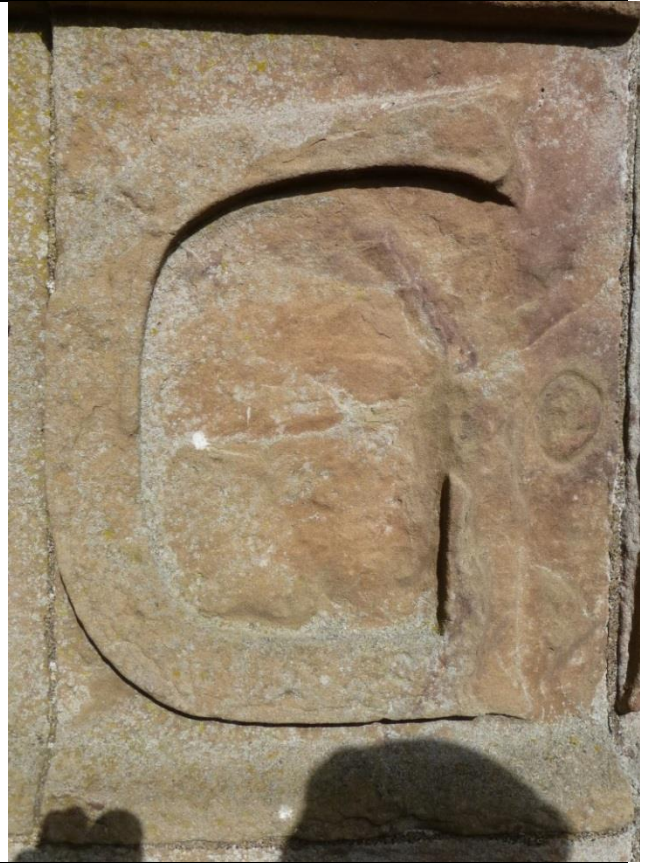
G – a number of minor old resin repairs are still in situ. Small areas of delamination are visible at the top of the stone.

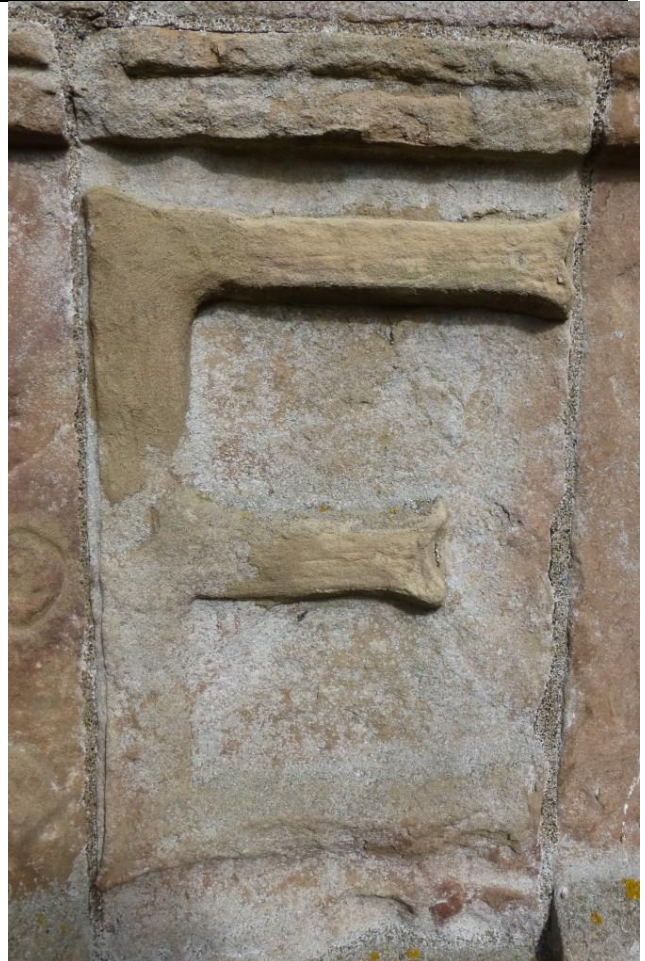
E – The two upper crossbars and connecting vertical shaft are GRP replica. Nonetheless, the top left corner of the letter has been rendered with resin mortar. The remaining original stone is eroded. The resin mortar pointing around the replica parts is cracking and failing. The background surface is covered in thin, potentially protective, lichen growth.

Failing resin repairs should be removed and large resinous surface repairs minimised to improve the permeability of the stone surfaces. In particular, the pointing around replica letters needs to be removed and re-applied with a reversible acrylic resin mortar consisting of 10% Paraloid B72 in acetone mixed with colour-matched sands.

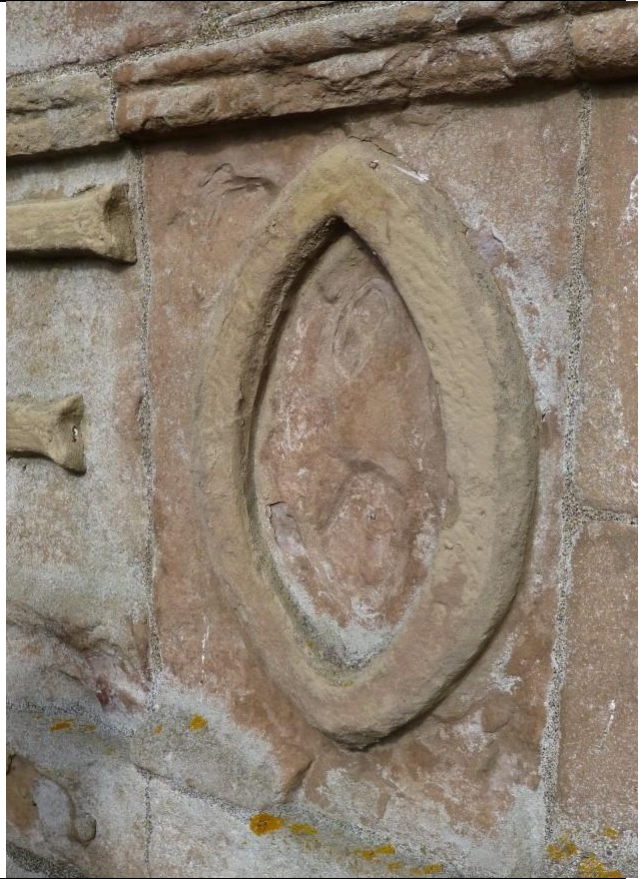
O – GRP replacement letter. The resin pointing around the letter is failing. The background is blistering in the centre where this has led to surface loss. Further open delamination edges are visible delaminations in the centre and corners of the stone., where old resin repairs have been lost or where new areas of decay have developed. A number of old resin repairs remain in situ.

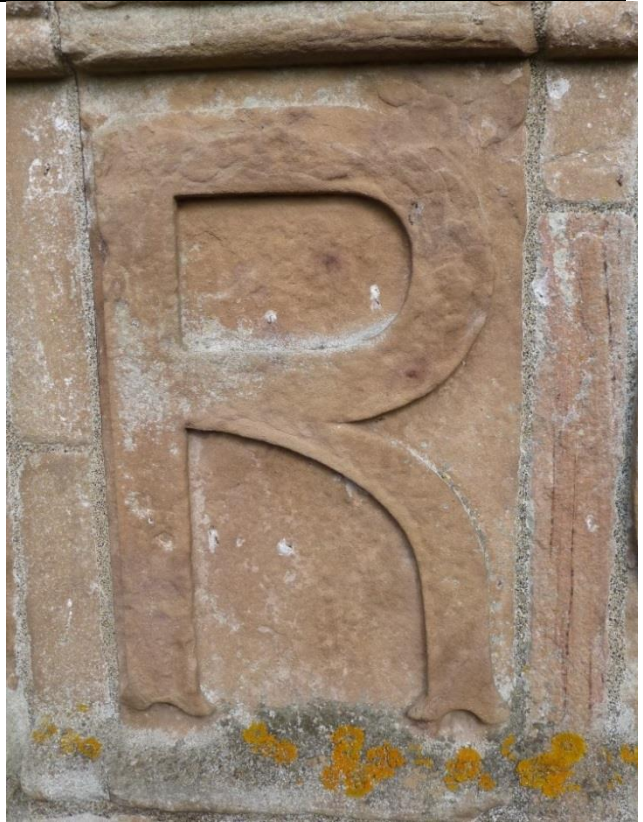
R – Minor fissures have been previously pointed and these fills are still in situ.

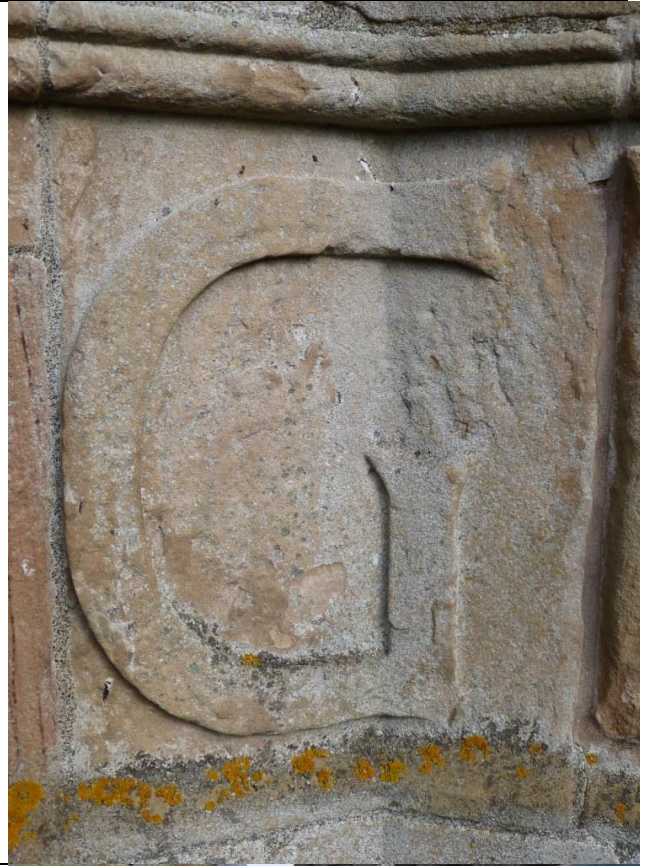
G – Minor areas of surface scaling in the lower part of the letter.

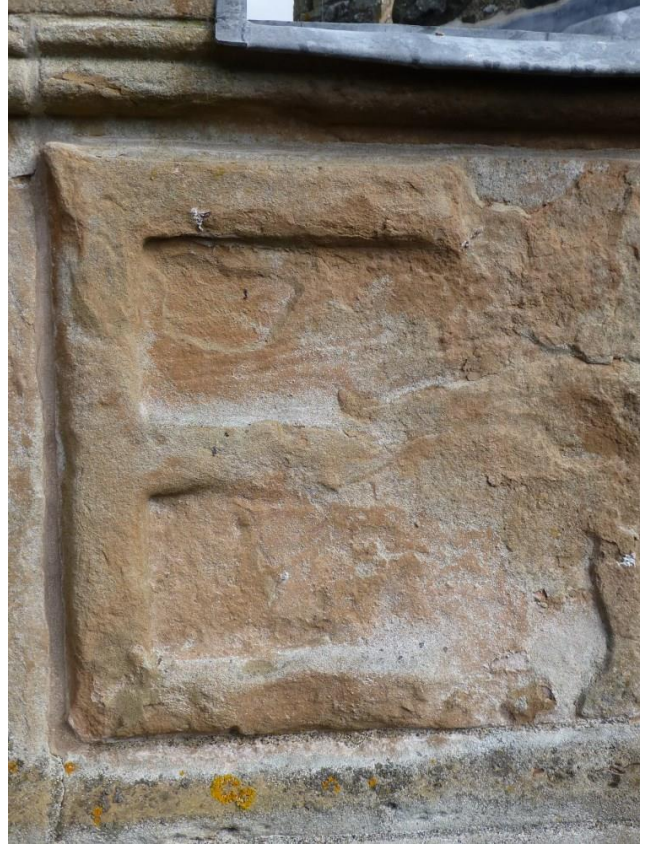
E – Many small areas of surface scaling and blistering, particularly towards the right side. The surface is boss in a number of areas. Fissures are visible at the top of the stone. Remaining old resin repairs are failing.

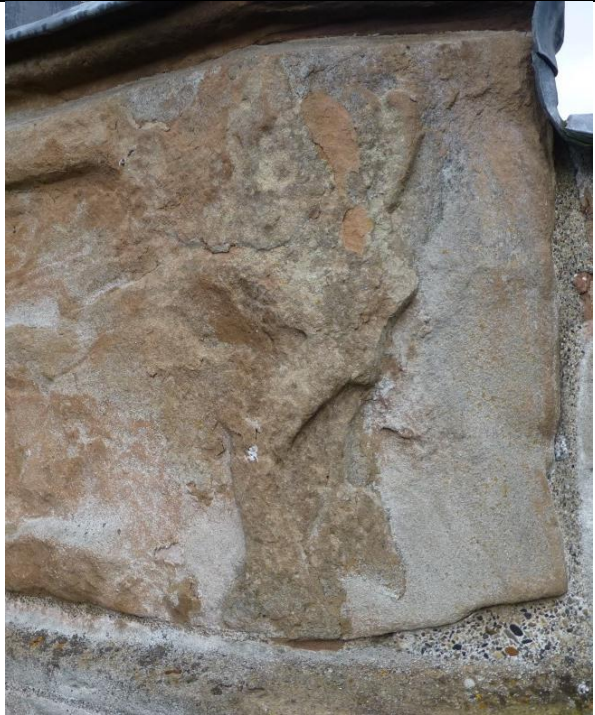
Star between 'GEORGE' and 'GORDOVN' - mostly missing and very eroded. The right side is almost completely sheared off. The delaminating remains are cracked and boss. This appears to have been caused water running off from the adjacent channel in the flashing.

The flashing on the left side of the gablet should be extended to prevent water run-off down the face of the pediment. Similarly, improvements may be possible to the flashing along the wall head where channelling of rainwater has led to local acceleration in surface erosion.

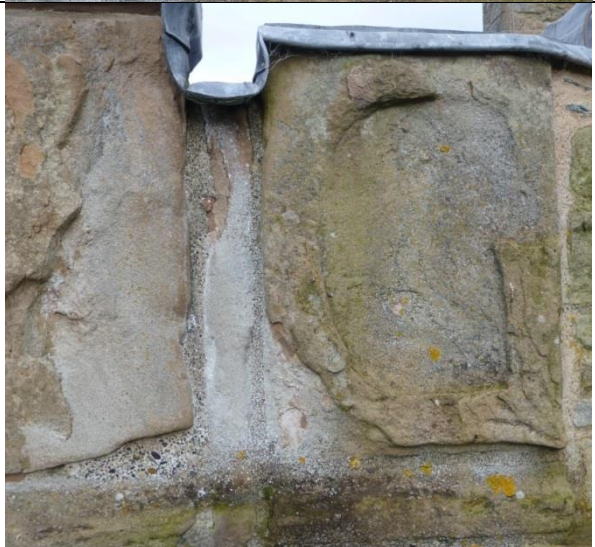
G - Delaminating in many areas, minor small resin repairs remain visible but most are missing or failing.

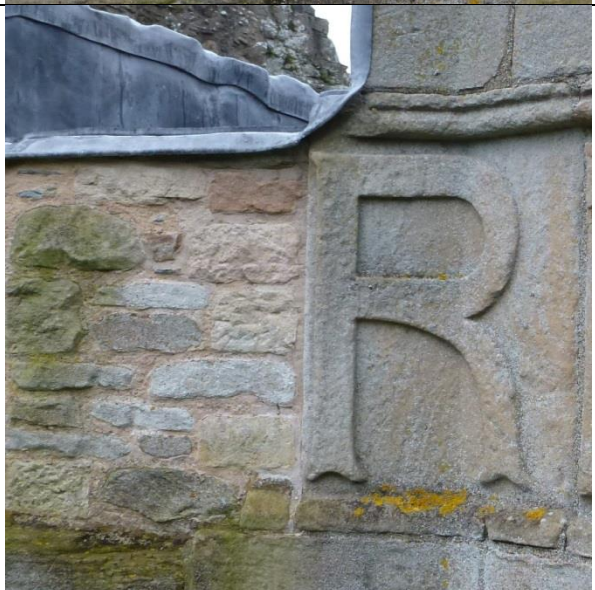
R - stable condition

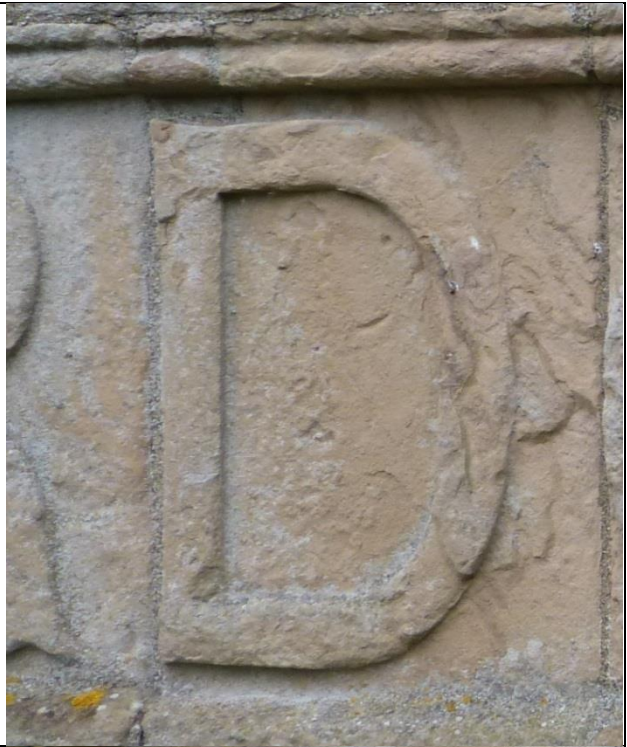
D - old repairs are starting to fail. Extensive pointing on right side is still in situ. Top of left side suffers surface scaling.

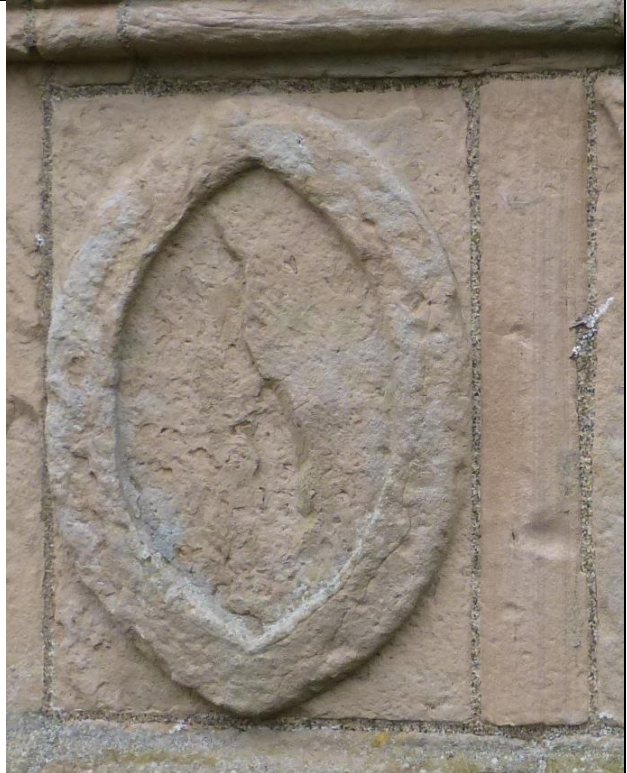
O - Extensively fissured, the left side and centre are particularly eroded and appear boss. Previous resin pointing is failing.

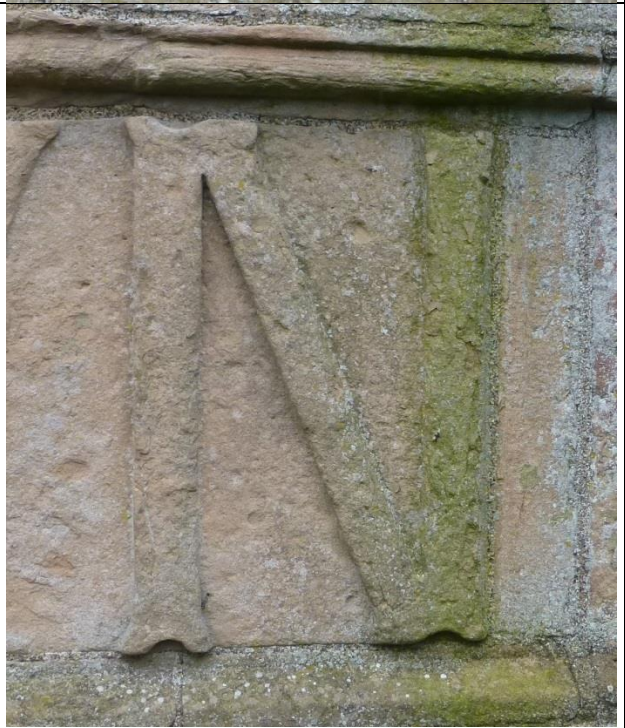
N – Flaking on right side with numerous small resin repairs visible in other areas which are starting to fail.

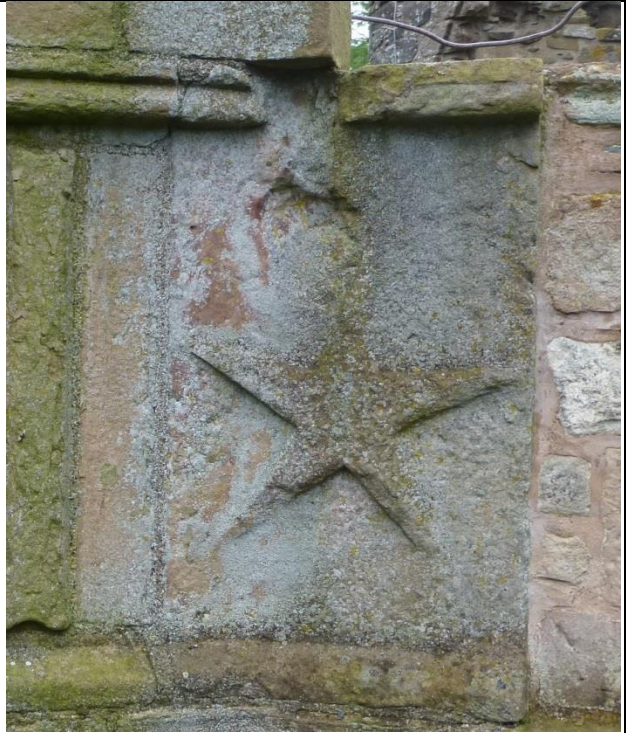
Star between 'GORDOVN' and 'FIRST'
- Eroded at top right side with minor delaminations visible here. This appears to be caused by water run off due to missing stringcourse stone above.

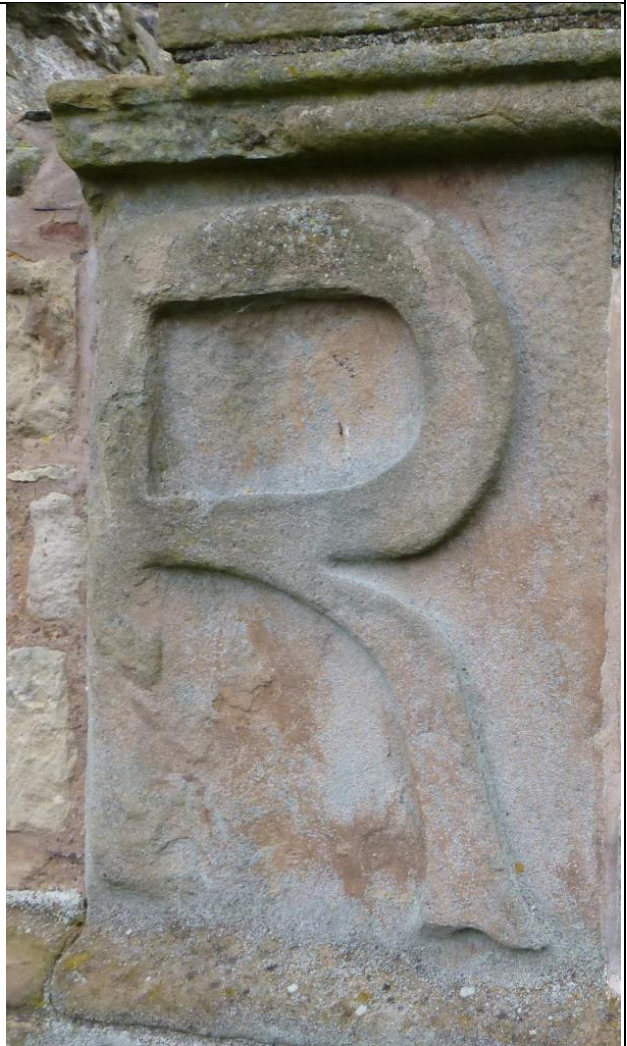
R - The lower leg is mostly eroded. Large old repairs in the top left corner are starting to open up. Minor delamination are visible below the crossbar.

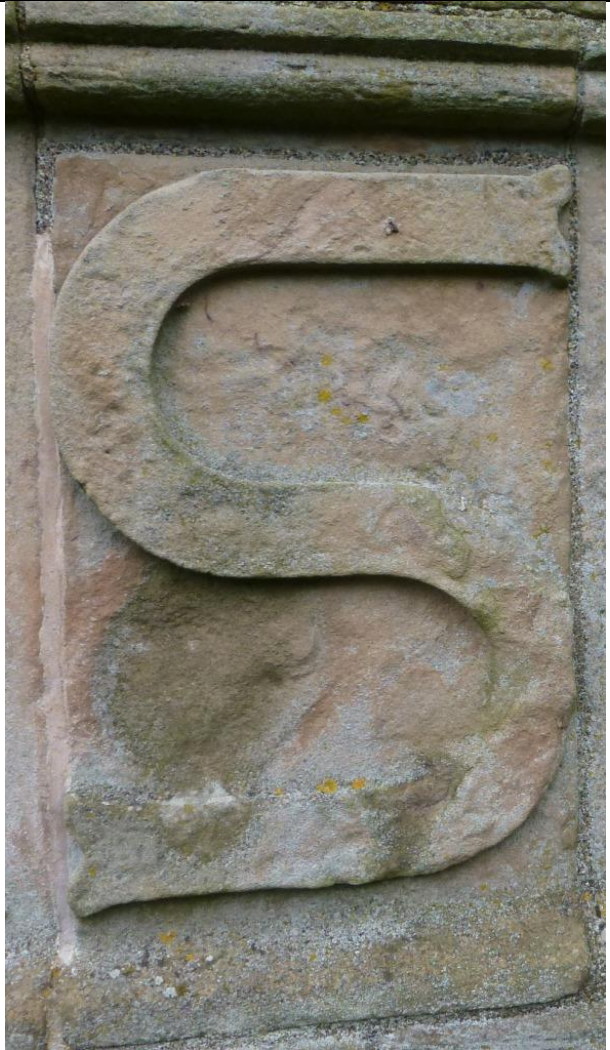
S – Minor fissures in top left corner.
Missing cement pointing appears to
have been replaced with acrylic mortar
pointing.

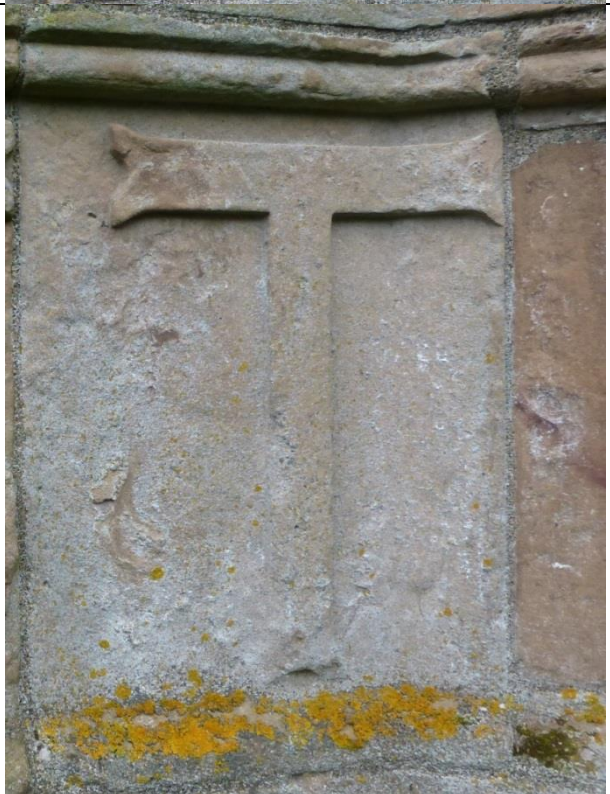
T - Surface blistering on left side with
old resin repairs still in place.

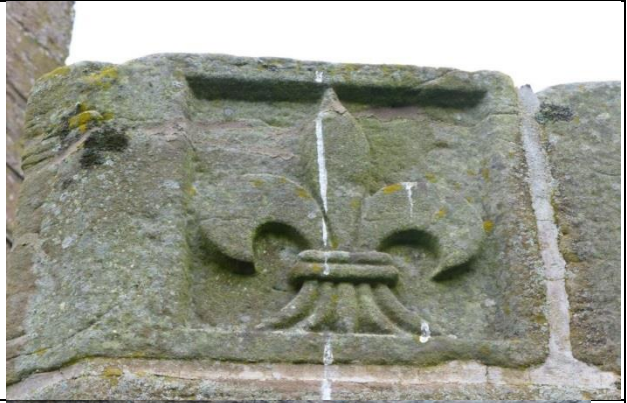
Fleur-de-lis above 'S' – The resin mortar pointing along fissures is starting to fail. Open masonry joints appear to have been pointed with acrylic resin mortar.

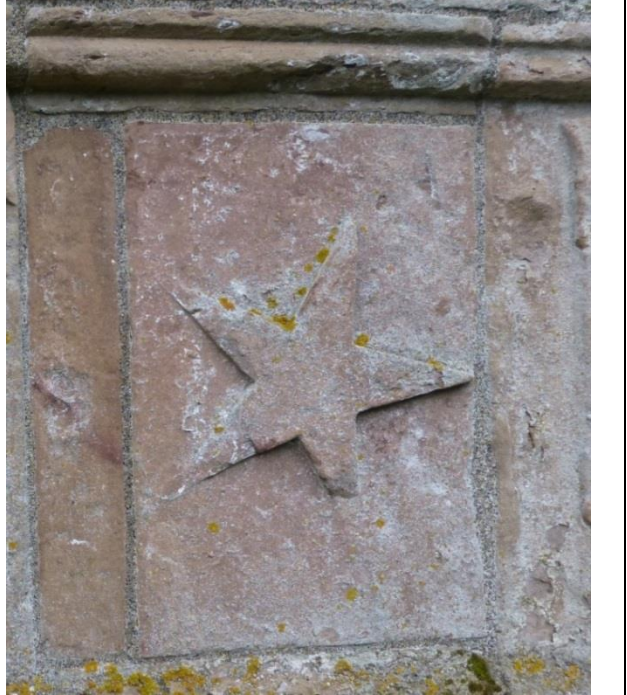
Star between 'FIRST' and 'MARQVIS' – Minor surface scaling on left side.

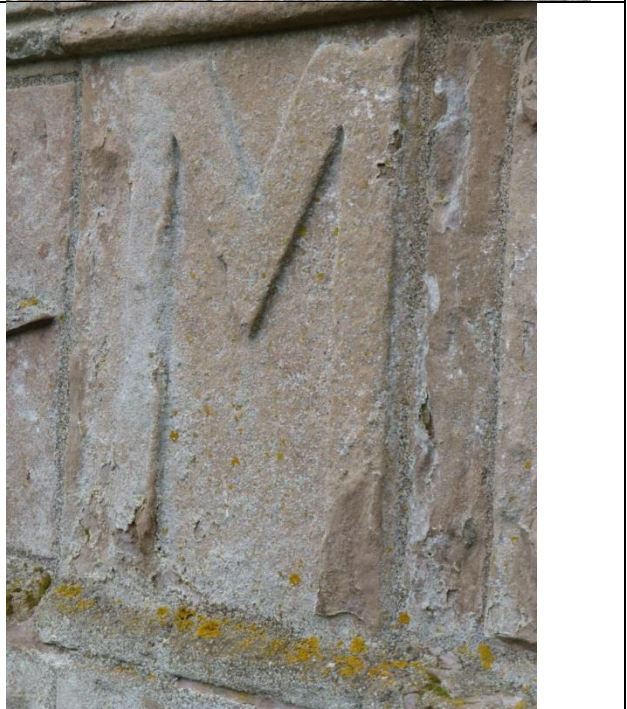
M - blistering and surface scaling on lower left side and top right hand side. Old repairs here are failing.

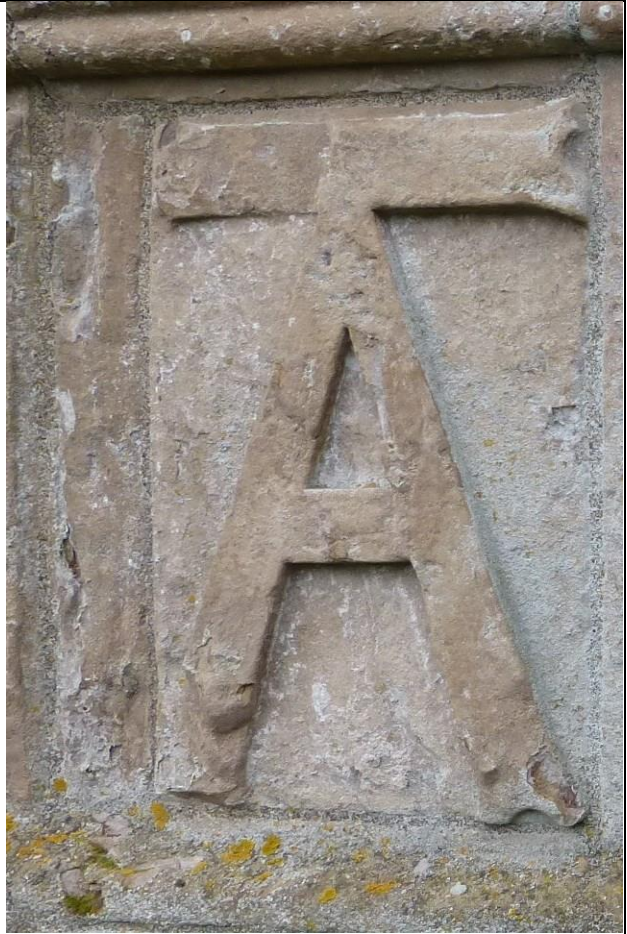
A – The lower right corner is lost and resin repairs on the lower left corner are starting to open up. Surface losses have occurred here and at the top right corner.

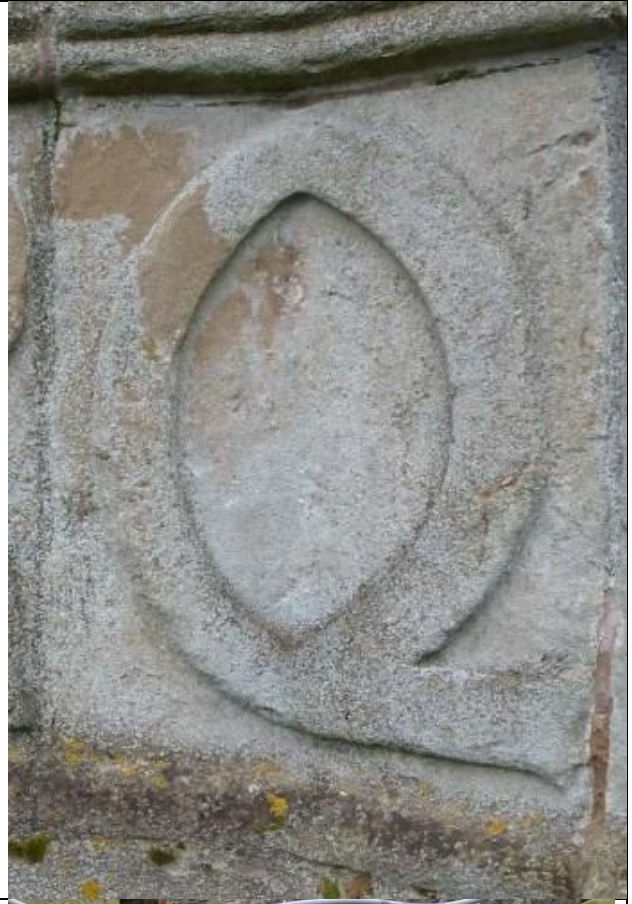
Q – Minor surface scaling and open delamination edge on lower right side of letter. Largely covered in thin lichen growth.

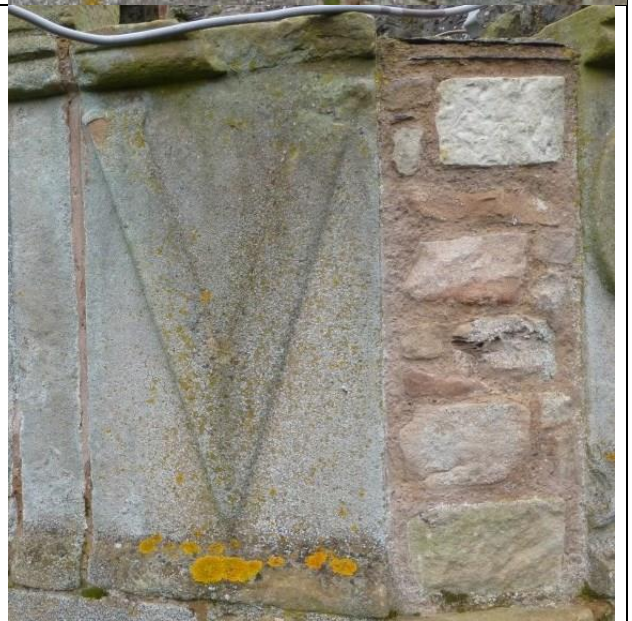
V – Delaminated top left corner. Thin lichen colonises all but the freshly revealed surface.

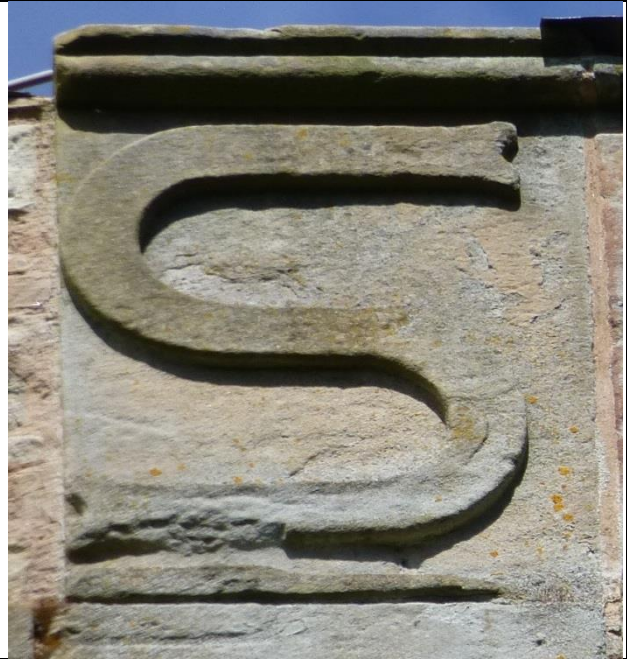
S – Eroded lower edge and minor surface scaling but otherwise stable.

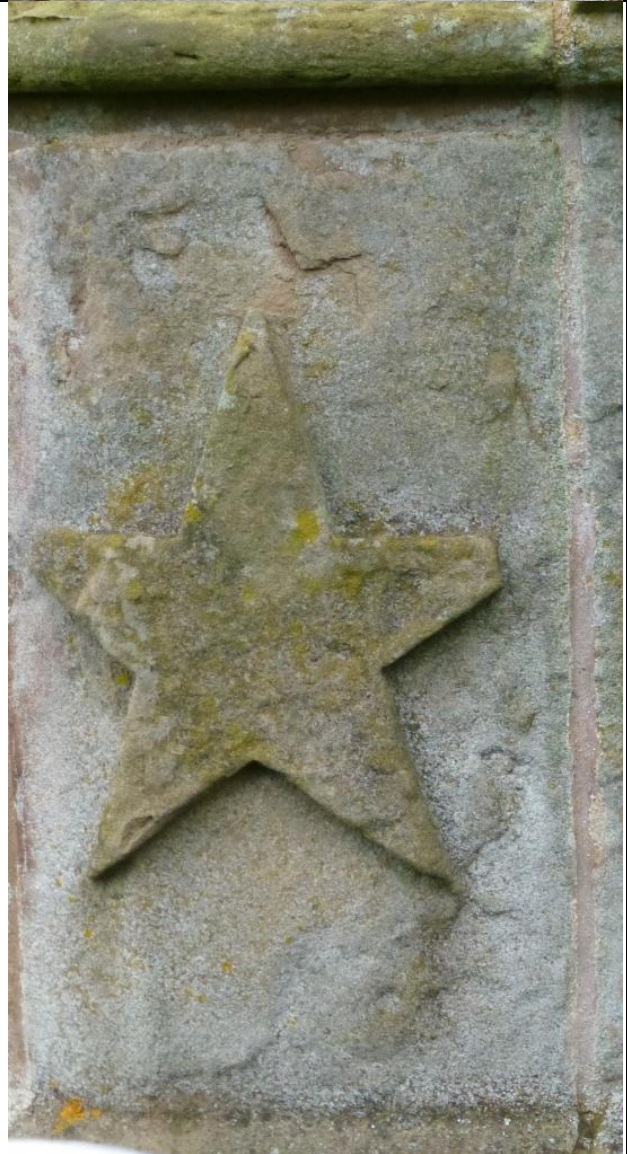
Star after 'MARQVIS' – delamination and surface loss at top. Acrylic resin mortar has been used to point vertical masonry stone joints to either side, indicating at least partially missing or failing mineral mortar pointing here.

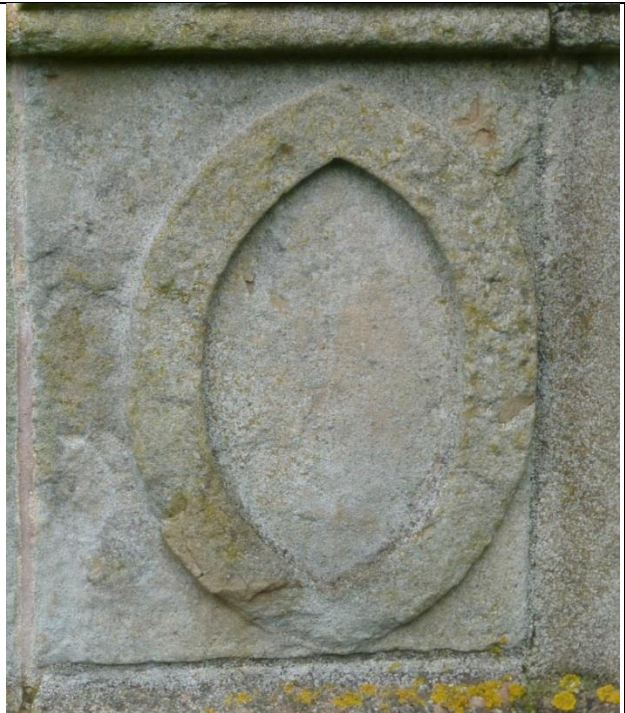
O - Fissures on lower left hand side with open repairs visible here. The lower right corner is also fissured and the surface appears boss. Minor delaminations have occurred on the top right corner.

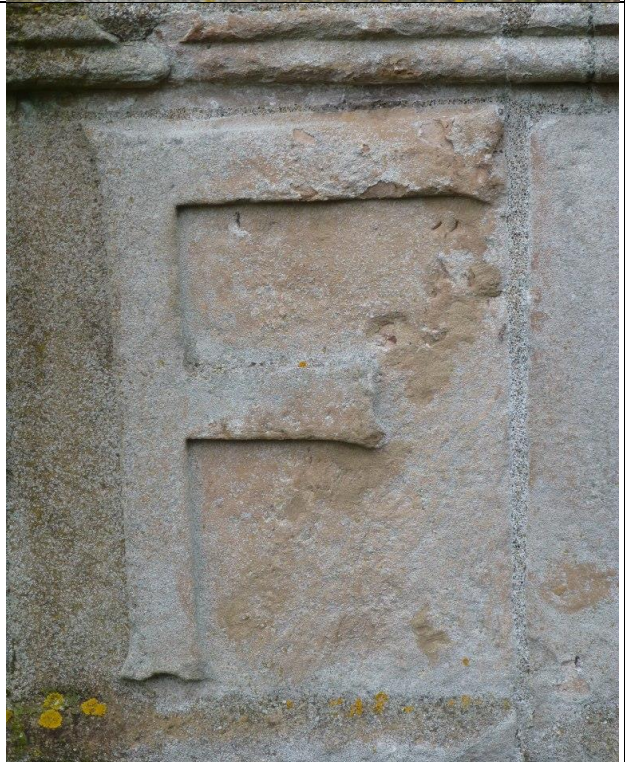
F - Minor surface scaling and losses along the top bar and fissured along lower cross bar. Appears boss. Failing old resin repairs on right side of background.

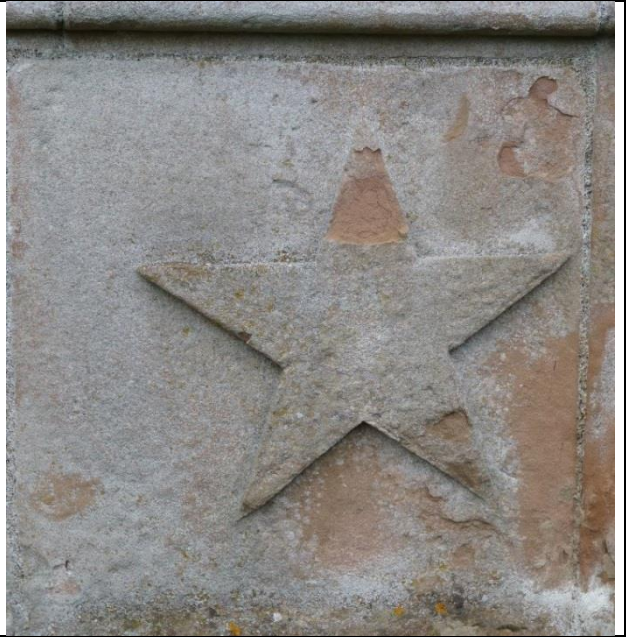
Star after 'OF': Top and bottom right hand arms are missing. The presence of cracks indicates that further areas are at risk of delamination.

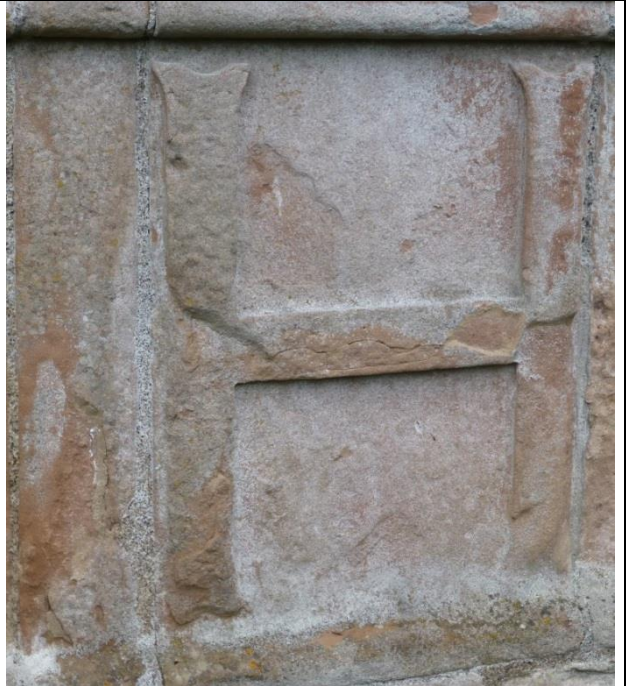
H - Old resin mortar repairs along delamination edges are starting to fail. Cracked along cross bar, also delamination edges starting to open up and fissures at top left corner.

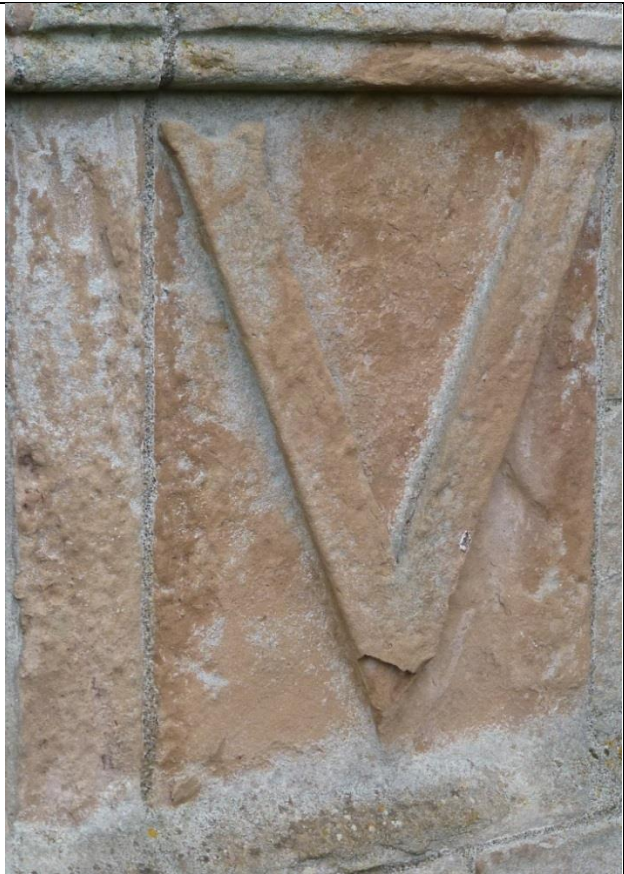
V: The lower part of the letter is lost due to delamination and the surface above appears boss and fragile. Old resin mortar repairs are visible in the top left corner and lower right side. These appear to be intact.

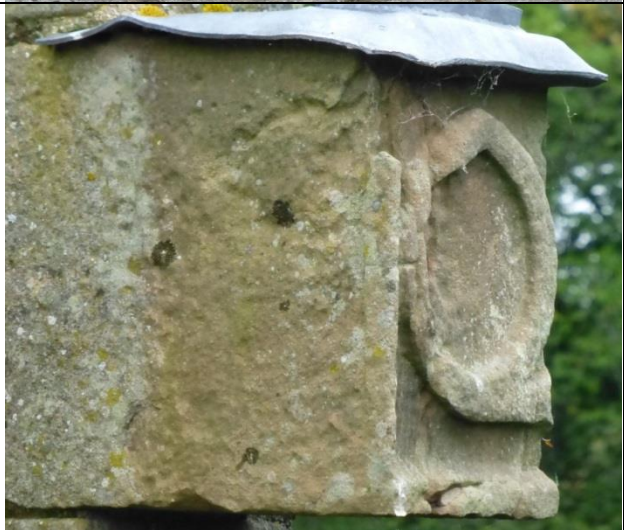
Q at far Eastern end: Loss of lower edge moulding and top left corner; cracks visible along the lower and left edge:

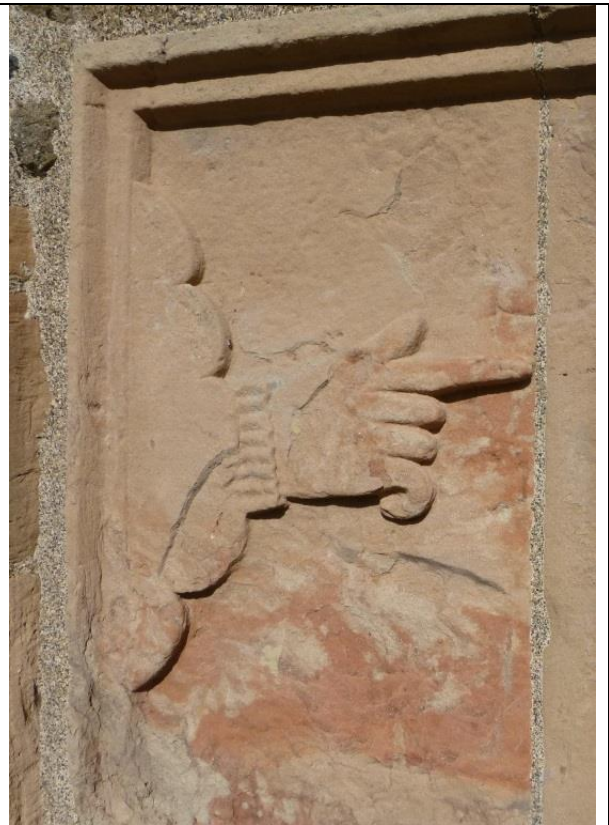
Pointing hand left of 'Henriette'. Small delamination at bottom and previously repaired delamination edges above hand.

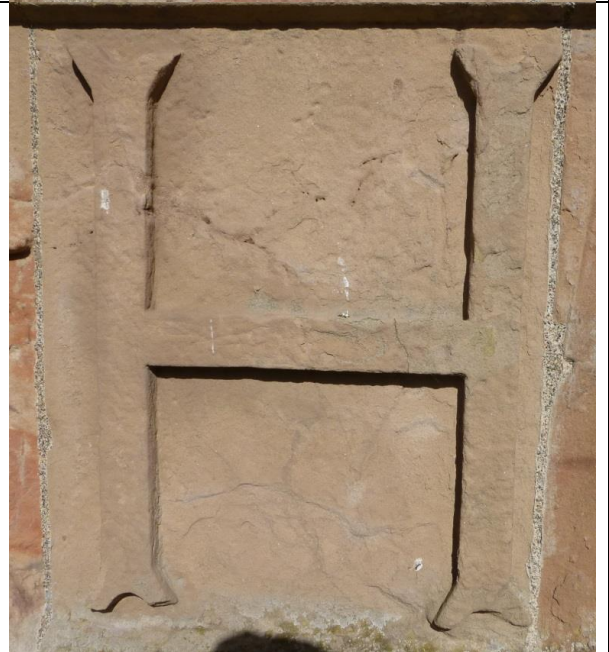
H - failing old repairs of cracks in the centre of the stone. The surface is delaminating and boss in the centre.

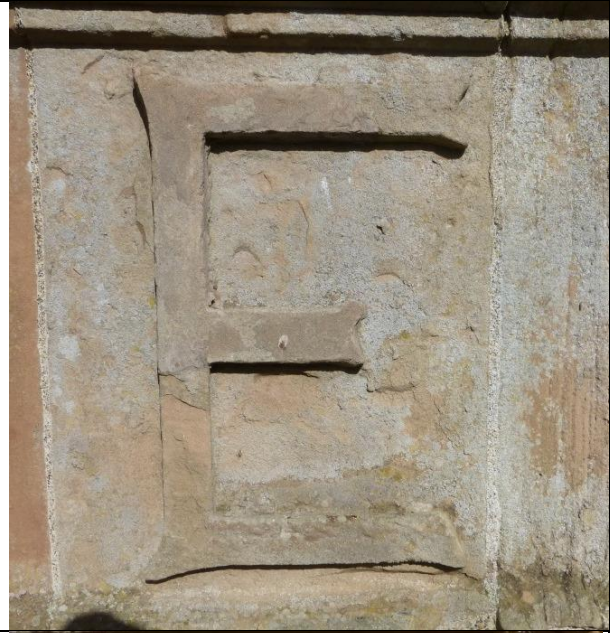
E - replica letter at the top and the joint is open here, delamination edges are visible on the original lower half of the letter. The resin mortar pointing round letter is cracked and failing.

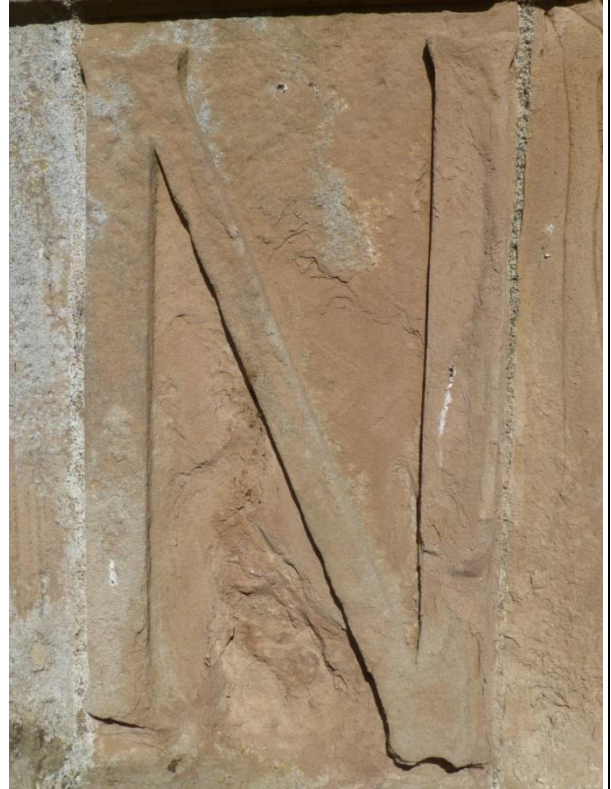
N - Very soft and disaggregating, severely eroded at the bottom.

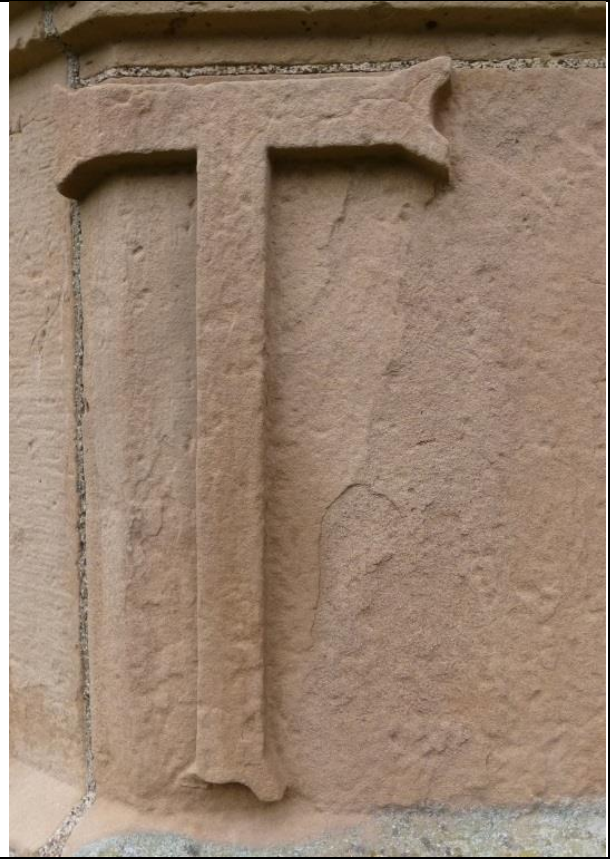
T - Minor fissures and surface scaling.

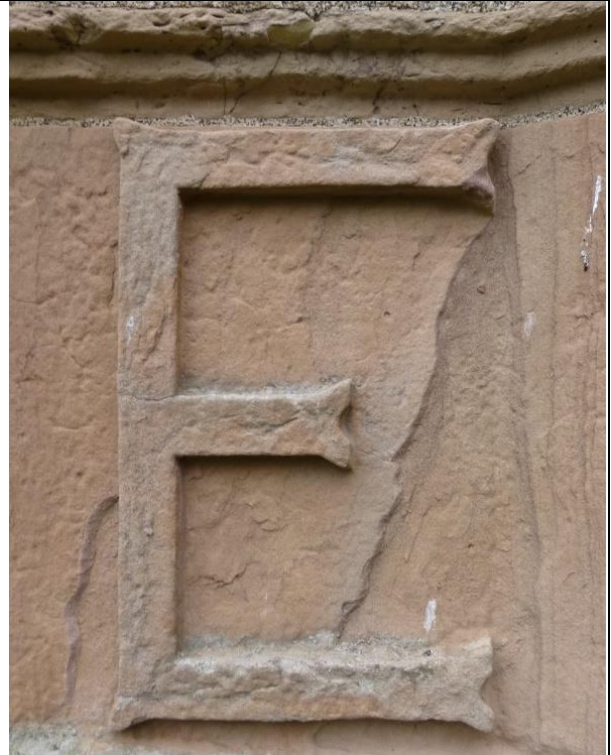
E - Old repairs of delamination edges are starting to fail. Minor new fissures have developed along central part.

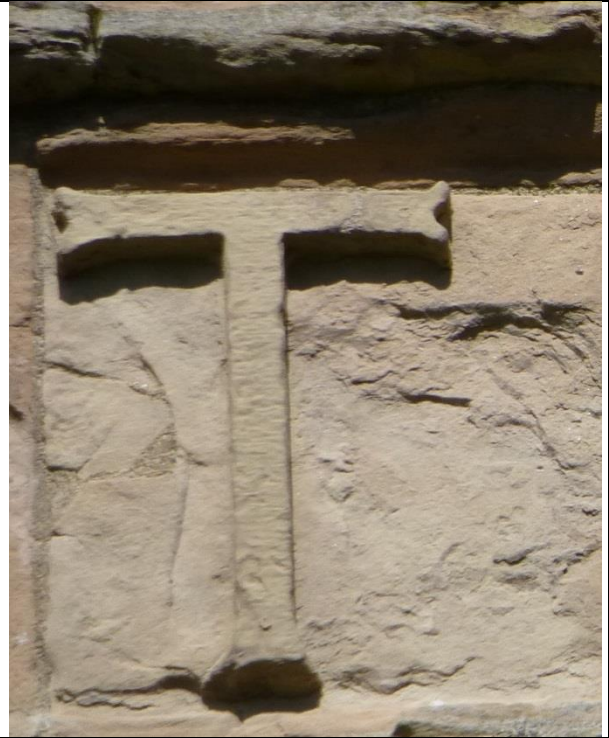
T - replacement letter; area to right of letter is very eroded. Delamination of stone background has led to considerable surface loss in the past. Edge pointing, where still present, is discoloured and failing. New areas of decay have opened up, particularly in the centre of the stone. The left side has been previously repaired with cement which is still in place. Fading resin repairs are visible in the lower left corner.

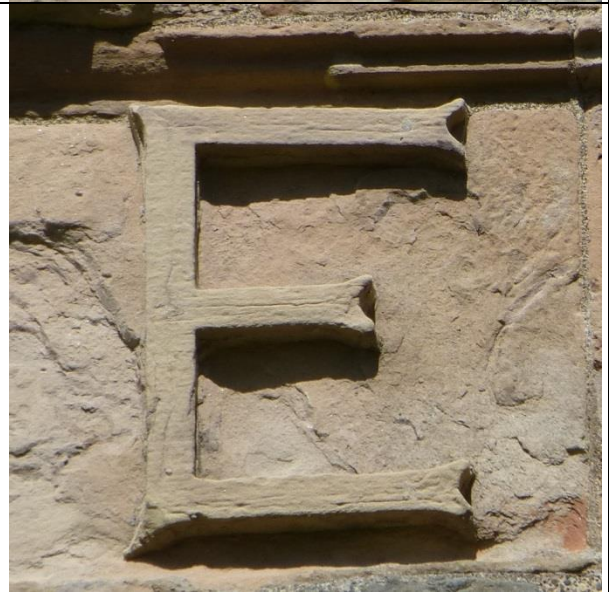
E - replacement letter; delamination of stone background has led to considerable surface loss in the past. Edge pointing, where still present, is discoloured and failing.

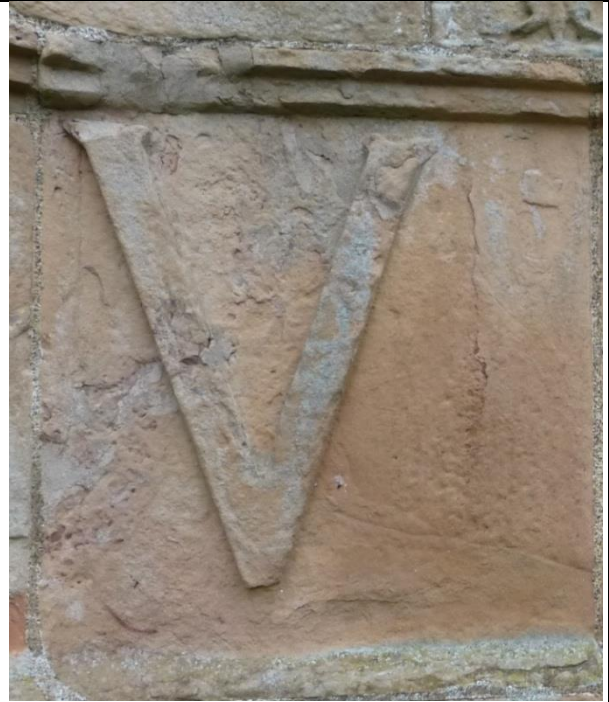
V - Vertical delamination on right side. A band of mineral inclusions has been preferentially eroded from bottom left to top central section, resulting in surface pitting. Previous resin mortar fills are now failing and discoloured. Cracks in top right corner of letter and central left side.

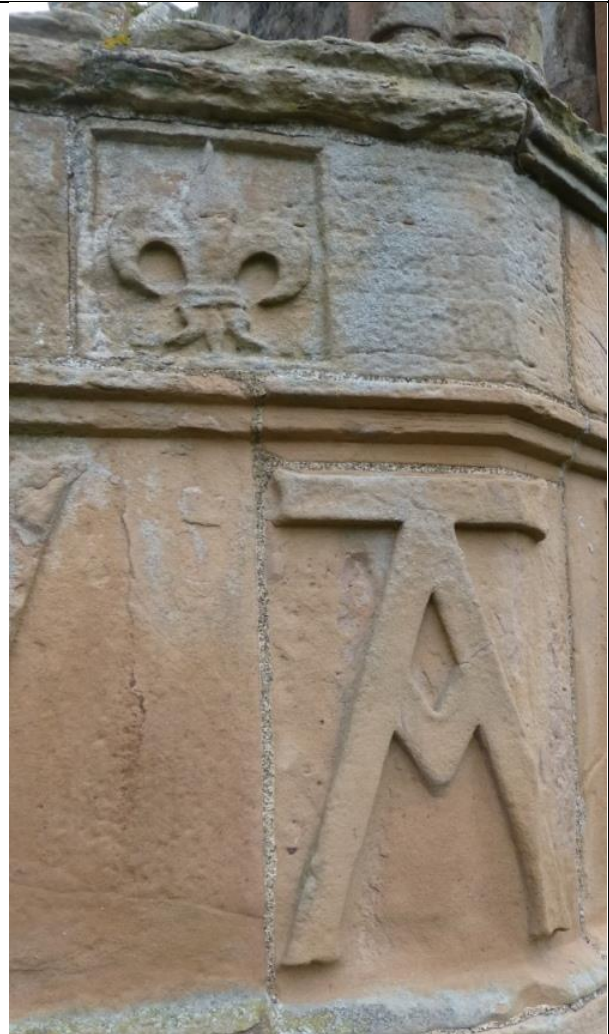
A - Crack on right side, disaggregating lower left area of central section.

Fleur-de-lis above – open bedding planes.

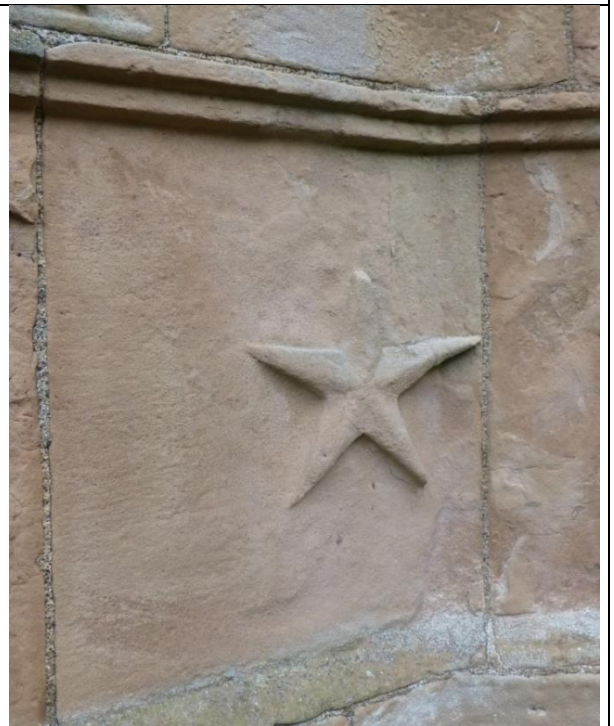
Star after 'Stevart' - some surface erosion and minor surface flaking, particularly on right side.

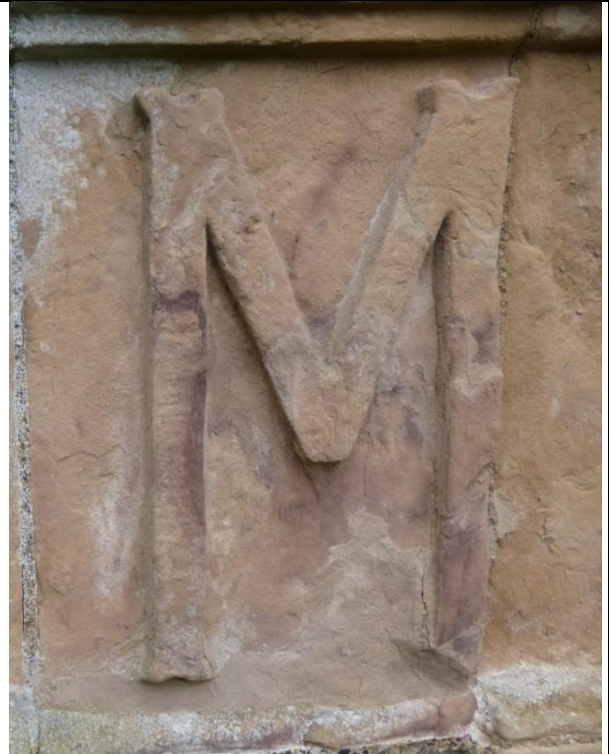
M - Heavy resin mortar repairs are starting to fail now with cracks opening up at the edges.

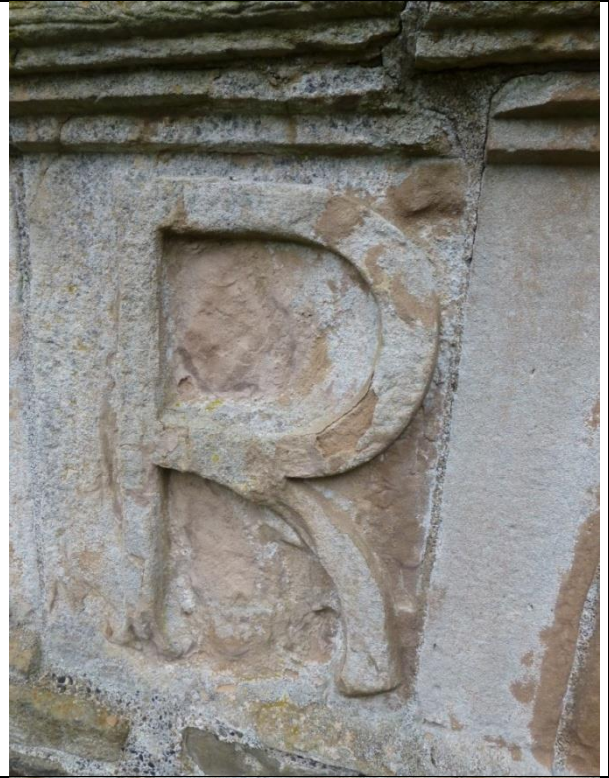
R - Appears fragile in spite of being heavily repaired in the past, particularly the middle section where surface losses have previously occurred and old resin mortar repairs are now failing.

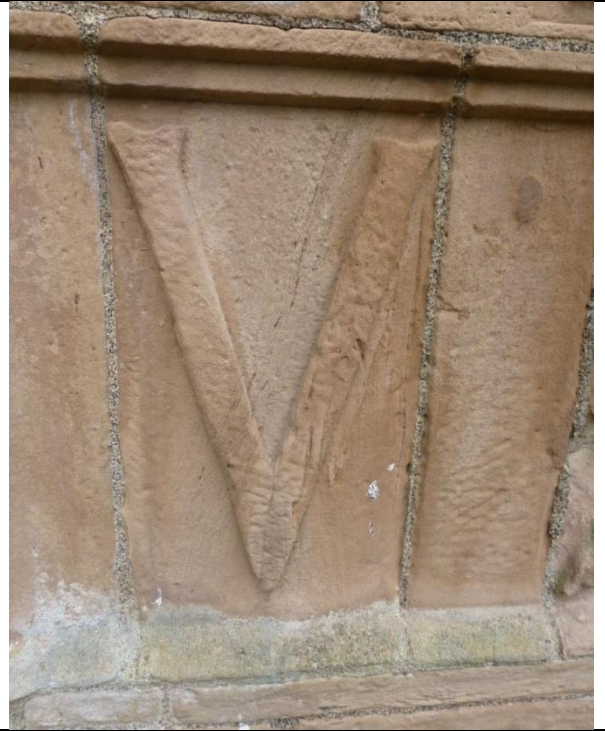
V – Disaggregating on right side. A dry appears stable.
