HUNTLY CASTLE

Survey of stone frieze and other ornamental stone

September 2015

Applied Conservation - Stone
Conservation Group
7 South Gyle Crescent
Edinburgh EH12 9EB
Tel: 0131-334 6367
Fax: 0131-334 6810

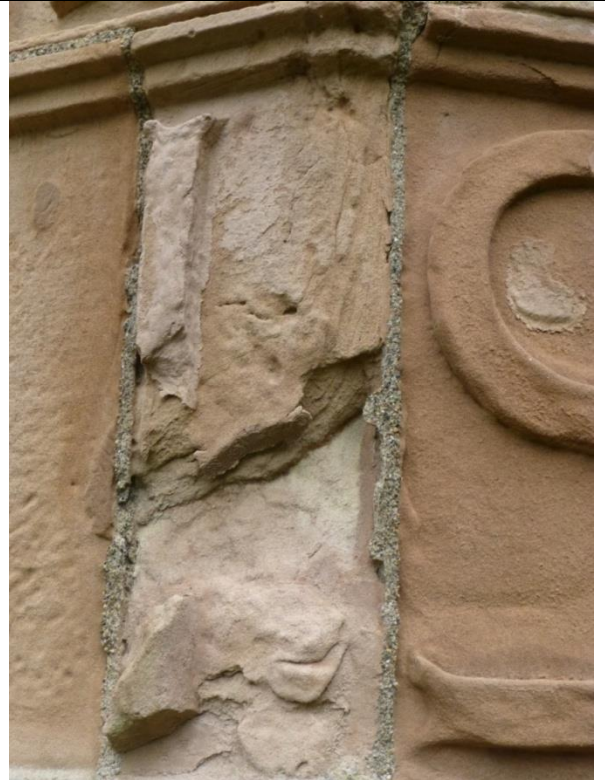
I - mostly missing letter and very decayed stone, suffering deep delamination of lower part which is very soft and displays open delamination and failing resin mortar repair edges.

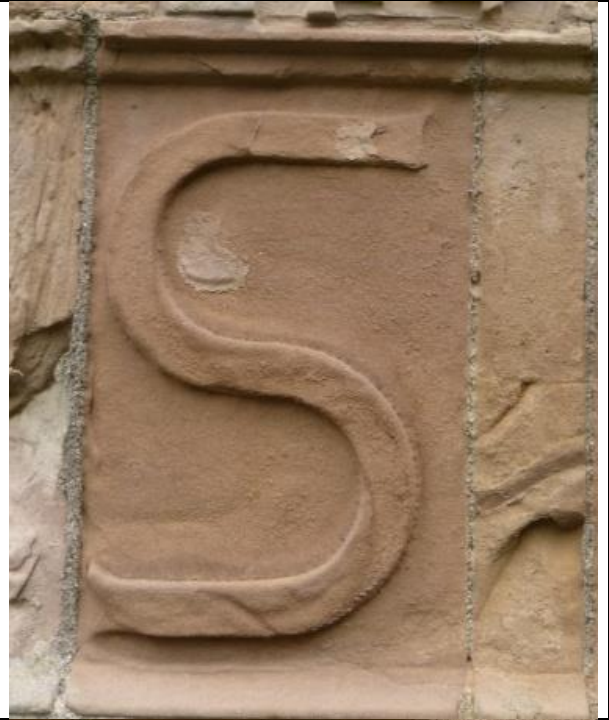
S - Delamination at top of letter. Minor opening up of small old resin repairs; disaggregating surface. Lower section of adjacent small stone is deeply eroded.

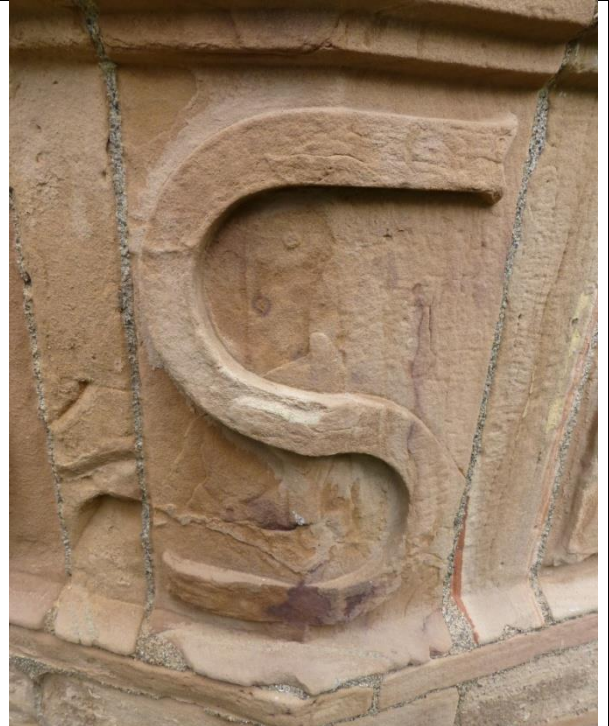
S - old repairs still visible but starting to fail. Fissures and areas of disaggregation are evident.

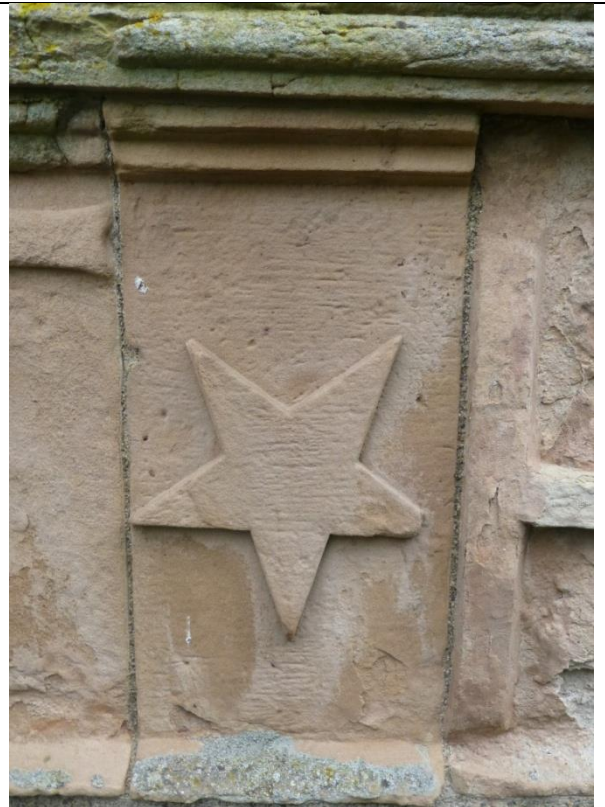
Star after 'of' – Minor disaggregation of lower part.

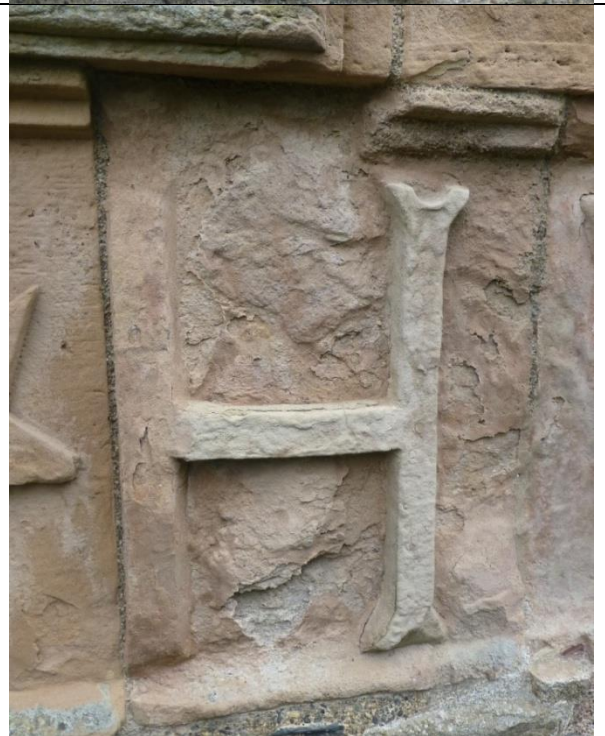
H - The background of the stone is delaminating and blistering while also being covered in extensive resin mortar repairs that are now failing. A large area in below the cross bar has lifted from the surface and is very fragile. Only the left vertical bar of the letter is original, the rest has been replicated in the past. The pointing mortar is failing around the replicated areas.

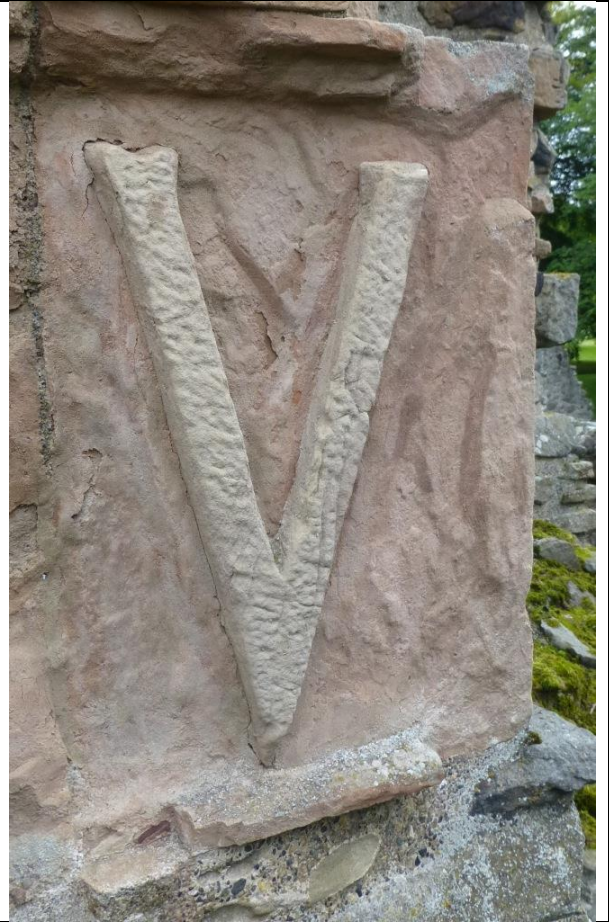
V – Replica letter with previously consolidated background where (extensive) repairs are still in place but now failing, particularly on the left side. The remaining letters and frieze is missing.

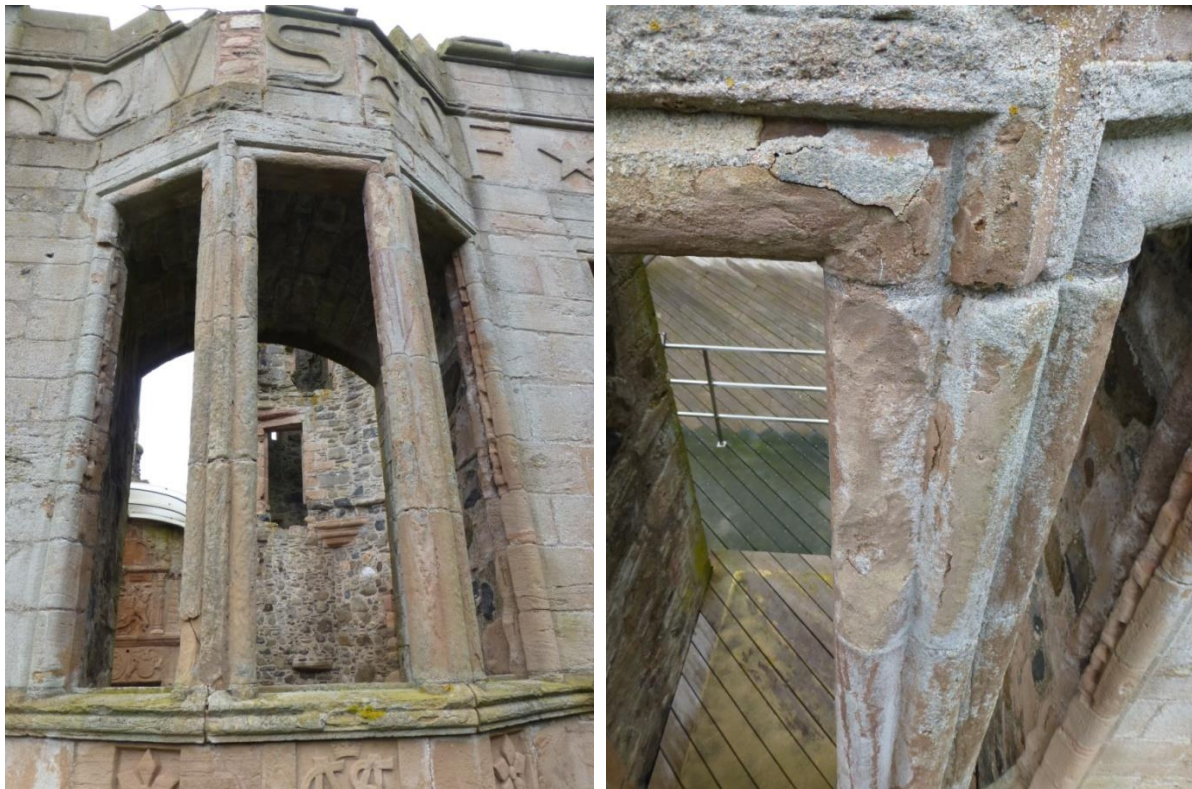
East bay window

Bay window furthest east: The mouldings have been extensively repaired with acrylic mortar in the past and these are now beginning to fail with some opened up to water ingress and potential entrapment already. Many areas are very fragile, particularly the top moulding which requires urgent repair. The mullions are very decayed and have been heavily repaired with resin mortar in the past which is now failing. The sill is cracked.

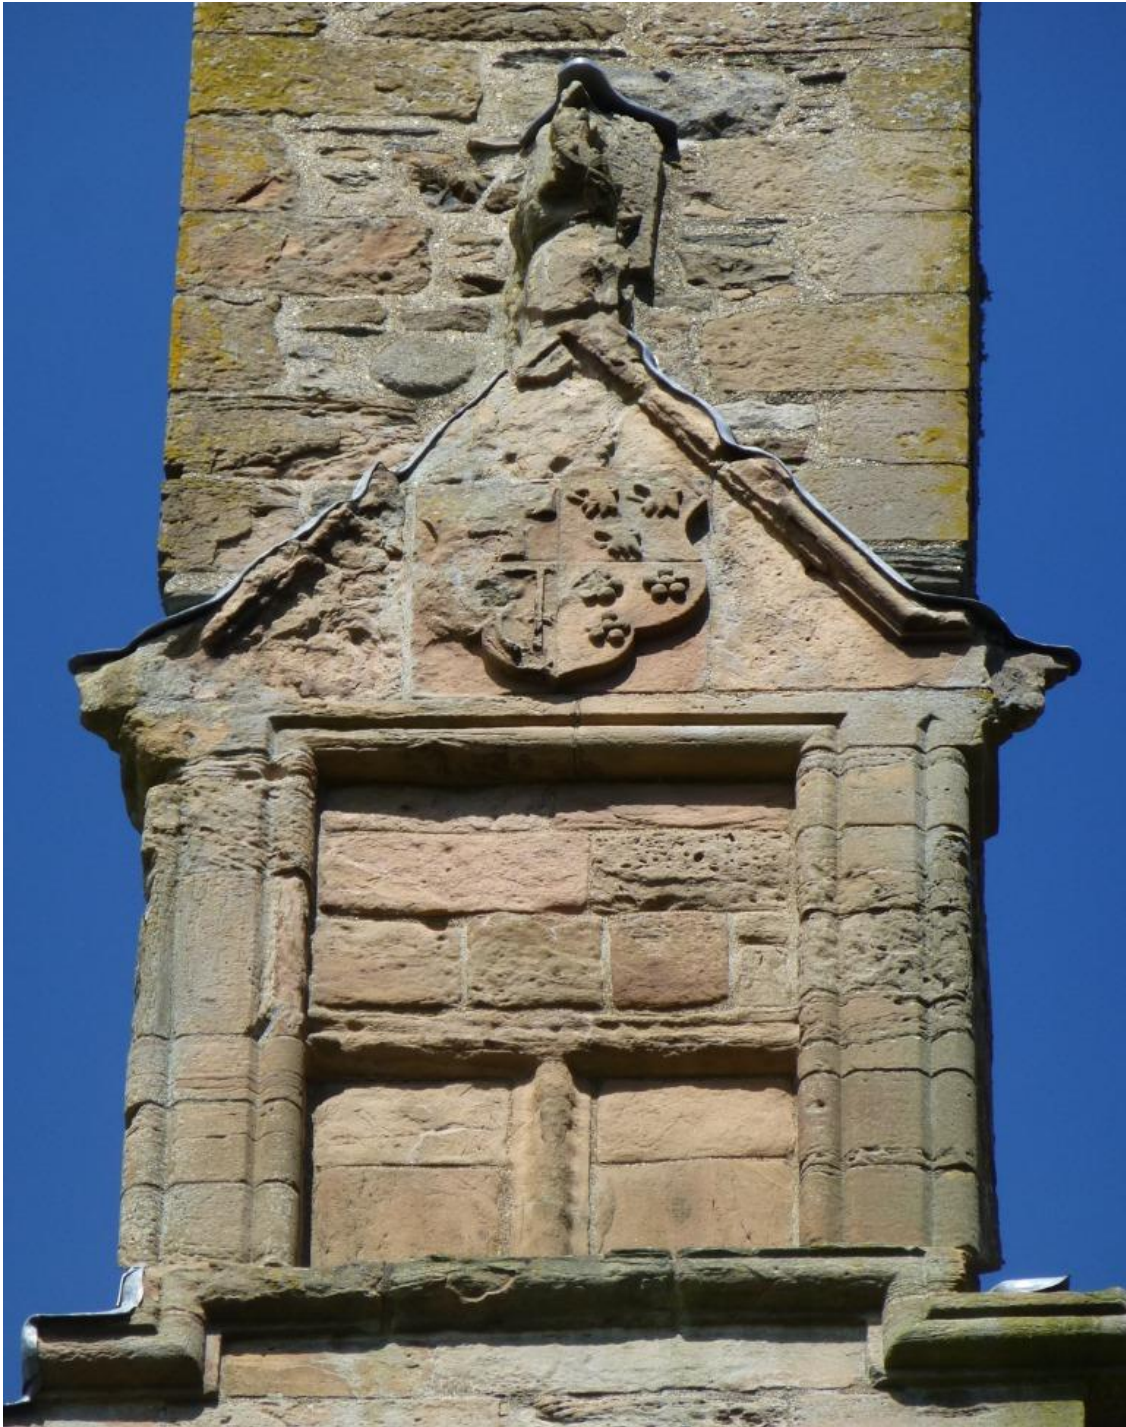
2.3 Gablet above 'GORDON':

The gablet could not be reached during the 2003 works. It suffers severe decay to its left gable as the pediment architrave here is eroded and not protecting the stone below. While the surface has been lead covered to prevent direct moisture ingress, this is not extended out far enough to shed water away from the carved detail below. As a result not only the pediment detail here but also the lower mouldings and sill have suffered increased surface decay in the form of open bedding planes, fissures, surface scaling and erosion.

The top sculpture is much eroded and cracks are visible on right side, in spite of lead flashing above it. Most of the top of the pediment has lost a substantial thickness of its surface through delamination. The left panel is very eroded and delaminating but nonetheless, old resin repairs remain visible. It appears fragile. The centre left side of the armorial panel is much eroded due to the missing stringcourse above. The right hand side is in much better condition. The moulding and sill below the left side is eroded along the bedding planes due to water run-off. Failing old resin repairs remain visible along open bedding planes. Extensive surface scaling on the moulding at the base of the gablet has been previously pointed.

The flashing on the left side of the gablet should be extended to prevent water run-off down the face of the pediment. Similarly, improvements may be possible to the flashing along the wall head where channelling of rainwater has led to local acceleration in surface erosion.

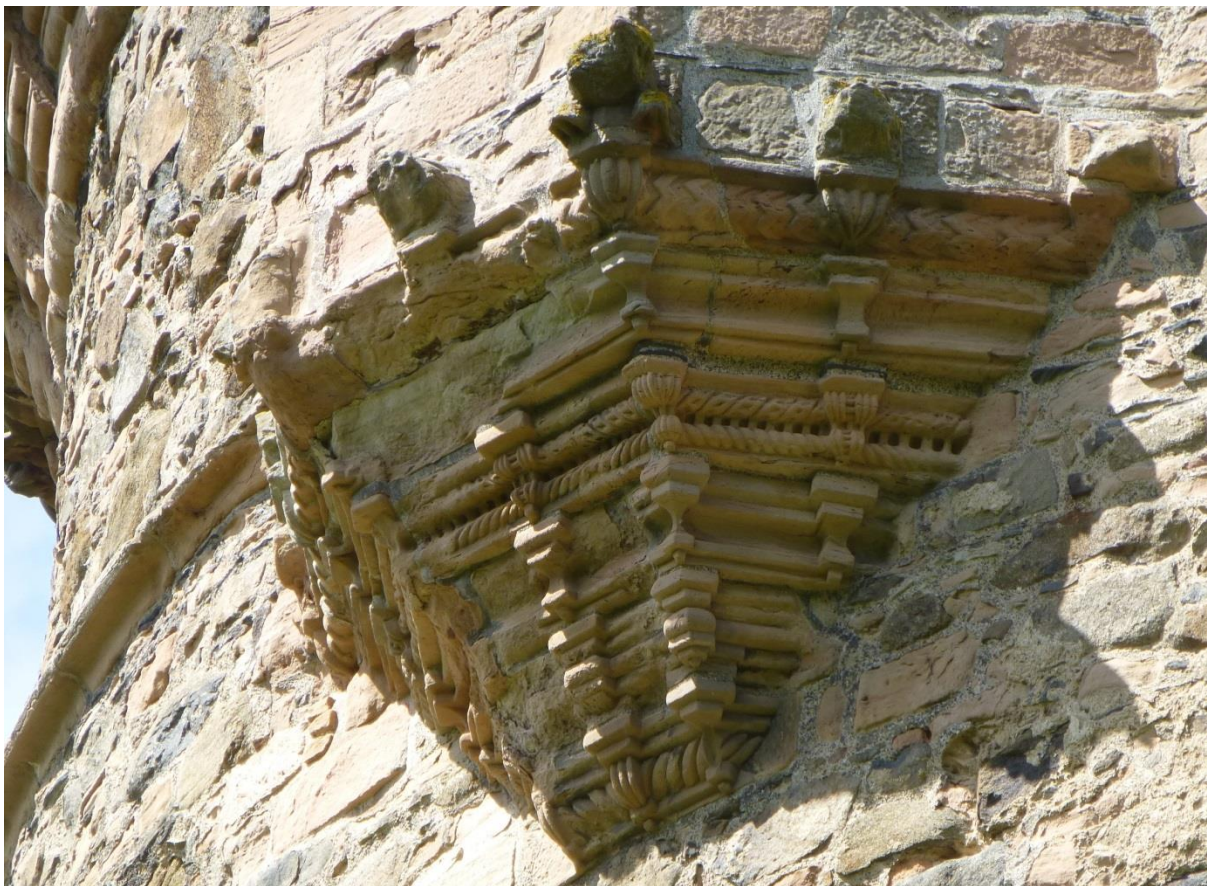
Oriel Window of South tower – east face

East face: The chevron moulding at the top is disaggregating on its right side whereas an area of delamination is visible on the left. Old repairs remain in situ on the moulding below. Further repairs are required, though, and surface losses have occurred since these repairs were carried out. A thick cement band of grit pointing has been applied below. The two rope mouldings below suffer open bedding planes, particularly the lower one. Similarly a stepped concave moulding below displays open bedding planes. A triple stepped moulding below is boss on its right side. A small area of delamination is visible on the base.

Areas of surface delaminations, cracks and fissures which have led to surface detachment need to be re-adhered through the localised injection of 2.5. – 10% Paraloid B72 in acetone. Conservation treatment may also require the re-adhesion of loose fragments with thixotropic polyester or reversible acrylic resin where possible. This is likely to particularly apply to the corbelling below the Oriel window which appears very fragile in many areas.

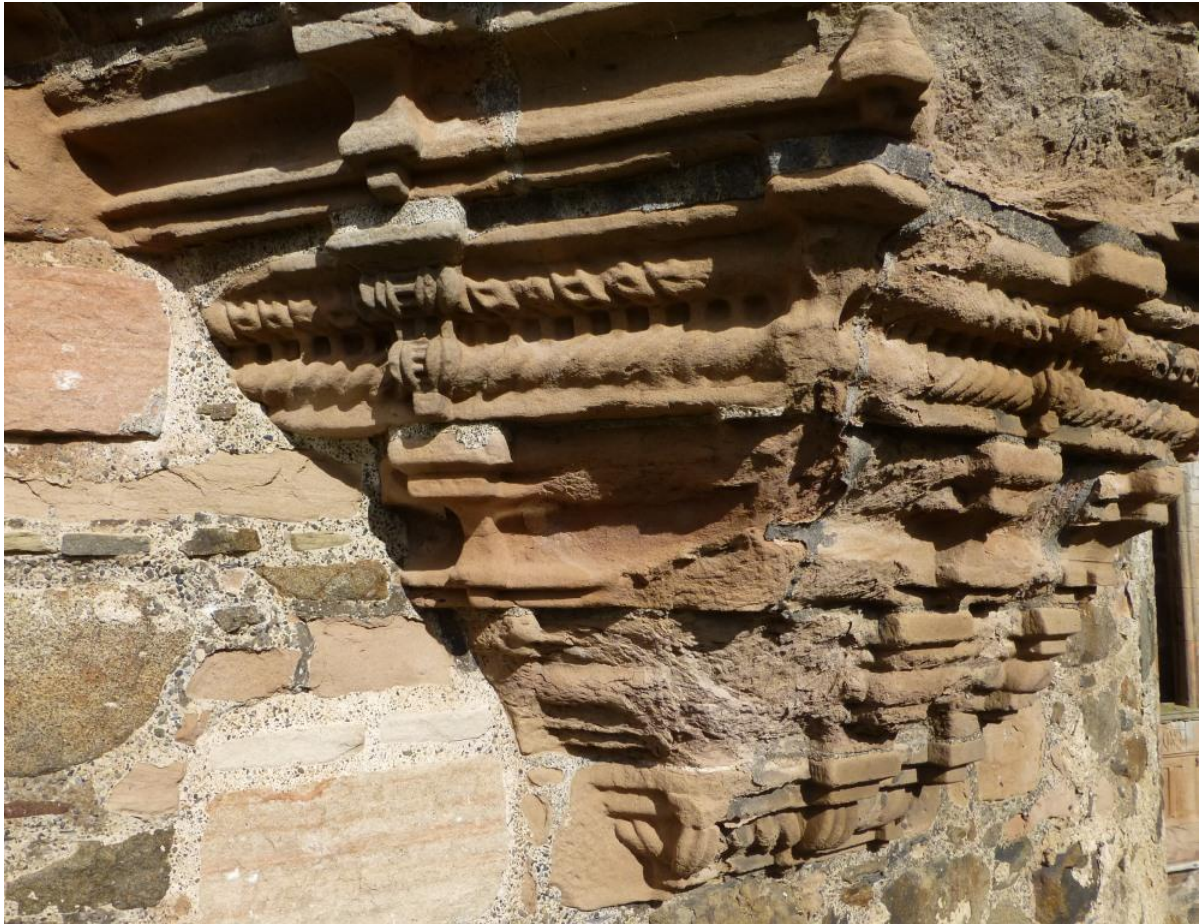
Oriel Window of South tower – west face

West face: The far left chevron moulding and lower part of the moulding and gargoyle above are cracked and at risk of loss. Nonetheless the stone retains most of its moulded detail. Cracks are visible on the right side of the chevron moulding and small areas of disaggregation on its left underside. The concave moulding below appears stable apart from its boss right side. The rope mouldings below appear stable whereas the stepped moulding below that is eroded on its right side. The lower step moulding is almost completely missing, only retaining traces of its far left side. Thick salt crystals are visible near the front corner and one loose surface area here had to be removed for safety reasons. The moulding below is eroded and a crack is visible on the corner detail.
