# Retaining Wall Principal Inspection

FC-056-018-L

Bowling Harbour Retaining Wall

August 2013

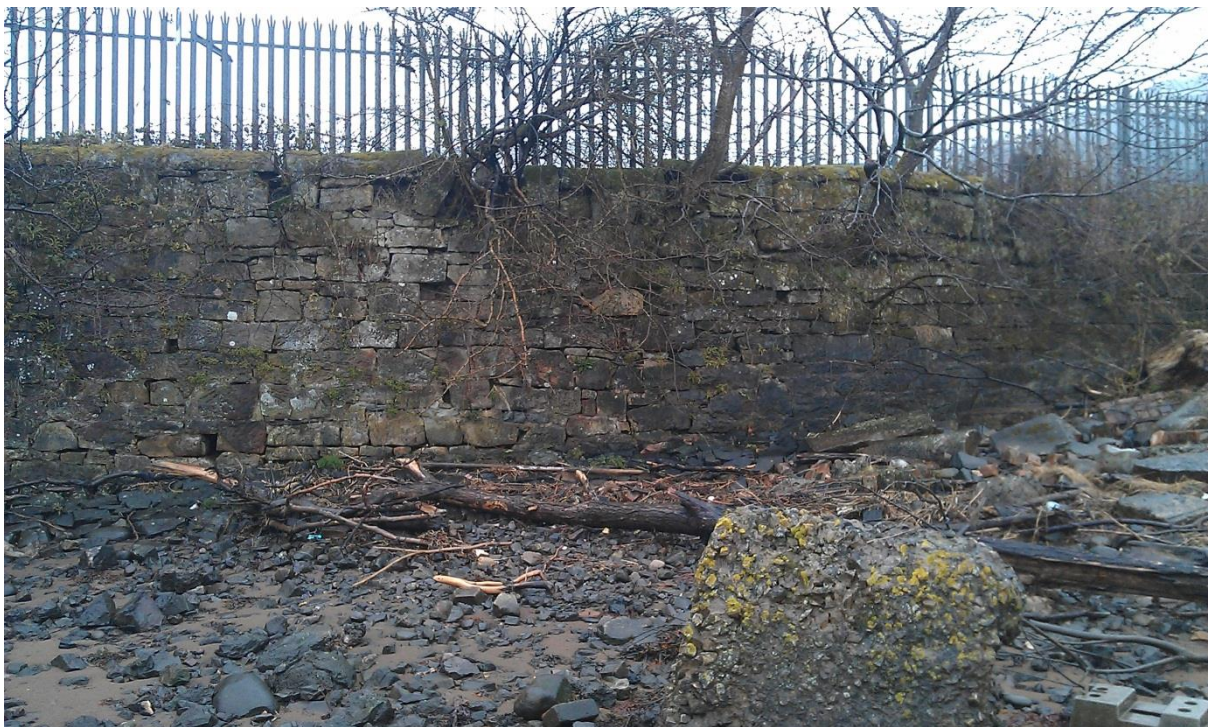
The face of the retaining wall is suffering from vegetation damage both from scrub and tree growth. This has damaged pointing and caused some masonry loss and deformation of the wall. The vegetation also prevents visual inspection during the summer months.

Vegetation damage occurring to the crest of the wall. Note storm debris at toe of the wall.

**P2 - Remove vegetation from the face and crest of the wall -** . It is recommended that the vegetation growing from the face and the crest of the retaining wall be removed. This is causing extensive damage to the upper face and, as the vegetation grows, will become progressively worse. The vegetation will require a herbicide treatment to ensure it does not regrow. Scaffolding may be required to access the upper face [REDACTED]

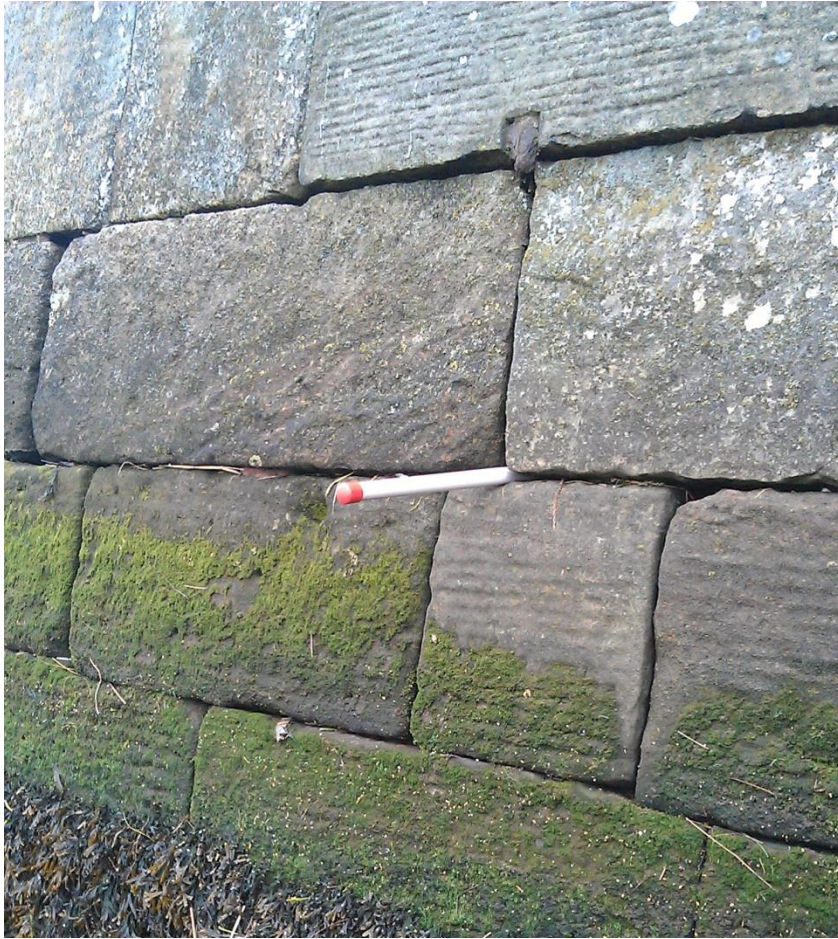
The pointing across the face of the wall is variable in condition and nature and it appears there have been numerous phases of patch repairs. Some areas of the face are devoid of pointing, with open joints typically on the upper face, a result of it being harder to access. The open jointing has allowed the development of voiding behind the facing blocks as tidal action has removed material. The voiding behind the facing blocks was proven to extend at

least 0.75 m. The crest above the wall is exhibiting an area of slight subsidence. This depression may be due to the loss of material from behind the retaining wall.

Voiding of 0.75 m behind facing blocks.

**P3 – Retaining wall repairs-** It is recommended that the remaining repairs required to the wall are undertaken as a single project. A programme of grout injection to repair the voiding behind the facing blocks, followed by replacing missing masonry, general repointing and rebuilding the collapsed parapet wall and replacing the revetment along the toe should be implemented. [REDACTED]

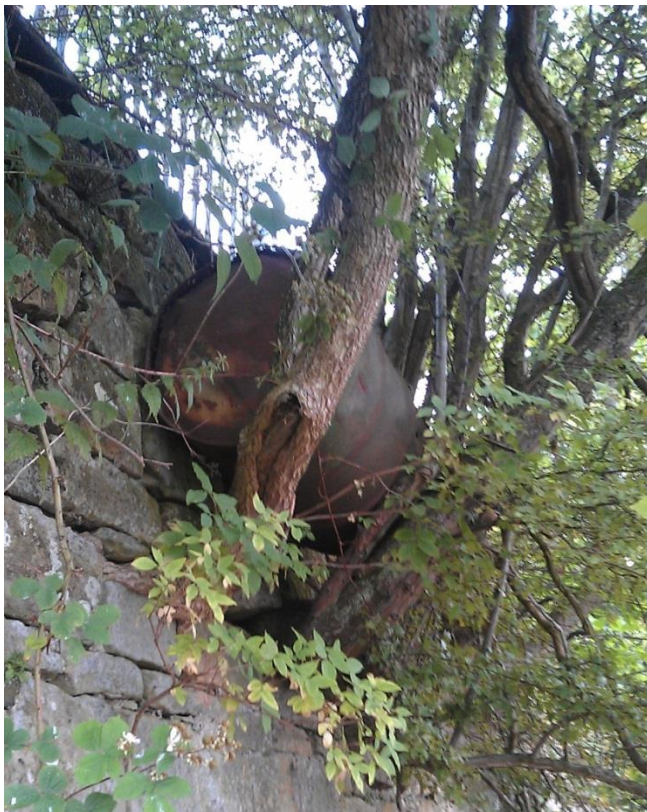
Vegetation damage to face.

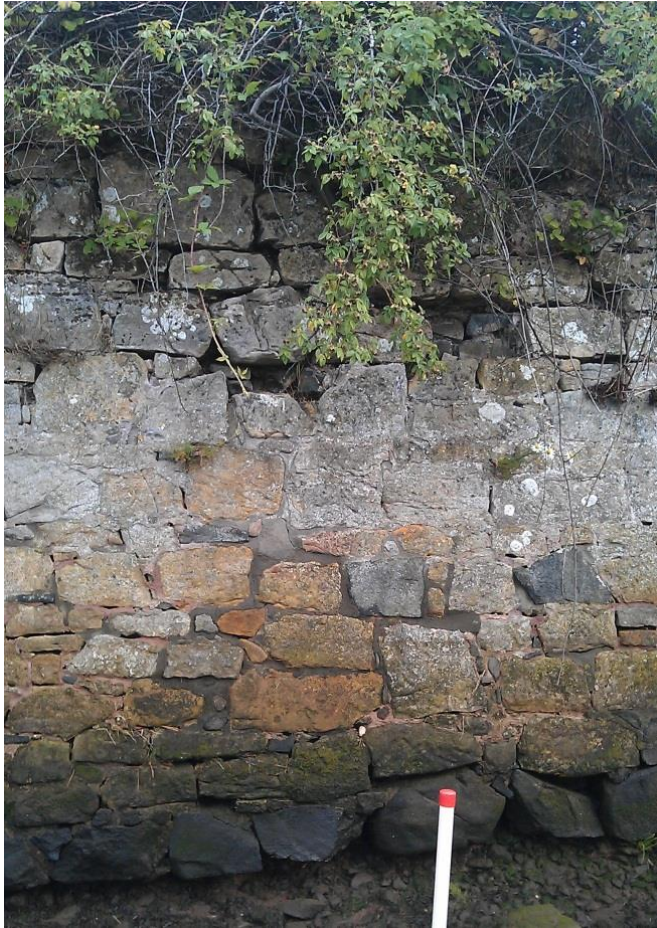
The toe of the retaining wall was originally protected by a revetment to prevent undercutting by the tidal action of the River Clyde. This has now been eroded along the majority of the wall with only the mass rock armour at the bullnose and sporadic patches of basaltic rock revetment remaining. Where missing the toe is undercut by up to 0.3 m with evidence of some voiding behind the facing blocks.

Undercut toe of the retaining wall. Note missing masonry, patch repairs to pointing and vegetation growth.
