EXTERNAL CONDITION SURVEY (SAFETY CHECK) – PARK WALLS

Cramond Walled Garden
Cramond Glebe Road
Edinburgh

Survey Date: 21st May 2015

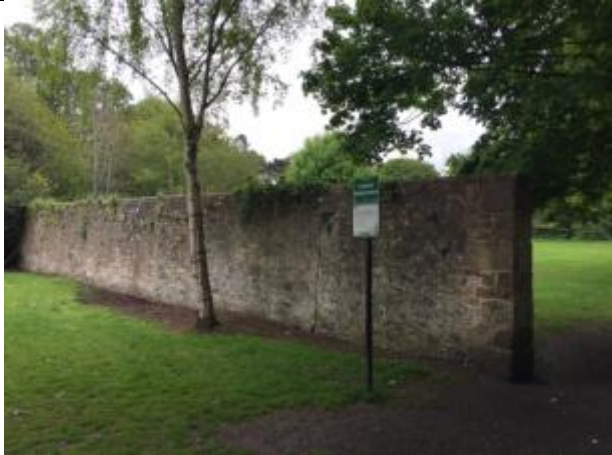
Wall ref: North Wall
	Description: Stone wall to North face, part stone/facing brick to South face, approximate height 3.0m, approximate length 50m
	Defect: vegetation growth, cracks and open joints, damage to brickwork
	Rating: B3

Work required	
North Wall – remove vegetation growth, re-build section of wall where badly cracked, replace frost damaged brickwork, rake out and re-point mortar joints to stonework and brickwork	
North/East corner Wall – remove lichen growth to brickwork, re-build section of wall where badly cracked, replace frost damaged brickwork, rake out and re-point mortar joints to stonework and brickwork	
East Wall – remove lichen growth and graffiti to brickwork and stonework, replace frost damaged brickwork, rake out and re-point mortar joints to stonework and brickwork	
South Wall – cut back dense vegetation to allow full examination of wall, take down and re-build defective sections of stone and brick wall, rake out and re-point	
West Wall – remove vegetation growth, rake out and re-point mortar joints to stonework, wall could be common repair with adjoining house owners

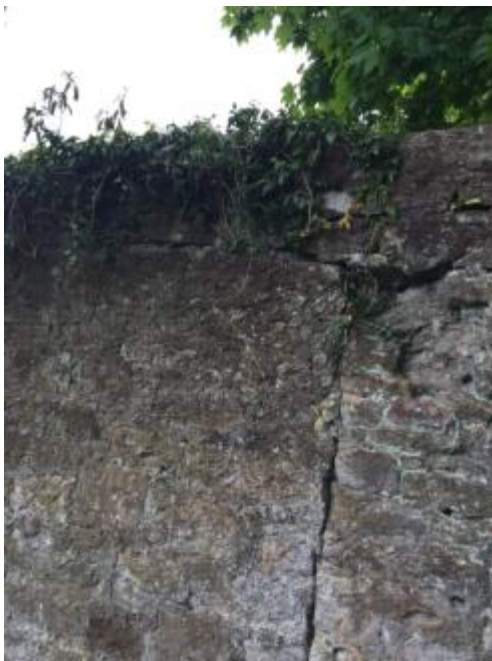
1: North Wall, North face
Vertical crack to wall and open joints

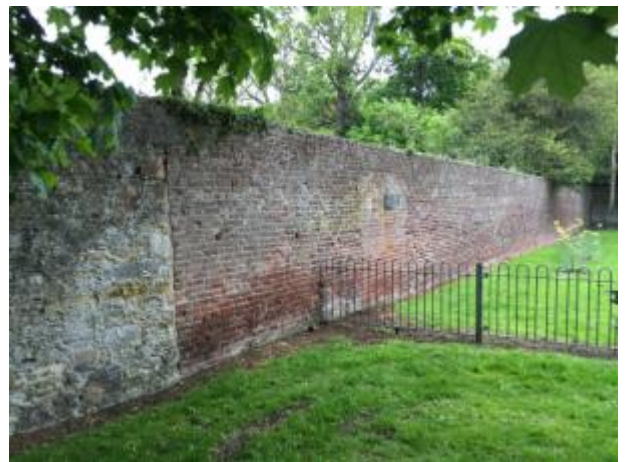
2: North Wall, South face, near Play Area
General view of wall

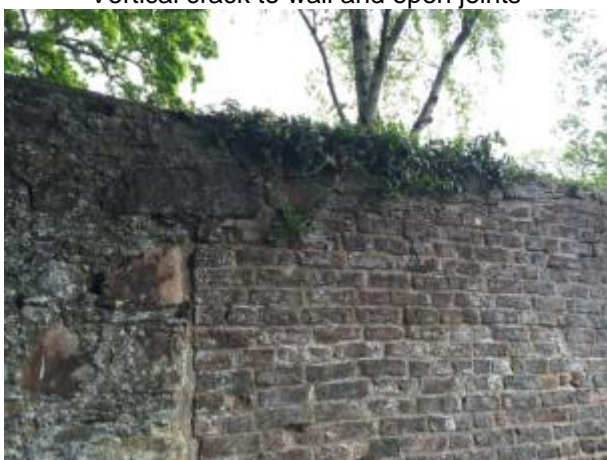
3: North Wall, South face
Vegetation growth at high level

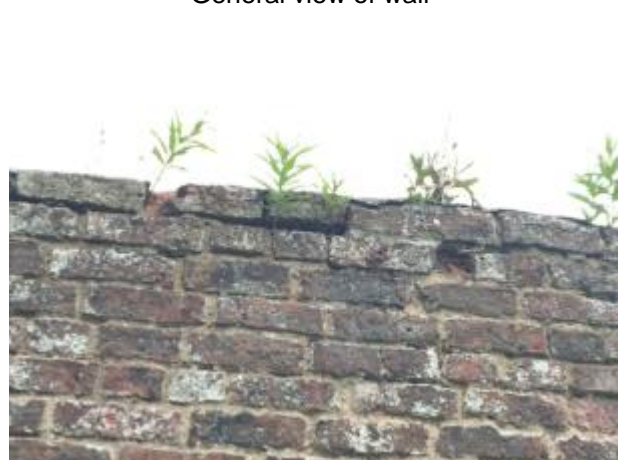
4: North Wall, South face
Vegetation growth at high level

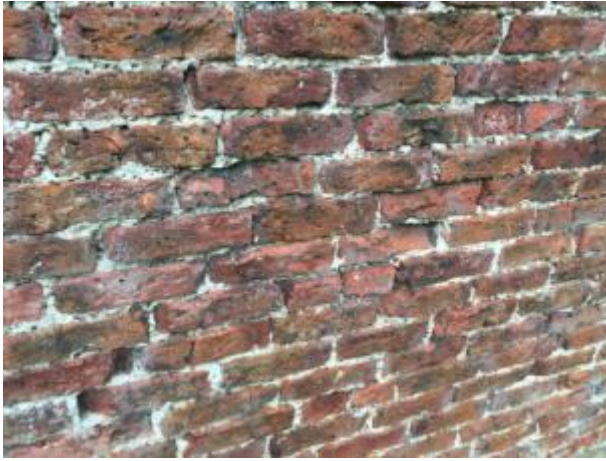
5: North Wall, South face
Defective brickwork

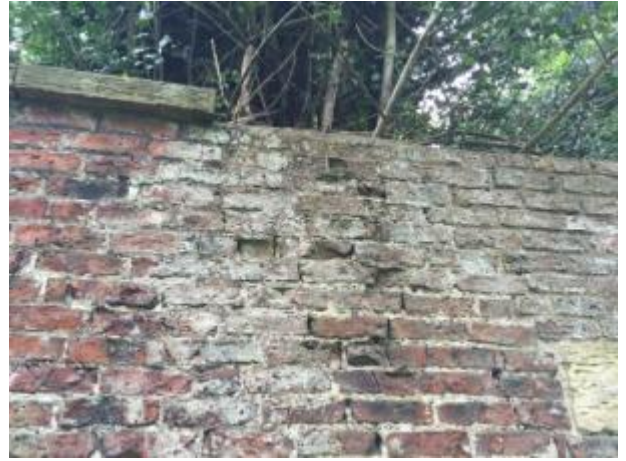
6: North Wall, South face
Missing cope stones, defective brickwork and open mortar joints

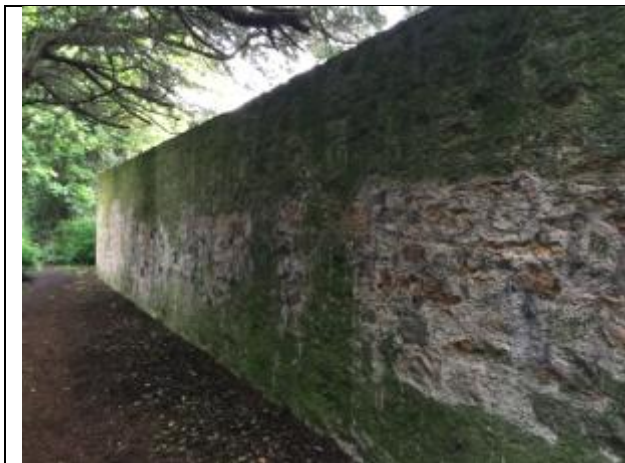
Wall ref: North/East corner of garden
Description: Stone to North face, facing brick to South face, approximate height 3.0m, approximate length 15m
Defect: Large crack around opening area, green algae growth to North face, lichen growth to South face
Rating: B3

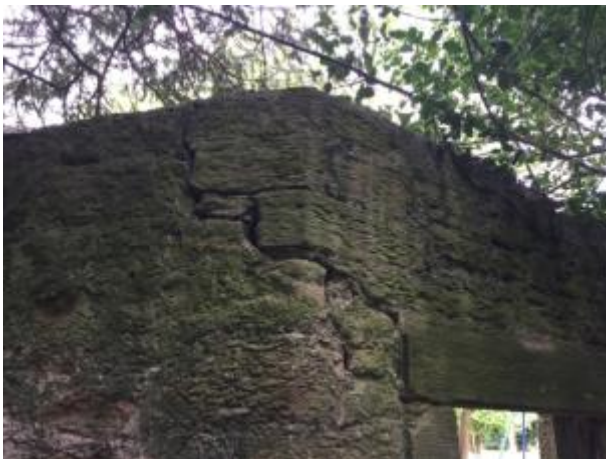
1: North/East corner, near opening
Large open crack to stonework

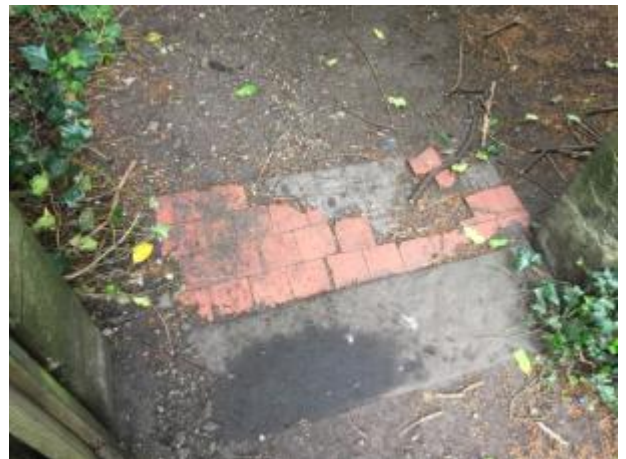
2: North/East corner, near opening
Damage to floor tiles at opening

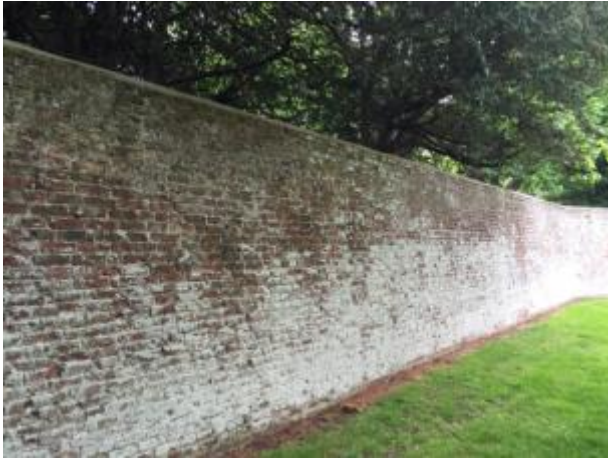
3: North/East corner, South face
Lichen growth to brickwork surface

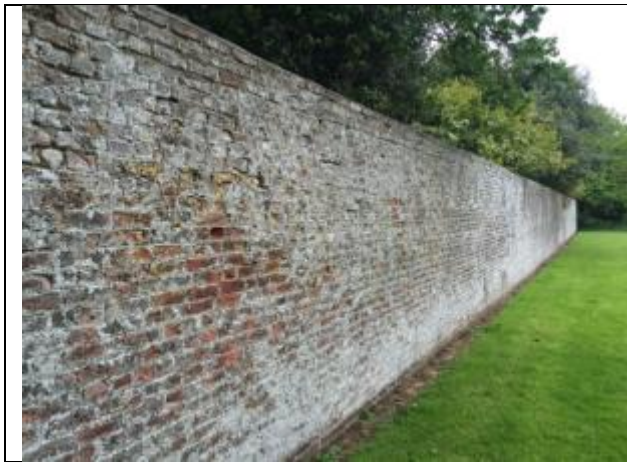
Wall ref: East Wall
Description: Stone to East face, facing brick to East face of wall, approximate height 3.0m, approximate length 120m
Defect: defective brickwork, open mortar joints, lichen growth to brickwork, vegetation growth, graffiti damage
Rating: B3

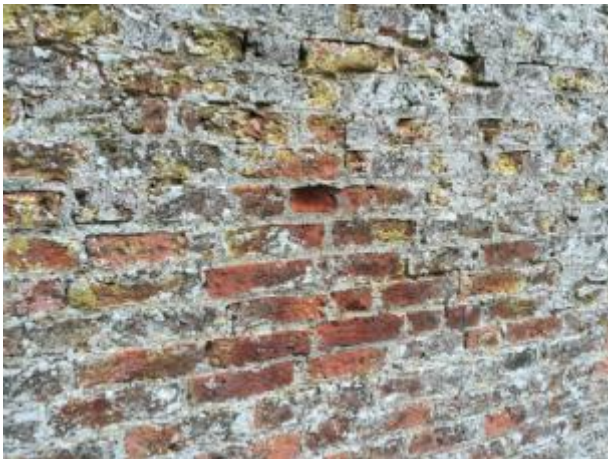
1: East wall, West face
Defective brickwork, lichen growth to face of brickwork, open mortar joints

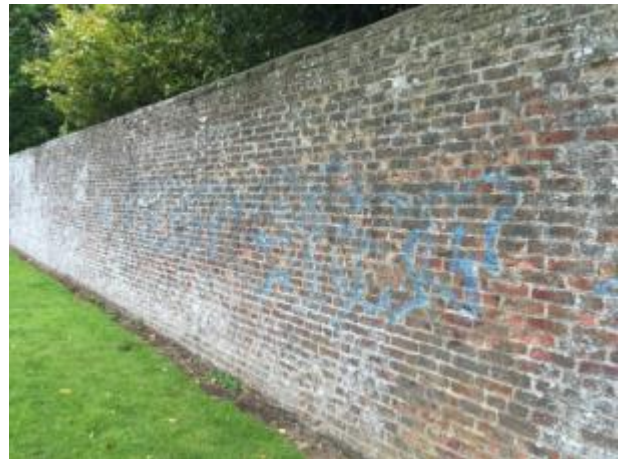
2: East wall, West face
Graffiti to wall

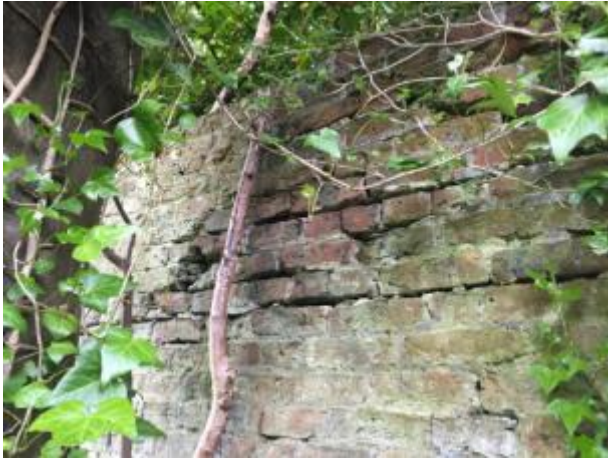
3: East wall, West face
Vegetation growth, open mortar joints

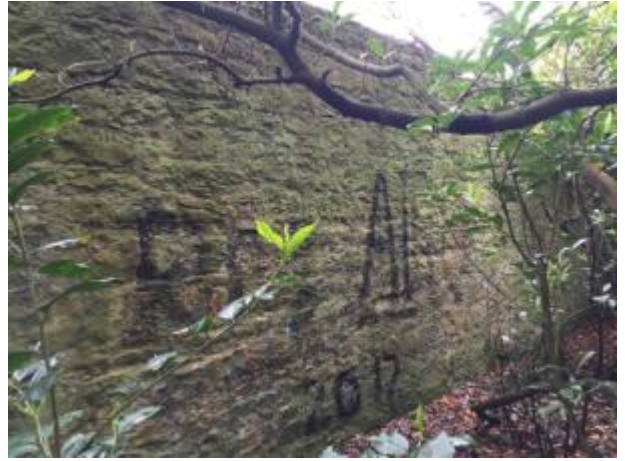
4: East wall, East face
Graffiti to wall

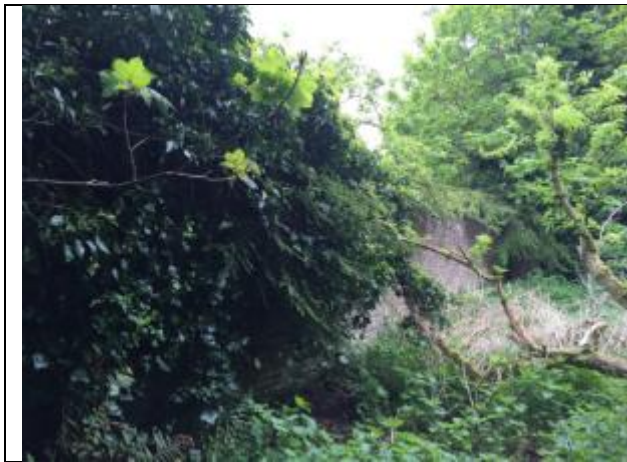
Wall ref: South Wall
Description: part stone, part brick wall, approximate height 3.0m, approximate length 65m
Defect: partial collapse of brickwork and stonework, excessive vegetation growth
Rating: B3

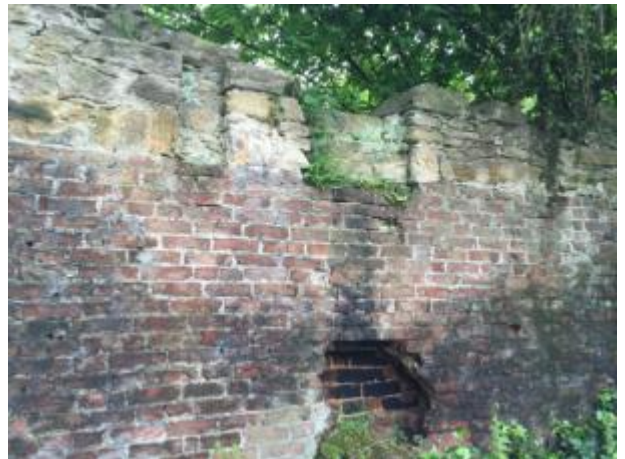
2: South Wall, North face

Section of wall collapsed

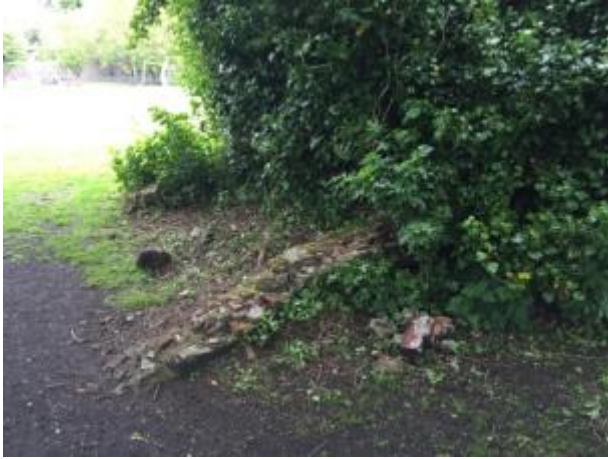
3: South Wall, close to path
Partial collapse of wall

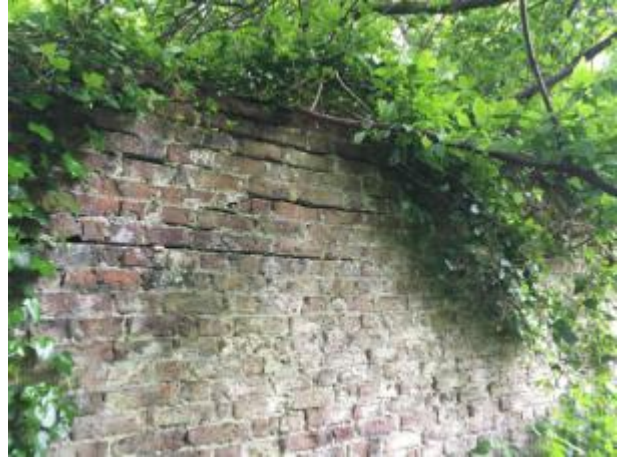
4: South Wall, North face
Shows general condition of brickwork

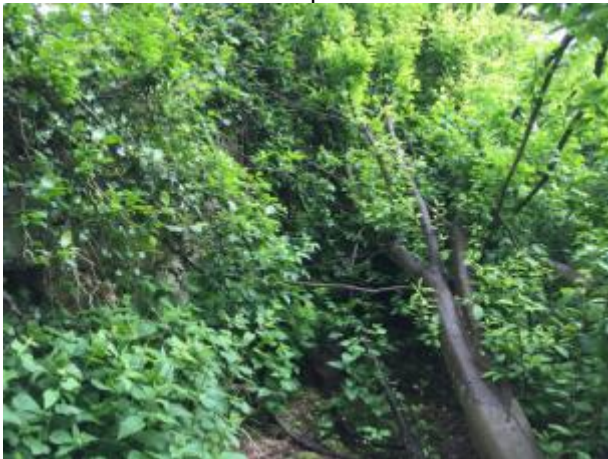
5: South Wall, South Face
Fallen tree, possible damage to wall

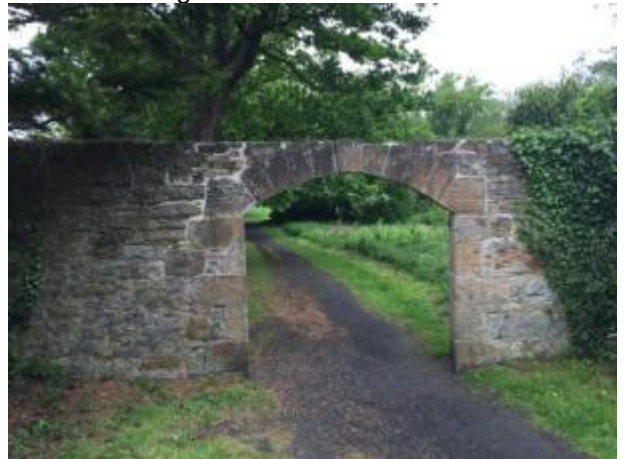
6: South Wall, South Face
Shows opening at path

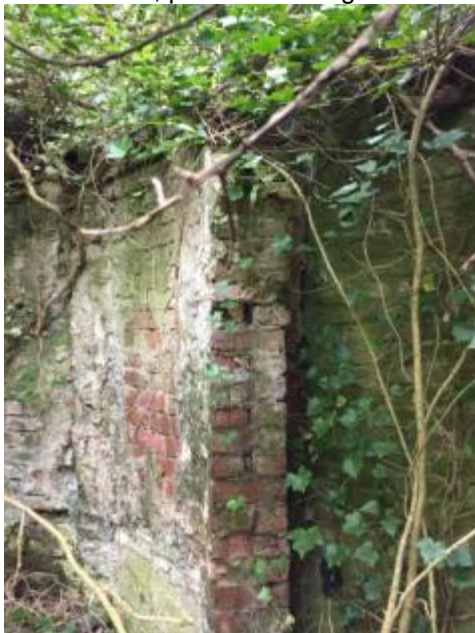
7: South Wall, South Face
Excessive vegetation growth, defective brickwork

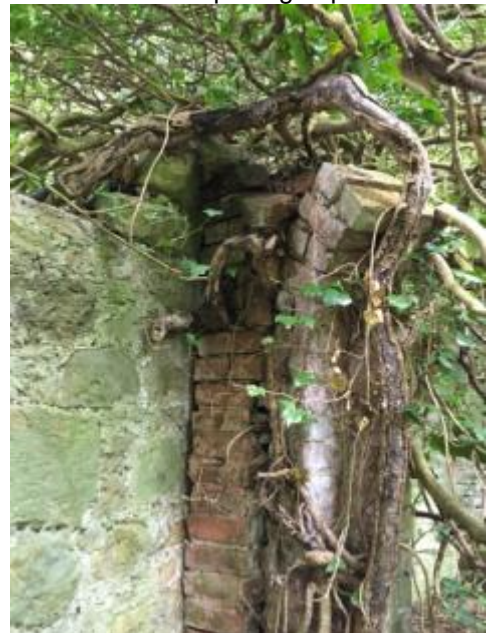
8: South Wall, South Face
Excessive vegetation growth, defective brickwork

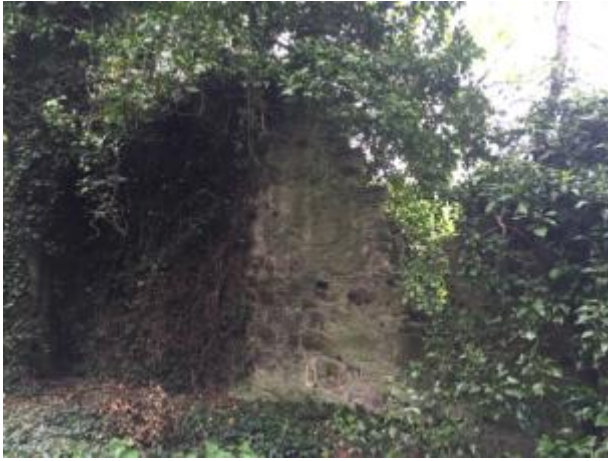
9: South Wall, South Face
Excessive vegetation growth, partial collapse of wall

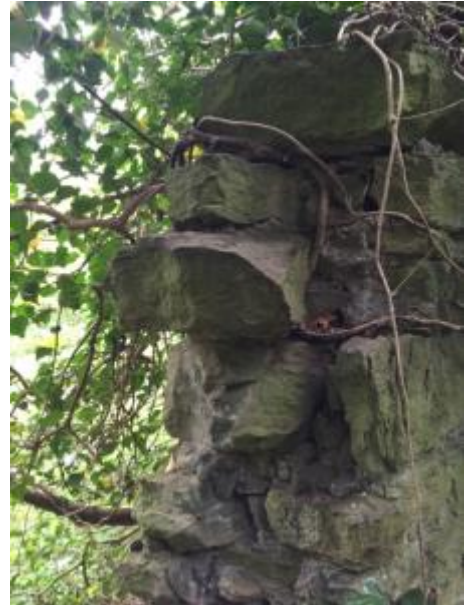
10: South Wall, South Face
Close up of wall showing construction

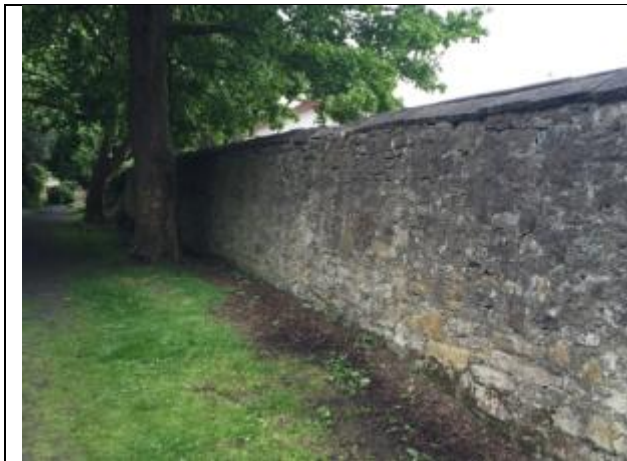
Wall ref: West Wall
Description: rubble stone finish to East face, assumed stone to West side (private dwellings) approximate height 3.0m, approximate length 155m
Defect: Vegetation growth, open joints to rubble stone and cement cope
Rating: B5

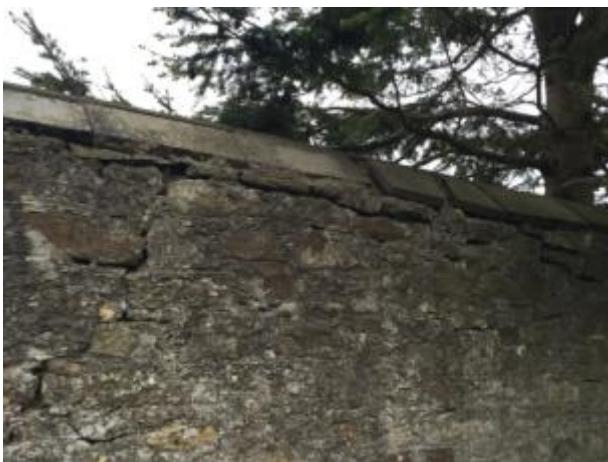
1: West Wall, East face
Open joints to stonework

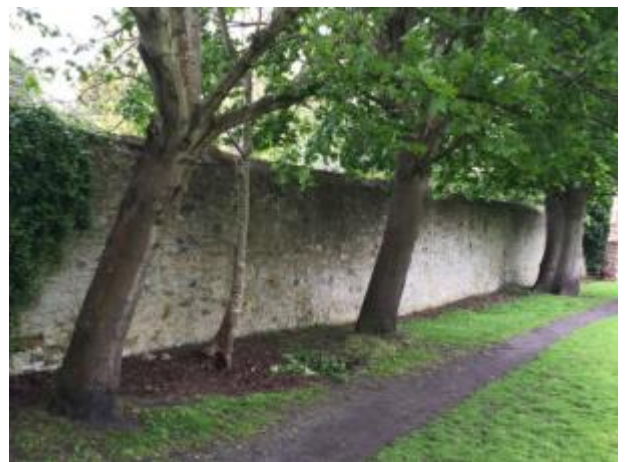
2: West Wall, East face
General view of wall

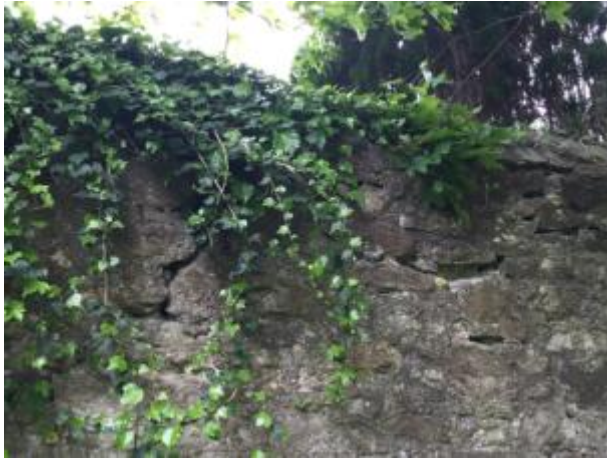
3: West Wall, East face

Open joints to stonework, vegetation growth

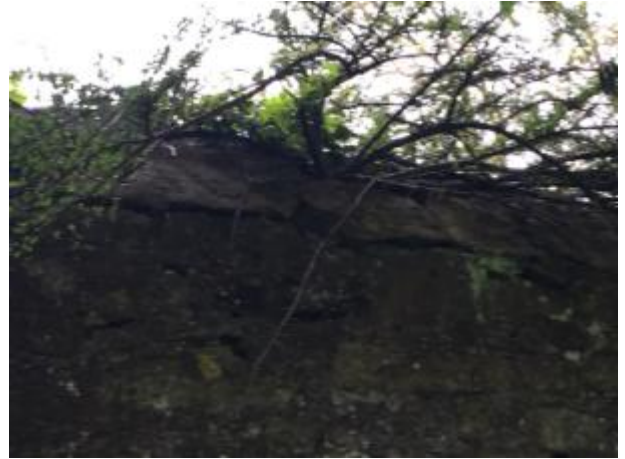
4: West Wall, East face

Open joints to stonework, vegetation growth
