**HISTORIC ENVIRONMENT SCOTLAND  
PROPERTIES IN CARE  
MINOR ARCHAEOLOGICAL WORKS 2016/2017**

**Kinneil House • Watching Brief • April 2016**

**SITE:** Kinneil House, near Bo'ness, West Lothian.

**DESCRIPTION:** Archaeological watching brief during the excavation of two test trenches against the north face of the south orchard wall ahead of stabilisation works.

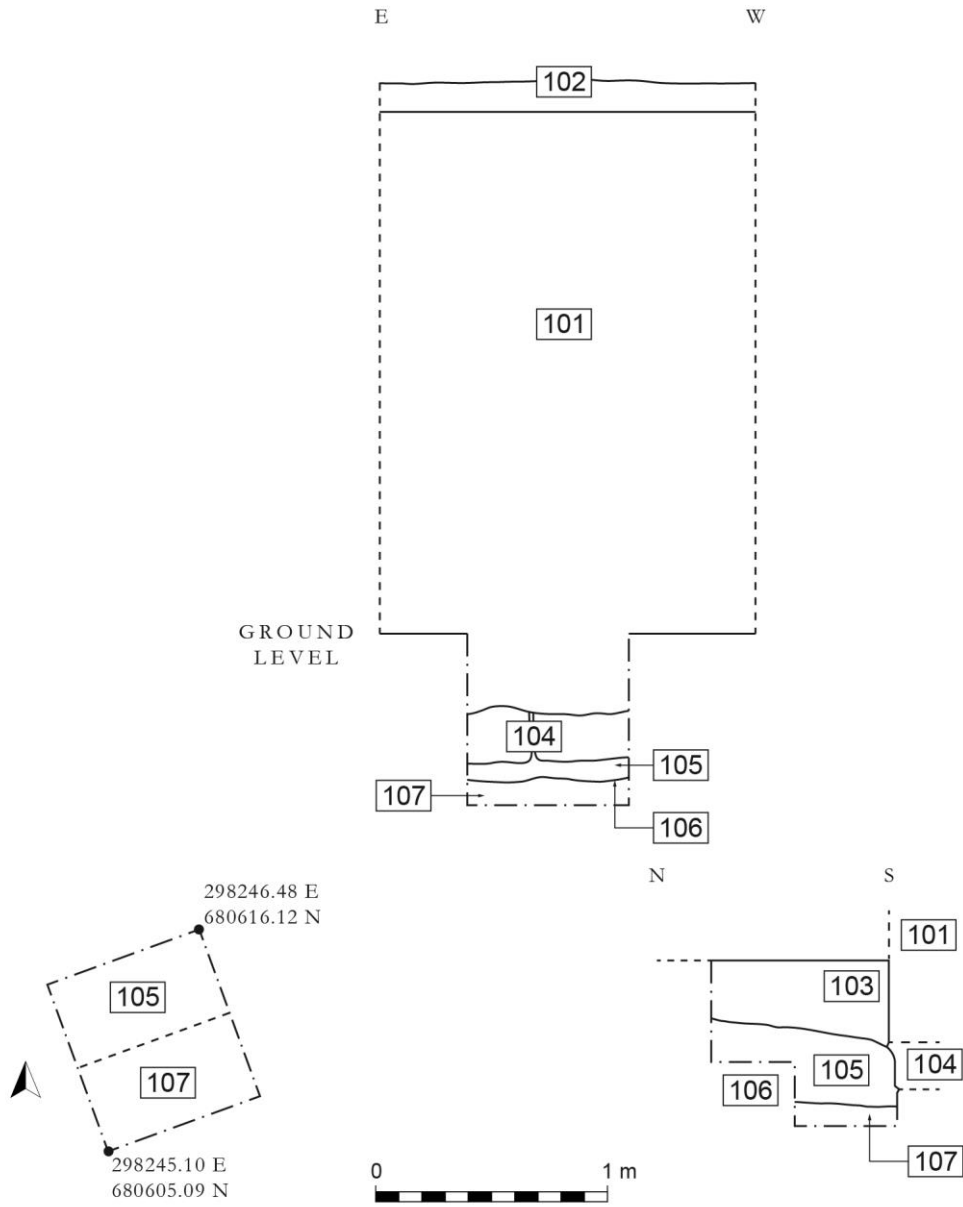
Figure 3: Clockwise from top: Trench 1, N-facing elevation, W-facing section, and post-excavation trench plan.

Test Trench 1 was positioned with its western edge 24m to the east of the angle formed by the west and south orchard walls. The trench measured 0.80m E/W x 0.80m N/S x 0.55m deep (the trench was deeper adjacent to the wall). The disturbed topsoil **103** was full of modern refuse such as plastic and broken glass. This layer was 0.32m deep and cleared onto a layer **105** of re-deposited clay flecked with charcoal up to 0.30m deep (with a 0.06m deep spread visible below the rubble wall foundation). This layer also carried, and abutted the northern edge of, the rubble foundation of the south orchard wall **104**.

The rubble foundation of the wall was recessed back from the main wall build **101** by 0.05m. The foundation was composed of angular sandstone rubble bonded in a lime mortar. The top of the foundation course was seen 0.35m below the current ground level; its base sat at a depth of  $\approx$ 0.60m. The main wall build **101** consisted of pieces of angular sandstone rubble bonded in a white/grey lime mortar with numerous small angular stone inclusions. This build was capped by a cope course **102** of flat sandstone slabs  $\approx$ 0.10m high. Below ground, the layer **105** carrying the wall foundation **104** was set within a cut **106** through the natural **107** below. This suggests that a degree of ground preparation was required in order to build the wall and that the ground level of the orchard was raised after the wall had been built (or was in the process of being built). The 'natural' consisted of a compact layer of yellow/brown clay containing numerous water-rolled pebbles. It was clean and carried no charcoal flecks, making it distinctive from layer **105** above.

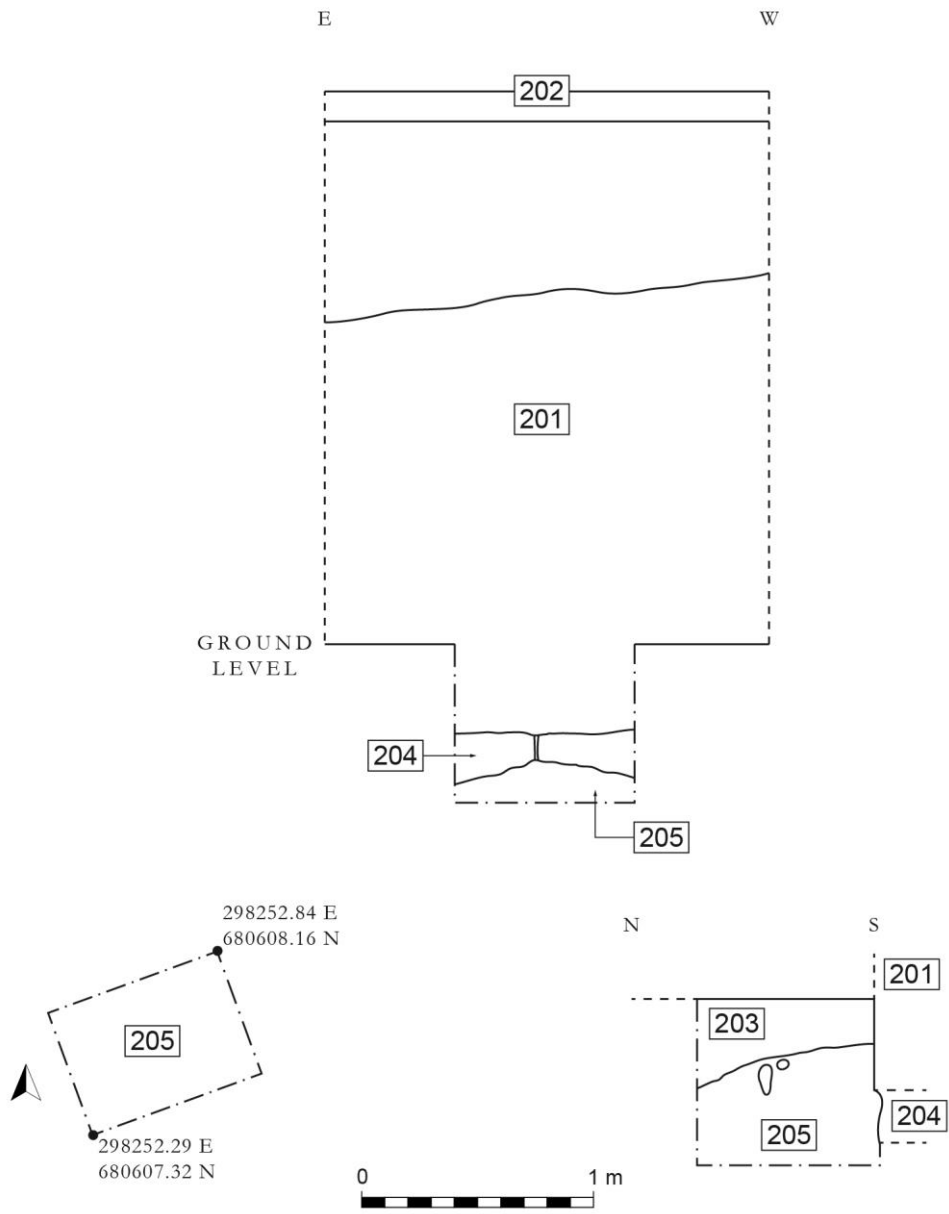
Figure 4: Clockwise from top: Trench 2, N-facing elevation, W-facing section, and post-excavation trench plan.

Test Trench 2 was positioned with its western edge 30m to the east of the angle formed by the west and south orchard walls. The trench measured 0.80m E/W x 0.60m N/S x 0.72m deep. The disturbed topsoil **203** was full of modern refuse such as plastic and broken glass. This layer was 0.30m deep and cleared onto a layer **205** of re-deposited clay flecked with charcoal up to 0.52m deep. This layer also carried, and abutted the northern edge of, the rubble foundation of the south orchard wall **204**.

The rubble foundation of the wall was recessed back from the main wall build **201** by 0.05m. The foundation was composed of angular sandstone rubble bonded in a lime mortar. The top of the foundation course was seen at 0.38m below the current ground level; its base sat at a depth of up to  $\approx$ 0.62m. The main wall build **201** consisted of pieces of angular sandstone rubble bonded in a white/grey lime mortar containing numerous small angular stones. This build was capped by an area of rebuild **202** consisting of buff-coloured angular pieces of sandstone bonded in a grey/brown mortar topped by a cope course of flat sandstone slabs  $\approx$ 0.15m high. There was no trace of the cut encountered in Test Trench 1.
