## Kinneil House - Garden Retaining Wall

### Addendum to Engineer's Report dated 29 April 2016

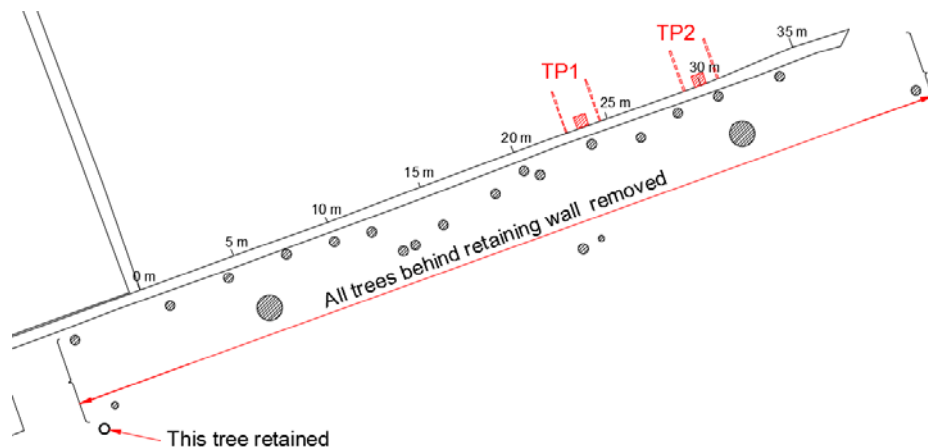
Figure 1 – Location of trial pits

- 2.0 Since the initial report, the Leylandii and other trees on the upper side of the wall have been remove and two trial pits have been dug to determine the nature of the ground, and the nature and depth of the foundation. See figure 1.

3. The trial pits revealed:
  - (i) that wall has substantially no foundation – it is built directly off re-deposited clay flecked with charcoal, 520 to 600 mm below the existing ground level on the bottom side of the wall. The base stones are recessed back from the main wall by 50 - 60 mm; and
  - (ii) the outward incline of the wall extends down to the bottom of the wall below ground level.

4. The removal of the trees adjacent to the back of the wall will have reduced the pressure on the wall to some extent. However, the lack of any foundation, the significant outward lean and the poor condition of some parts of the wall means that there is still an unacceptable risk that the wall will collapse at some time in the future. As this is an amenity area, this potential instability poses a direct risk to the public.

5. It is the recommendation that the whole length of the wall should be taken down and rebuilt with a more substantial foundation. Stainless steel joint reinforcement should be provided along the length of the wall to provide some additional lateral strength.
