Scottish Medieval Castles & Chapels C-14 Project

Preliminary mortar & masonry survey of Lochmaben Castle,
Dumfries-shire

SC14-LCD-PRE-01

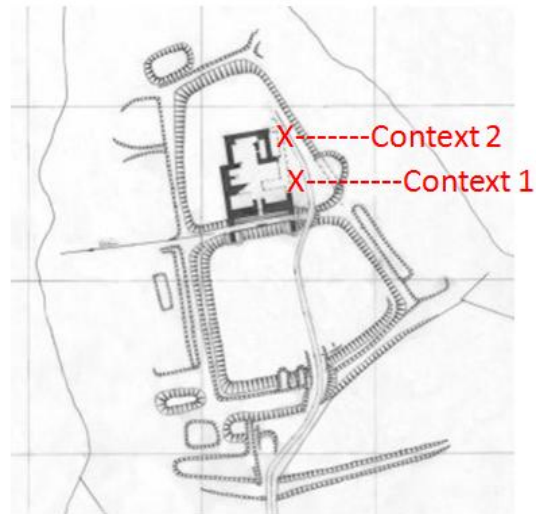
Figure 3 (above) – Locations of masonry contexts 1 and 2 (original image: SC1354829 © crown copyright HES).

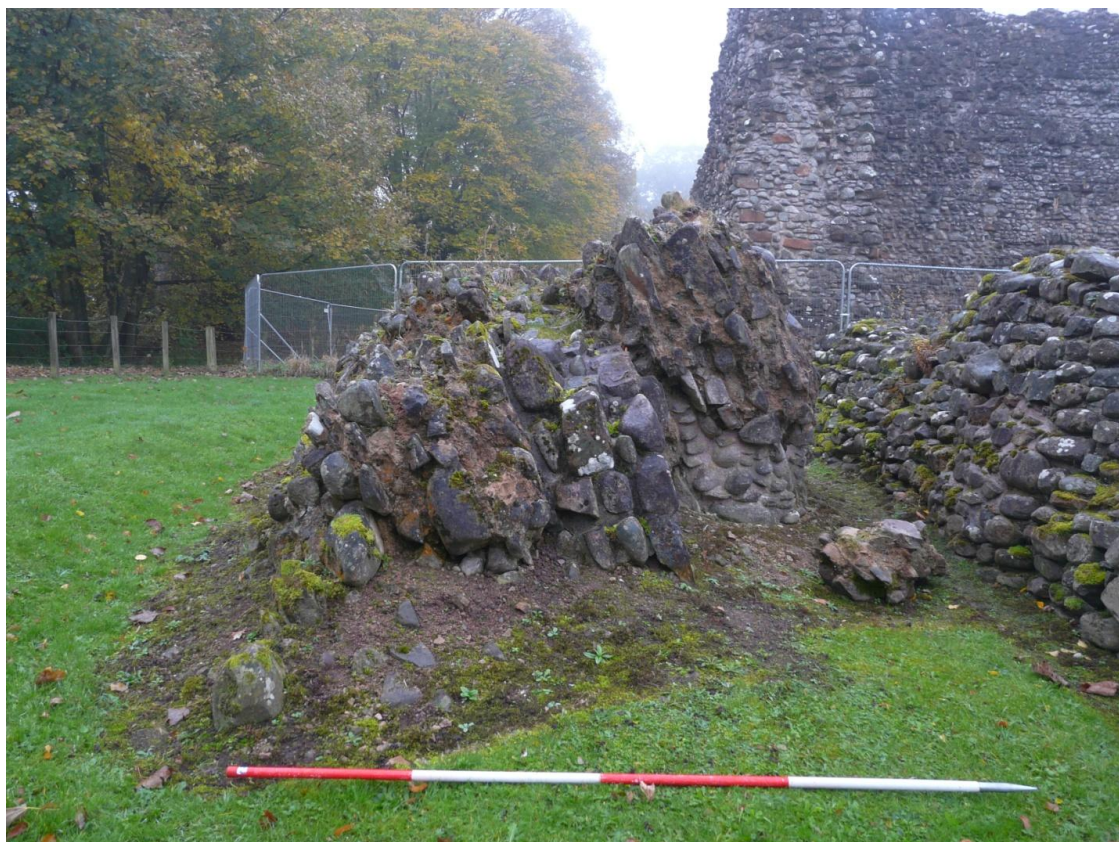
Figure 4 (above) – Context 1 from the north; loose masonry fragment; note also much smaller masonry fragment (context 1b) to the west (between Context 1 and the upstanding wall). Scale 500mm; photograph M. Thacker.

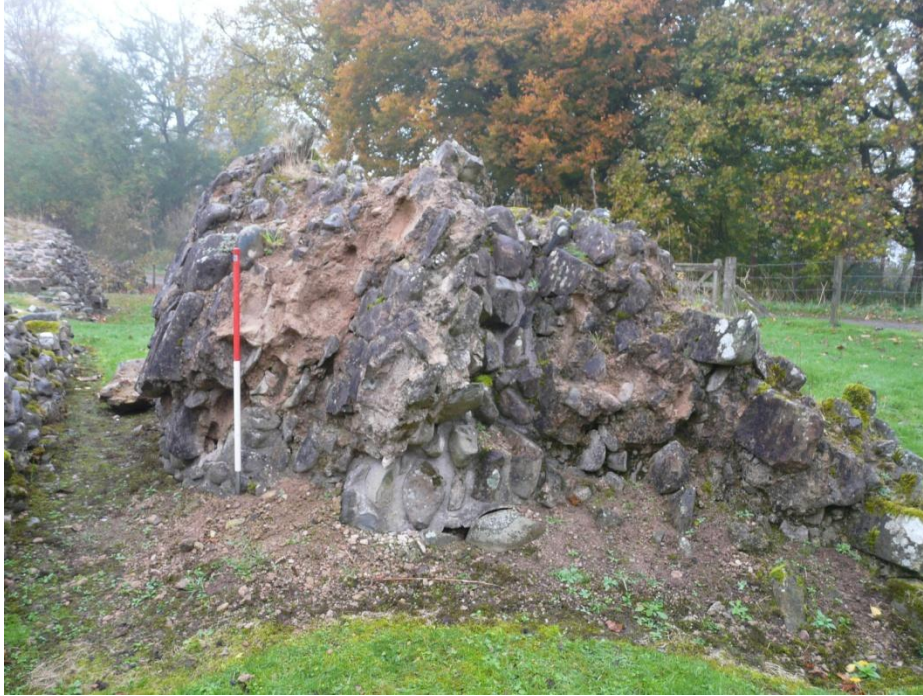
It is important to note that in some areas of contexts 1 and 2 this constructional mortar material is highly degraded, and this is of particular concern in context 1 where three further features of the are apparent: 1, there is an additional small section of masonry lying to the east of context 1 (here labelled context 1b- see figures) which has probably become recently detached from the larger masonry fragment; 2, there are varying volumes of very degraded dissolute mortar ‘spoil’ lying in the ground around the larger masonry fragment, which appears to have recently fallen from the masonry above; and 3, there are some areas of very degraded and/or crazed mortar still lying in-situ, but which are largely dissolute and contain very loose compositional inclusions. Much of this (in-situ) degraded mortar will join the loose (ex-situ) spoil on the adjacent ground surface in the very near future.

Figure 5 (above) – Context 1 from the south. Note area of degrading mortar to the right of the ranging rod and on the ground below. Scale 500mm; photograph M. Thacker.

- the immediate collection of accessible loose and vulnerable mortar kiln-relicts (and associated loose mortar samples) from contexts 1 and 2, for further lab-based characterisation.
- further materials survey and possible sampling from the rest of the upstanding building to which access is currently restricted - subject to discussion with the HES conservation team, and HES and University of Stirling health and safety protocols (see accompanying sampling strategy document SC14-LCD-PRE-02).

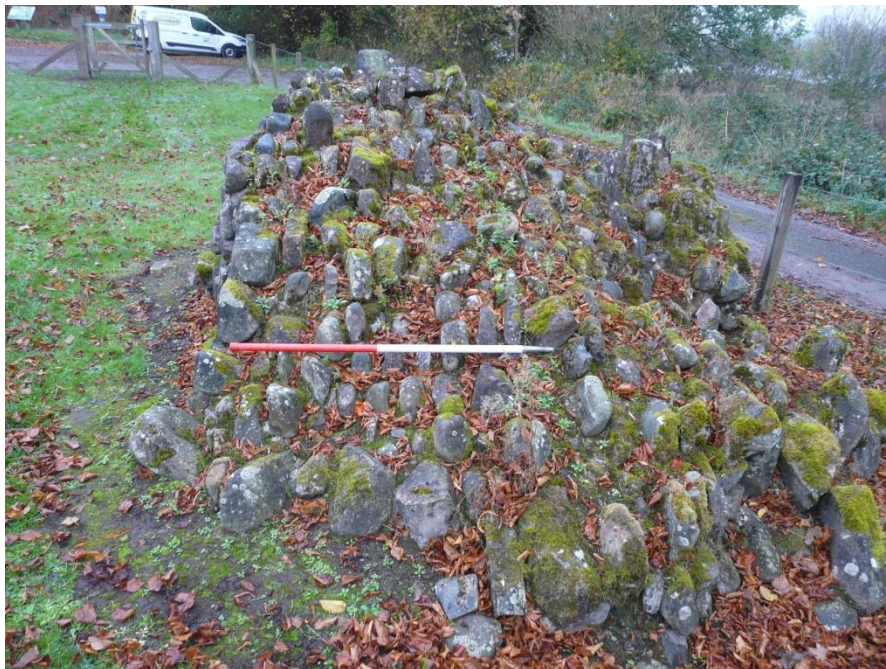
Figure 6 (above) – Context 2 from the south. Scale 500mm; photograph M. Thacker.

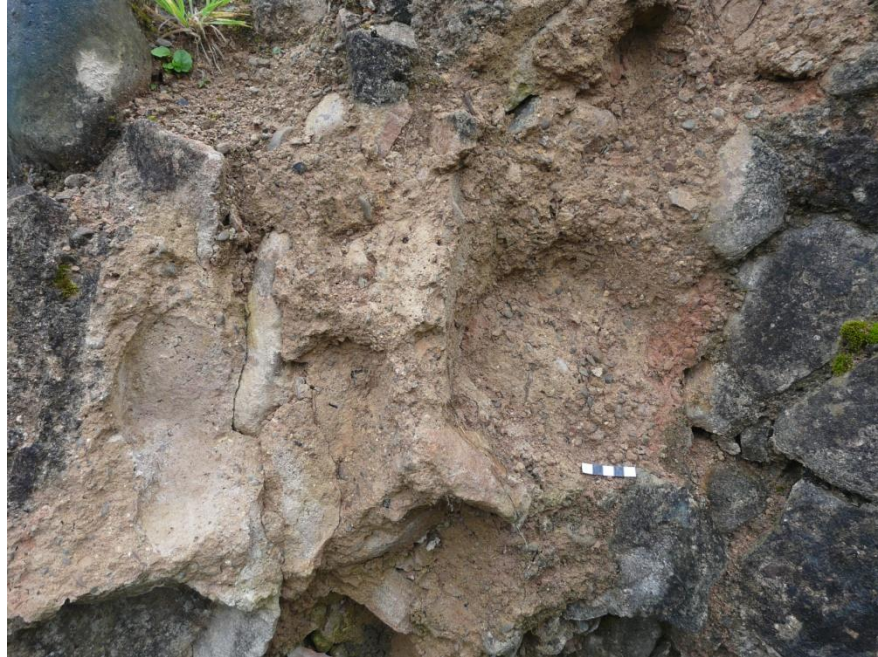
Figure 7 (above) – Degrading mortar in Context 1. Scale 10mm; photograph M. Thacker.

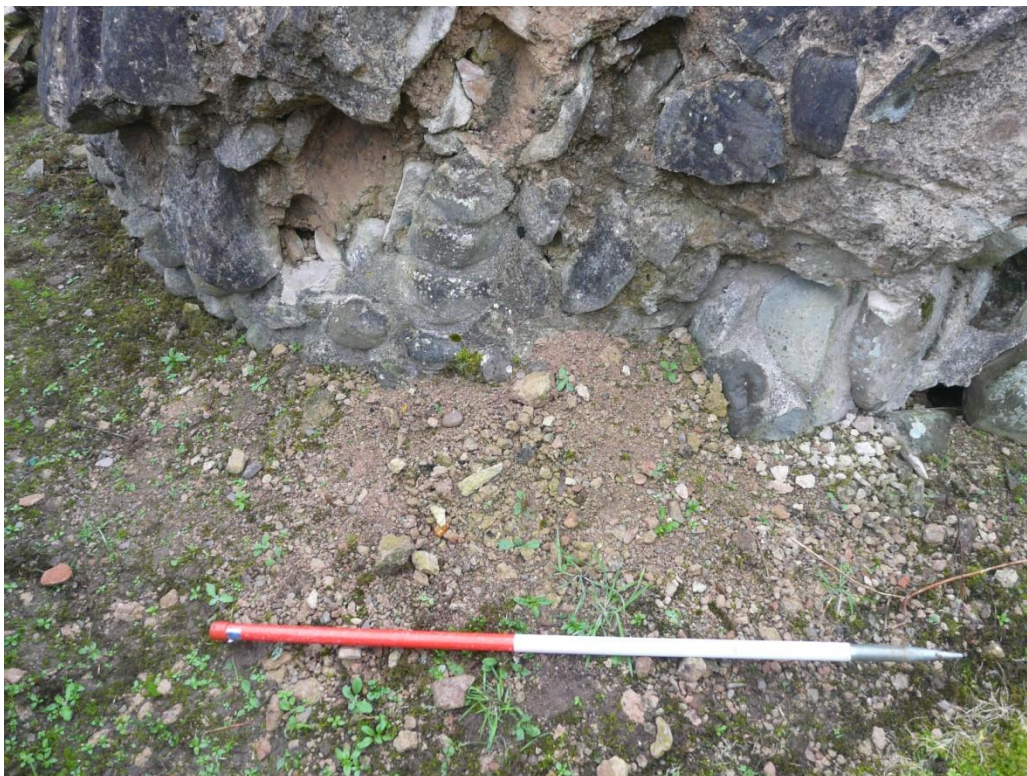
Figure 8 (above) – Degraded mortar at base of context 1. Scale 500mm; photograph M. Thacker.
