# The Chesters, Drem, East Lothian

## Erosion Survey

Rampart Scotland Project 002:

### Season 4

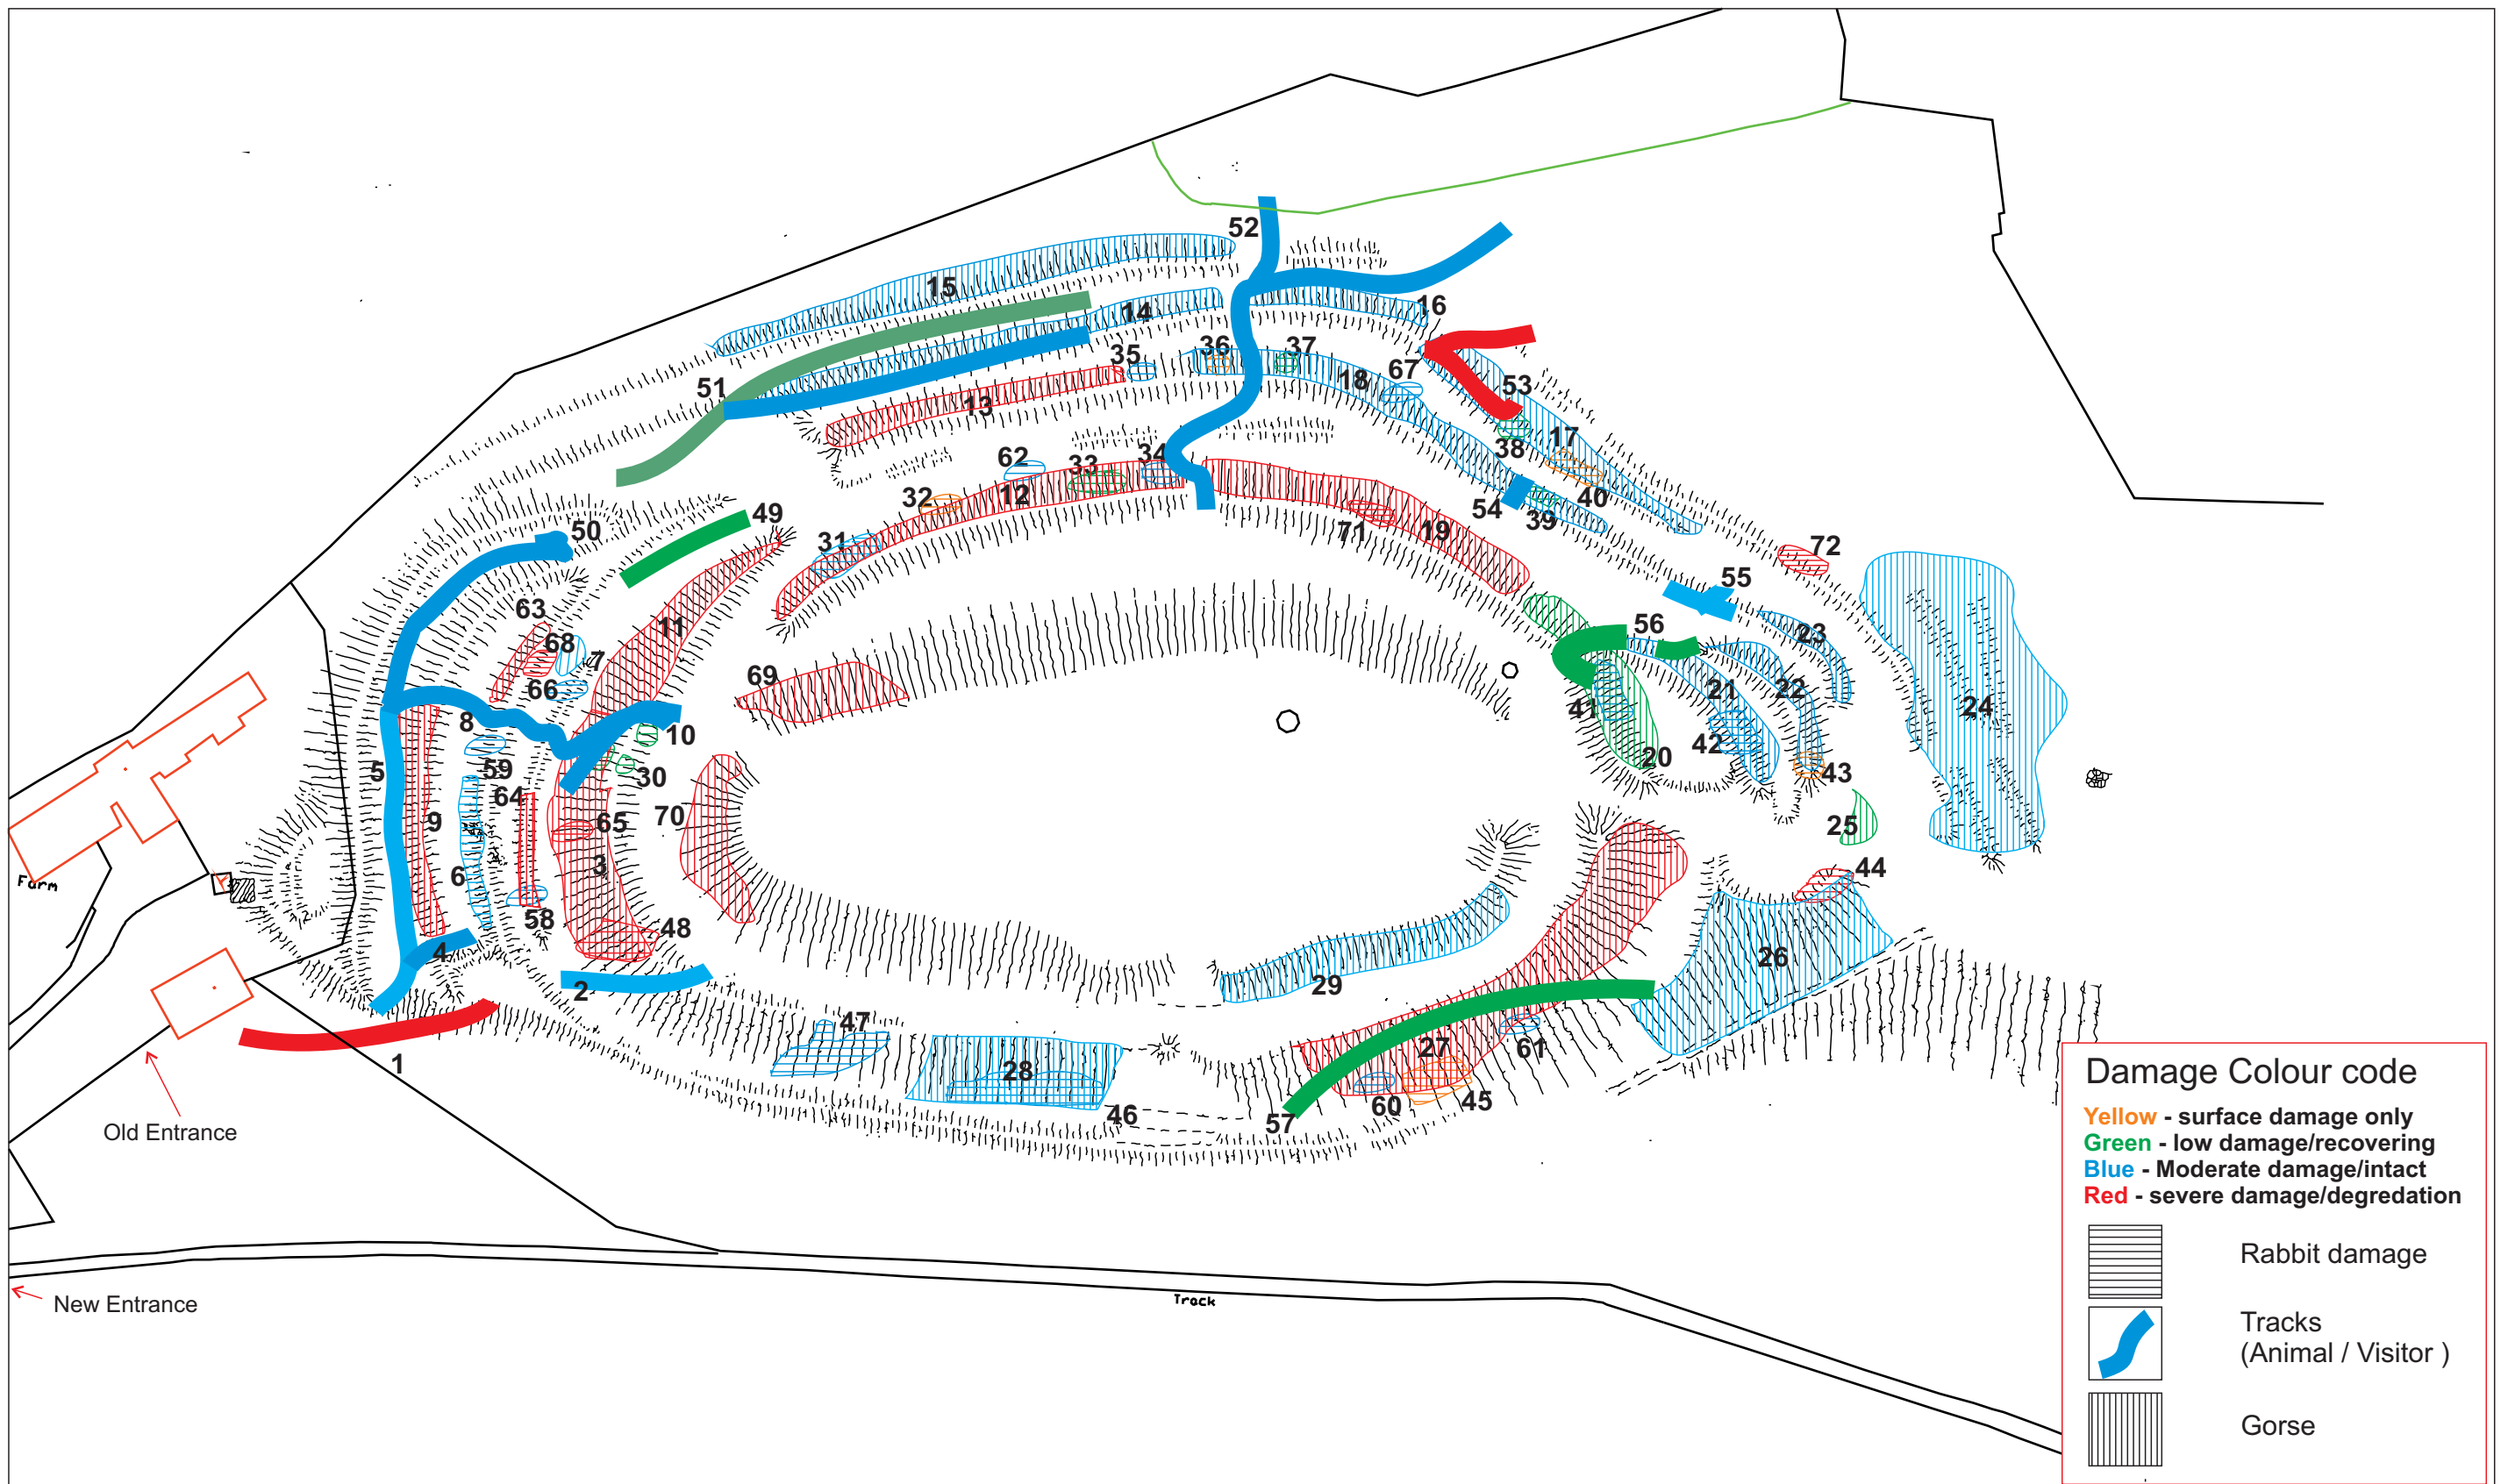
Figure 3: Site plan and erosion survey

The updated 2013/14 results of the survey are presented in Table 1 and Figure 2, with the associated photographic record presented in appendix 1.

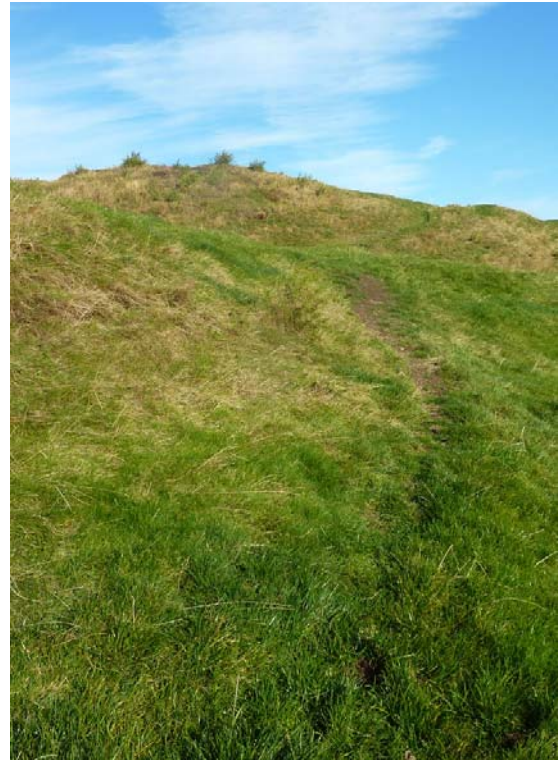
7.1.1 The damage from visitors continues to be localised and clearly follows established paths. Visitor access is focussed along Tracks 1 and 2, leading directly into the interior, and there is no evidence for *ad hoc* alternative routes. Of course while this activity minimises the overall spread of erosion it concentrates it in particular locations. The new entry has had no effect on visitor activity, as they seem to continue on the old routes after entering the site via the new pathway.

PLATE 1: VISITOR DAMAGE 2 THROUGH UPPER RAMPART

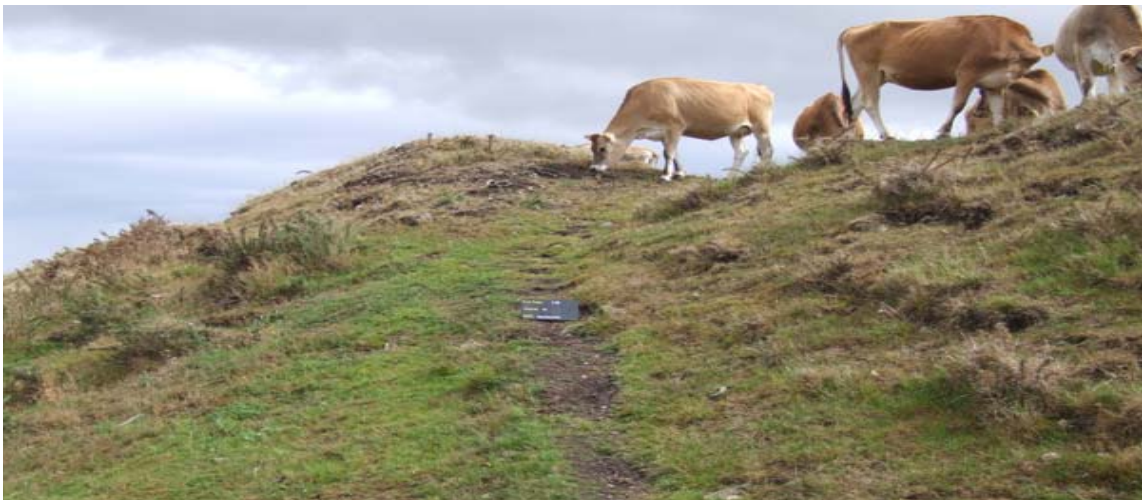
7.1.2 It is likely that the visible stock erosion has been in place for years, as many of the rampart breaches such as those associated with Tracks 10, 52 and 54, are significant and are likely to have taken some time to 'wear' through the rampart. Again, like the visitor tracks, these are now established and show continued use, causing further but localised damage.

PLATE 2: STOCK DAMAGE 10 OF RAMPART BANK AND SLOPE

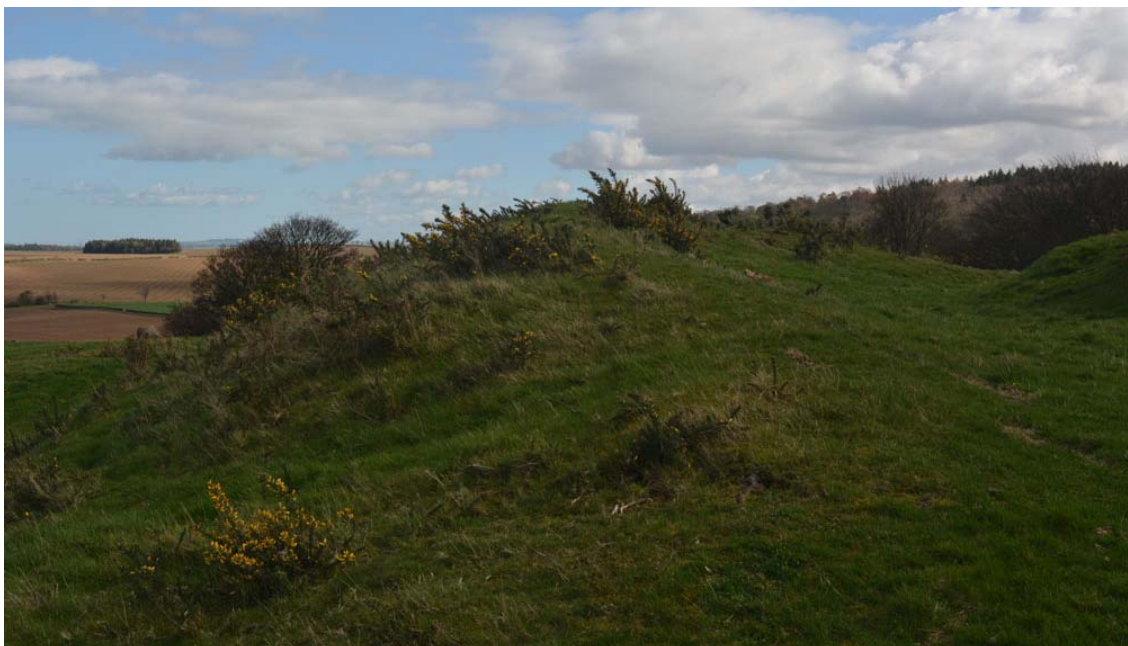
- 7.2.1 The 2010 gorse clearance removed large areas of this intrusive vegetation and is to be welcomed in principle. However, the removal resulted in the exposure of unvegetated and loose soil and rampart material leading to some erosion.
- 7.2.2 There is also clear evidence of gorse regeneration and it is recommended that the situation is continued to be monitored.
- 7.2.3 Several locations are showing signs of new growth, though this may be controlled with grazing, however, although some areas of gorse are showing no sign of life, there is a potential that gorse could begin re-colonisation if left unchecked.
- 7.2.4 On the 4<sup>th</sup> season of survey, there was not only signs of some limited regeneration of new growth, but also areas where previously there was none present (Gorse 63 & 64 68 & 69). The problem seems to be ongoing.

PLATE 3: REGENERATING GORSE AREA 22 IN 2014.

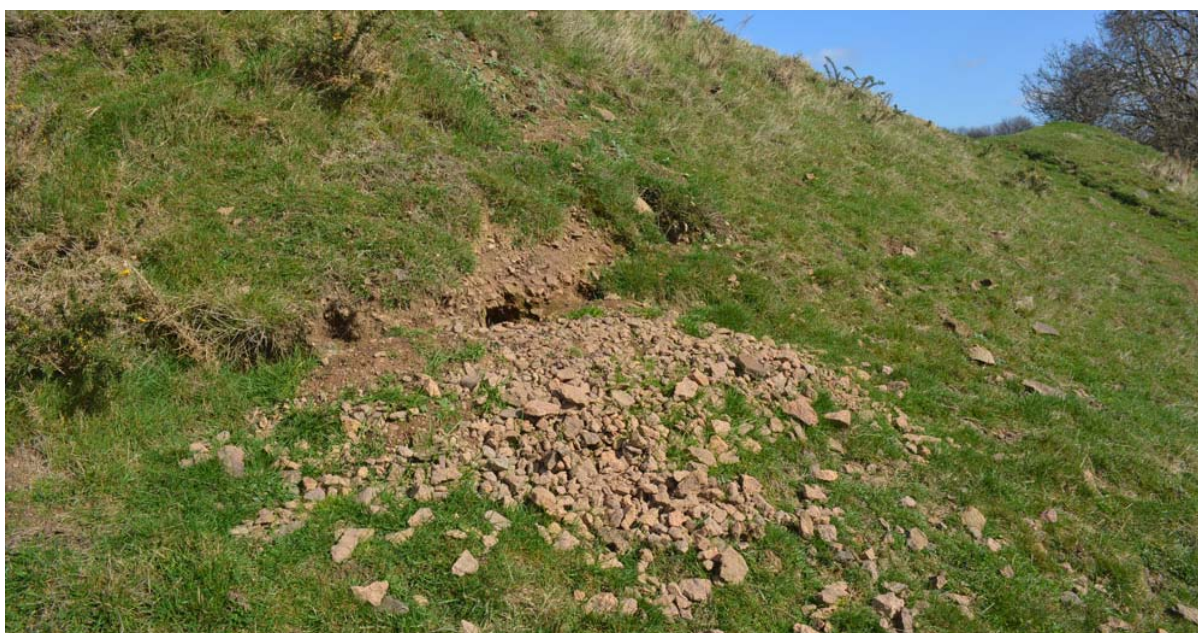
- 7.3.2 In very specific locations, for example, the south slope, where warrens and isolated burrows penetrate the once-covered gorse slopes (rabbit damage 43–48) the erosion represents a real threat to the structural integrity of the rampart, with deep burrows and clear activity throwing up large amounts of core material. As mentioned above (Section 6.1.3) rabbit damage (31-39) combine with cattle tracks (Tracks 52 and 53) to increase the level of collapse. It is unclear as to whether the rabbit population is increasing or has decreased at the present as new damage is clearly in evidence (Damage 58-62) but other locations seem to be no longer active. (Damage 32,33,35 &36).

PLATE 4: NEW RABBIT DAMAGE [48]

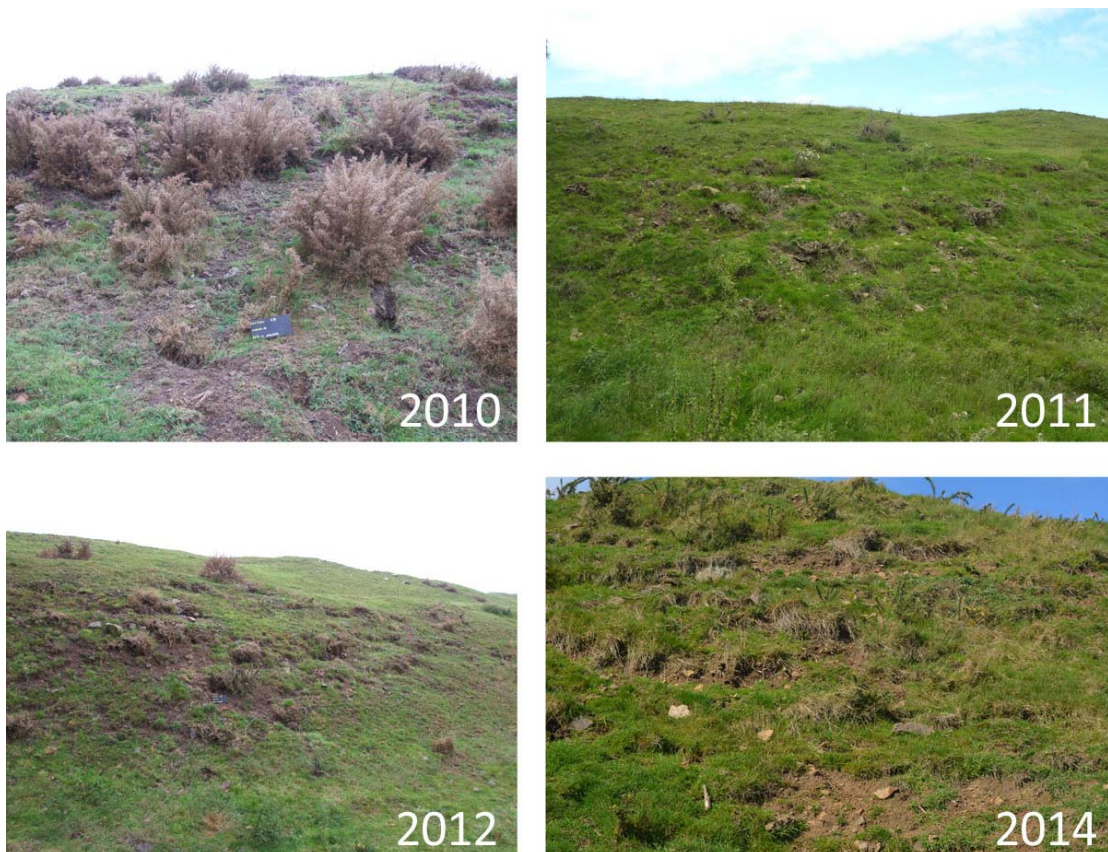
- 7.4.2 The nature of management is clear when studied over a number of years. As seen in plate 5, below, the initial cutting of gorse exposed the slope to erosion and although there was a period of repair to the rampart slope the recolonization by rabbits soon grew to levels where the area was compromised, and introduction of cattle to prevent gorse regrowth also resulted in trample and further deflation and slumping.

PLATE 5: DAMAGE 47 - COMPARATIVE DAMAGE RECORD EXAMPLE

- 7.4.3 Initial removal of gorse should be followed up by regular continuous assessment of the various issues in a quick walkround, that can provide an overview of potential new threats to the site. It is clear from this location that the gorse – though visually intrusive, has already damaged the surface as much as it can, while rabbit and animal tracks are far more destructive when allowed to continue unchecked.
