# HUNTLY CASTLE

## Survey of stone frieze and other ornamental stone

**September 2015**

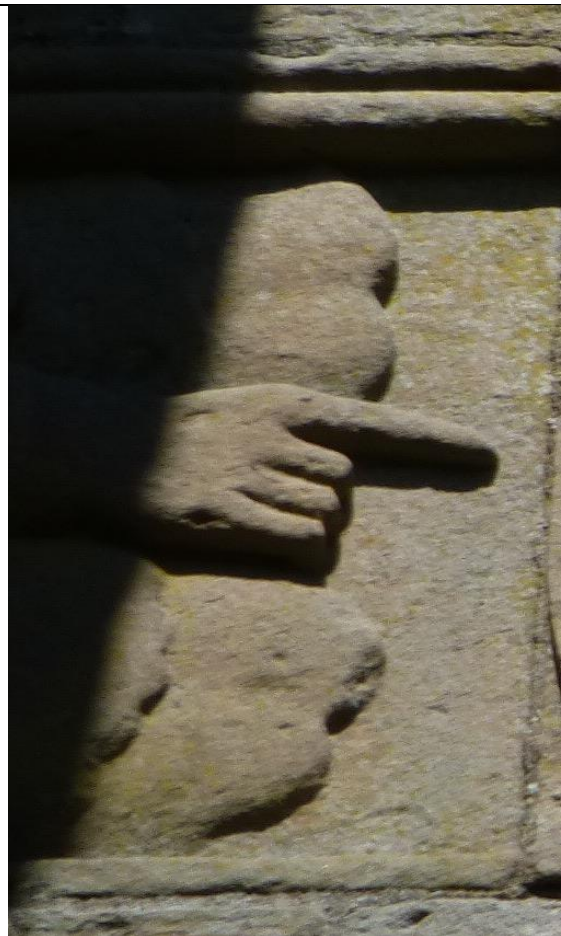
Pointing hand: Small crack on index finger and lower side of hand.

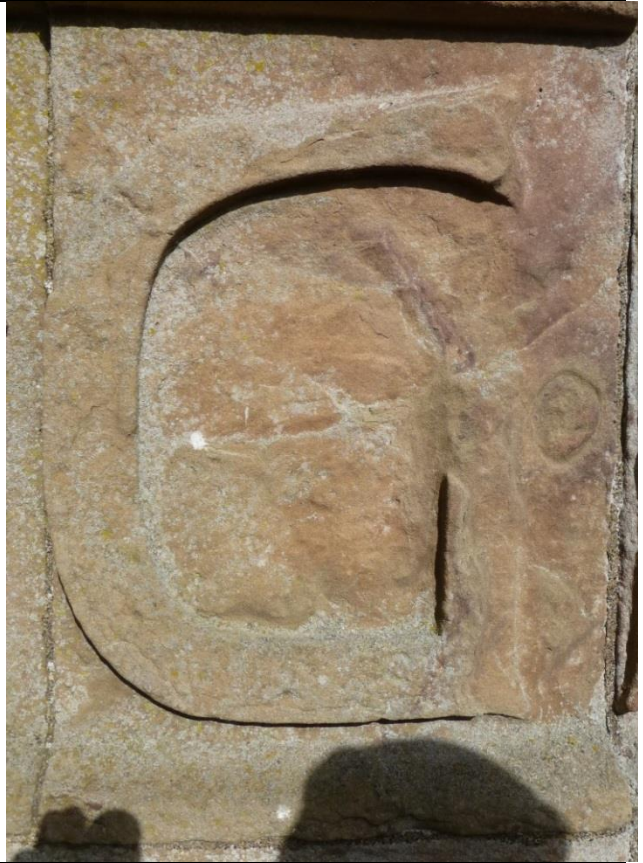
G – a number of minor old resin repairs are still in situ. Small areas of delamination are visible at the top of the stone.

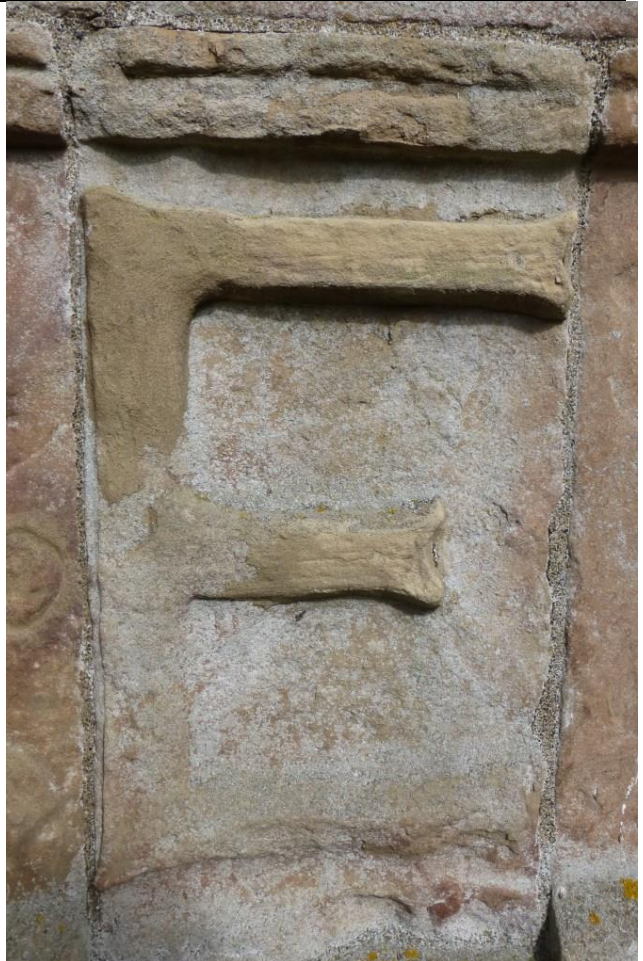
E – The two upper crossbars and connecting vertical shaft are GRP replica. Nonetheless, the top left corner of the letter has been rendered with resin mortar. The remaining original stone is eroded. The resin mortar pointing around the replica parts is cracking and failing. The background surface is covered in thin, potentially protective, lichen growth.

Failing resin repairs should be removed and large resinous surface repairs minimised to improve the permeability of the stone surfaces. In particular, the pointing around replica letters needs to be removed and re-applied with a reversible acrylic resin mortar consisting of 10% Paraloid B72 in acetone mixed with colour-matched sands.

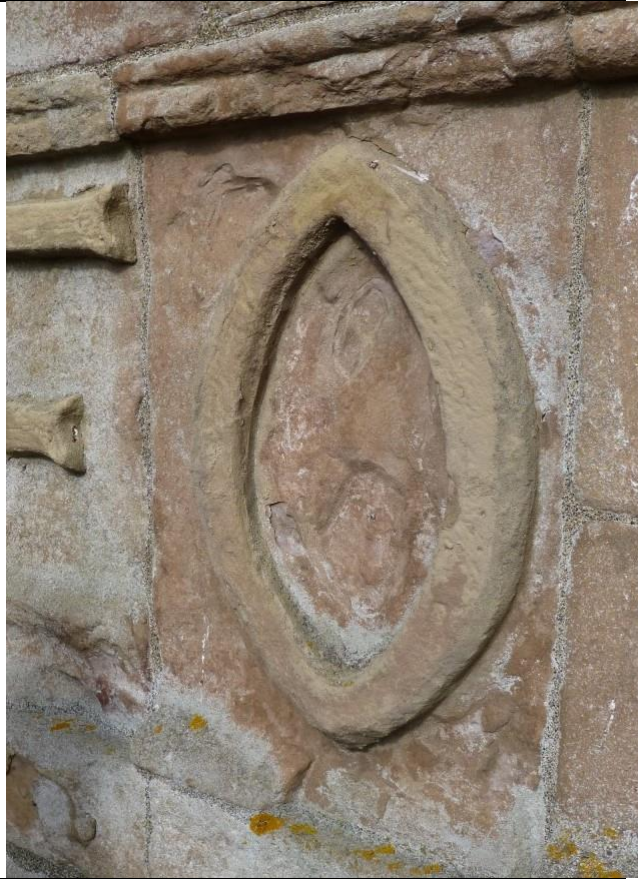
O – GRP replacement letter. The resin pointing around the letter is failing. The background is blistering in the centre where this has led to surface loss. Further open delamination edges are visible delaminations in the centre and corners of the stone., where old resin repairs have been lost or where new areas of decay have developed. A number of old resin repairs remain in situ.

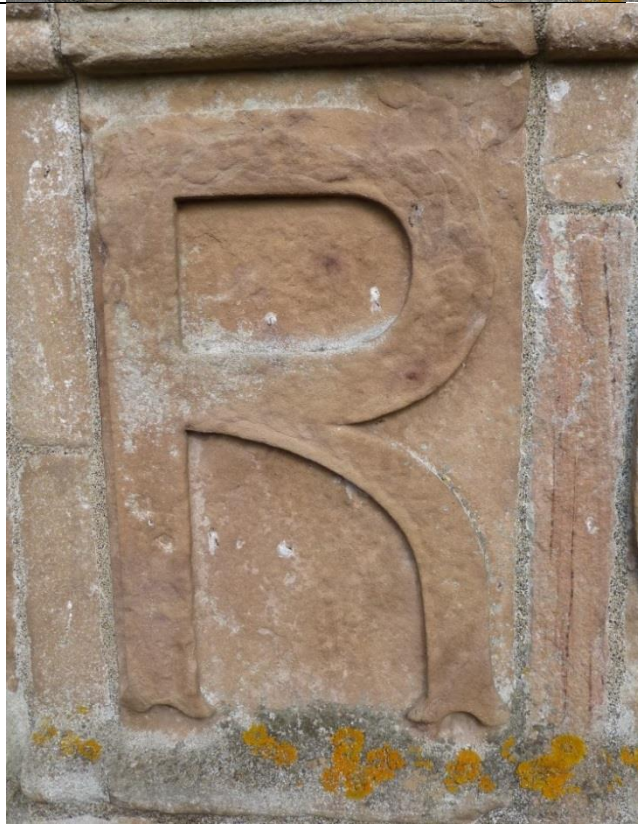
R – Minor fissures have been previously pointed and these fills are still in situ.

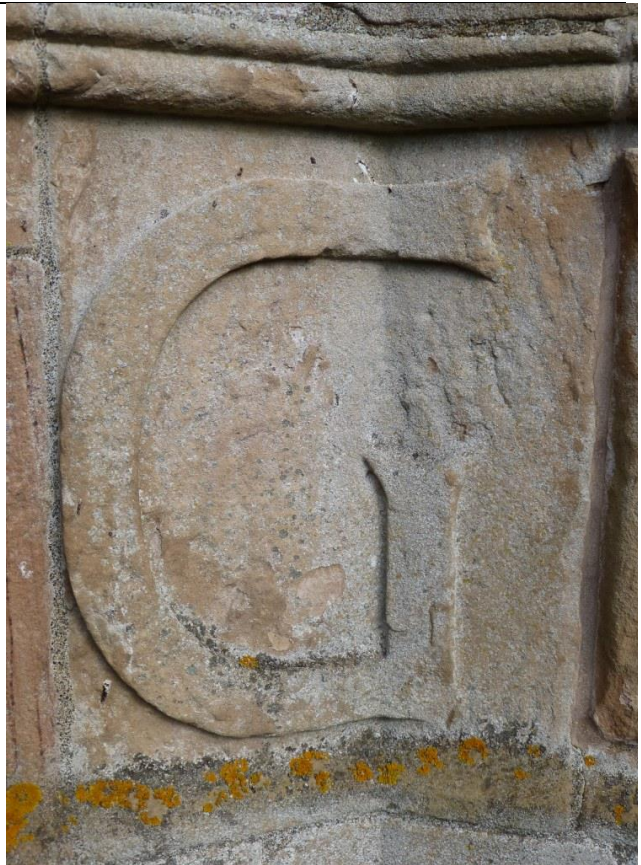
G – Minor areas of surface scaling in the lower part of the letter.

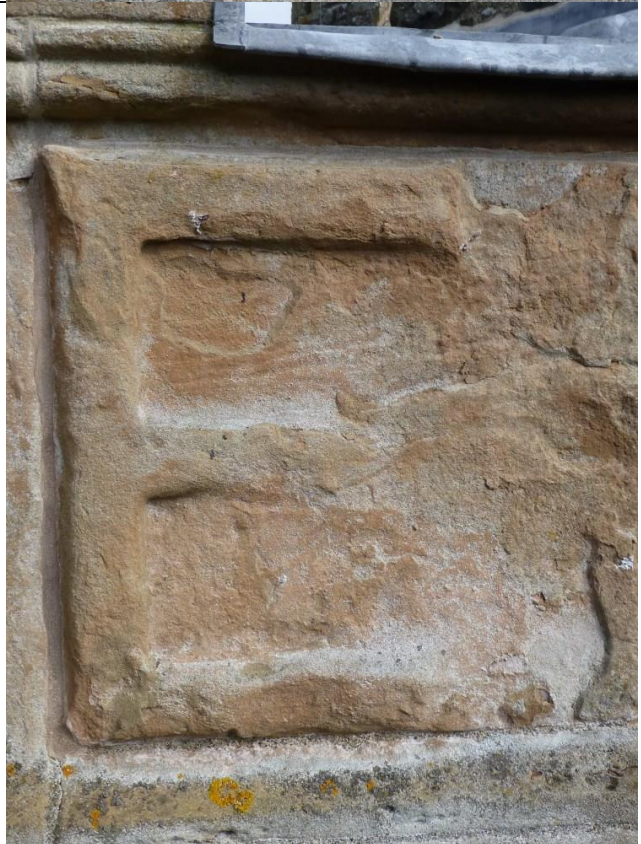
E – Many small areas of surface scaling and blistering, particularly towards the right side. The surface is boss in a number of areas. Fissures are visible at the top of the stone. Remaining old resin repairs are failing.

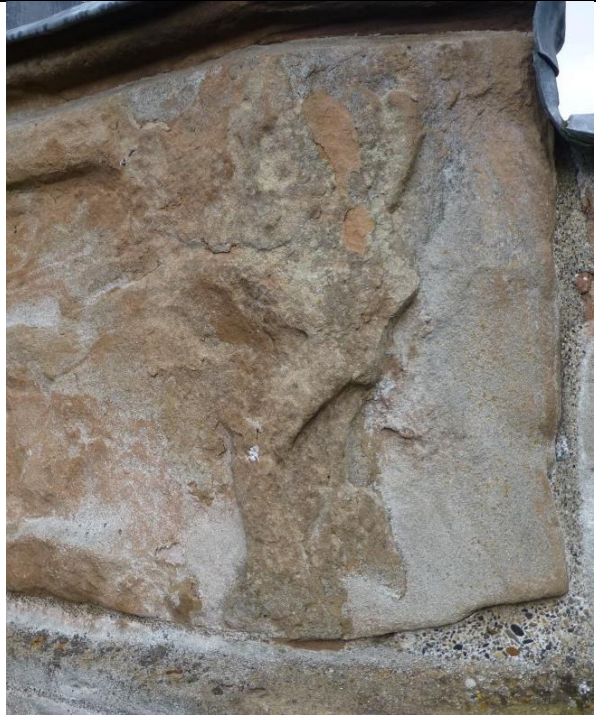
Star between 'GEORGE' and 'GORDOVN' - mostly missing and very eroded. The right side is almost completely sheared off. The delaminating remains are cracked and boss. This appears to have been caused water running off from the adjacent channel in the flashing.

The flashing on the left side of the gablet should be extended to prevent water run-off down the face of the pediment. Similarly, improvements may be possible to the flashing along the wall head where channelling of rainwater has led to local acceleration in surface erosion.

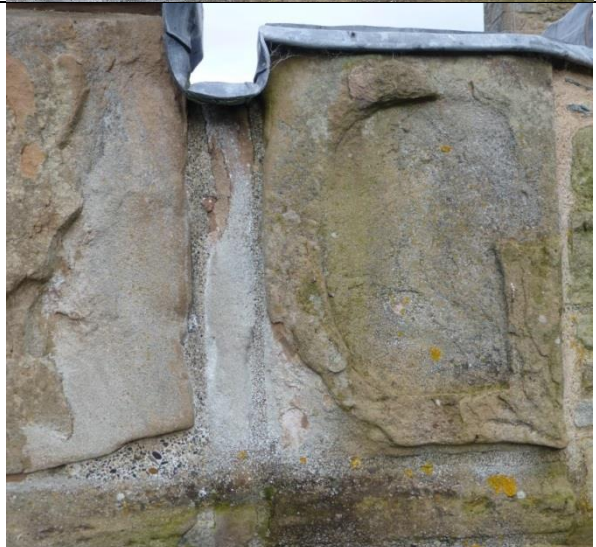
G - Delaminating in many areas, minor small resin repairs remain visible but most are missing or failing.

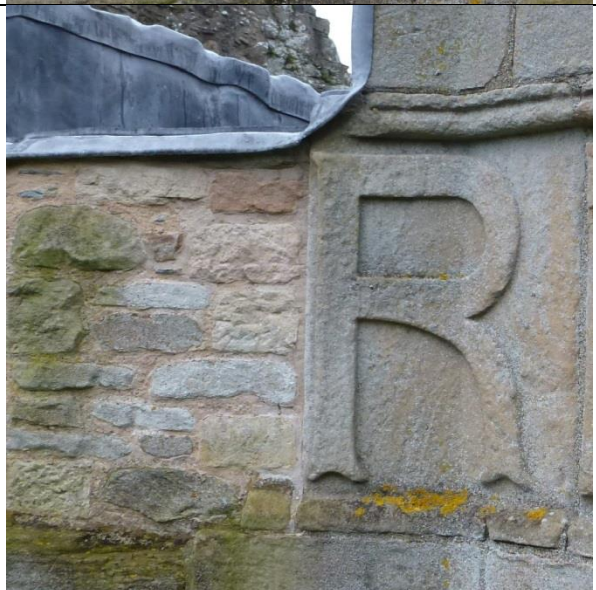
O - missing

R - stable condition

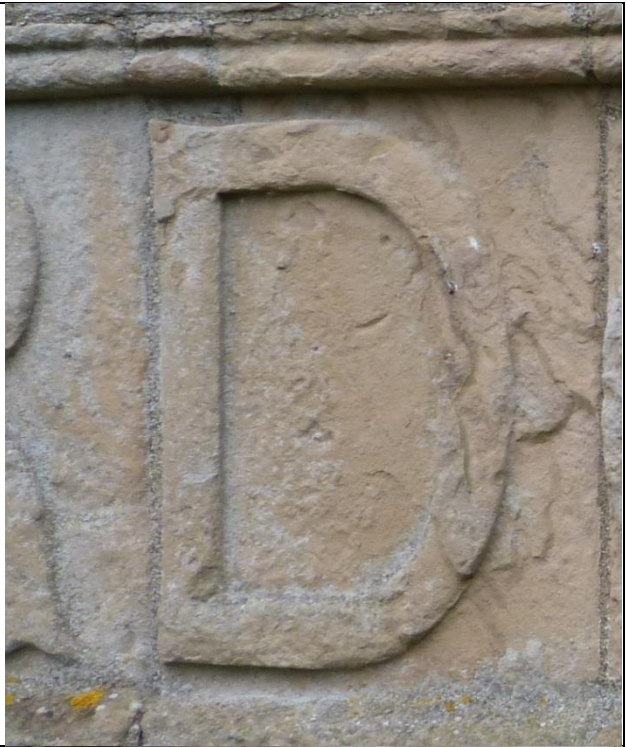
D - old repairs are starting to fail. Extensive pointing on right side is still in situ. Top of left side suffers surface scaling.

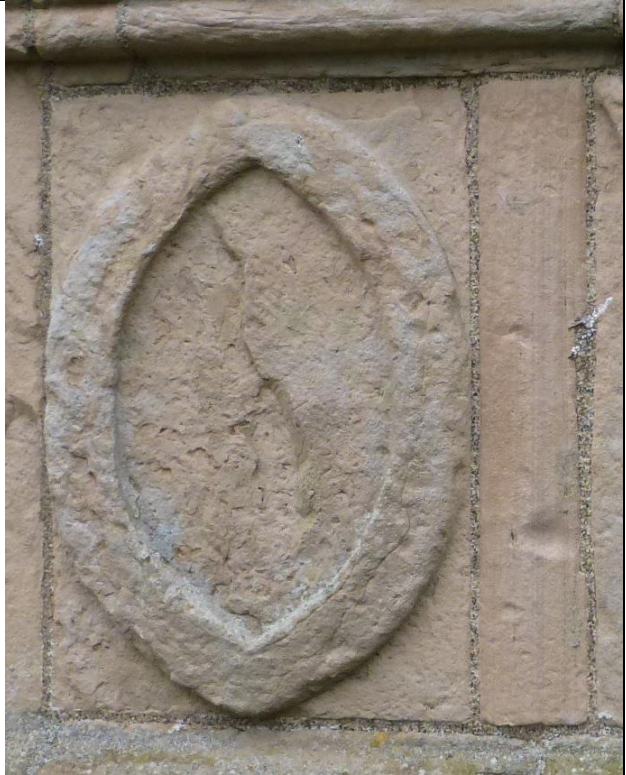
O - Extensively fissured, the left side and centre are particularly eroded and appear boss. Previous resin pointing is failing.

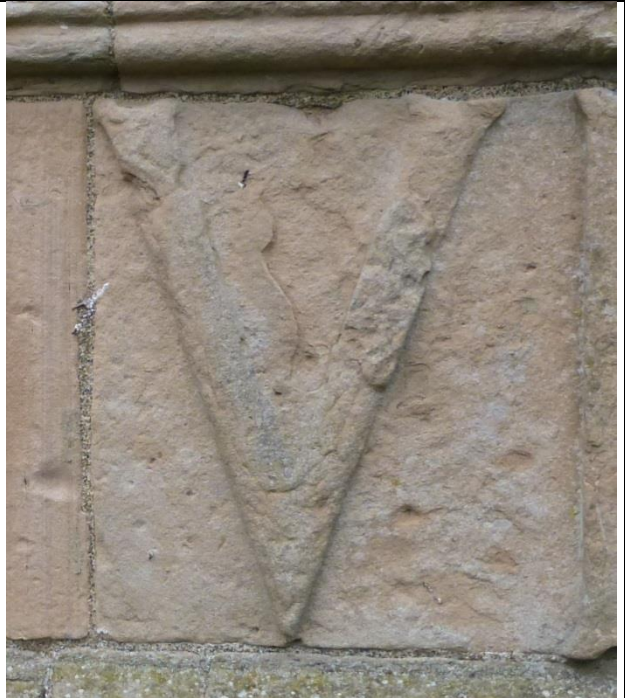
V - Numerous but minor fissures in all areas; small delamination are opening up in centre of the stone.

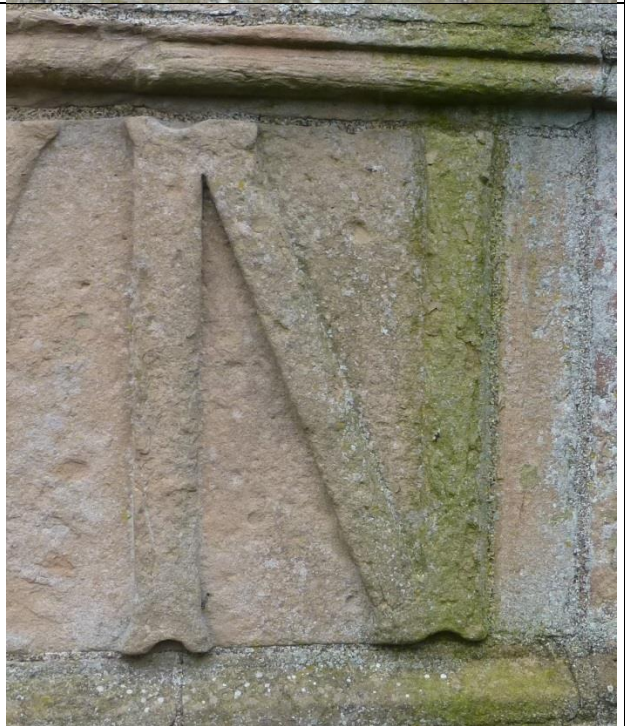
N – Flaking on right side with numerous small resin repairs visible in other areas which are starting to fail.

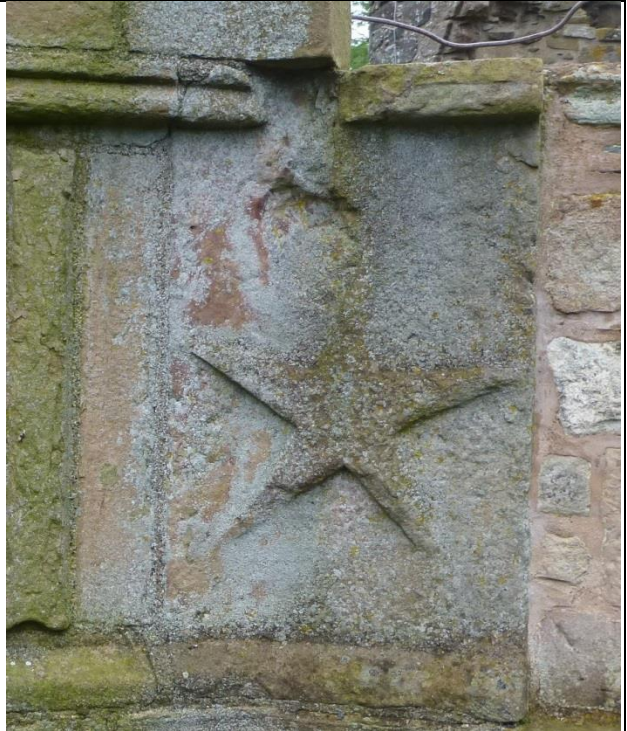
Star between 'GORDOVN' and 'FIRST'

- Eroded at top right side with minor delaminations visible here. This appears to be caused by water run off due to missing stringcourse stone above.

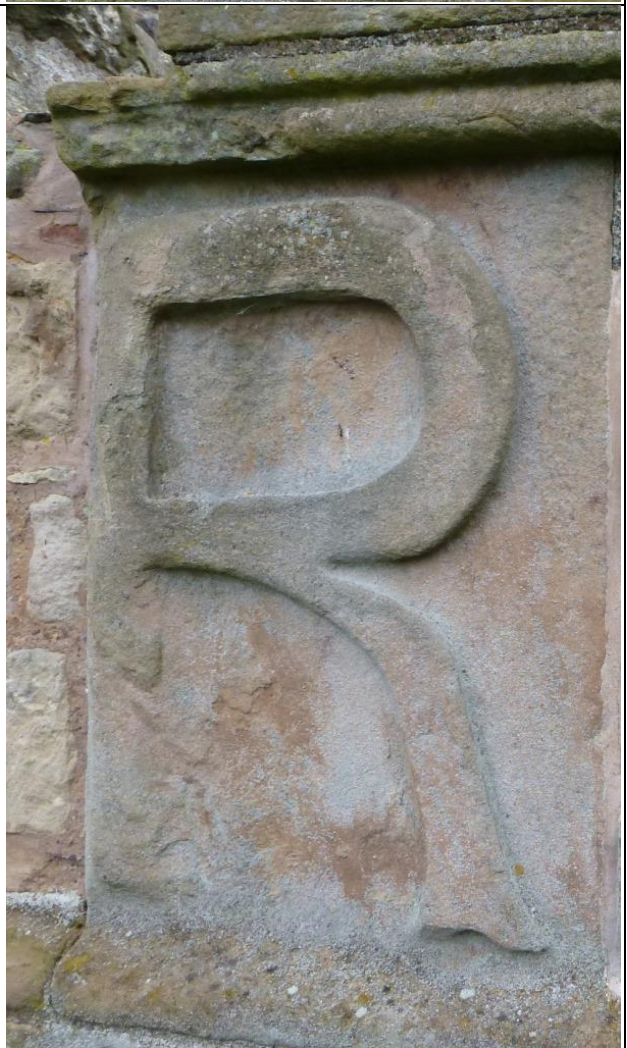
R - The lower leg is mostly eroded. Large old repairs in the top left corner are starting to open up. Minor delamination are visible below the crossbar.

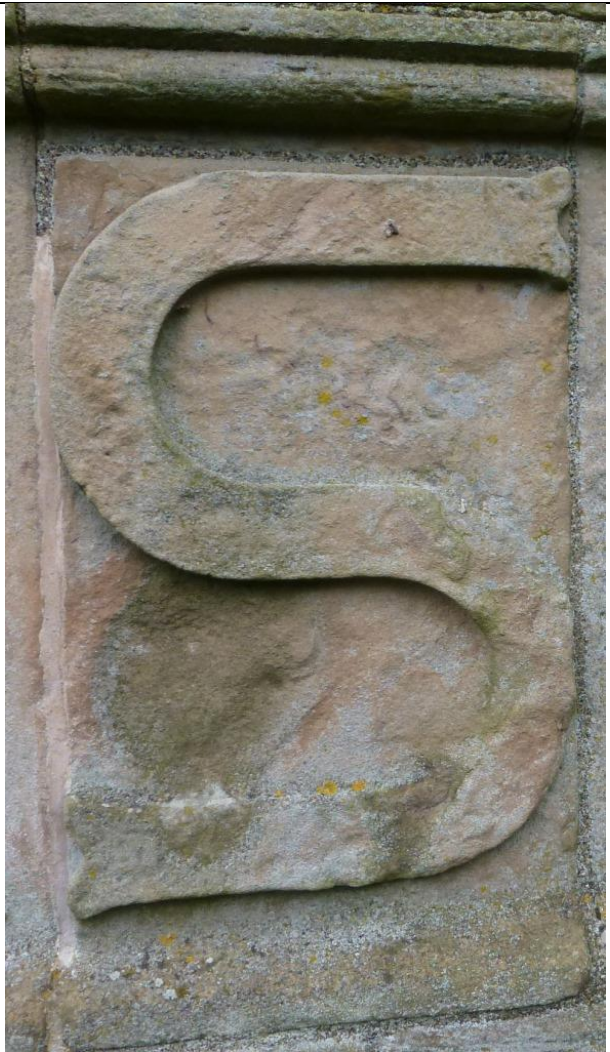
S – Minor fissures in top left corner.  
Missing cement pointing appears to  
have been replaced with acrylic mortar  
pointing.

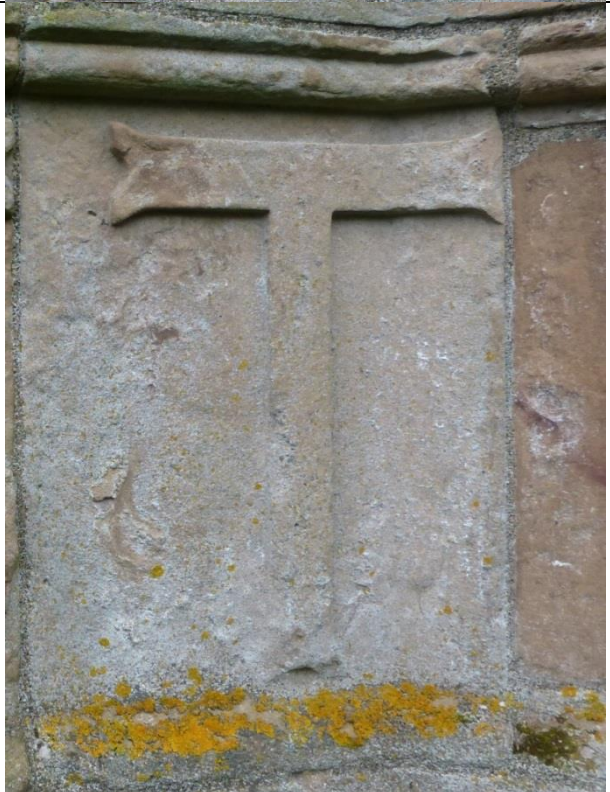
T - Surface blistering on left side with  
old resin repairs still in place.

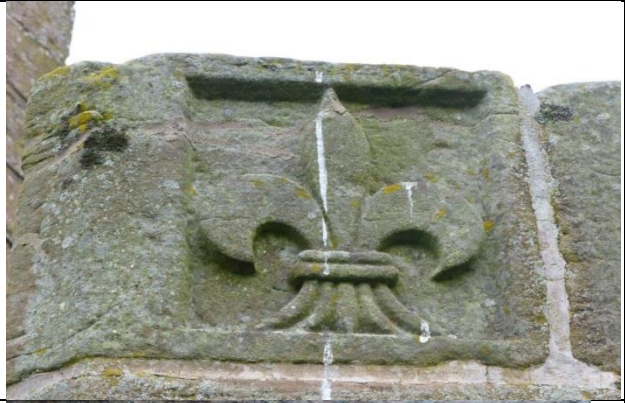
Fleur-de-lis above 'S' – The resin mortar pointing along fissures is starting to fail. Open masonry joints appear to have been pointed with acrylic resin mortar.

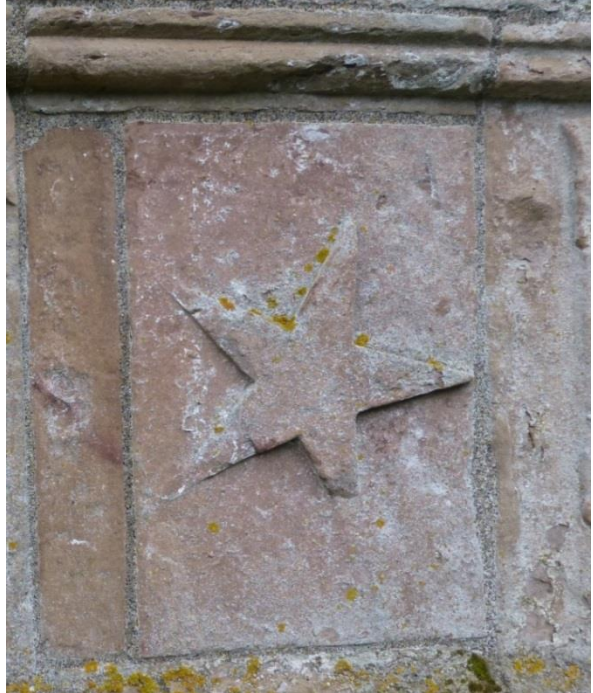
Star between 'FIRST' and 'MARQVIS' – Minor surface scaling on left side.

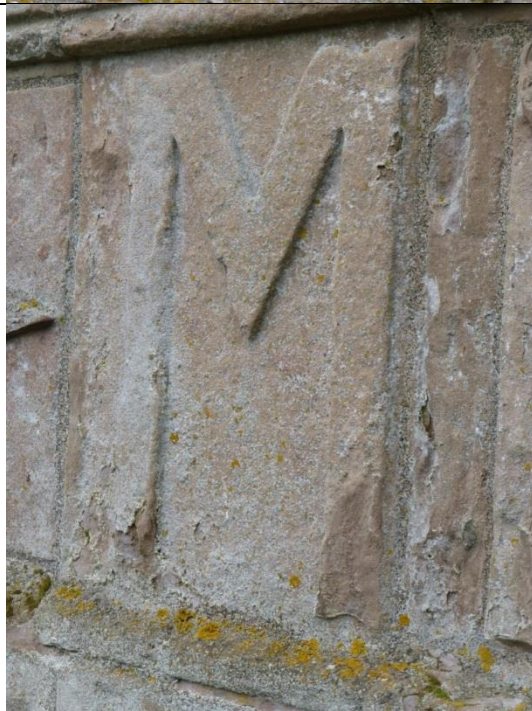
M - blistering and surface scaling on lower left side and top right hand side. Old repairs here are failing.

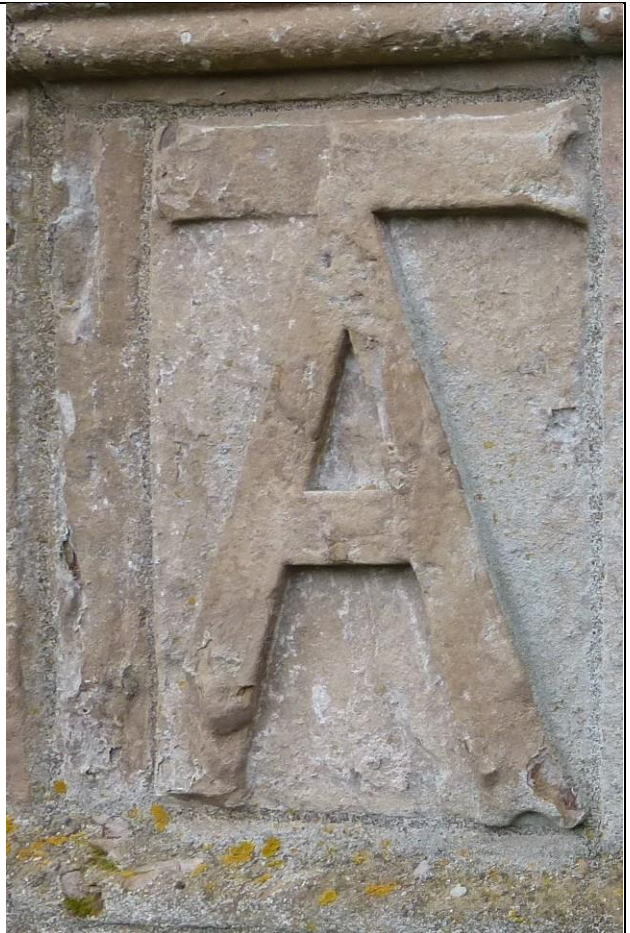
A – The lower right corner is lost and resin repairs on the lower left corner are starting to open up. Surface losses have occurred here and at the top right corner.

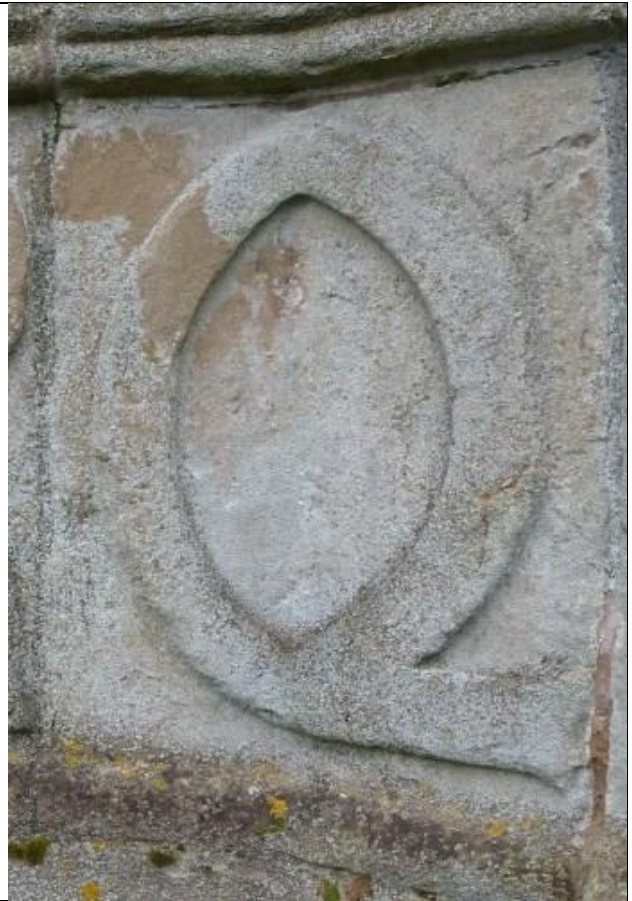
Q – Minor surface scaling and open delamination edge on lower right side of letter. Largely covered in thin lichen growth.

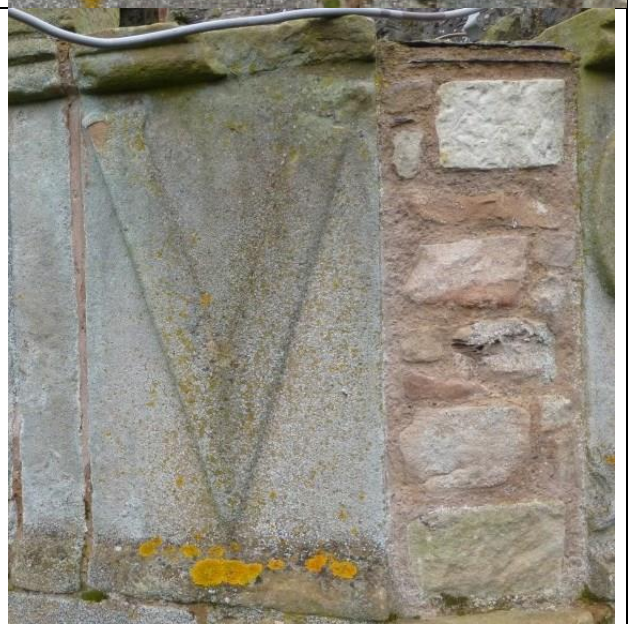
V – Delaminated top left corner. Thin lichen colonises all but the freshly revealed surface.

I - missing

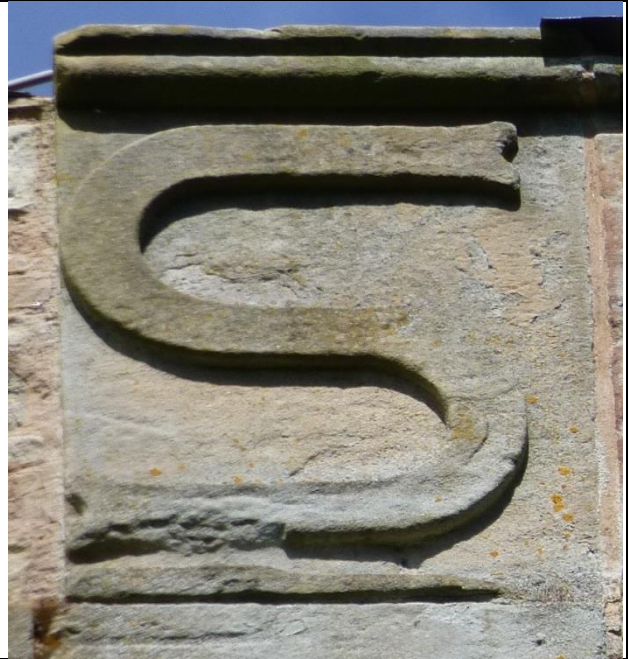
S – Eroded lower edge and minor surface scaling but otherwise stable.

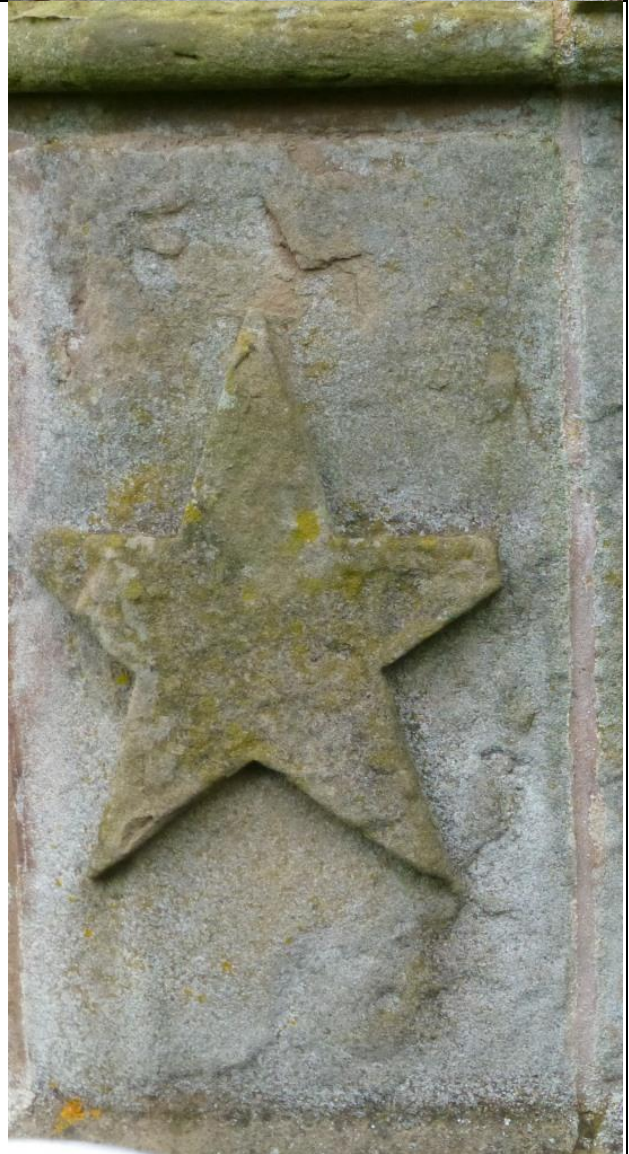
Star after 'MARQVIS' – delamination and surface loss at top. Acrylic resin mortar has been used to point vertical masonry stone joints to either side, indicating at least partially missing or failing mineral mortar pointing here.

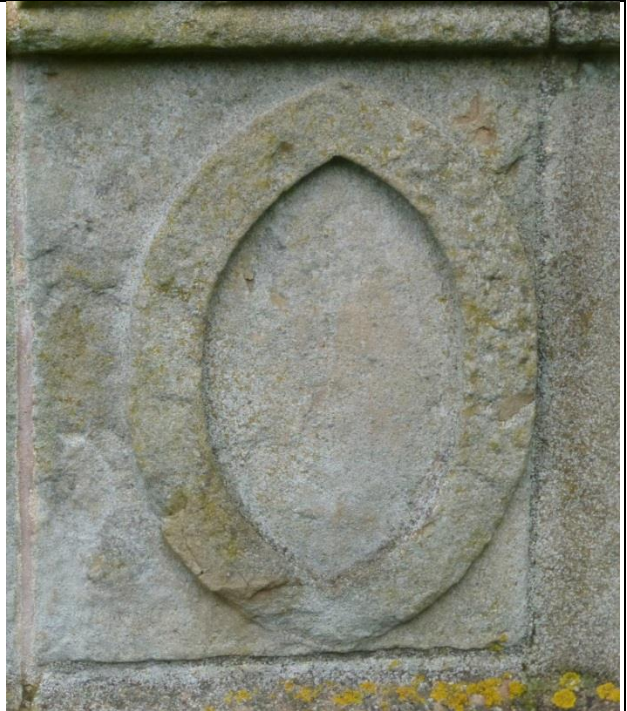
O - Fissures on lower left hand side with open repairs visible here. The lower right corner is also fissured and the surface appears boss. Minor delaminations have occurred on the top right corner.

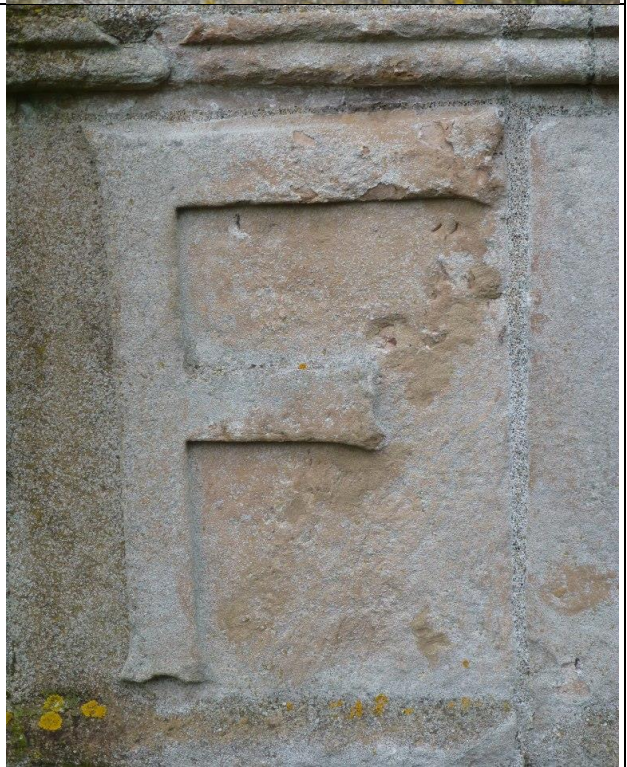
F - Minor surface scaling and losses along the top bar and fissured along lower cross bar. Appears boss. Failing old resin repairs on right side of background.

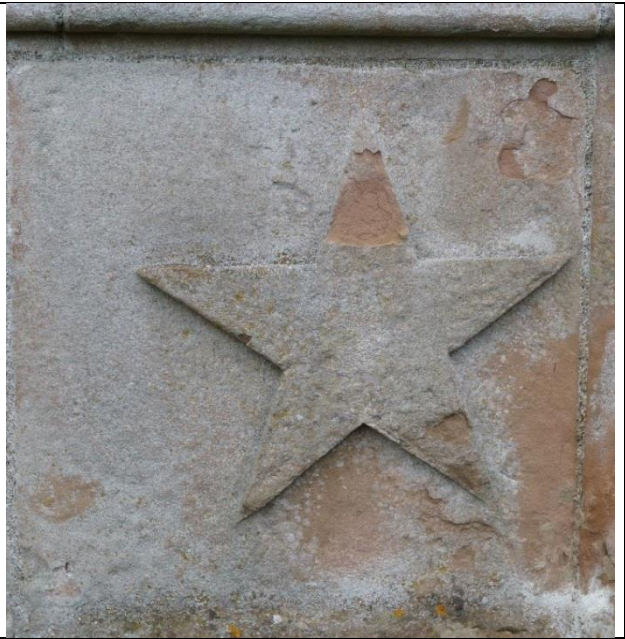
Star after 'OF': Top and bottom right hand arms are missing. The presence of cracks indicates that further areas are at risk of delamination.

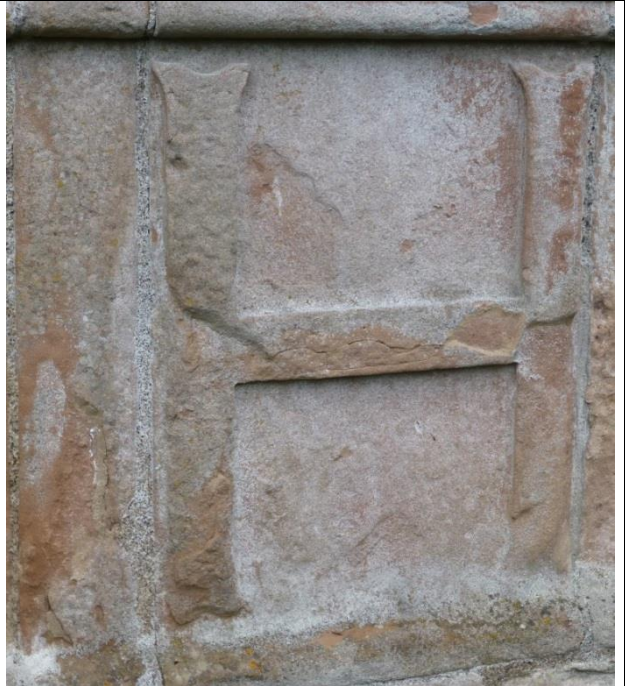
H - Old resin mortar repairs along delamination edges are starting to fail. Cracked along cross bar, also delamination edges starting to open up and fissures at top left corner.

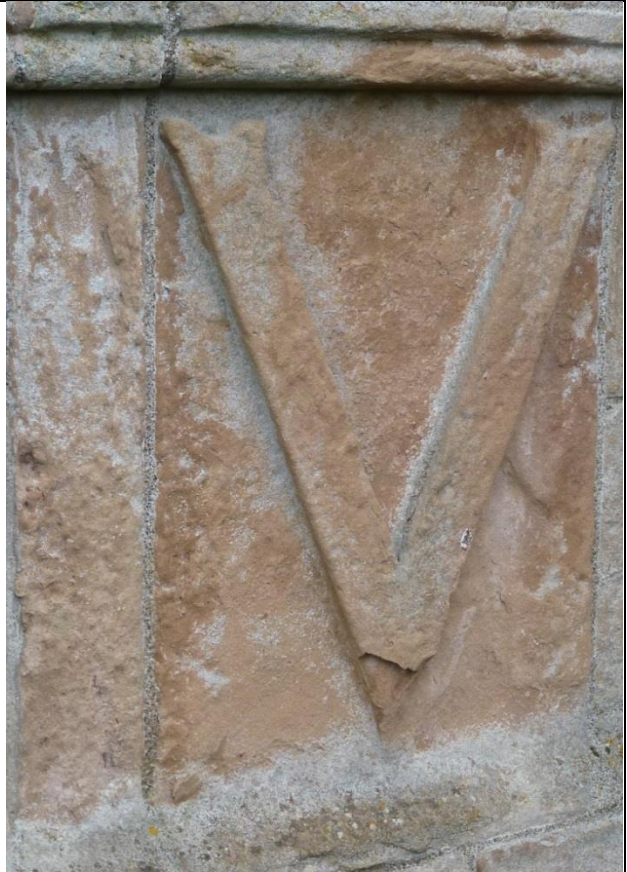
V: The lower part of the letter is lost due to delamination and the surface above appears boss and fragile. Old resin mortar repairs are visible in the top left corner and lower right side. These appear to be intact.

The remaining letters of the word 'HVNTLY' are missing.

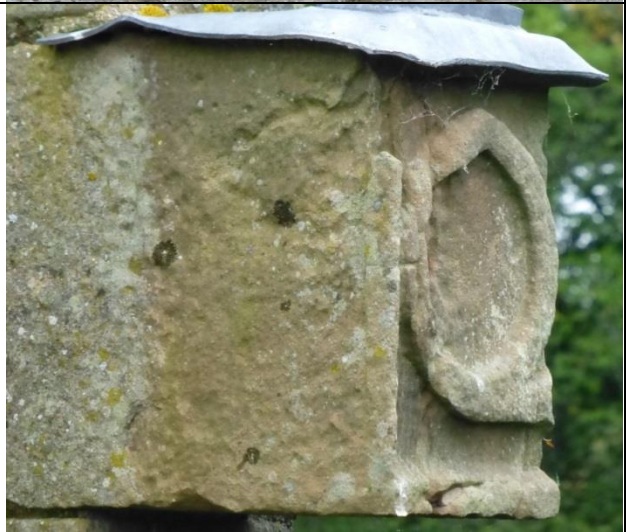
Q at far Eastern end: Loss of lower edge moulding and top left corner; cracks visible along the lower and left edge:

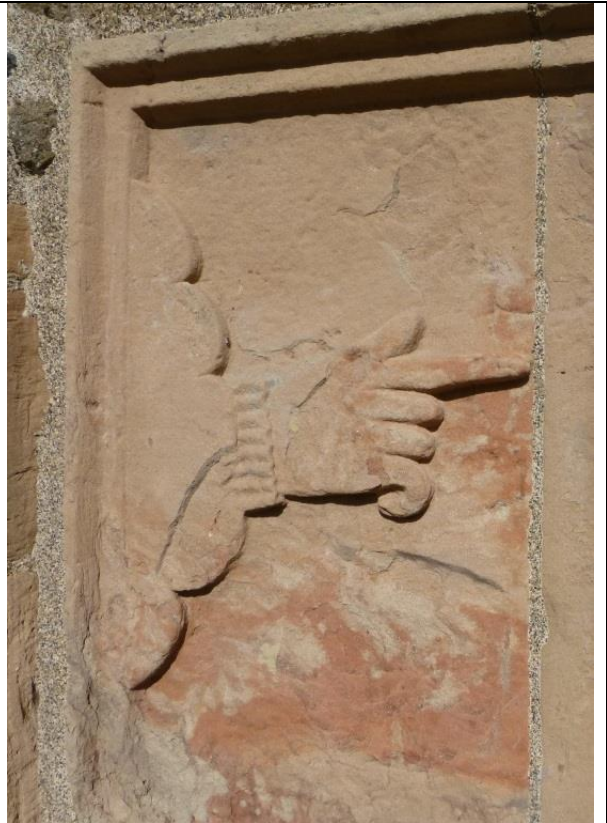
Pointing hand left of 'Henriette'. Small delamination at bottom and previously repaired delamination edges above hand.

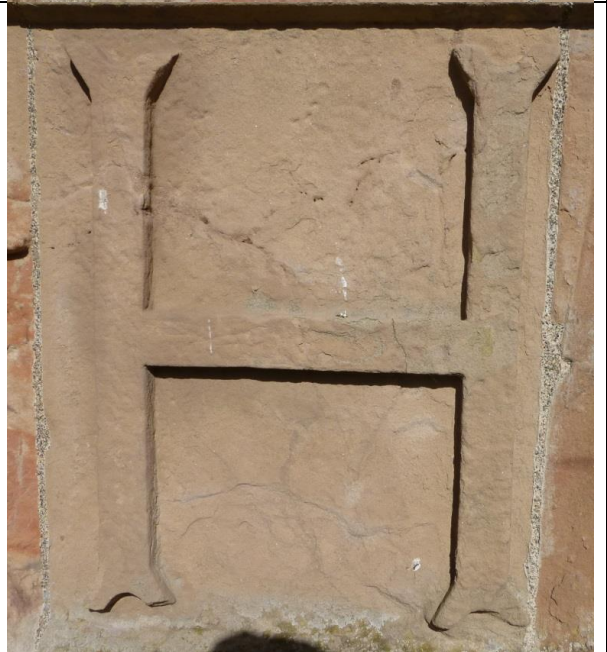
HENRIETTE:  
H - failing old repairs of cracks in the centre of the stone. The surface is delaminating and boss in the centre.

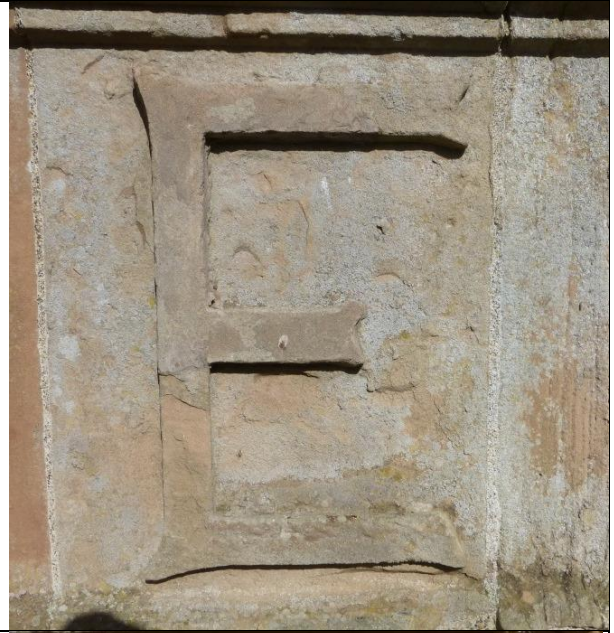
E - replica letter at the top and the joint is open here, delamination edges are visible on the original lower half of the letter. The resin mortar pointing round letter is cracked and failing.

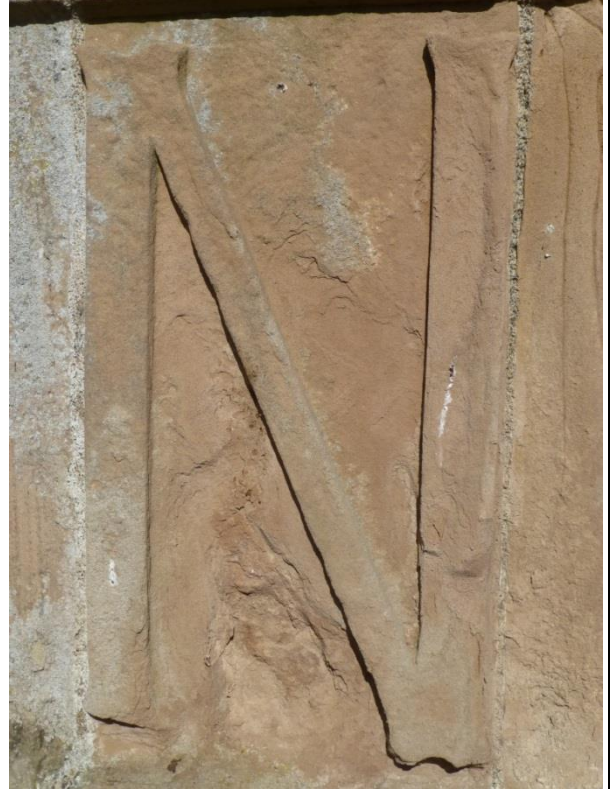
N - Very soft and disaggregating, severely eroded at the bottom.

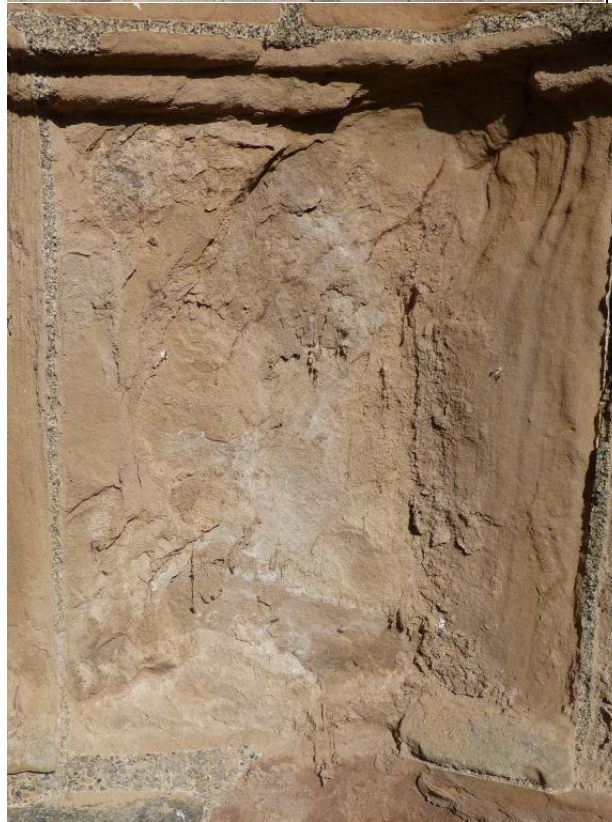
Stone after removal of the letter 'R'

I - almost completely missing letter and stone is very eroded.

The indentation or replacement of the stone, from which the letter 'R' for 'HENRIETTE' was removed, is recommended as the name is now difficult to read. The shape and size of the letter can be obtained by taking a mould from or laser scan of the same letter elsewhere on the frieze. A suitable replacement stone can be identified through petrographic analysis and stone matching services. The remaining stone is not sufficiently sound to form a suitable surface to which a replacement letter could be attached.

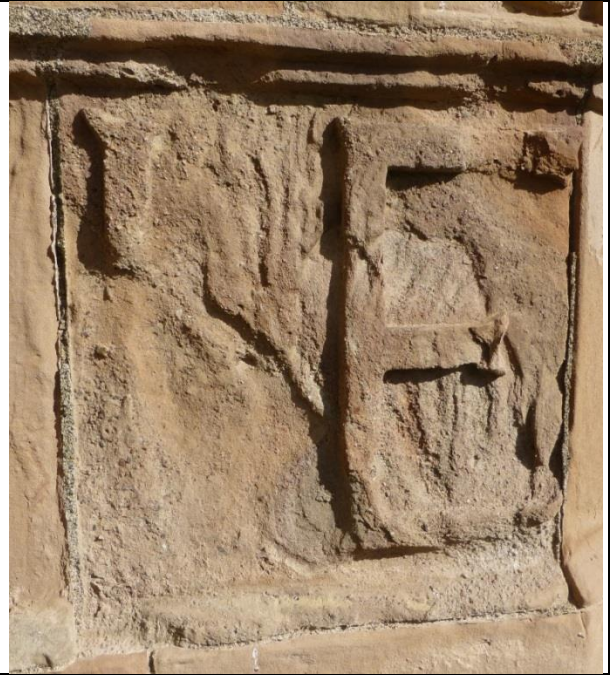
E - very worn, same stone as above, marked increase in decay since 2009. The stone is very coarse grained and very fragile on its right side.

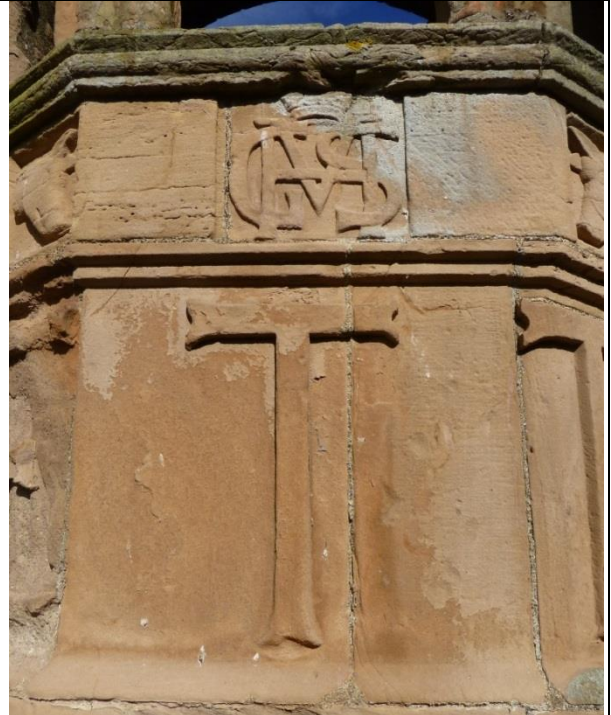
T - Minor surface scaling and disaggregation. Area of decay at the top centre edge of the stone

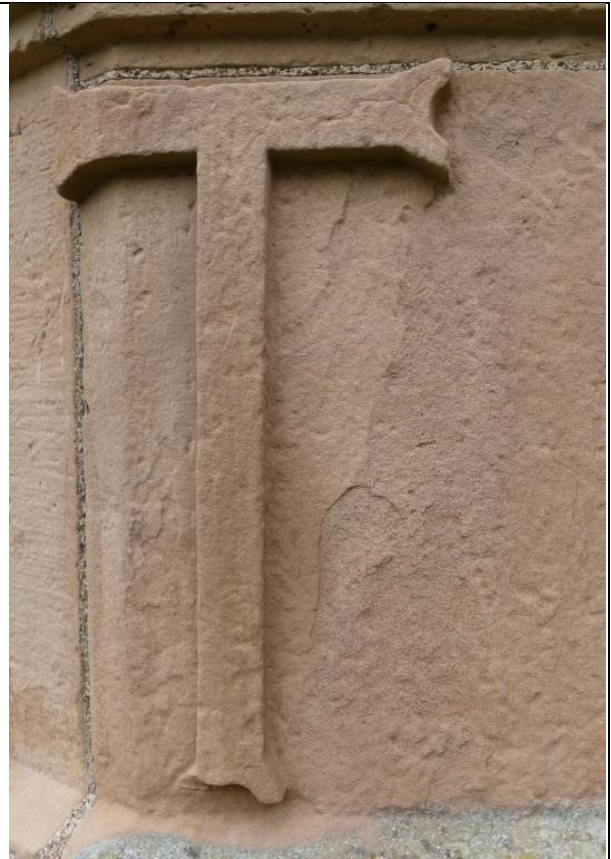
T - Minor fissures and surface scaling.

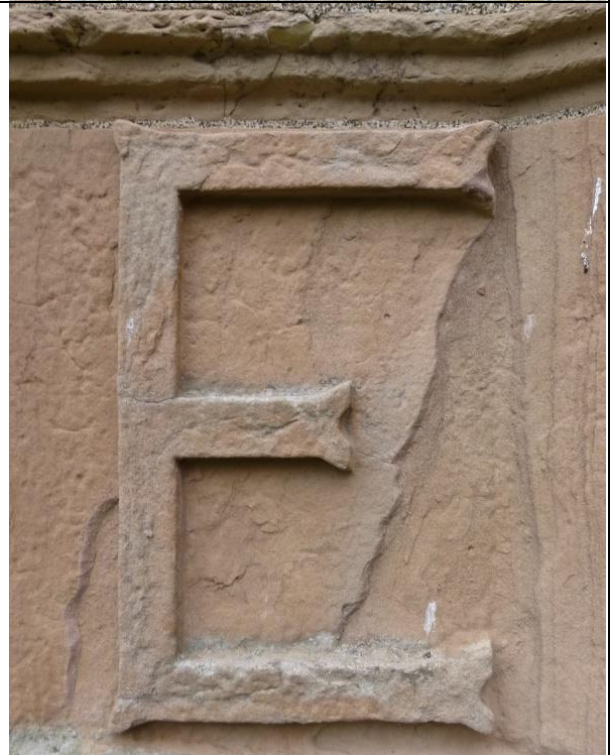
E - Old repairs of delamination edges are starting to fail. Minor new fissures have developed along central part.

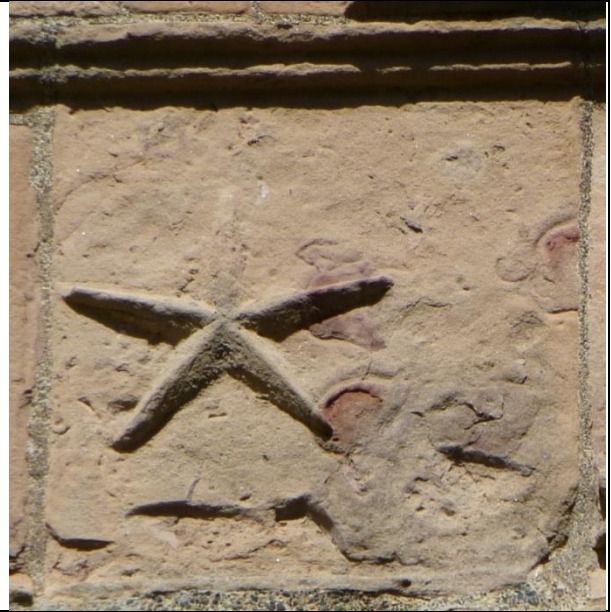
Star after 'Henriette - Boss and surface has become rounded through distortion. The lower edge and lower right corner are decayed with cracks and delaminations edges visible. Further decay is visible all over the stone. The lower part of the star is disaggregating.

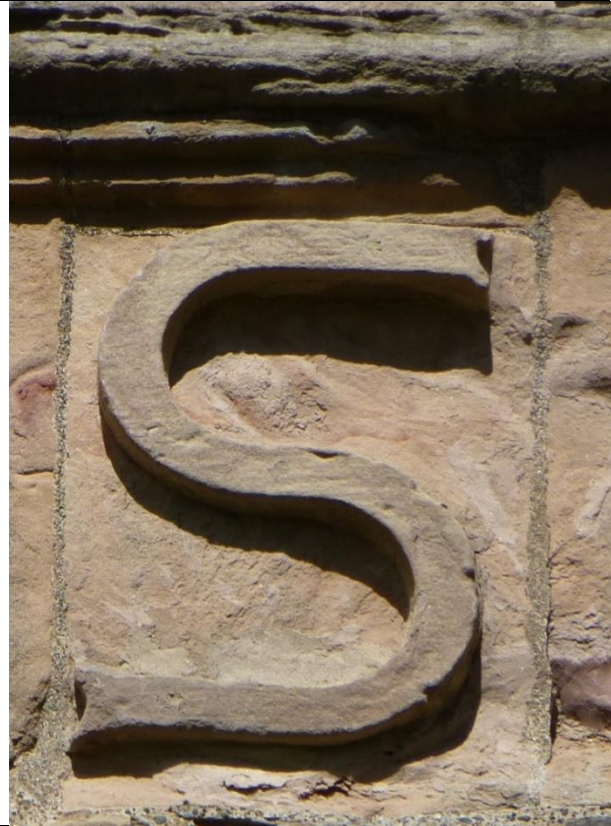
S - replacement letter, failing repair to lower edges. The background is disaggregating and has been heavily repaired with resin mortar in the lower part where it is failing.

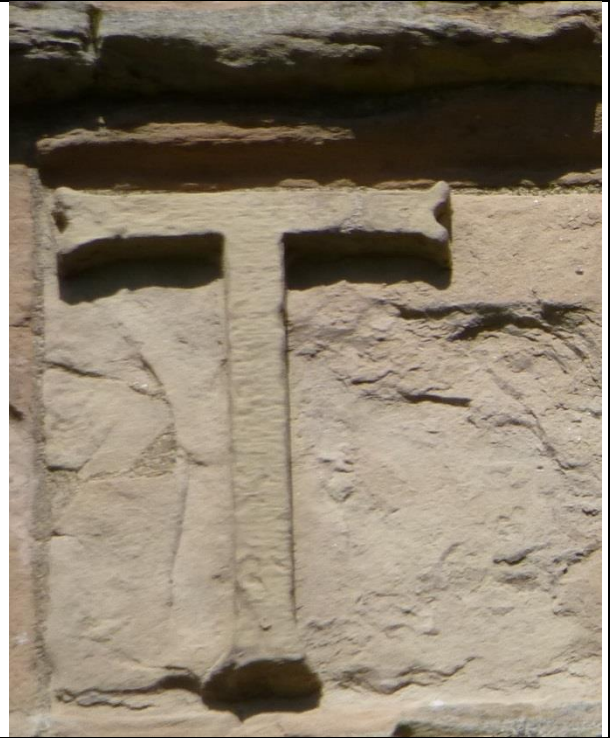
T - replacement letter; area to right of letter is very eroded. Delamination of stone background has led to considerable surface loss in the past. Edge pointing, where still present, is discoloured and failing. New areas of decay have opened up, particularly in the centre of the stone. The left side has been previously repaired with cement which is still in place. Fading resin repairs are visible in the lower left corner.
