# HUNTLY CASTLE

## Survey of stone frieze and other ornamental stone

**September 2015**

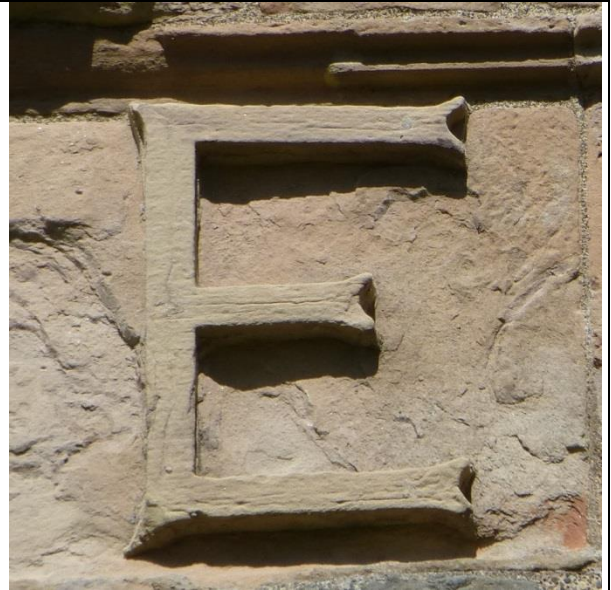
E - replacement letter; delamination of stone background has led to considerable surface loss in the past. Edge pointing, where still present, is discoloured and failing.

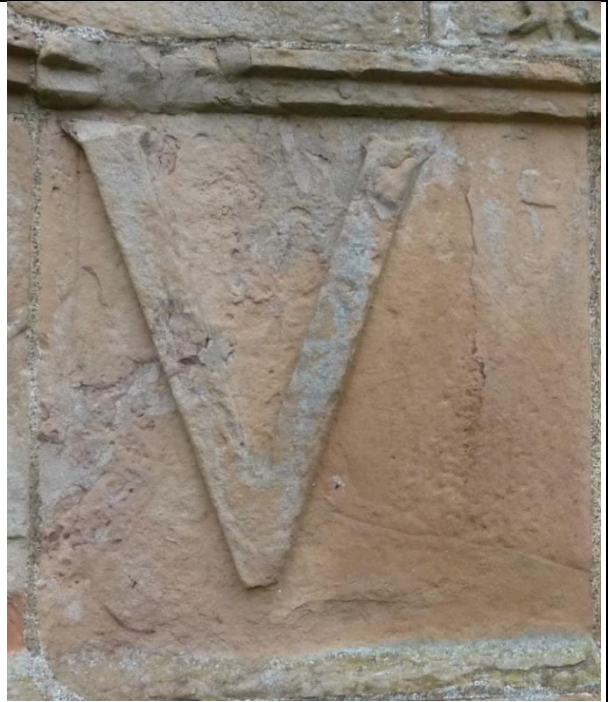
V - Vertical delamination on right side. A band of mineral inclusions has been preferentially eroded from bottom left to top central section, resulting in surface pitting. Previous resin mortar fills are now failing and discoloured. Cracks in top right corner of letter and central left side.

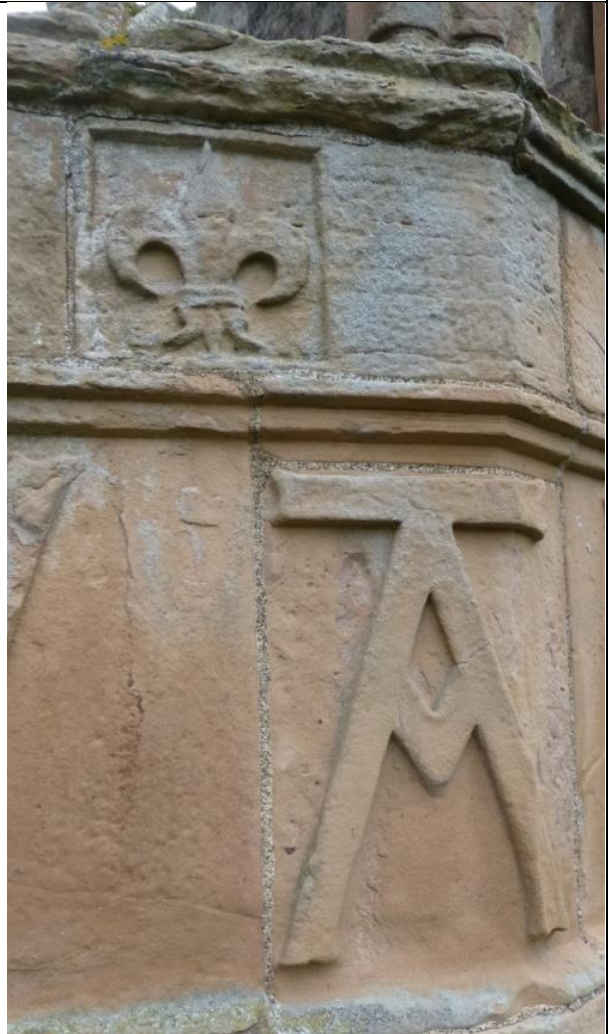
A - Crack on right side, disaggregating lower left area of central section.

Fleur-de-lis above – open bedding planes.

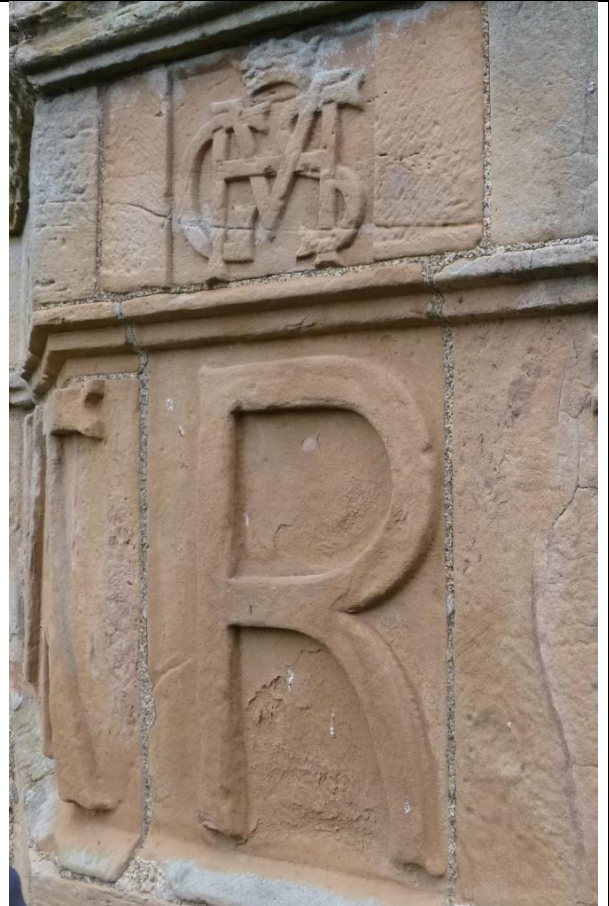
R - Surface blistering and disaggregation of central lower part.

Lettering above – Open bedding planes and a large dry would benefit from being pointed.

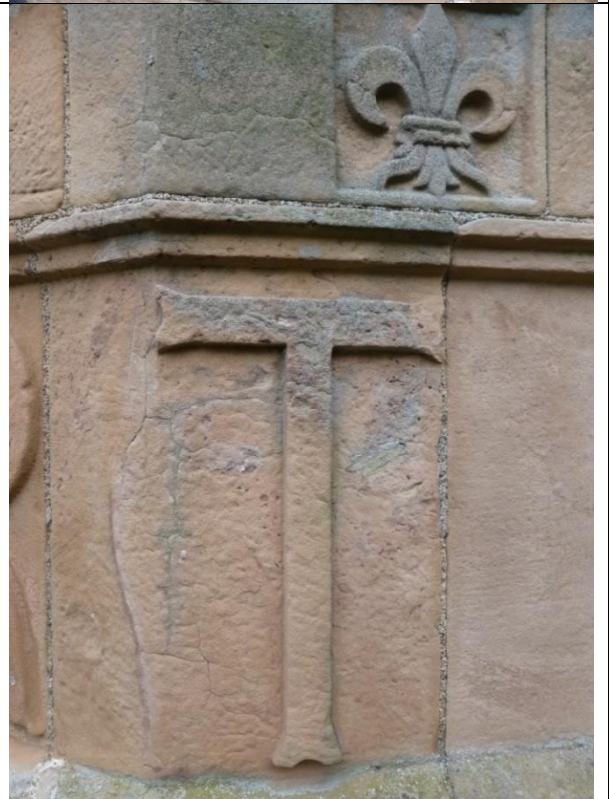
T - Disaggregating and cracked throughout and many surface areas are boss. Previous resin mortar pointing is partially missing.

Fleur-de-lis above – open bedding planes.

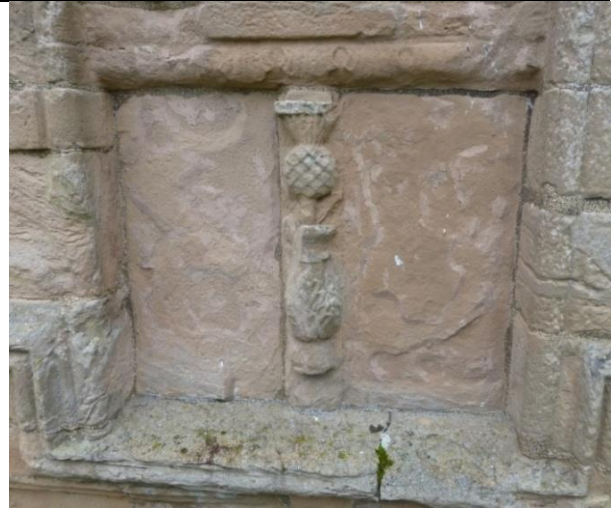
Thistle above 'Stevart' - An area of decay is visible in the centre of the top moulding of the (missing) panel above the thistle. Missing pointing here. The panel of the thistle itself has been extensively resin mortar pointed in the past with many of the repairs now failing while others are still in position but faded and unsightly. Boss surfaces were detected in many areas. The left side of the thistle has been extensively repaired in the past whereas the right side is in good condition. The eroded ends of the moulding above the thistle have previously been heavily resin mortar repaired while the central section is missing. The stringcourse below the thistle is eroded but appears stable.

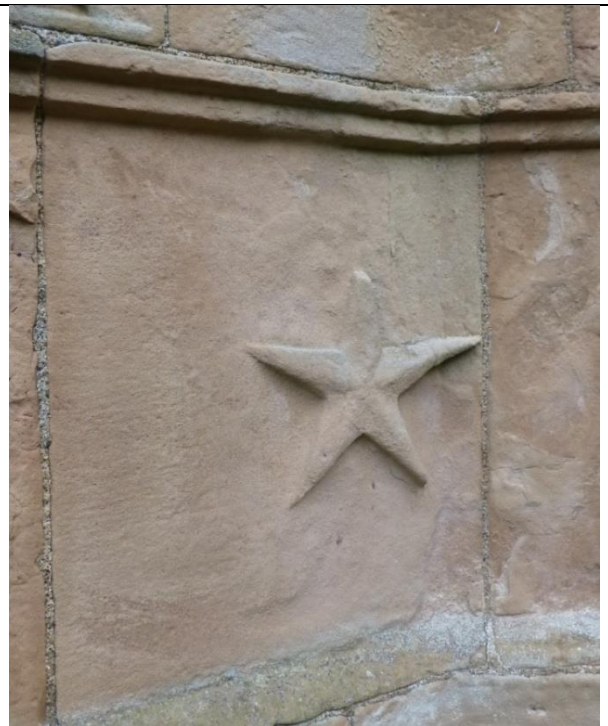
Star after 'Stevart' - some surface erosion and minor surface flaking, particularly on right side.

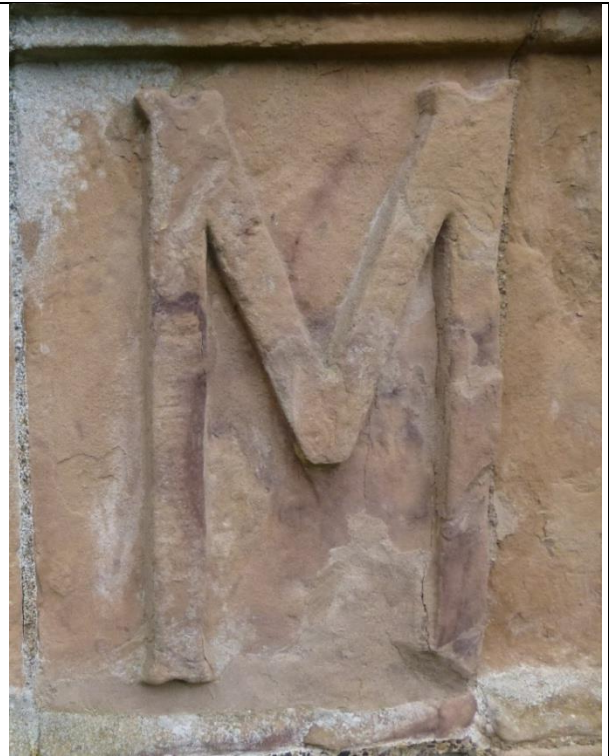
M - Heavy resin mortar repairs are starting to fail now with cracks opening up at the edges.

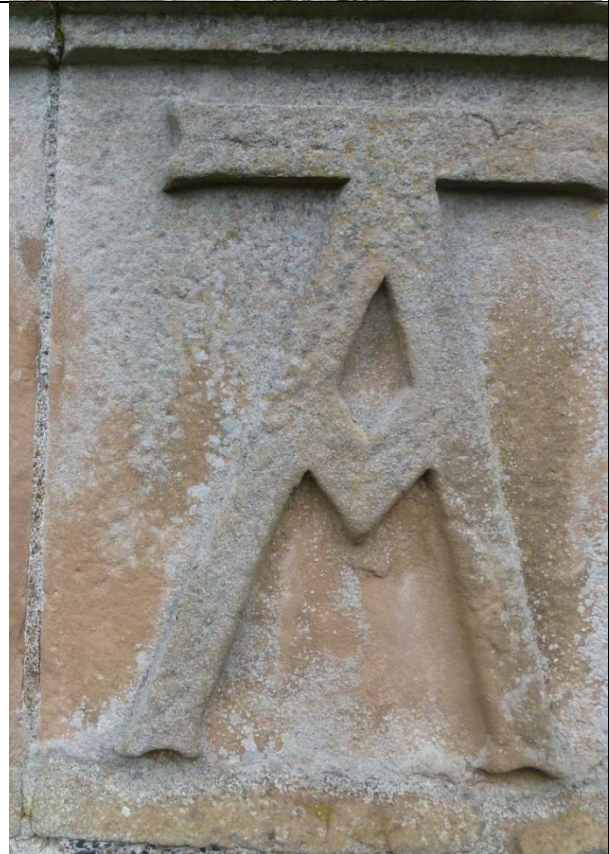
A – Suffers minor disaggregation below the cross bar.

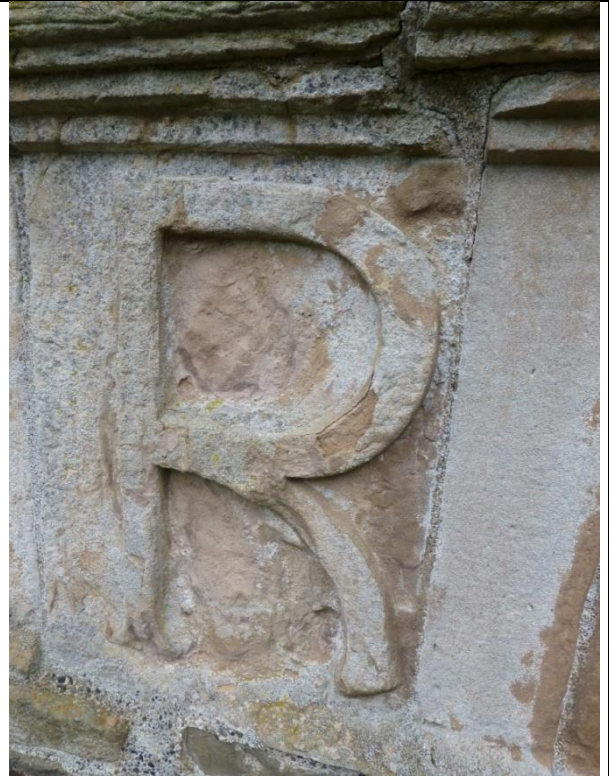
R - Appears fragile in spite of being heavily repaired in the past, particularly the middle section where surface losses have previously occurred and old resin mortar repairs are now failing.

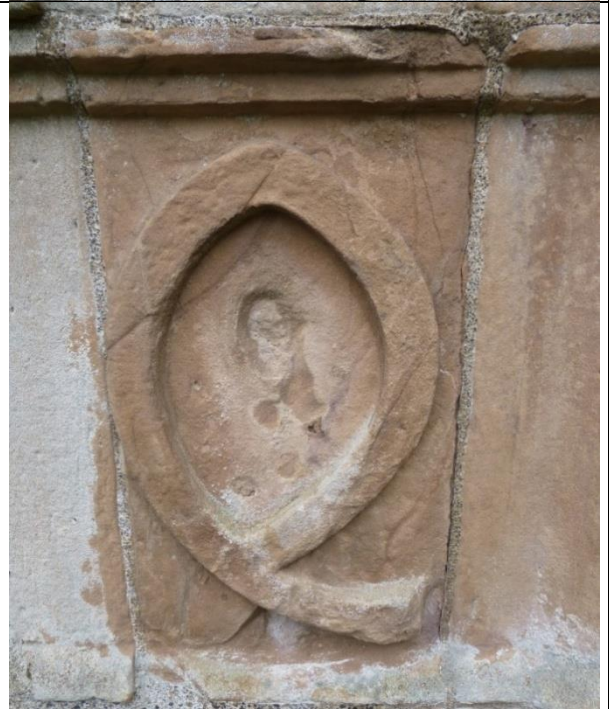
Q – Extensive old resin mortar repairs are evident which are mostly still in position but have started to lift away from the surface near the bottom edge.

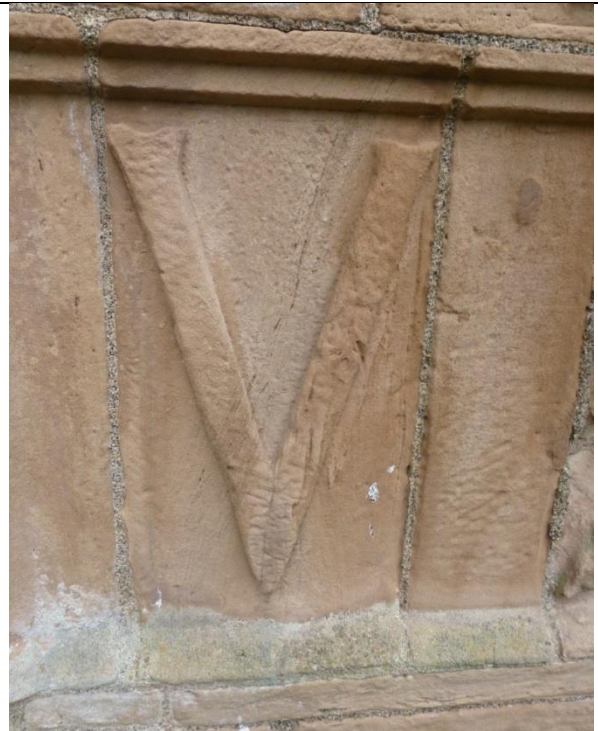
V – Disaggregating on right side. A dry appears stable.

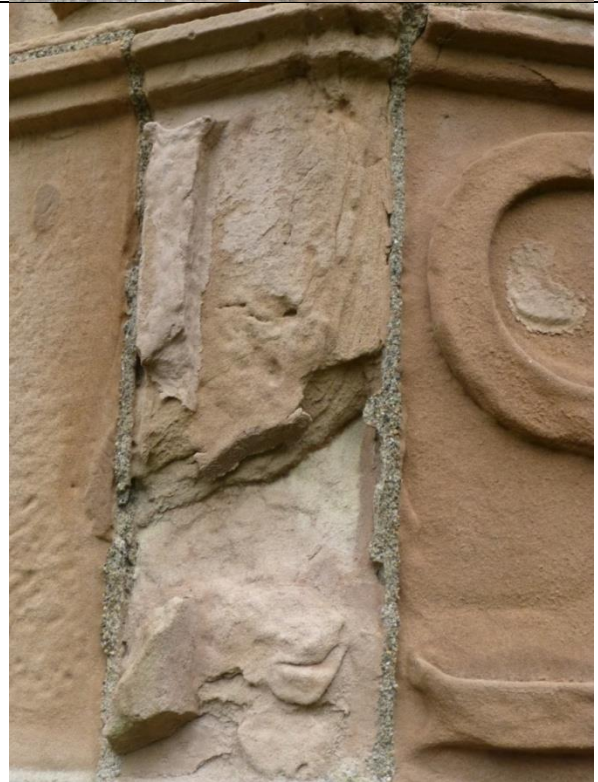
I - mostly missing letter and very decayed stone, suffering deep delamination of lower part which is very soft and displays open delamination and failing resin mortar repair edges.

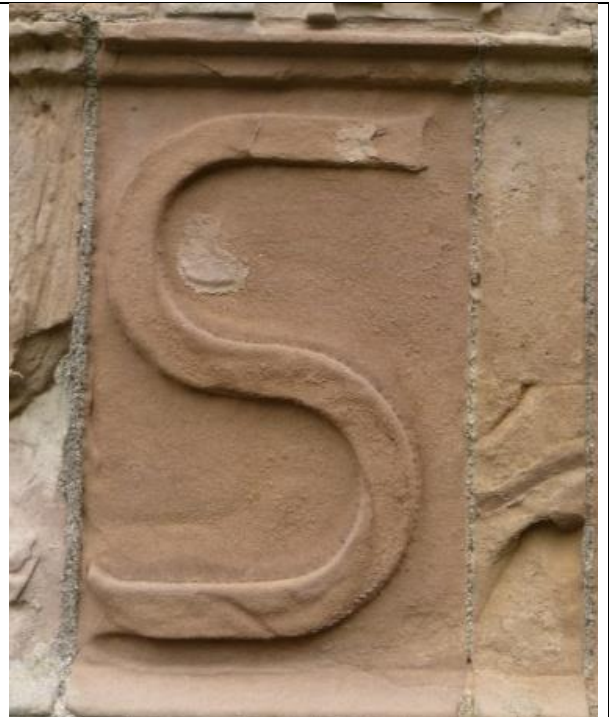
S - Delamination at top of letter. Minor opening up of small old resin repairs; disaggregating surface. Lower section of adjacent small stone is deeply eroded.

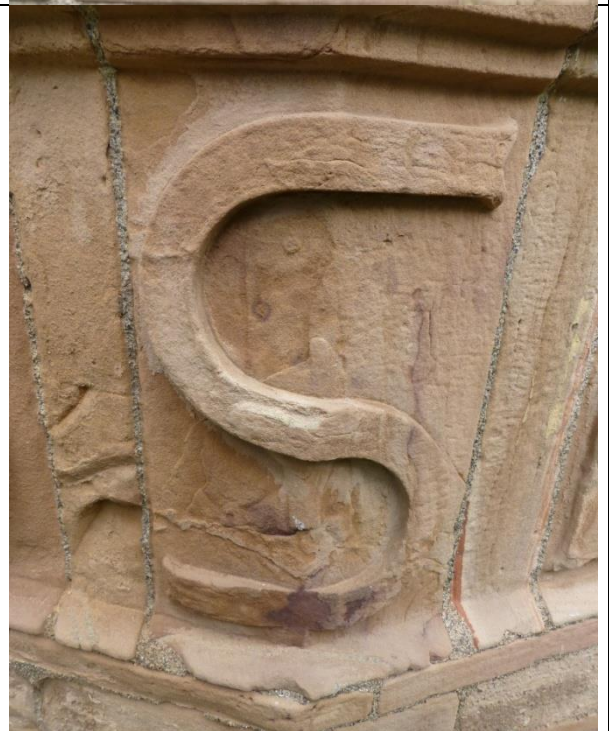
S - old repairs still visible but starting to fail. Fissures and areas of disaggregation are evident.

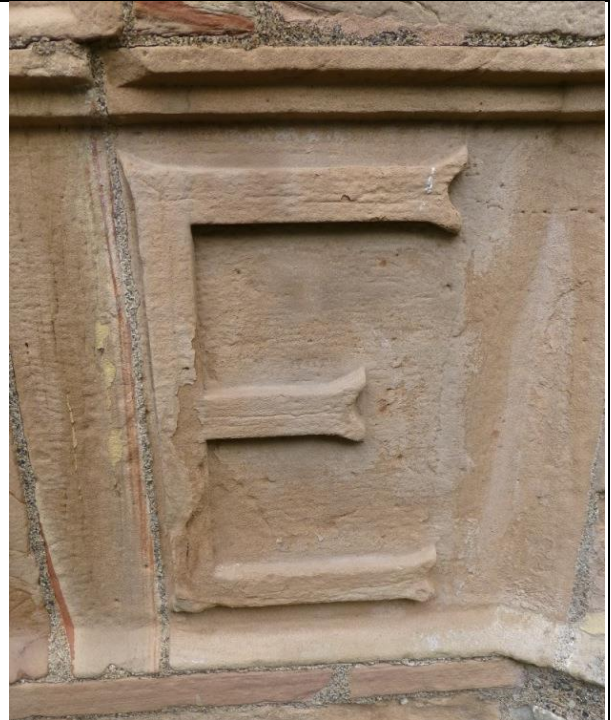
E - fissured and scaling (exfoliation) in places, particularly on lower part of vertical bar.

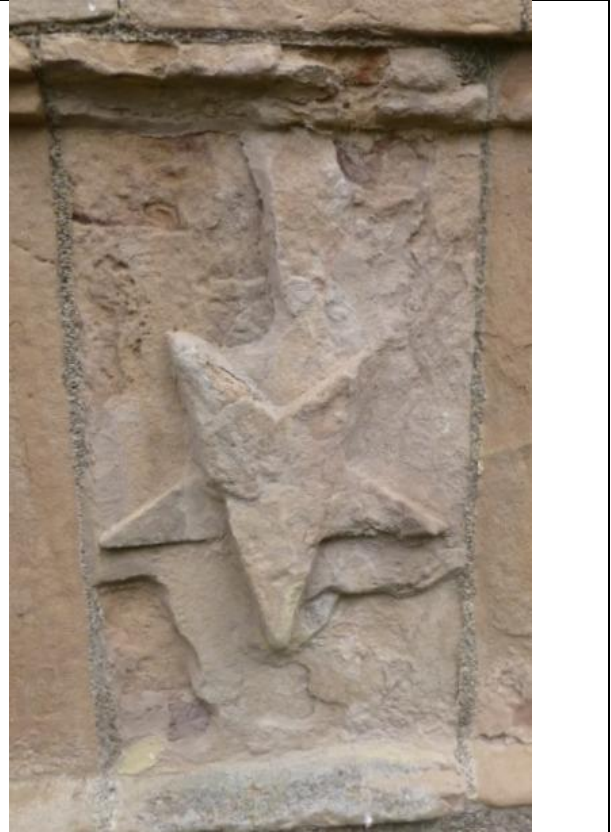
Star after MARQUISSE - Much of the original background surface is missing, the stone has been extensively repaired in the past. Heavy resin mortar edge pointing is now failing. The upper part retains original background surface but has lifted away from the substrate. The star is fissured at the top and its right side is disaggregating.

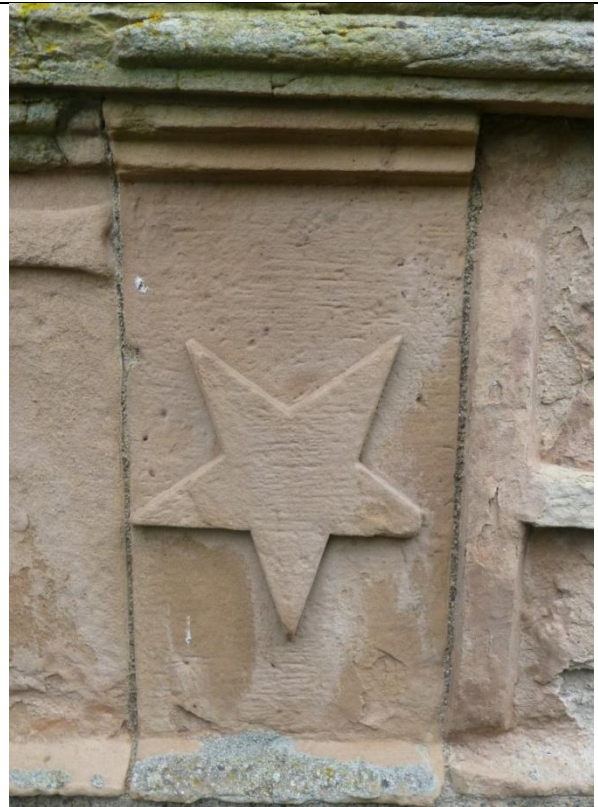
Star after 'of' – Minor disaggregation of lower part.

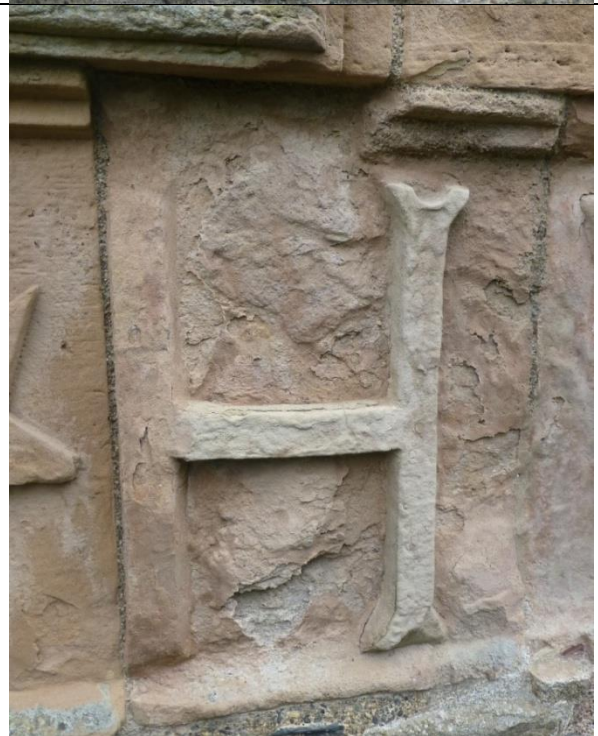
H - The background of the stone is delaminating and blistering while also being covered in extensive resin mortar repairs that are now failing. A large area in below the cross bar has lifted from the surface and is very fragile. Only the left vertical bar of the letter is original, the rest has been replicated in the past. The pointing mortar is failing around the replicated areas.

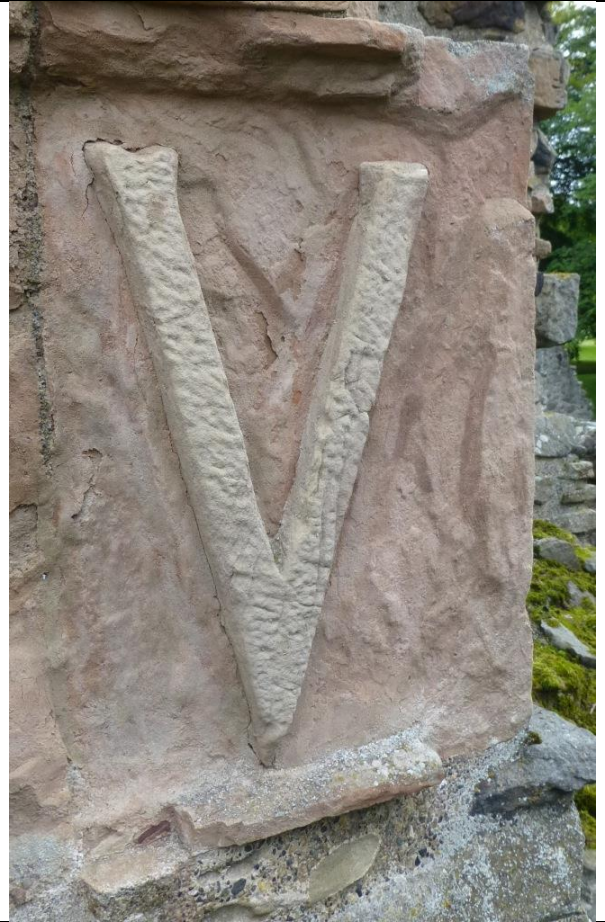
V – Replica letter with previously consolidated background where (extensive) repairs are still in place but now failing, particularly on the left side. The remaining letters and frieze is missing.

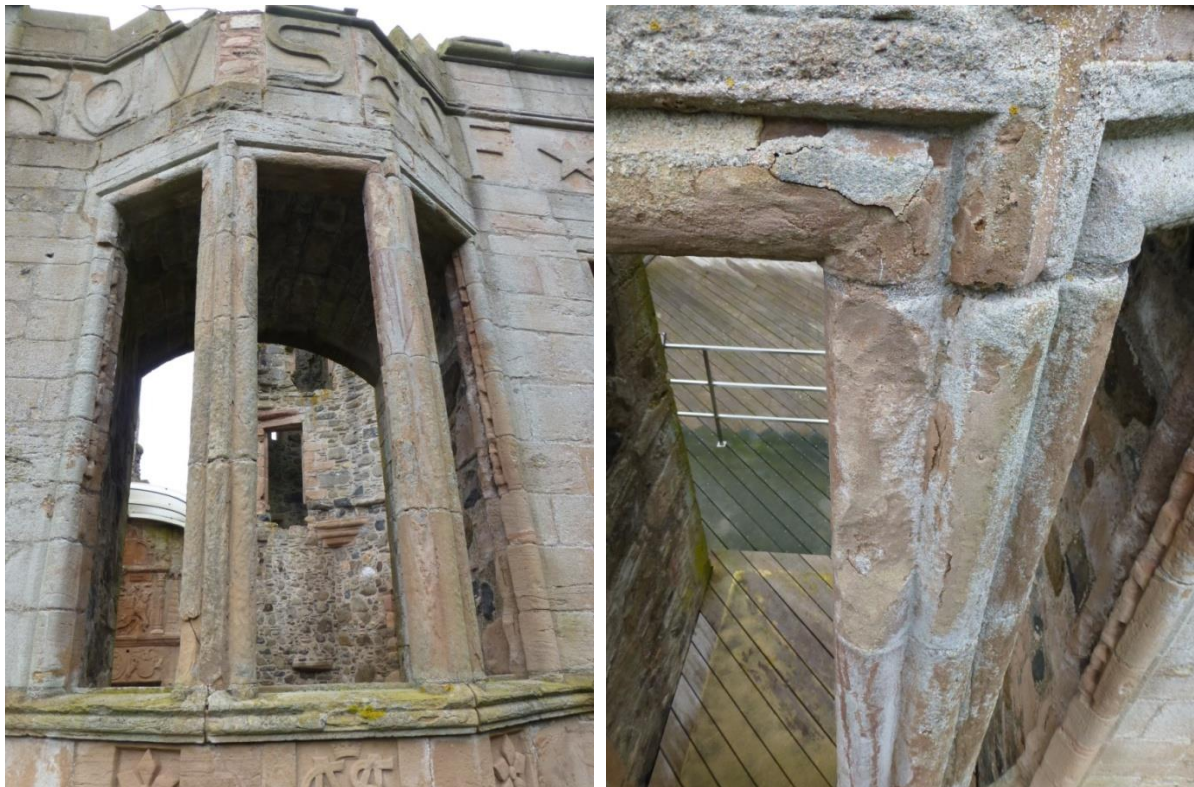
East bay window

Bay window furthest east: The mouldings have been extensively repaired with acrylic mortar in the past and these are now beginning to fail with some opened up to water ingress and potential entrapment already. Many areas are very fragile, particularly the top moulding which requires urgent repair. The mullions are very decayed and have been heavily repaired with resin mortar in the past which is now failing. The sill is cracked.

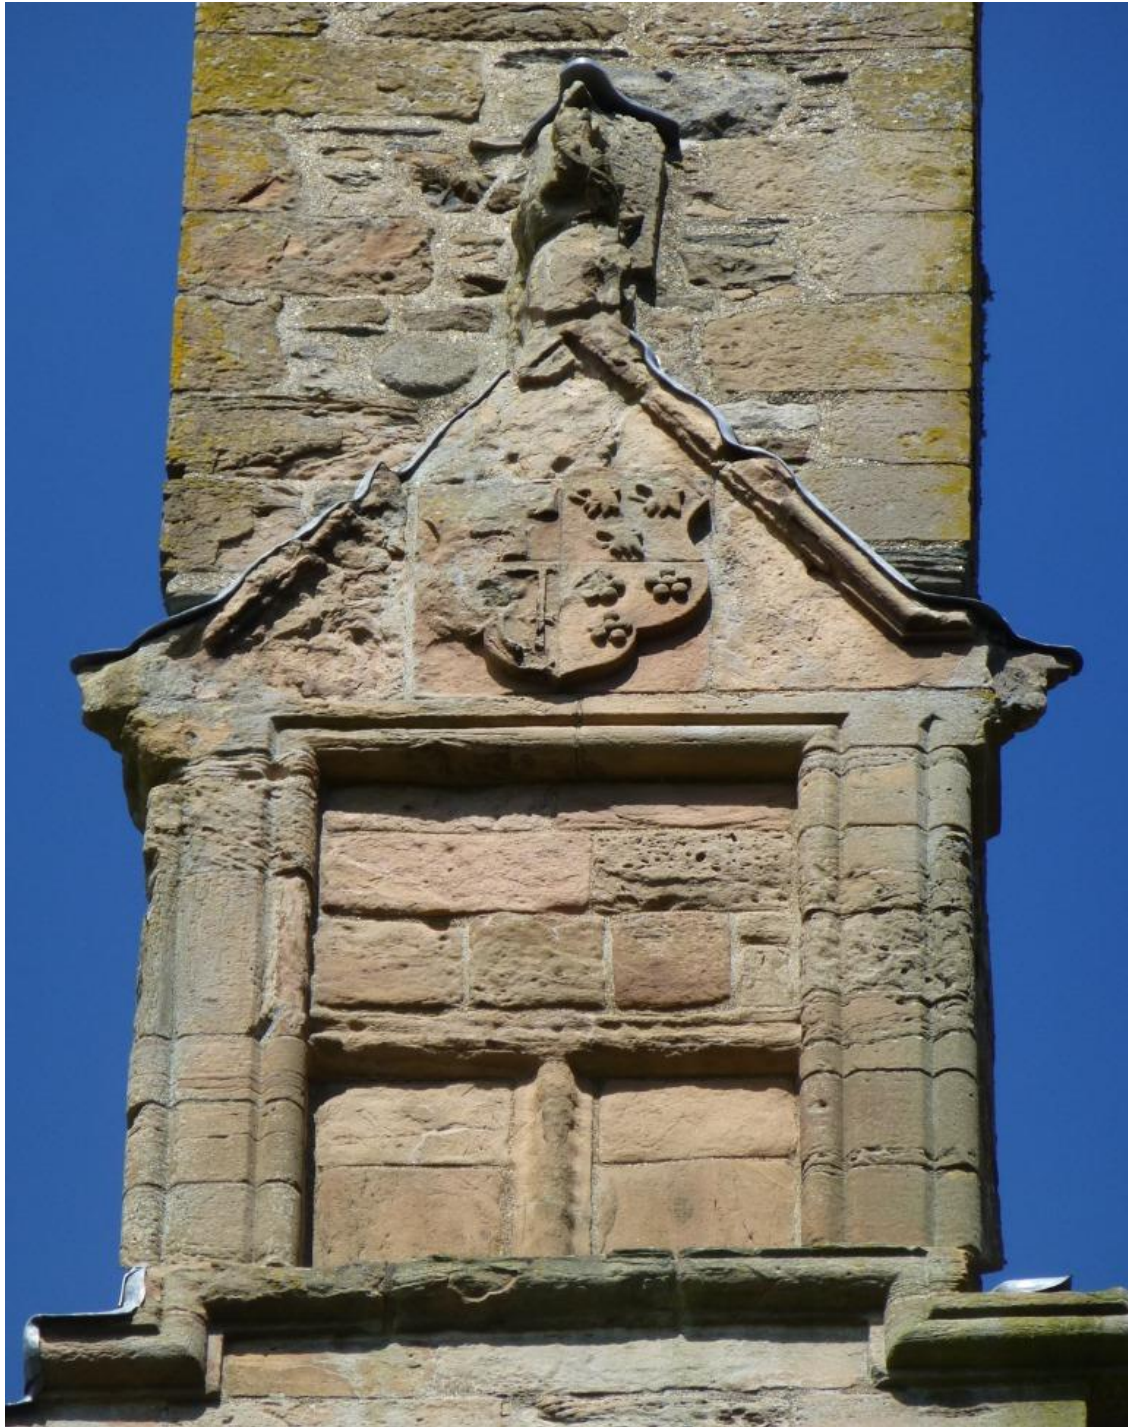
### 2.3 Gablet above 'GORDON':

The gablet could not be reached during the 2003 works. It suffers severe decay to its left gable as the pediment architrave here is eroded and not protecting the stone below. While the surface has been lead covered to prevent direct moisture ingress, this is not extended out far enough to shed water away from the carved detail below. As a result not only the pediment detail here but also the lower mouldings and sill have suffered increased surface decay in the form of open bedding planes, fissures, surface scaling and erosion.

The top sculpture is much eroded and cracks are visible on right side, in spite of lead flashing above it. Most of the top of the pediment has lost a substantial thickness of its surface through delamination. The left panel is very eroded and delaminating but nonetheless, old resin repairs remain visible. It appears fragile. The centre left side of the armorial panel is much eroded due to the missing stringcourse above. The right hand side is in much better condition. The moulding and sill below the left side is eroded along the bedding planes due to water run-off. Failing old resin repairs remain visible along open bedding planes. Extensive surface scaling on the moulding at the base of the gablet has been previously pointed.

The flashing on the left side of the gablet should be extended to prevent water run-off down the face of the pediment. Similarly, improvements may be possible to the flashing along the wall head where channelling of rainwater has led to local acceleration in surface erosion.

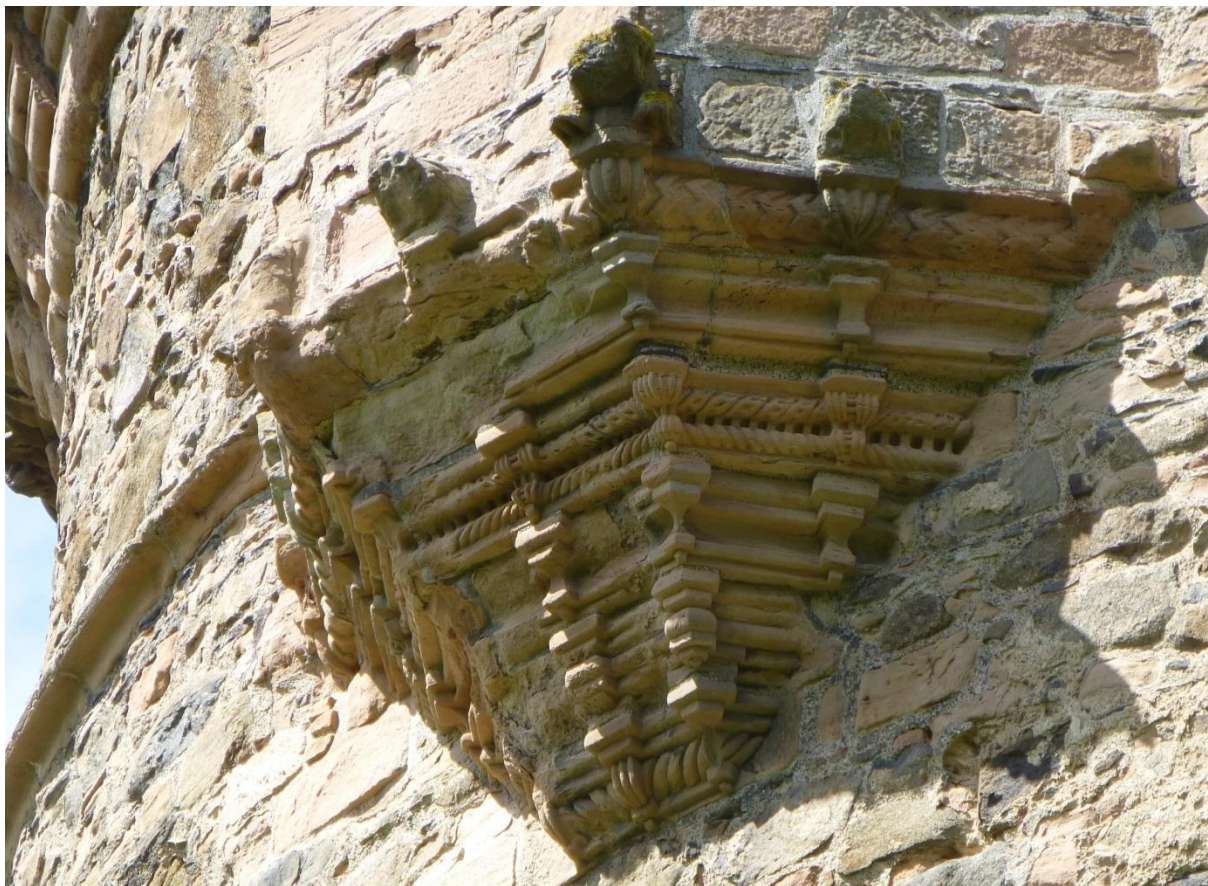
Oriel Window of South tower – east face

East face: The chevron moulding at the top is disaggregating on its right side whereas an area of delamination is visible on the left. Old repairs remain in situ on the moulding below. Further repairs are required, though, and surface losses have occurred since these repairs were carried out. A thick cement band of grit pointing has been applied below. The two rope mouldings below suffer open bedding planes, particularly the lower one. Similarly a stepped concave moulding below displays open bedding planes. A triple stepped moulding below is boss on its right side. A small area of delamination is visible on the base.

Areas of surface delaminations, cracks and fissures which have led to surface detachment need to be re-adhered through the localised injection of 2.5. – 10% Paraloid B72 in acetone. Conservation treatment may also require the re-adhesion of loose fragments with thixotropic polyester or reversible acrylic resin where possible. This is likely to particularly apply to the corbelling below the Oriel window which appears very fragile in many areas.

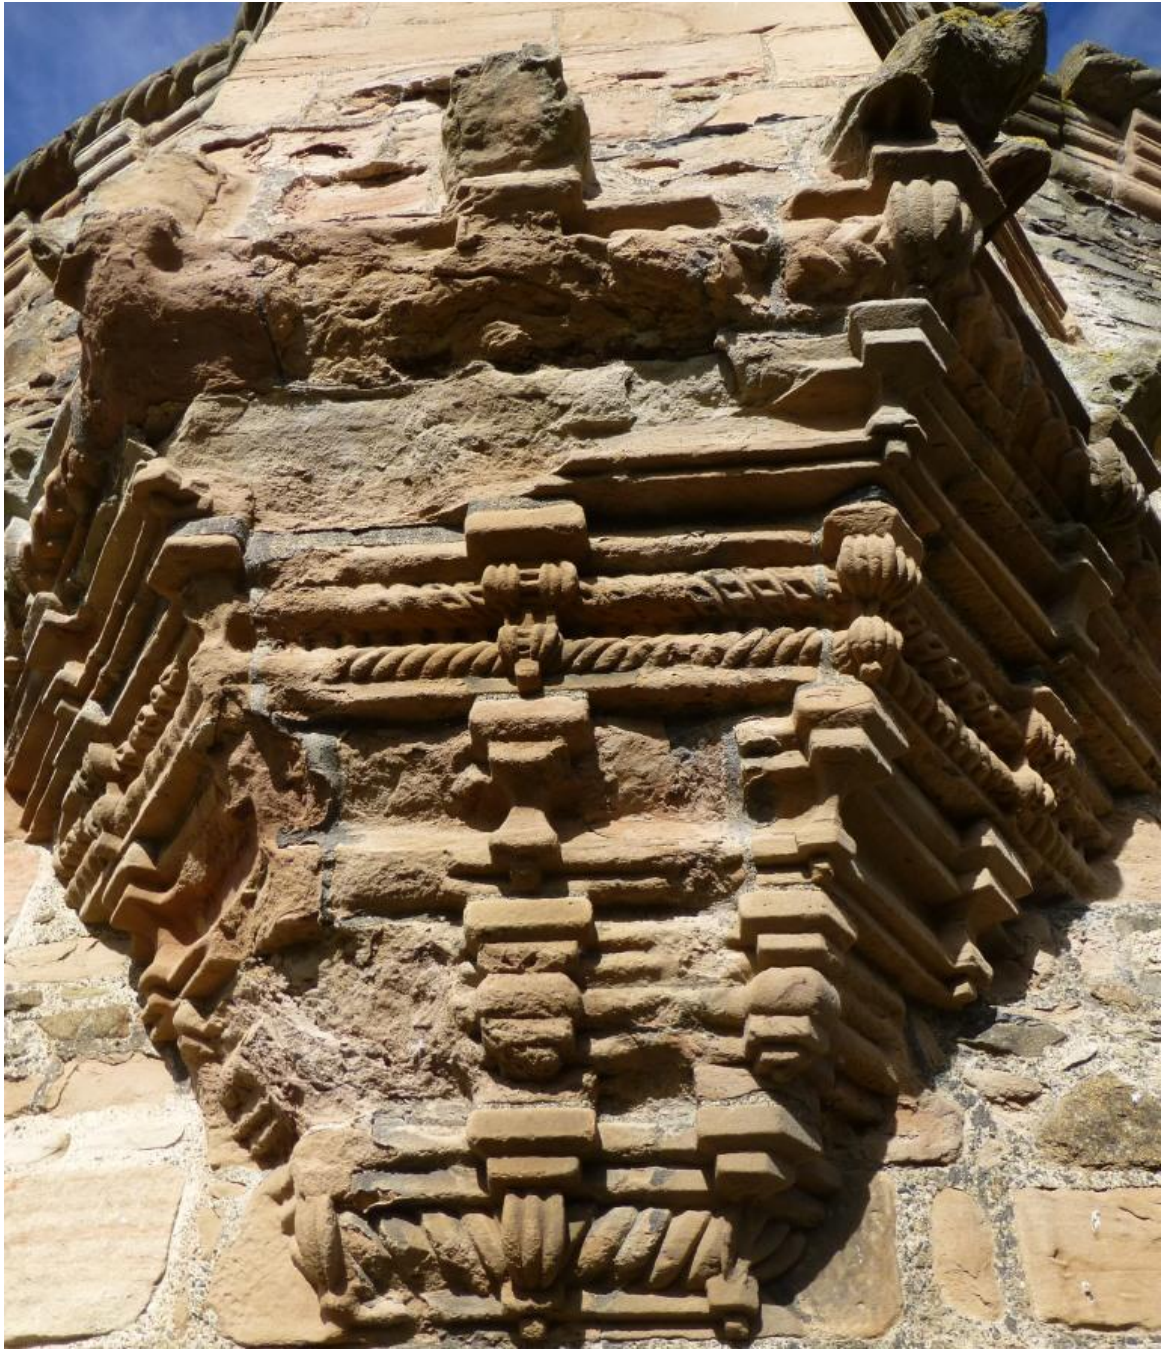
Oriel Window of South tower – south face

South face (front): The top moulding has lost all detail apart from the chevron on right side which is detached from its substrate while the central part of this moulding is very fragmented. The moulding below is disaggregating and only retains detail on its right side. The two rope mouldings below are disaggregating on the left side and scaling on the right side. The stepped moulding below has been extensively repaired, almost rendered, in the past on the right side and this is now failing. The left side is disaggregating. The stepped moulding below has lost much of its surface and salt crystals are visible on the right while the left side is disaggregating and has lost all detail. The left side of the base moulding is missing and minor scaling is visible on the right side. Three stone courses above the corbelling (front face) are deeply eroded. The left and central gargoyle are cracked.

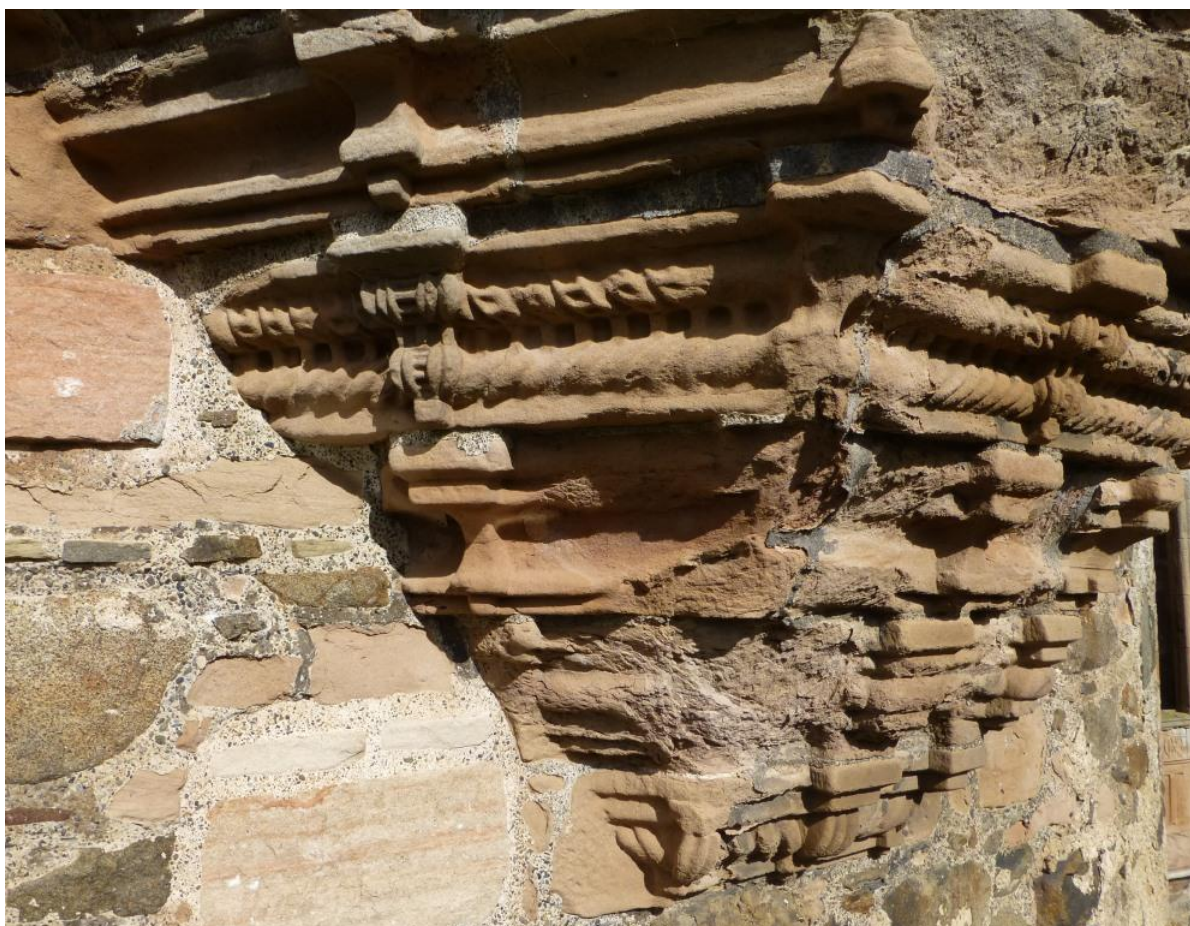
Oriel Window of South tower – west face

West face: The far left chevron moulding and lower part of the moulding and gargoyle above are cracked and at risk of loss. Nonetheless the stone retains most of its moulded detail. Cracks are visible on the right side of the chevron moulding and small areas of disaggregation on its left underside. The concave moulding below appears stable apart from its boss right side. The rope mouldings below appear stable whereas the stepped moulding below that is eroded on its right side. The lower step moulding is almost completely missing, only retaining traces of its far left side. Thick salt crystals are visible near the front corner and one loose surface area here had to be removed for safety reasons. The moulding below is eroded and a crack is visible on the corner detail.
