The Chesters, Drem, East Lothian

Erosion Survey

Rampart Scotland Project 002:

Season 4

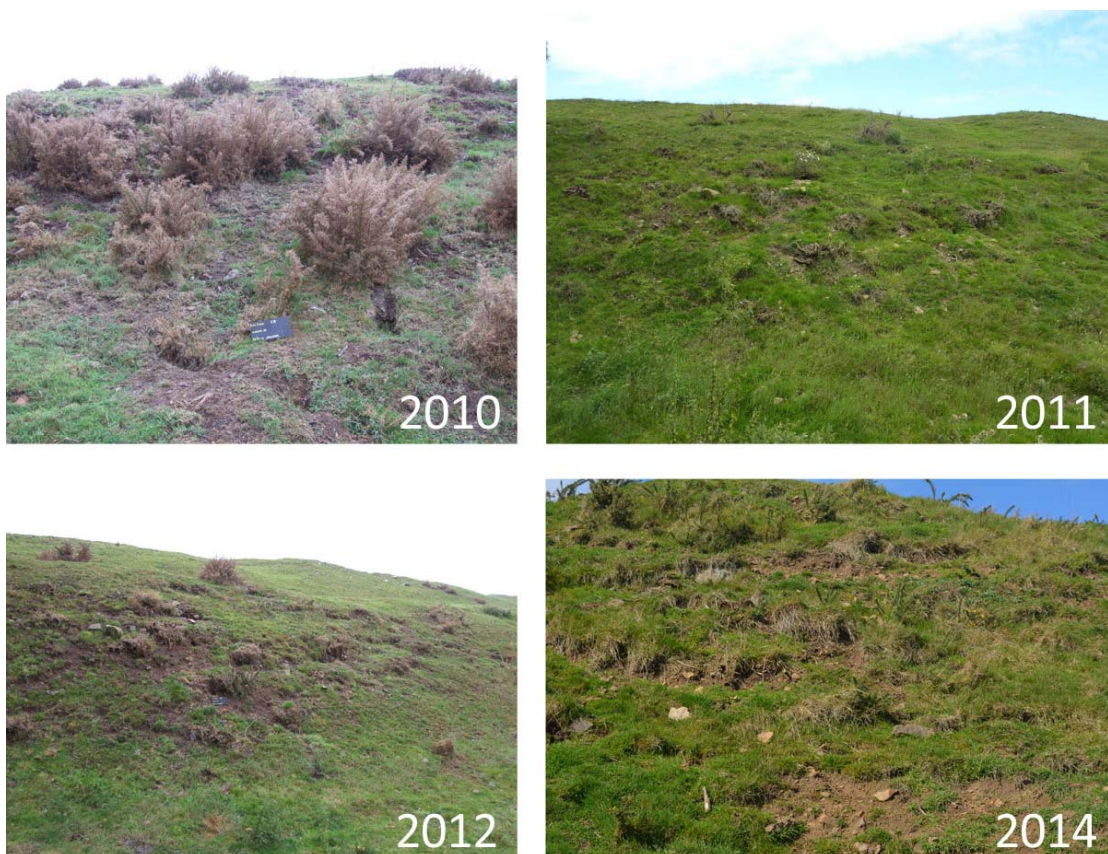
- 7.4.2 The nature of management is clear when studied over a number of years. As seen in plate 5, below, the initial cutting of gorse exposed the slope to erosion and although there was a period of repair to the rampart slope the recolonization by rabbits soon grew to levels where the area was compromised, and introduction of cattle to prevent gorse regrowth also resulted in trample and further deflation and slumping.

- 7.4.3 Initial removal of gorse should be followed up by regular continuous assessment of the various issues in a quick walkround, that can provide an overview of potential new threats to the site. It is clear from this location that the gorse – though visually intrusive, has already damaged the surface as much as it can, while rabbit and animal tracks are far more destructive when allowed to continue unchecked.

PLATE 5: DAMAGE 47 - COMPARATIVE DAMAGE RECORD EXAMPLE

7.4.5 The current recommendation would be to provide monument wardens with a simplified system of recording erosion activity;

7.4.6 This can be updated on a yearly basis, allowing a more proactive approach to increased threat/damage and forming an ongoing process of data collection for a number of sites. Given that bracken and gorse will already have caused maximum damage that can be caused, the decisions on removal of this cover should be based on visual impact and visitor access, and this leads to a concomitant issue of maintenance and potential additional erosional activity.
