Job Title:
 1566: Fabric Repairs
 The Cathedral Church of St Machar,
 ABERDEEN

Drawing Title:
 Scheduled Monument Consent
 Site Plan, Suggested Drainage Repairs

Drawing Number:
 1566_L(SM)011

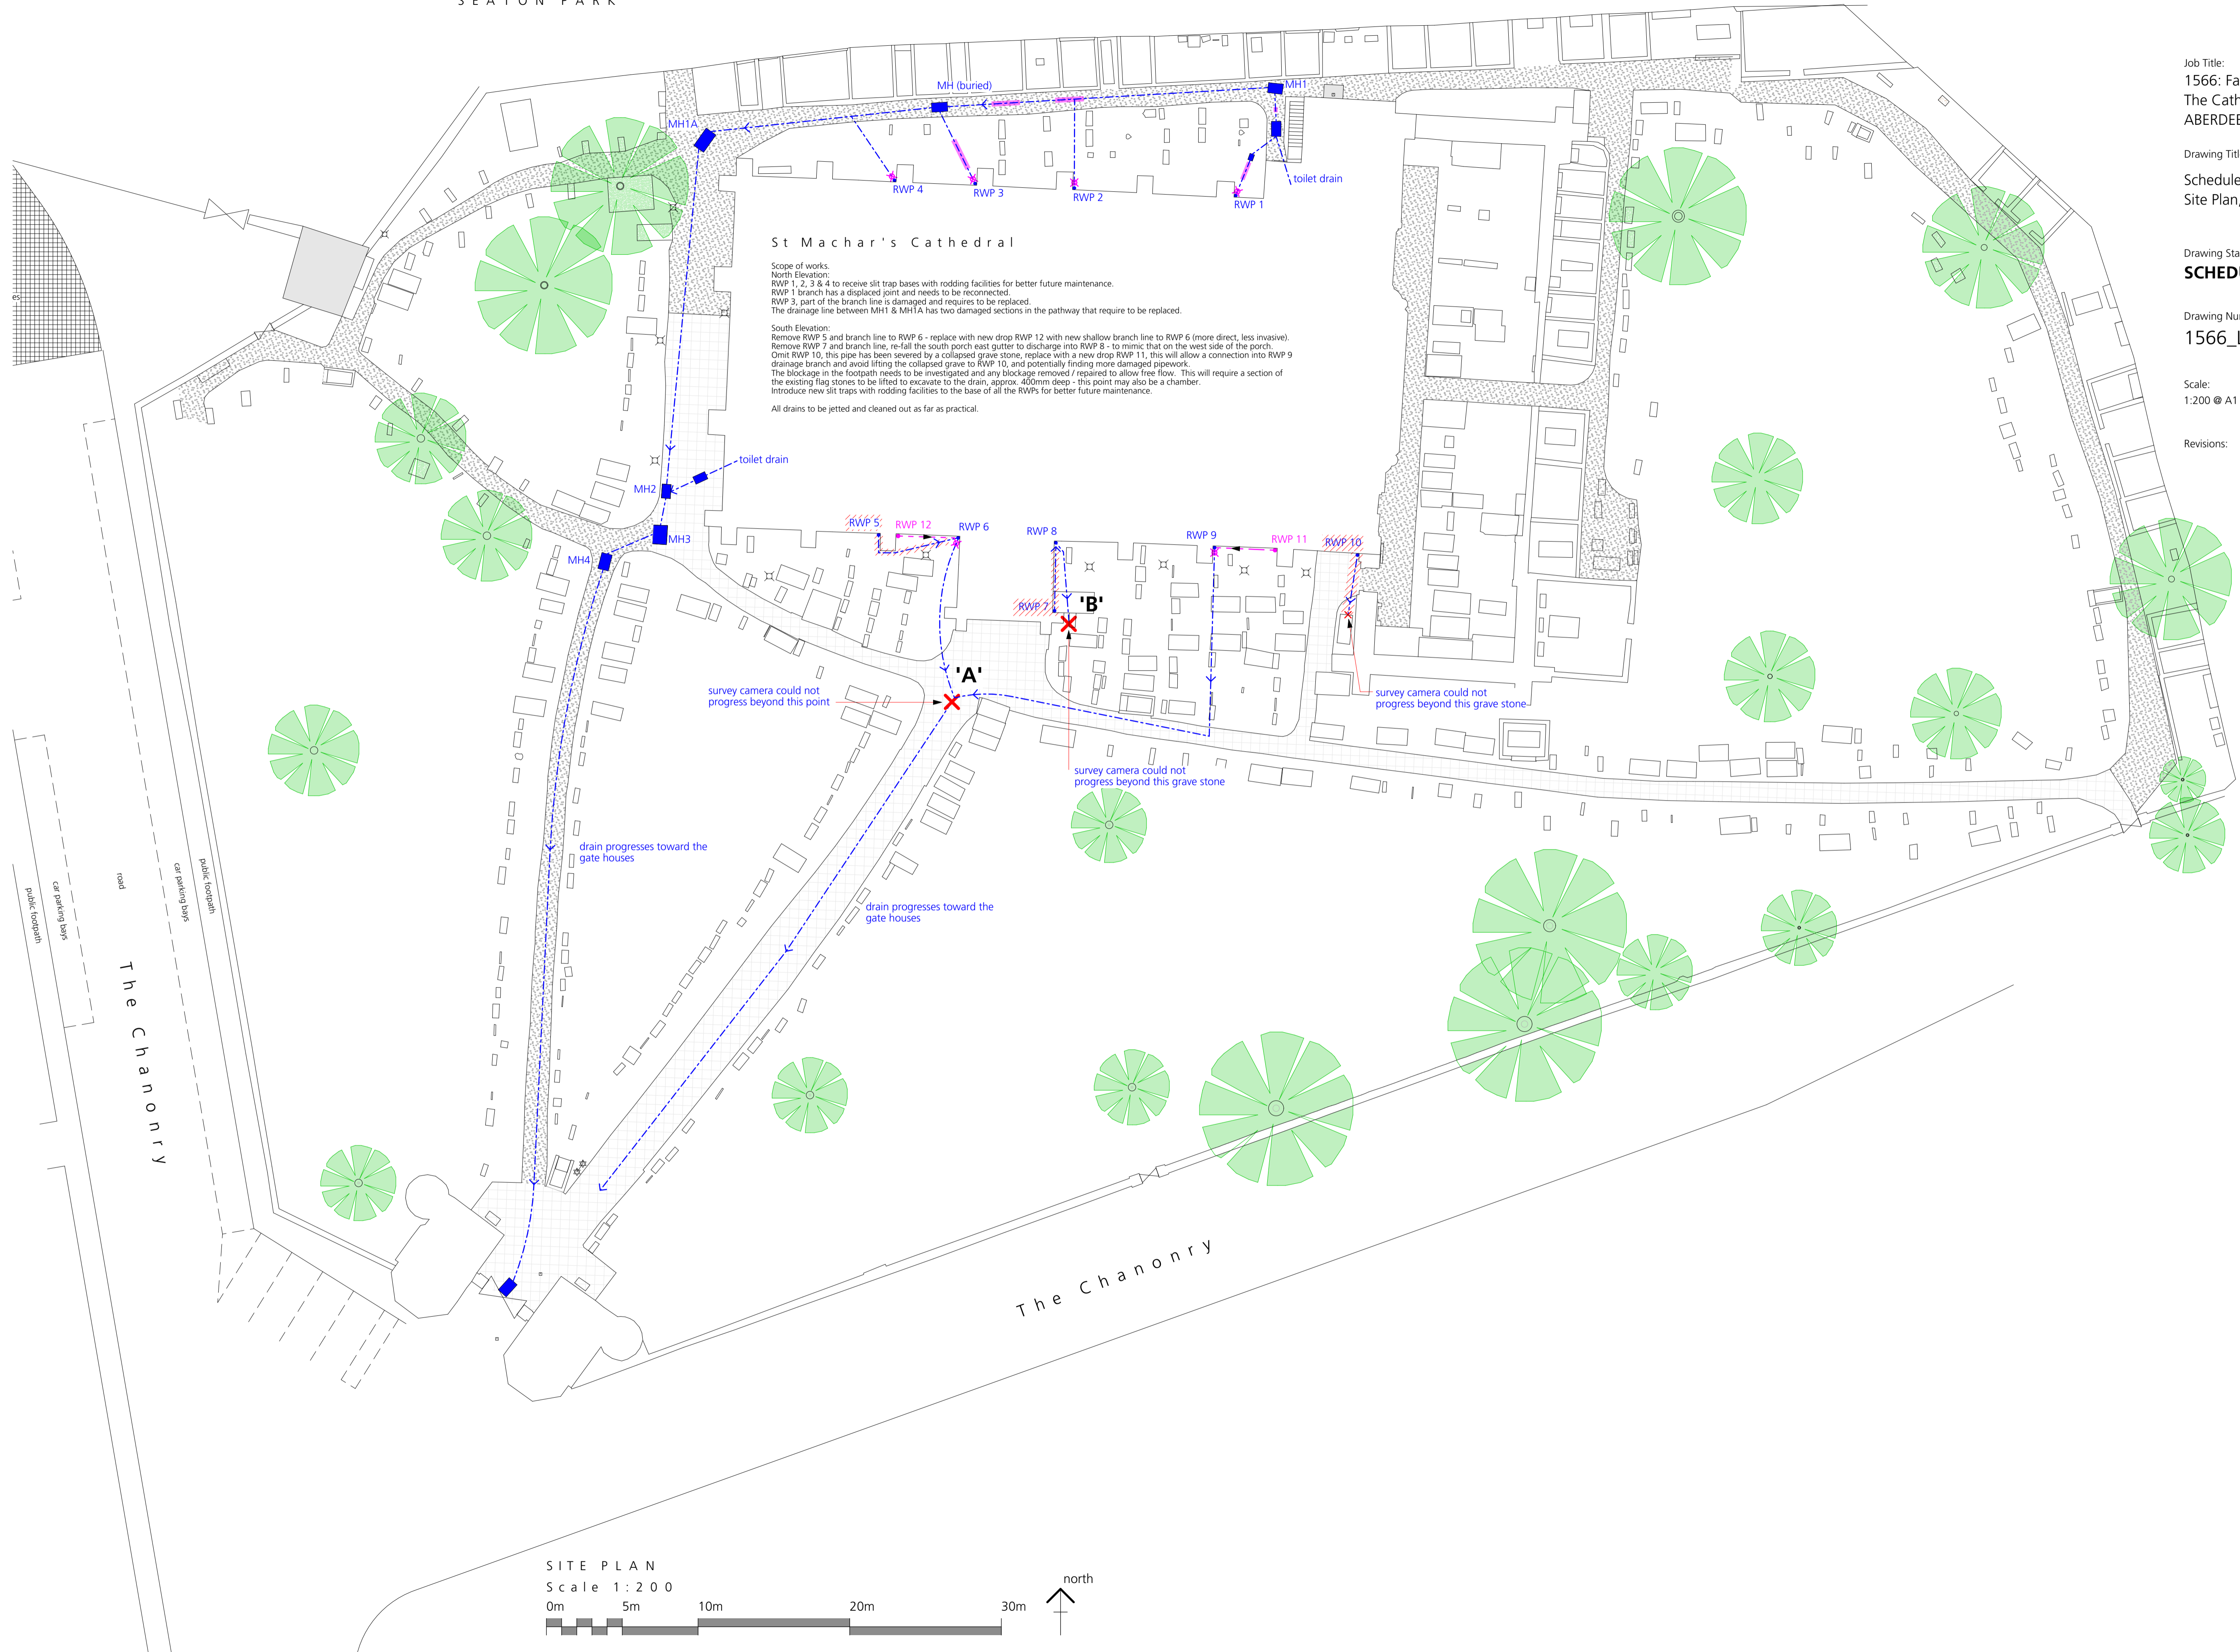
Scope of works:
 North Elevation:
 RWP 1, 2, 3 & 4 to receive slit trap bases with rodding facilities for better future maintenance.
 RWP 1 branch has a displaced joint and needs to be reconnected.
 RWP 3, part of the branch line is damaged and requires to be replaced.
 The drainage line between MH1 & MH1A has two damaged sections in the pathway that require to be replaced.

South Elevation:
 Remove RWP 5 and branch line to RWP 6 - replace with new drop RWP 12 with new shallow branch line to RWP 6 (more direct, less invasive).
 Remove RWP 7 and branch line, re-fill the south porch east gutter to discharge into RWP 8 - to mimic that on the west side of the porch.
 Omit RWP 10, this pipe has been severed by a collapsed grave stone, replace with a new drop RWP 11, this will allow a connection into RWP 9
 drainage branch and avoid lifting the collapsed grave to RWP 10, and potentially finding more damaged pipework.
 The blockage in the footpath needs to be investigated and any blockage removed / repaired to allow free flow. This will require a section of
 the existing flag stones to be lifted to excavate to the drain, approx. 400mm deep - this point may also be a chamber.
 Introduce new slit traps with rodding facilities to the base of all the RWPs for better future maintenance.

All drains to be jetted and cleaned out as far as practical.
