MONUMENT	ARGYLL'S LODGING
PROJECT	Corridor 2.05 and Room 2.07
Repairs to lower tie and rafter of roof truss-Methodology

PROJECT DRAWING NUMBER		PIC107-2021-CE-18A	
SCALE	As shown @ A3	Engineer	F Nanopoulou
DATE	13/10/2021	DRAWN BY	FN
ARCHIVE NUMBER

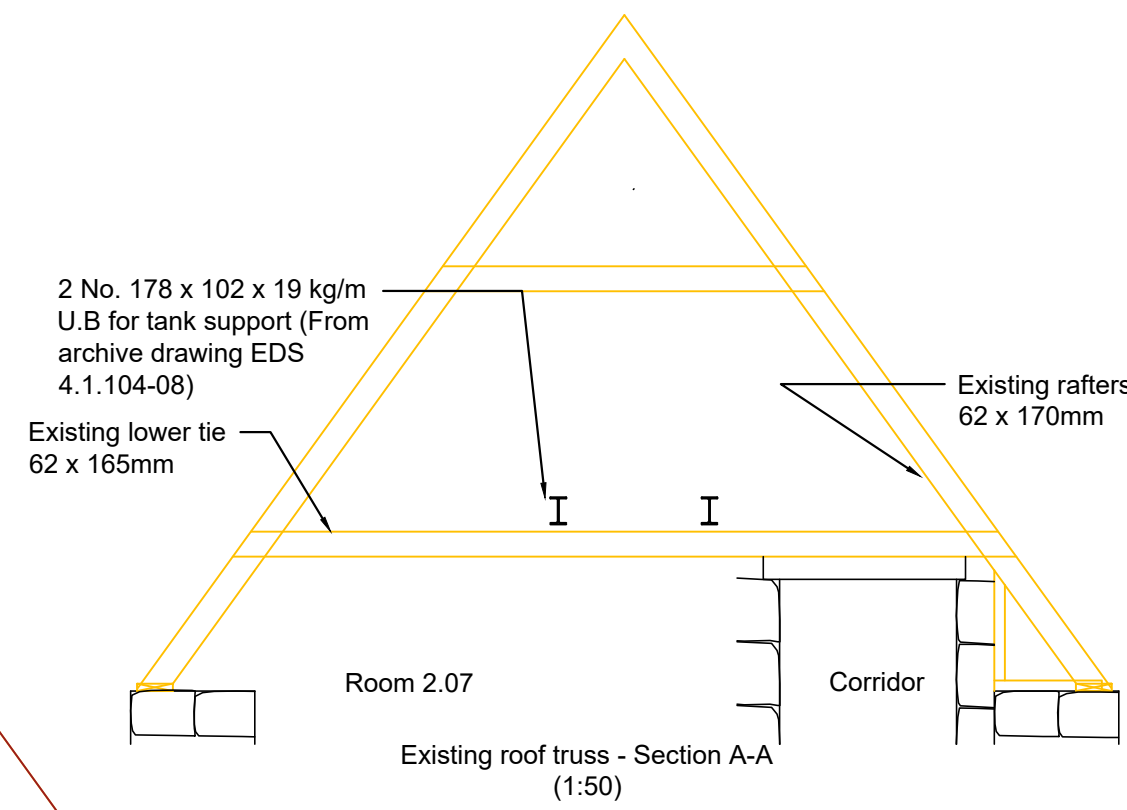
2. Existing tie to be removed as a whole and set aside. Tie to be examined for signs of rot at its ends. Ceiling is probably supported off tie in Room 2.07. To be ascertained if this is the case as plaster ceiling will have to be locally removed to allow for tie removal

- Methodology**
1. New temporary tie 62x165mm to be installed above existing (approx. 600mm above) as shown with red dashed lines. Connection of tie to rafter as per Detail 1

3. Rotten part of rafter to be removed and new timber piece to be installed butted against existing and notched in as in Detail 2. Prop rafter on each side of the rotten timber prior to removing it. Props to continue to first floor level (Similar propping arrangement as for lintels replacement-Drawing PIC107-2022-CE-21)

4. New splice steel plates to be installed along rafter as shown in Detail 3 on sound timber. Ensure centre of new bolts to be at least 100mm from end of rotten timber section of rafter

5. If timber tie is in good condition with no signs of rot, to be re-instated and connected to rafter on RHS as per Detail 5 and to LHS as per Detail 1. If timber is rotten at ends, replace it with same size timber Grade C24

6. Temporary tie can be removed
