RECORDING OF STEPS
DUNNOTTAR CASTLE
STONEHAVEN
ABERDEENSHIRE

Recording of steps

Carried out 16th August 2018

Report No: MAS 2018-19

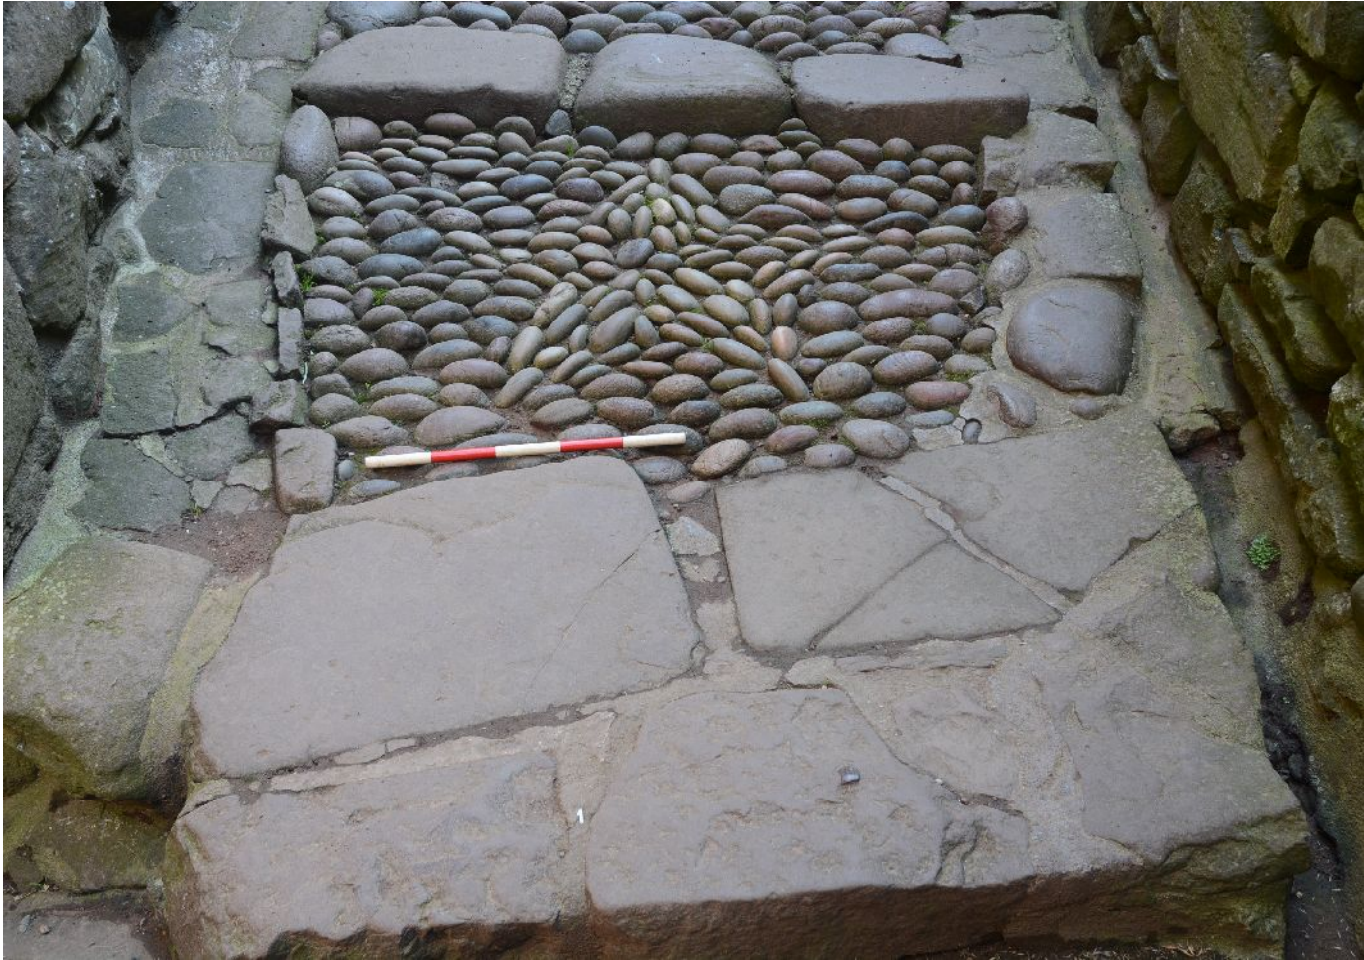
Illus 10 Step 1

Width across path	<1.6m
Depth along path	<1.85m
Rise from previous step	170mm

Description Small cobbles set on edge, with white stones used to form a central ‘star’ pattern c. 780mm across. The step is fronted by a double row of slabs, the inner line is of worn dressed stones and may be one of the occasional steps noted by MacGibbon and Ross in 1887, the outer line is of less worn stones and appears to be a repair. LHS Flat stones set in concrete form a rough drain with a rough infill of cobbles on this side. RHS a large waterworn pebble and two squared stones set in concrete form a rough edge.

The intention is to retain the fronting stones of the treads and it should be stressed that this should include instances such as Step 1, where a double line of fronting stones may include steps that pre-date the 1920s restoration.

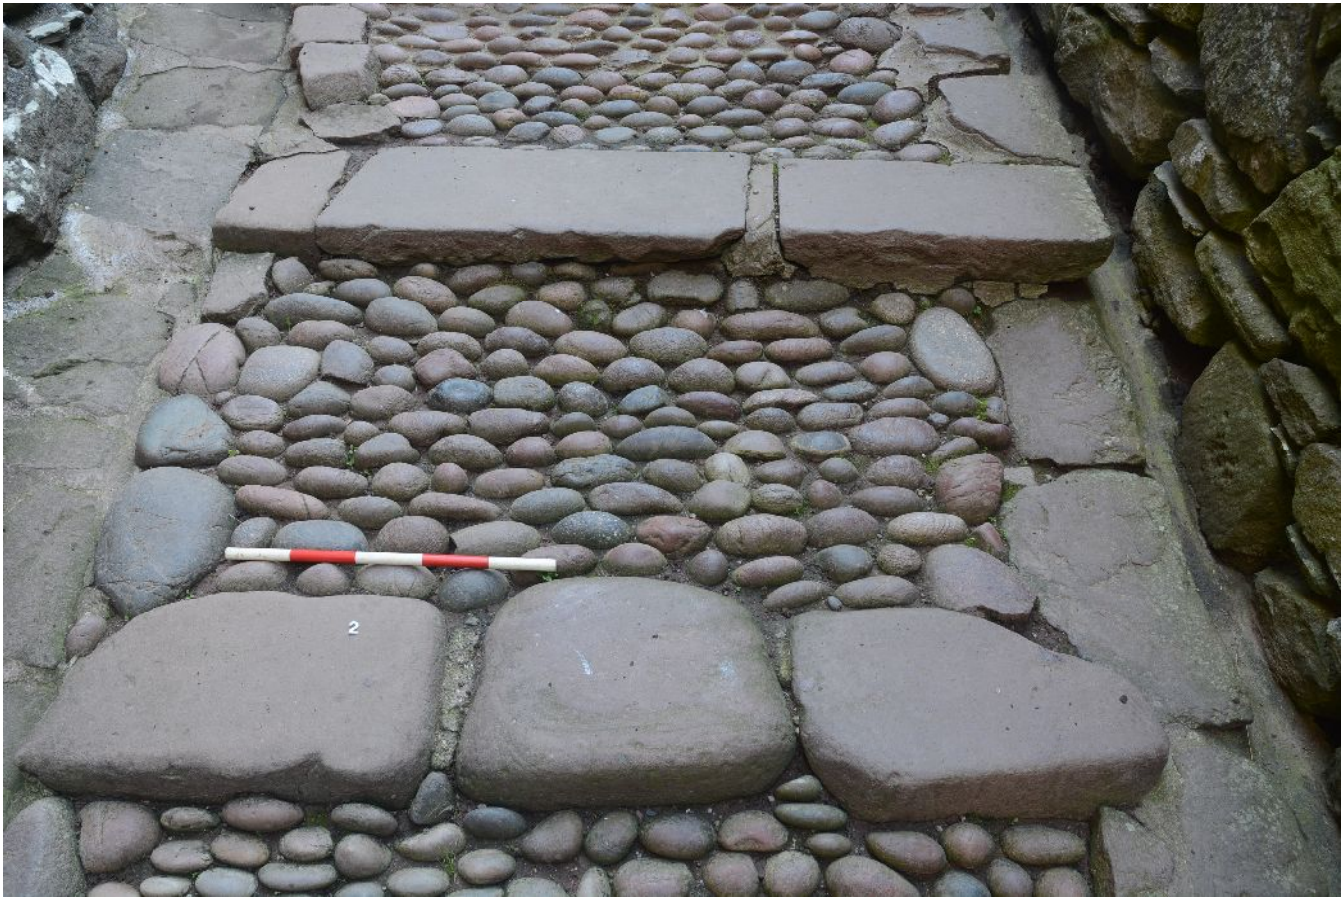
Illus 11 Step 2

Width across path	1.70m
Depth along path	1.02m
Rise from previous step	800-900mm

Description Small cobbles set on edge with the exception of a few larger pebbles at sides which may be repairs. The step is fronted by three large flat waterworn stones. LHS Flat stones set in concrete form a rough drain with a rough infill of cobbles on this side. RHS a two squared stones set in concrete form a rough edge.

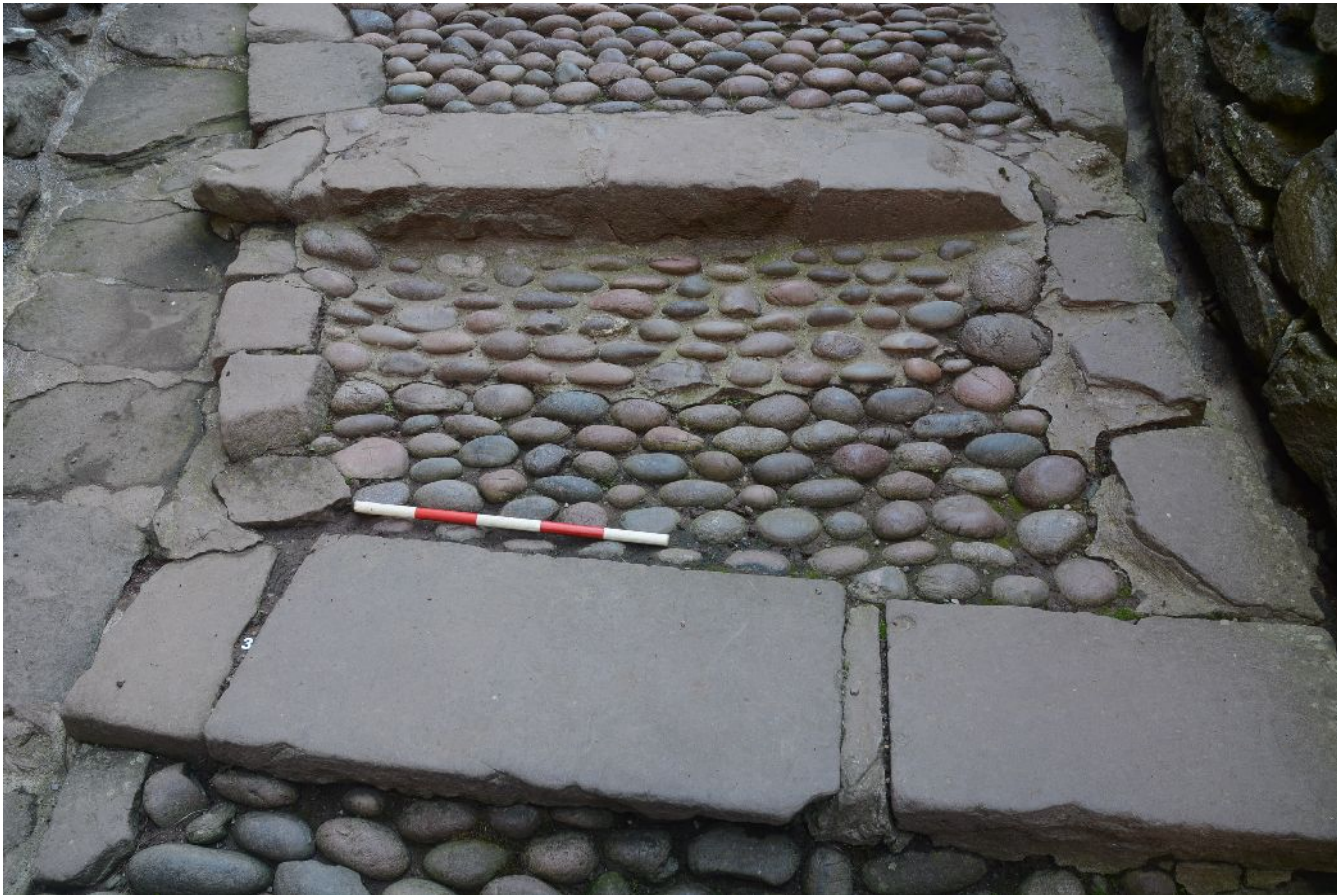
Illus 12 Step 3

Width across path	1.75m
Depth along path	1.15m
Rise from previous step	100mm

Small cobbles set on edge with some attempt to stabilize them with concrete and a few larger pebbles which may be repairs. LHS flat stones set in concrete form a rough drain with a edging of angular stones on this side. RHS a three squared stones set in concrete form a rough edge.

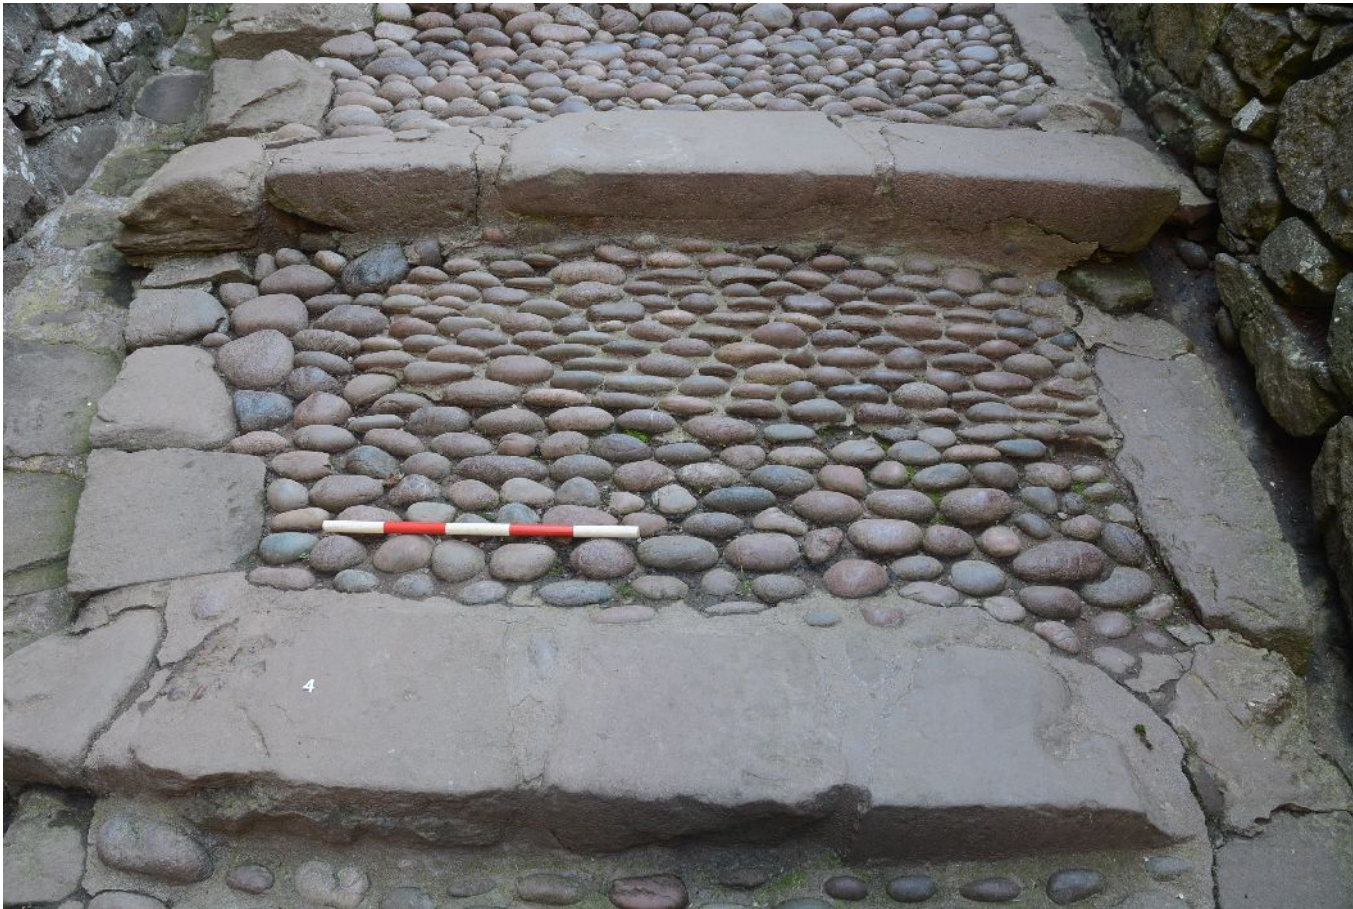
Illus 13 Step 4

Width across path	2.02m
Depth along path	1.25m
Rise from previous step	130mm

The back of the step is surfaced with small cobbles set on edge, with some attempt having been made to stabilize them with cement. The front cobbles appear more varied and may include repairs. LHS Flat stones set in concrete form a rough drain with a rough edging of flat stones on this side; these may post-date the 1920s cobbles as there appears to be infilling on this side. On the RHS squared stones set in concrete form a rough edge.

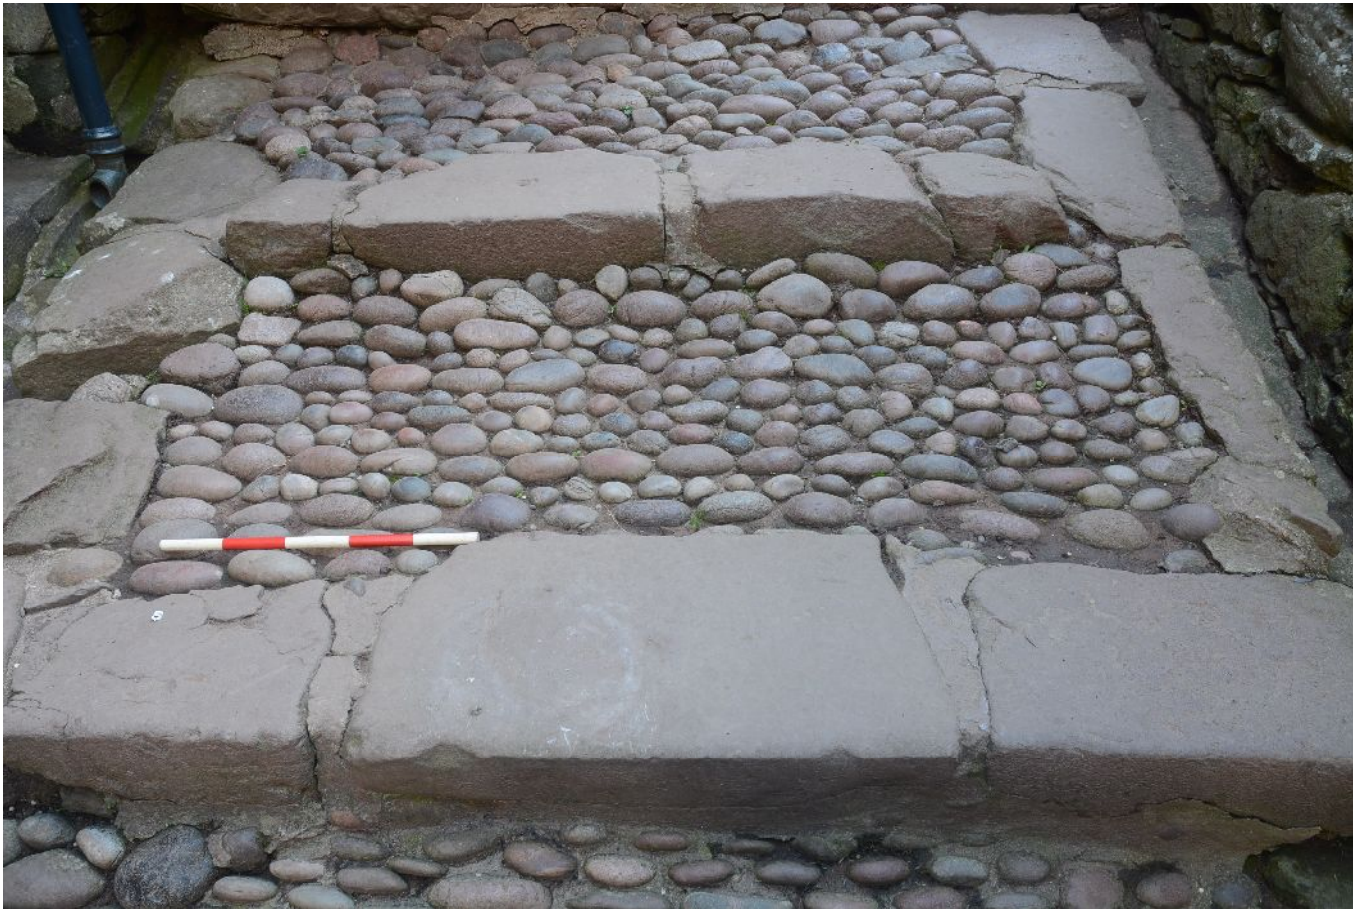
Illus 14 Step 5

Width across path	2.28m
Depth along path	1.11m
Rise from previous step	150mm

Surface of varied cobbles with no patterning and evidence of repairs. Front of tread formed by three fairly worn dressed stones. LHS Flat stones set in concrete form a rough drain with a rough edging of flat stones on this side. RHS Flat stones set in concrete form a rough edge.

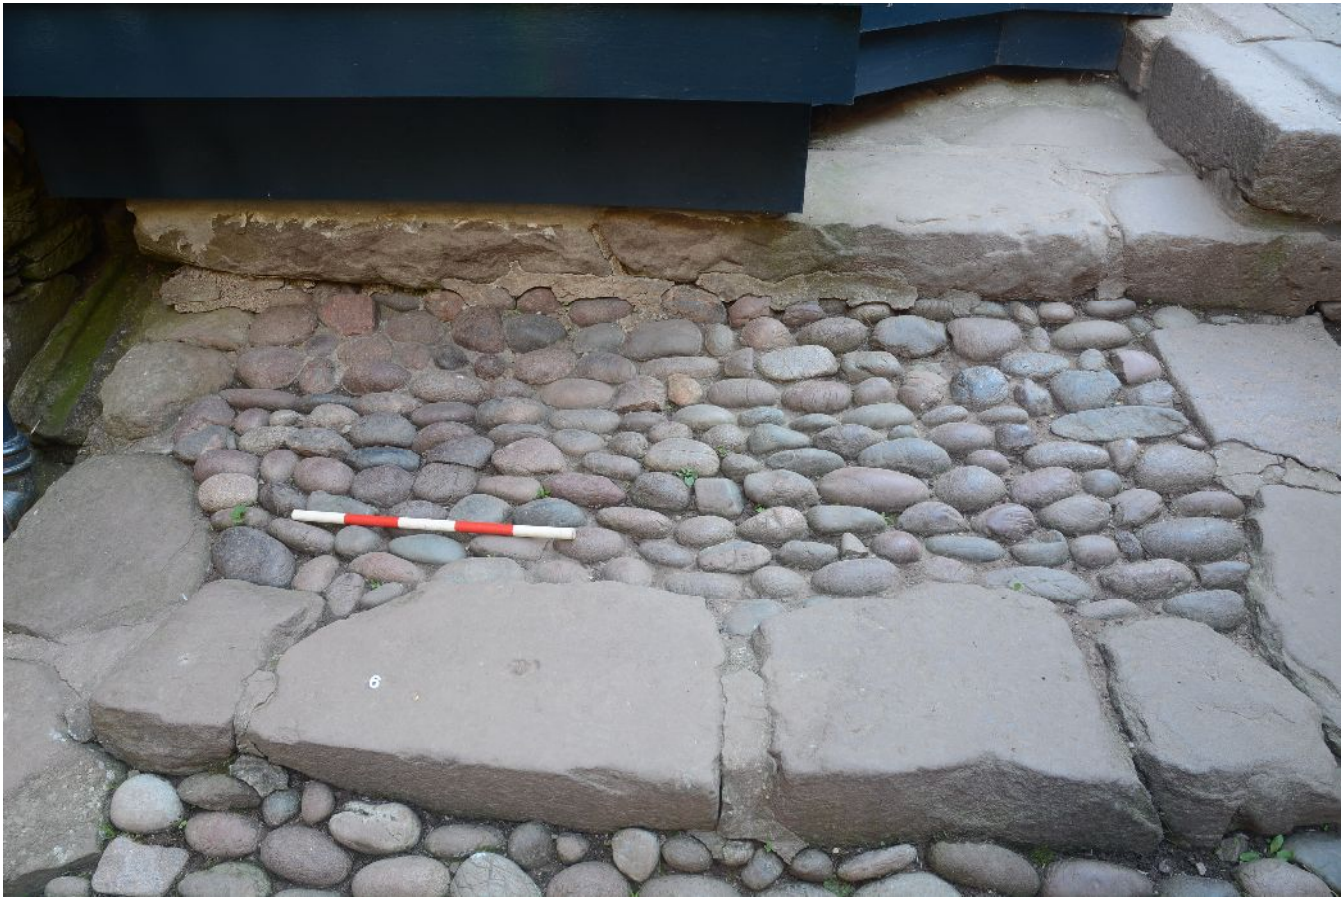
Illus 15 Step 6

Width across path	2.39m
Depth along path	1.10m
Rise from previous step	140mm

Surface of varied cobbles with no patterning and evidence of repairs with concrete at back. Front of tread formed by three fairly worn irregular flat stones. LHS Flat stones set in concrete form a rough drain with a rough edging of flat stones on this side. RHS Flat stones set in concrete form a rough edge.

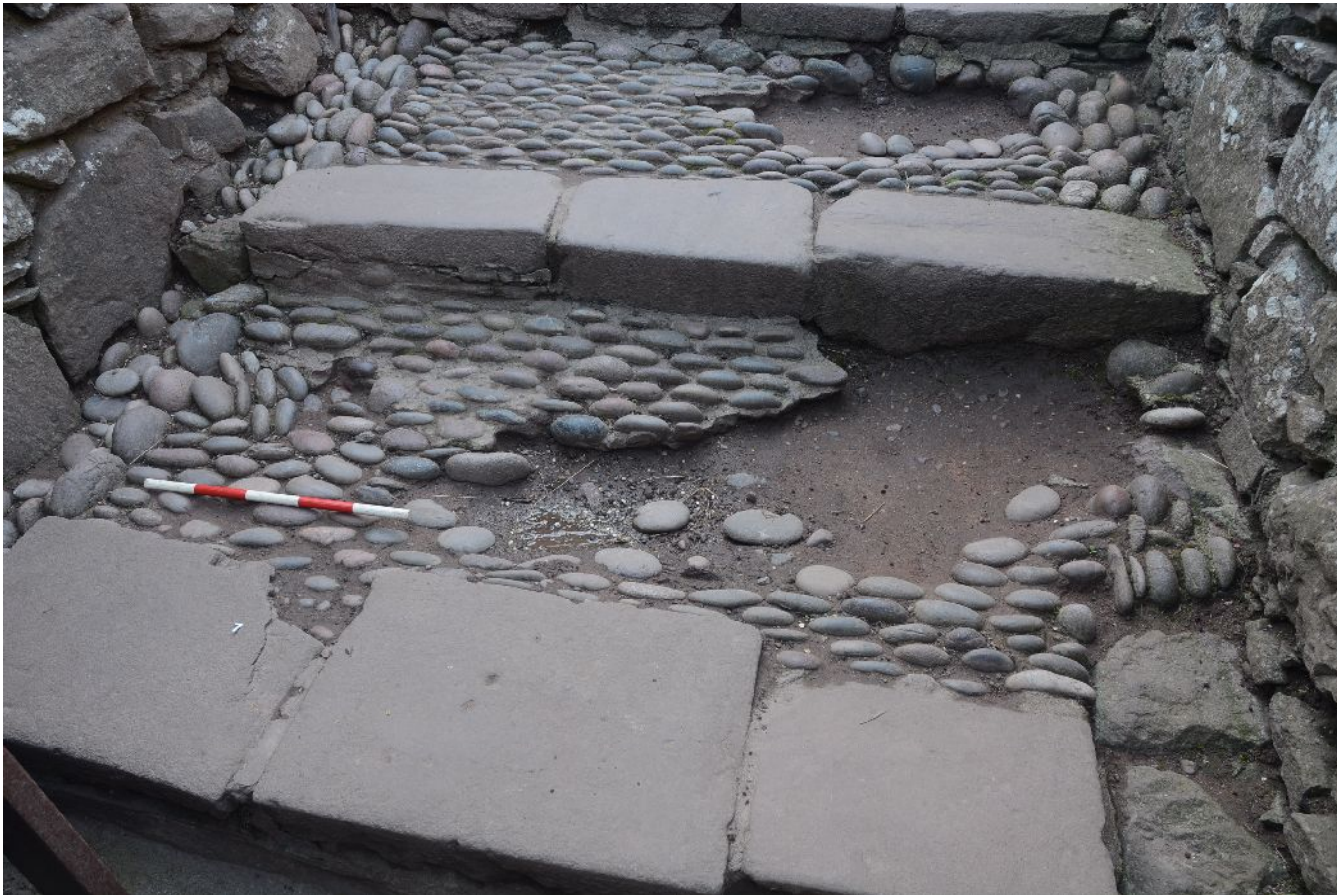
Illus 16 Step 7

Width across path	1.71m
Depth along path	1.17m
Rise from previous step	210mm

Small cobbles set on edge but many missing on upper RHS and some repairs with cement. Front of tread formed by three worn dressed stones. Along LHS larger pebbles used to form a drain. On RHS flat stones forming part of the edge appear to project below the wall on RHS.

3. Special attention should be paid to the relationship of any underlying layers with the stones on the RHS (going up) of Steps, 7, 13 and 14 where the side edging appears to project below the foundation of the buttressing side wall. Any such foundations should be recorded and retained.

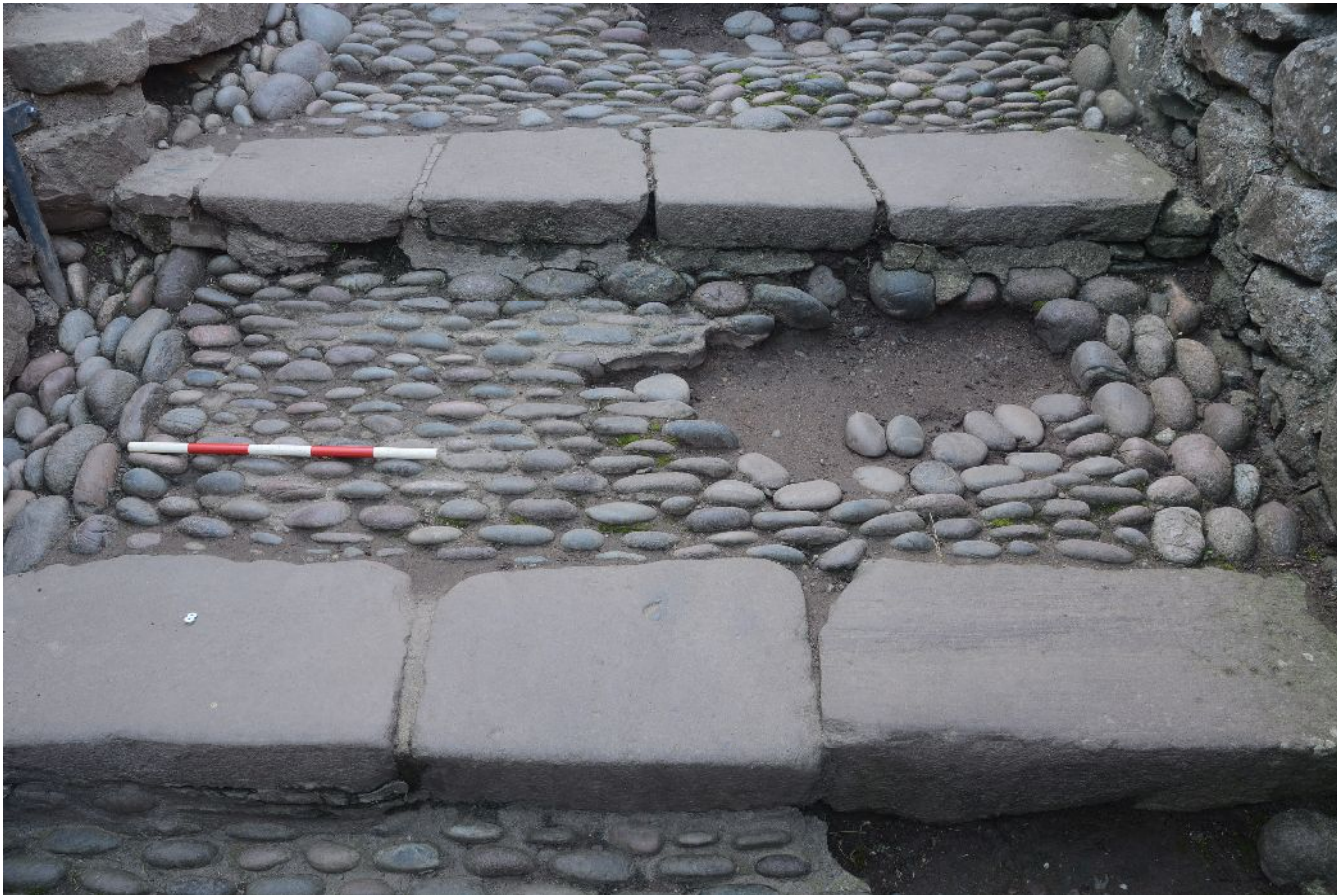
Illus 17 Step 8

Width across path	1.97m
Depth along path	0.95m
Rise from previous step	160mm

Small cobbles set on edge but no obvious surviving pattern. A large patch of cobbles is missing and some attempt has been made to stabilize them with cement. The front of tread is formed by three worn dressed stones. On LHS rows of cobbles laid parallel with wall may have assisted drainage. There is a similar but rougher arrangement of cobbles beside RHS wall.

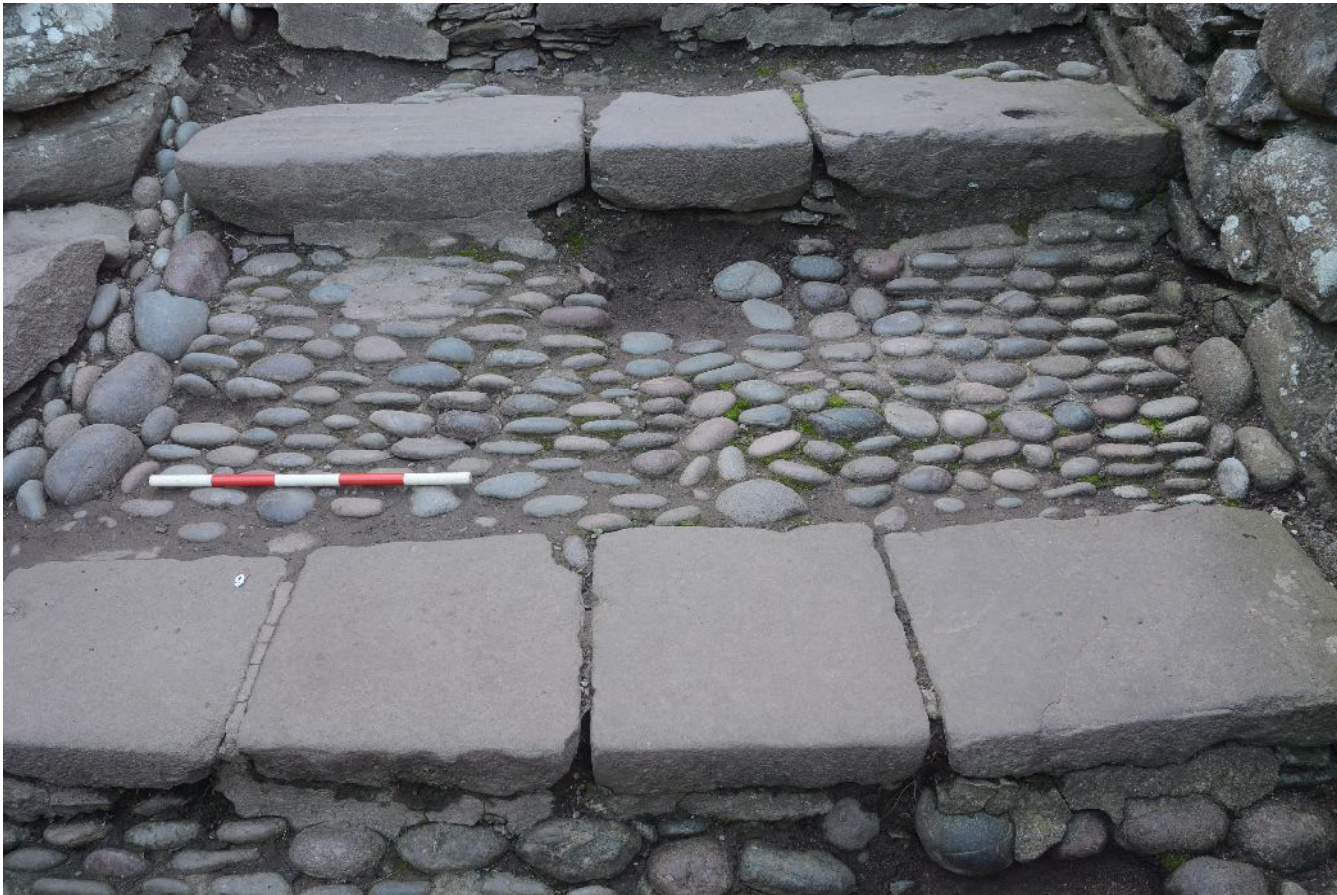
Illus 18 Step 9

Width across path	2.00m
Depth along path	1.10m
Rise from previous step	140mm

A mixture of small cobbles set on edge and larger pebbles used to fill in. There is a bare patch in the centre of the back of the step and some cement. No pattern is visible. The LHS is bordered by larger pebbles parallel to the LHS wall with smaller cobbles parallel to the wall forming a drain. The front of the tread is formed of four worn dressed stones.

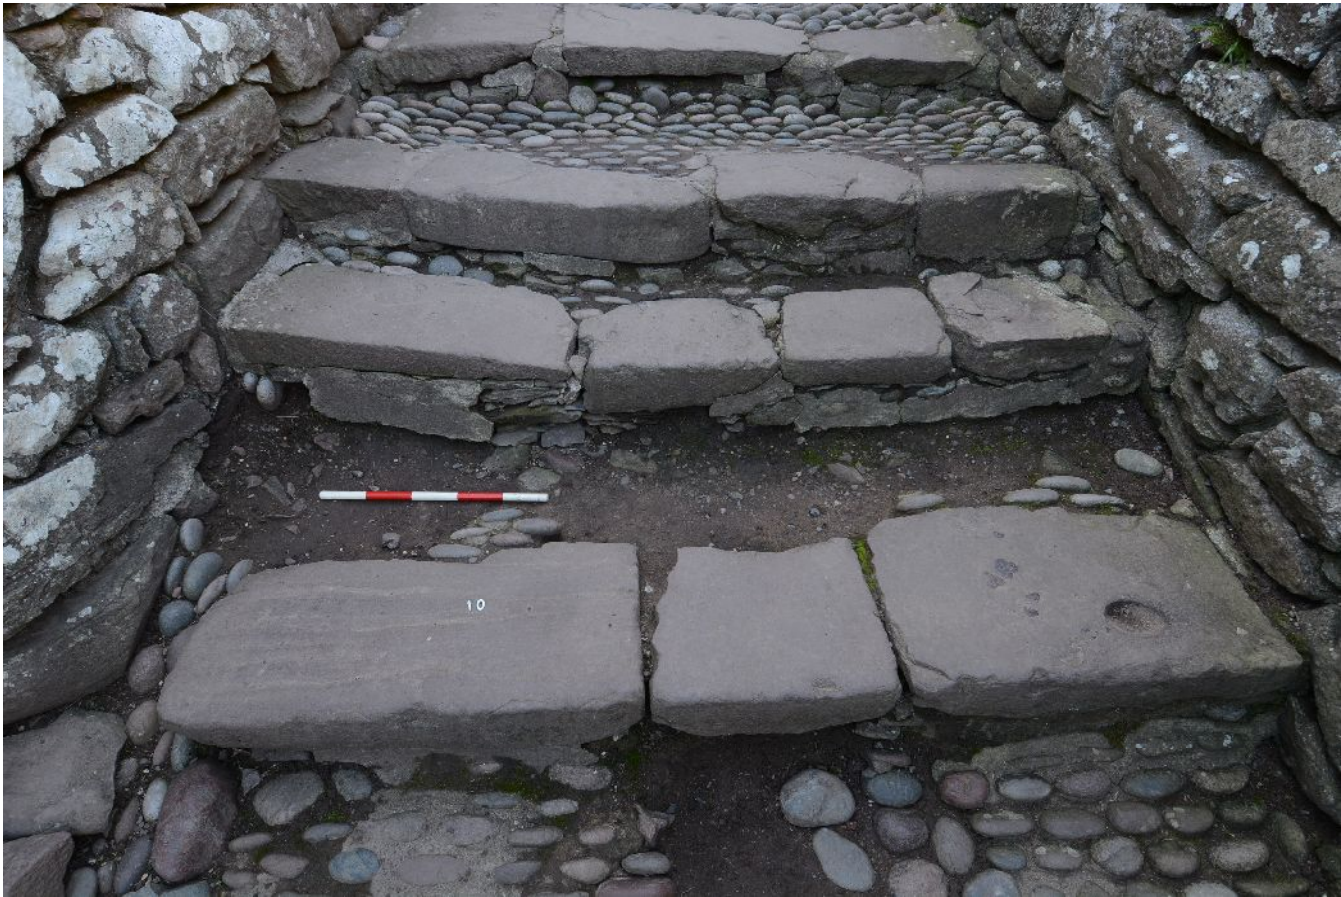
Illus 19 Step 10

Width across path	1.87m
Depth along path	0.69m
Rise from previous step	250mm

The cobbles are almost completely missing. The front of the tread is formed of three worn flat dressed stones. The RHS stone has an almost circular hole in its upper surface and may have been re-used from elsewhere, possibly having had a shutter or door swivelling in the hole.

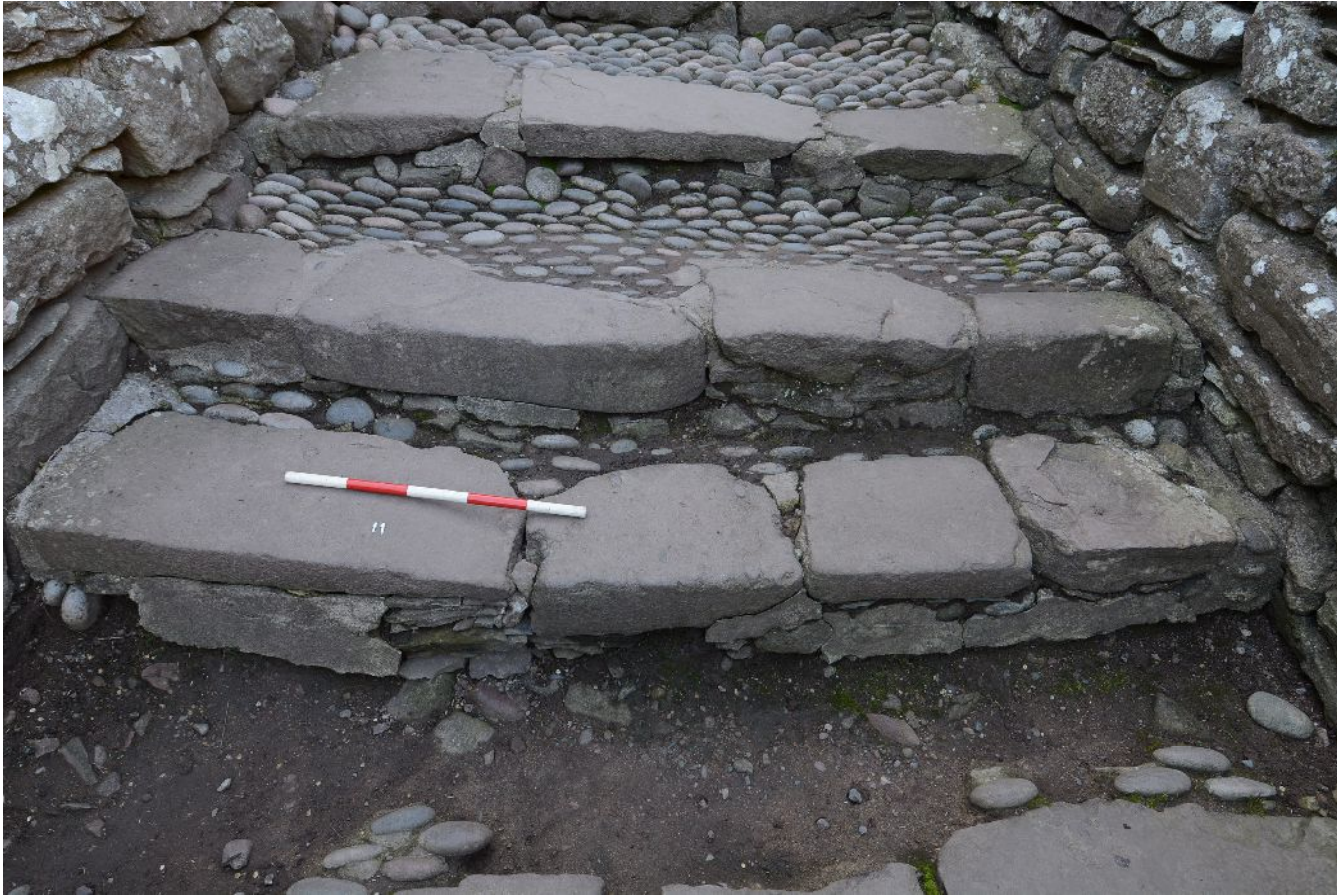
Illus 20 Step 11

Width across path	2.12m
Depth along path	0.43m
Rise from previous step	210mm

This is a very narrow step with few cobbles. The front of the tread is formed of four worn flat dressed stones.

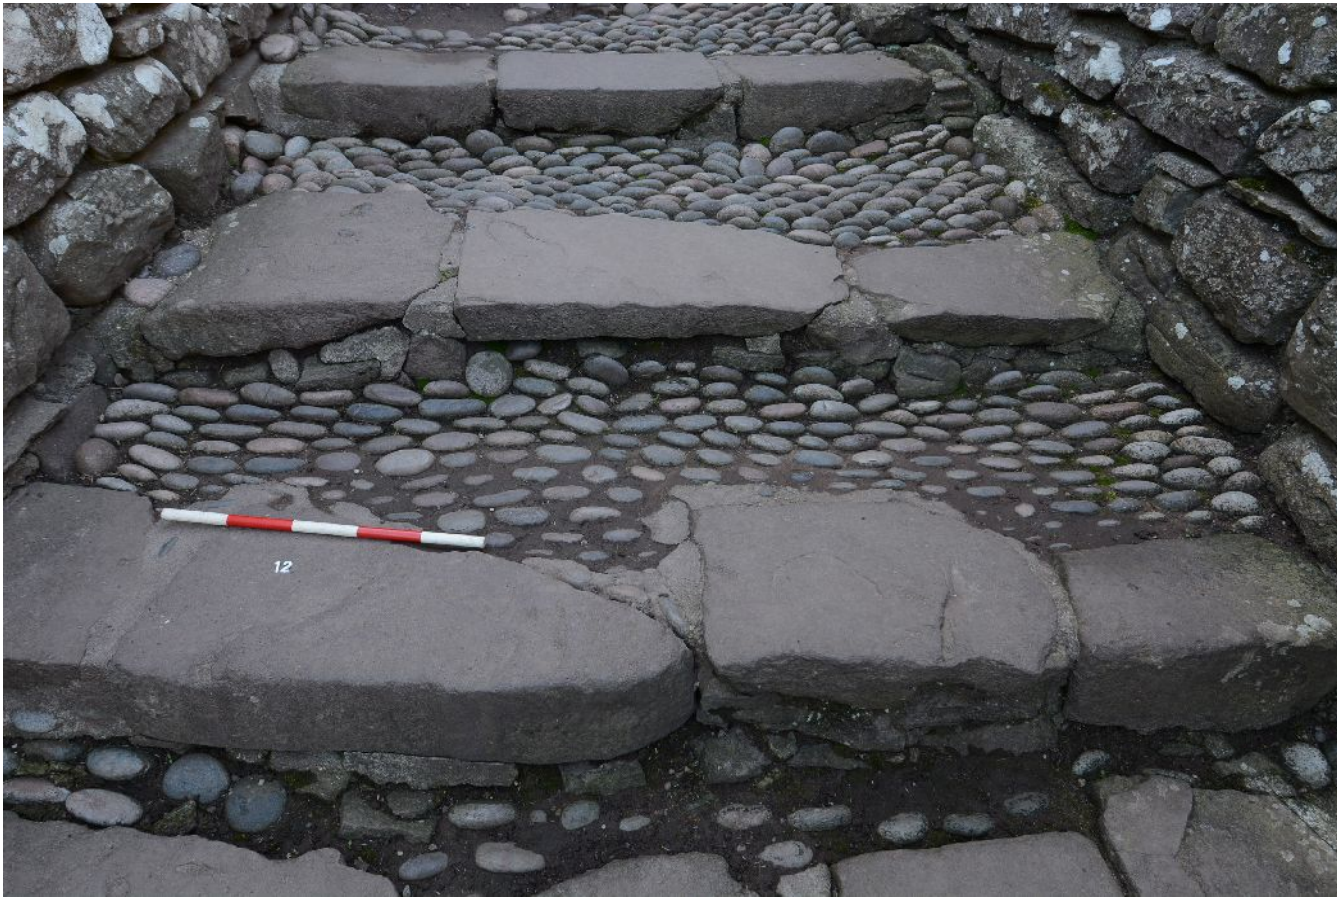
Illus 21 Step 12

Width across path	2.15m
Depth along path	0.75m
Rise from previous step	200mm

Surface formed of small cobbles set on edge. The front of the tread comprises four fairly irregular flat stones.

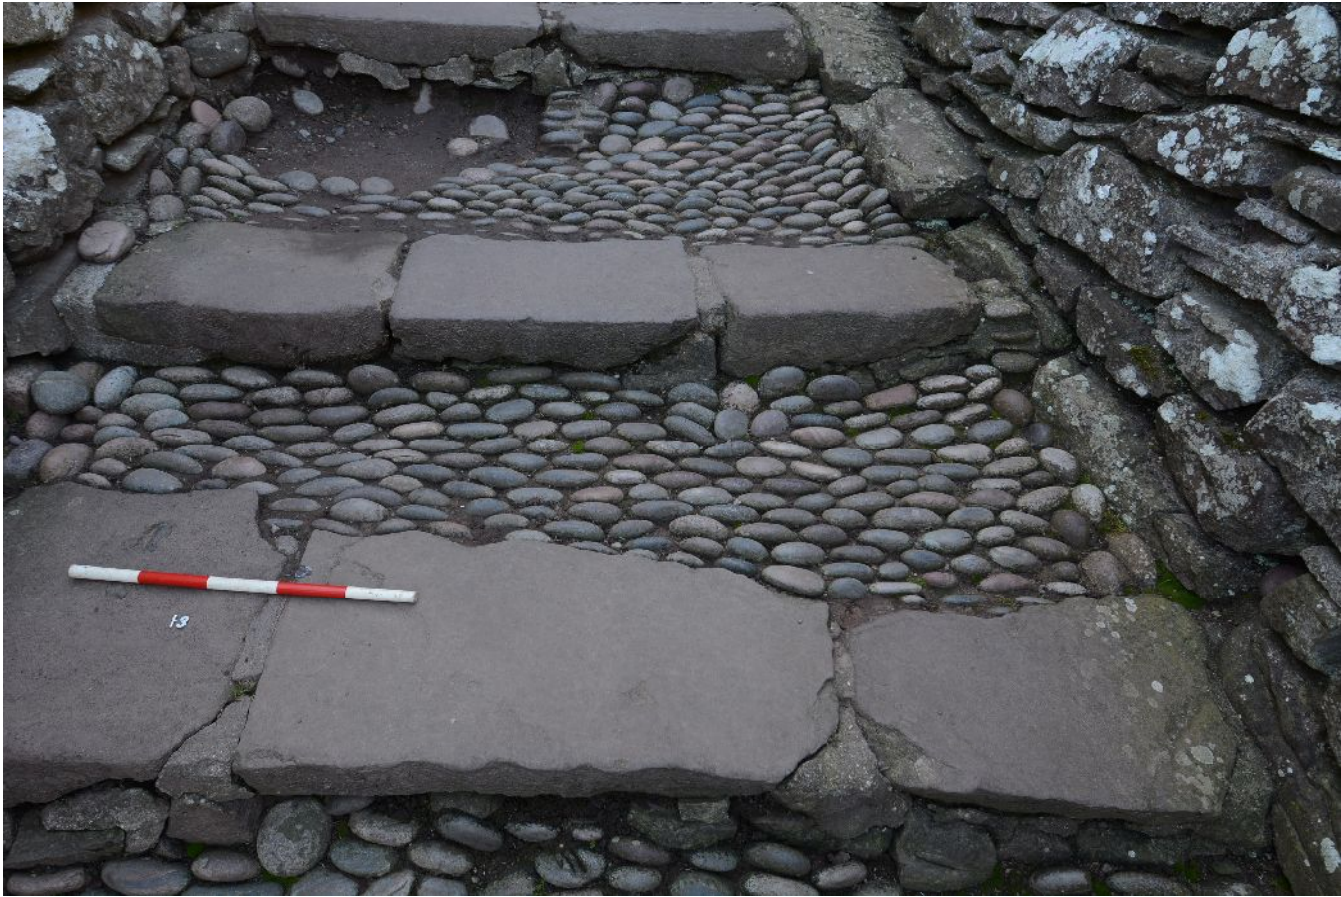
Illus 22 Step 13

Width across path	2.03m
Depth along path	0.83m
Rise from previous step	150mm

Surface formed of small cobbles set on edge but with no visible pattern. The front of the tread is formed of three worn flat dressed slabs. On RHS the lowest stone of bounding wall projects into the step in line with projecting foundation stones at edge of Steps 14 and 15.

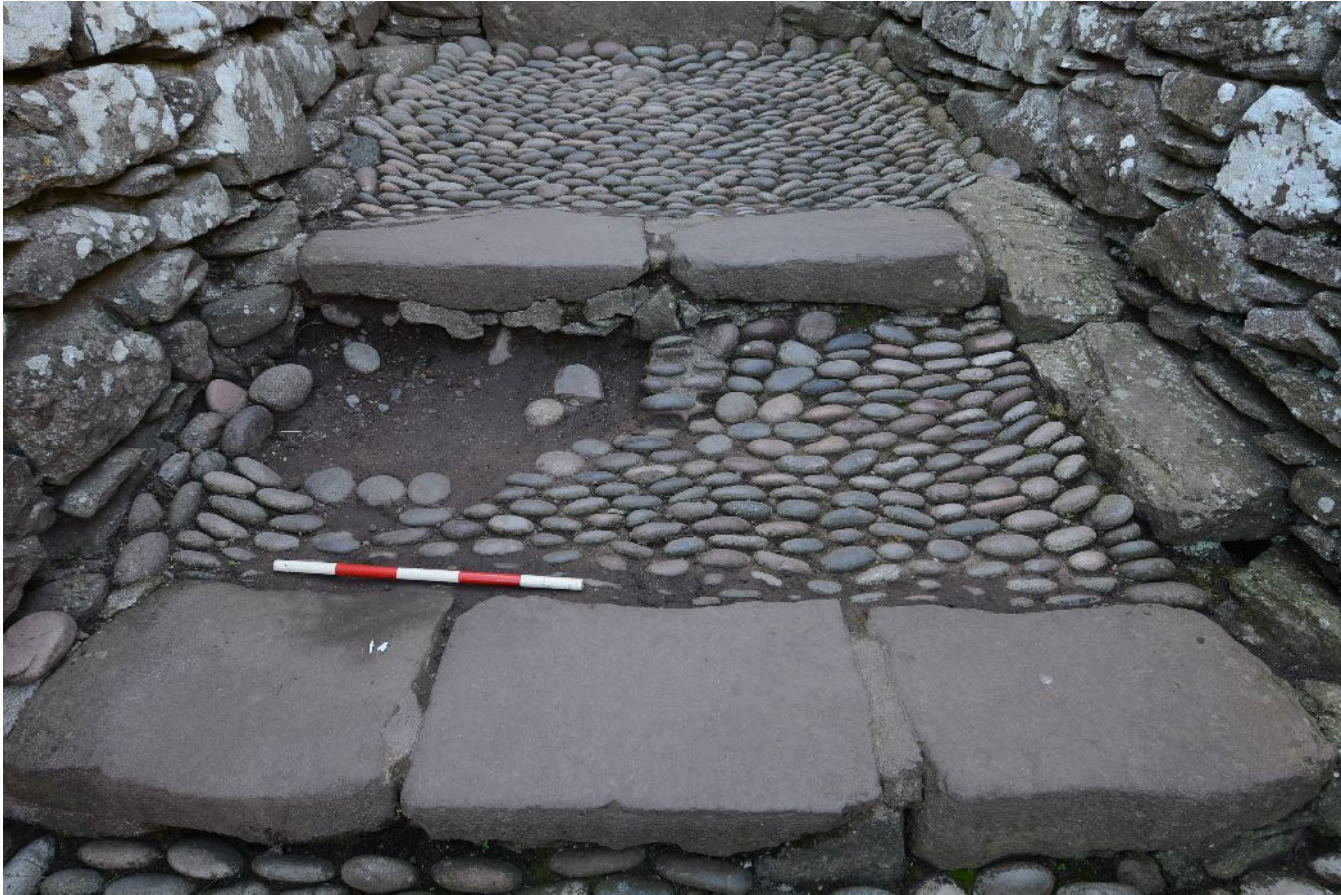
Illus 23 Step 14

Width across path	1.74m
Depth along path	1.13m
Rise from previous step	170mm

Small cobbles set on edge with worn patch and missing stones at LHS. Front of tread formed by three worn flat dressed stones. The foundation of RHS bounding wall projects on to the line of the step.

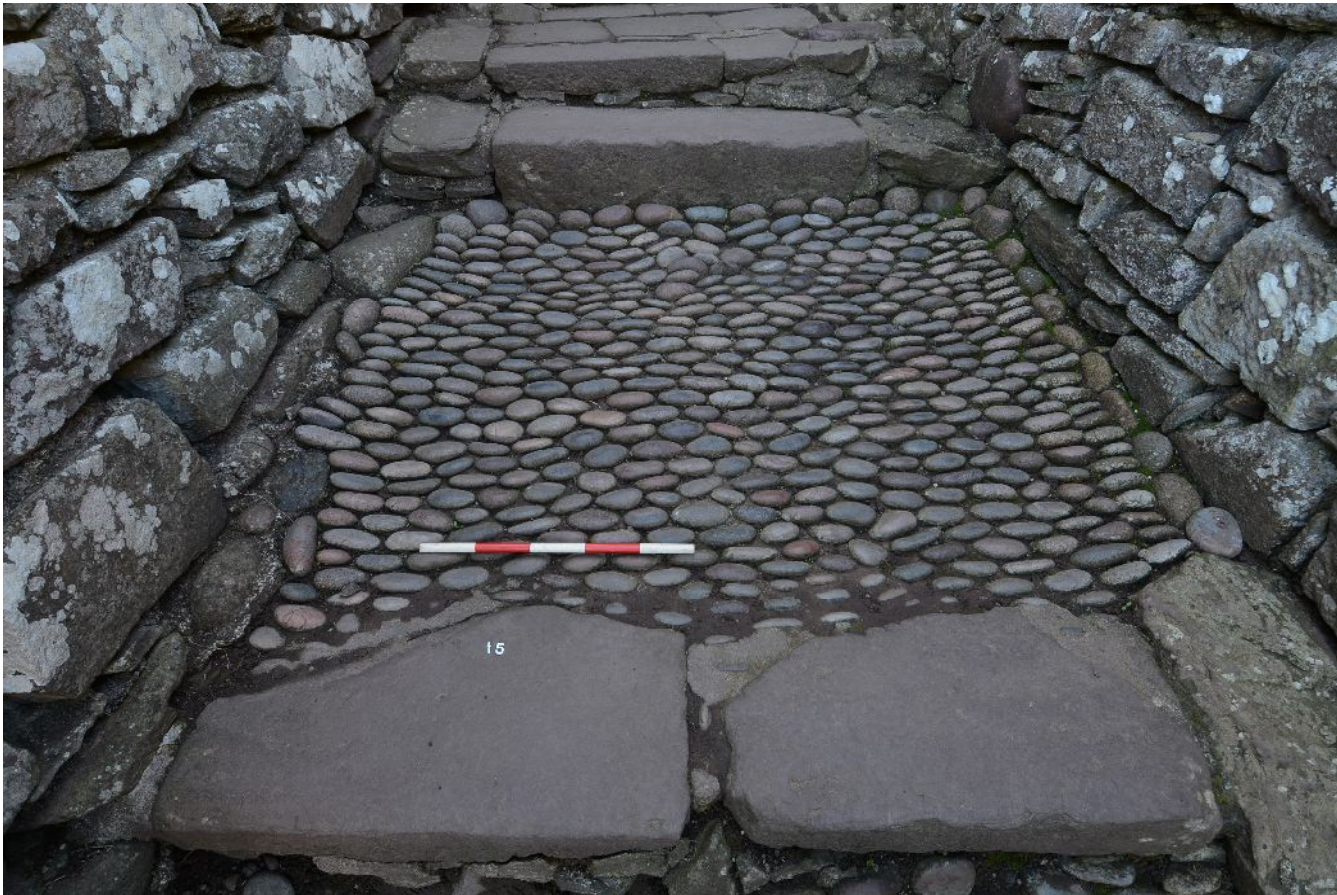
Illus 24 Step 15

Width across path	1.79m
Depth along path	1.59m
Rise from previous step	180mm

Small cobbles set on edge and generally in good condition. The front of tread is formed by two flat dressed stones with a third stone at RHS at right angles, which appears to be in line with projecting foundation of this wall visible at Steps 13 and 14.

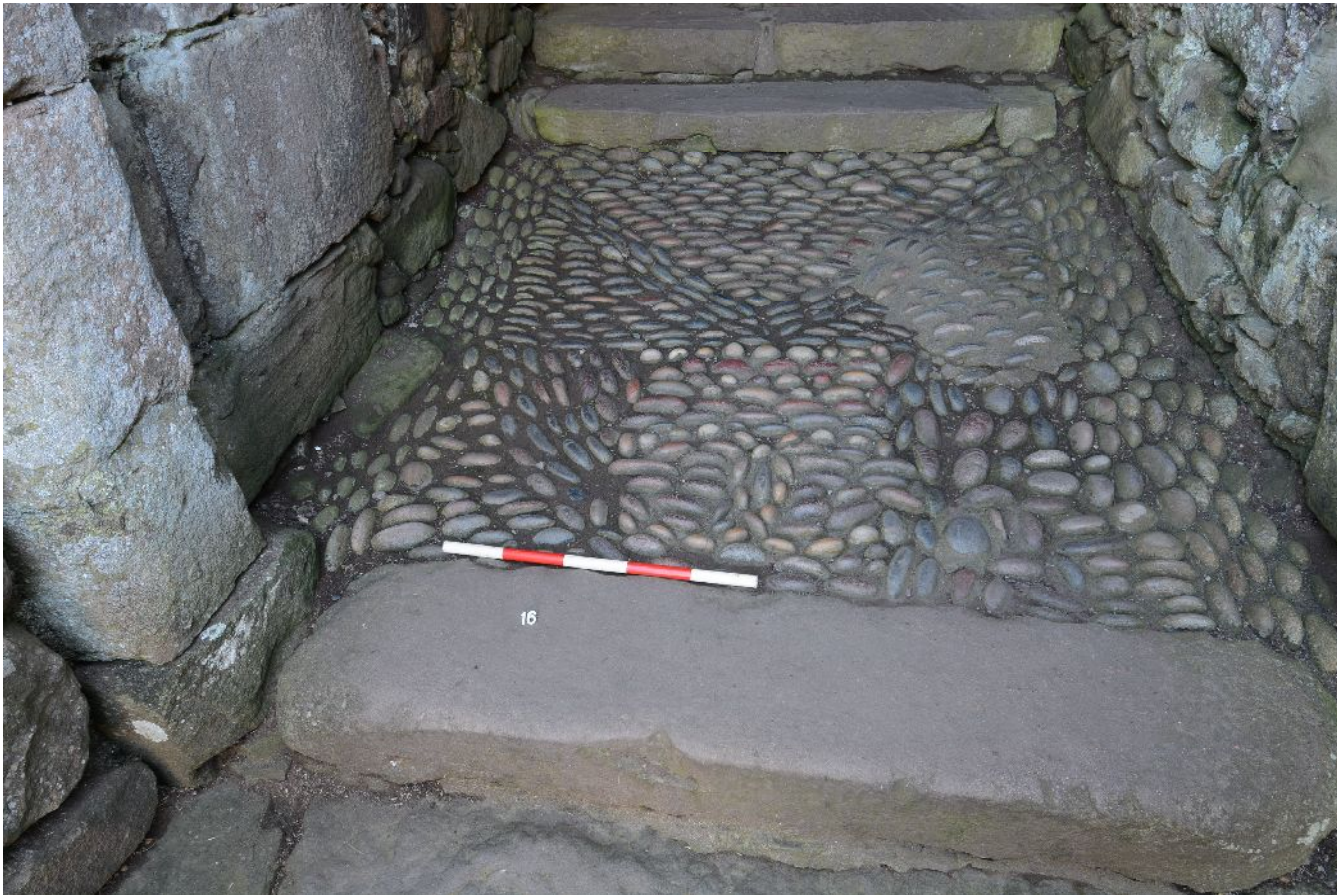
Illus 25 Step 16

Width across path	1.70m
Depth along path	1.93m
Rise from previous step	200mm

There are flagstones between Steps 15 and 16. Step 16 forms the doorway into the first covered pend and the front of the tread is a single large slab which essentially formed the sill of the doorway which shut off this lower end of this part of the passage.

Step 16 was formed of small cobbles set on edge, with different coloured stones used to emphasise the pattern. The front is disturbed but there are clear triangular patterns almost forming a letter M in the back part of the step. On both RHS and LHS four to five rows of cobbles have been set parallel to the walls forming a border.

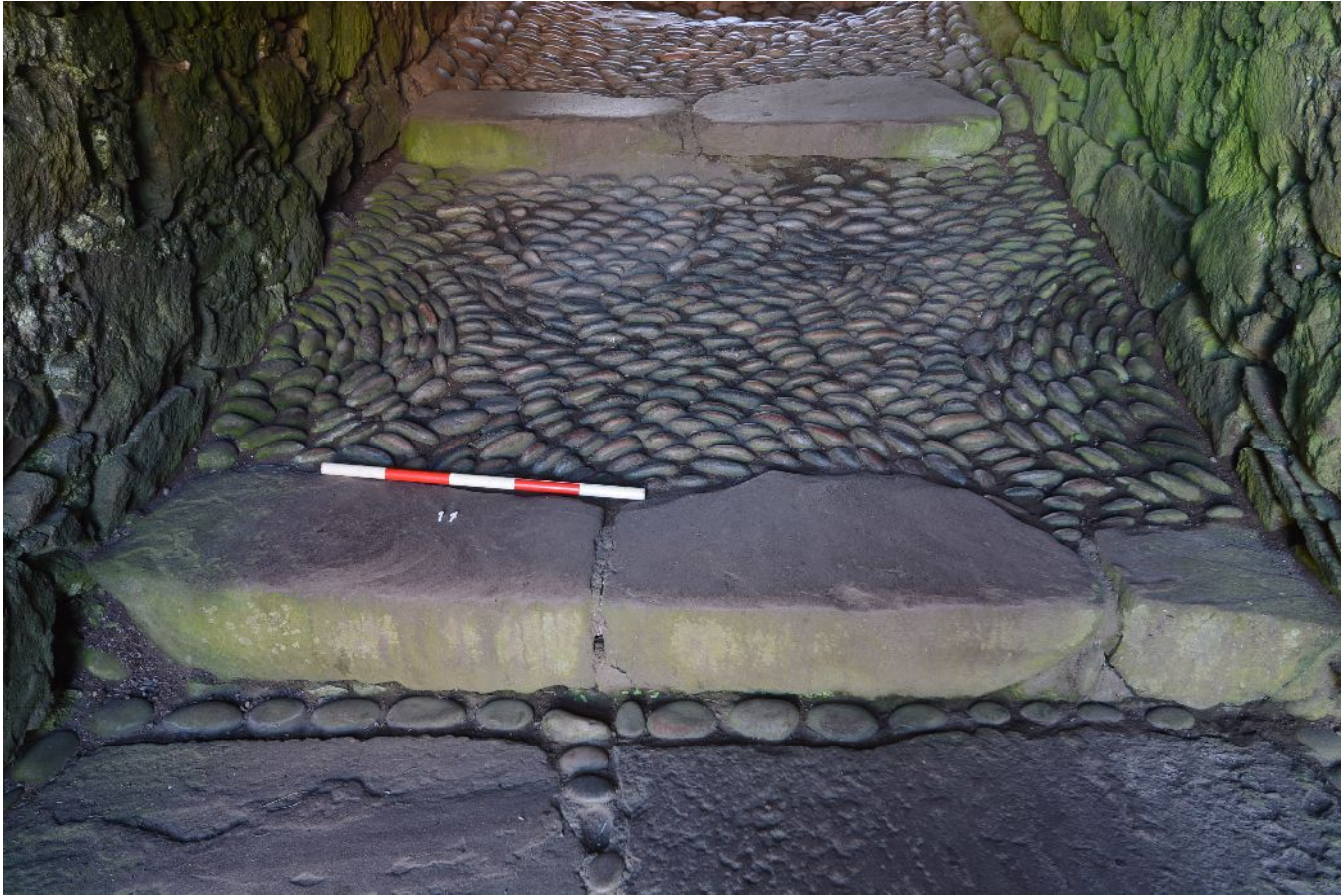
Illus 26 Step 17

Width across path	1.63m
Depth along path	1.66m
Rise from previous step	170mm

Small cobbles set on edge form four arcs, each facing towards a different side of the step.

The front of the tread is formed of three worn dressed stones.
