RECORDING OF STEPS
DUNNOTTAR CASTLE
STONEHAVEN
ABERDEENSHIRE

Recording of steps

Carried out 16th August 2018

Report No: MAS 2018-19

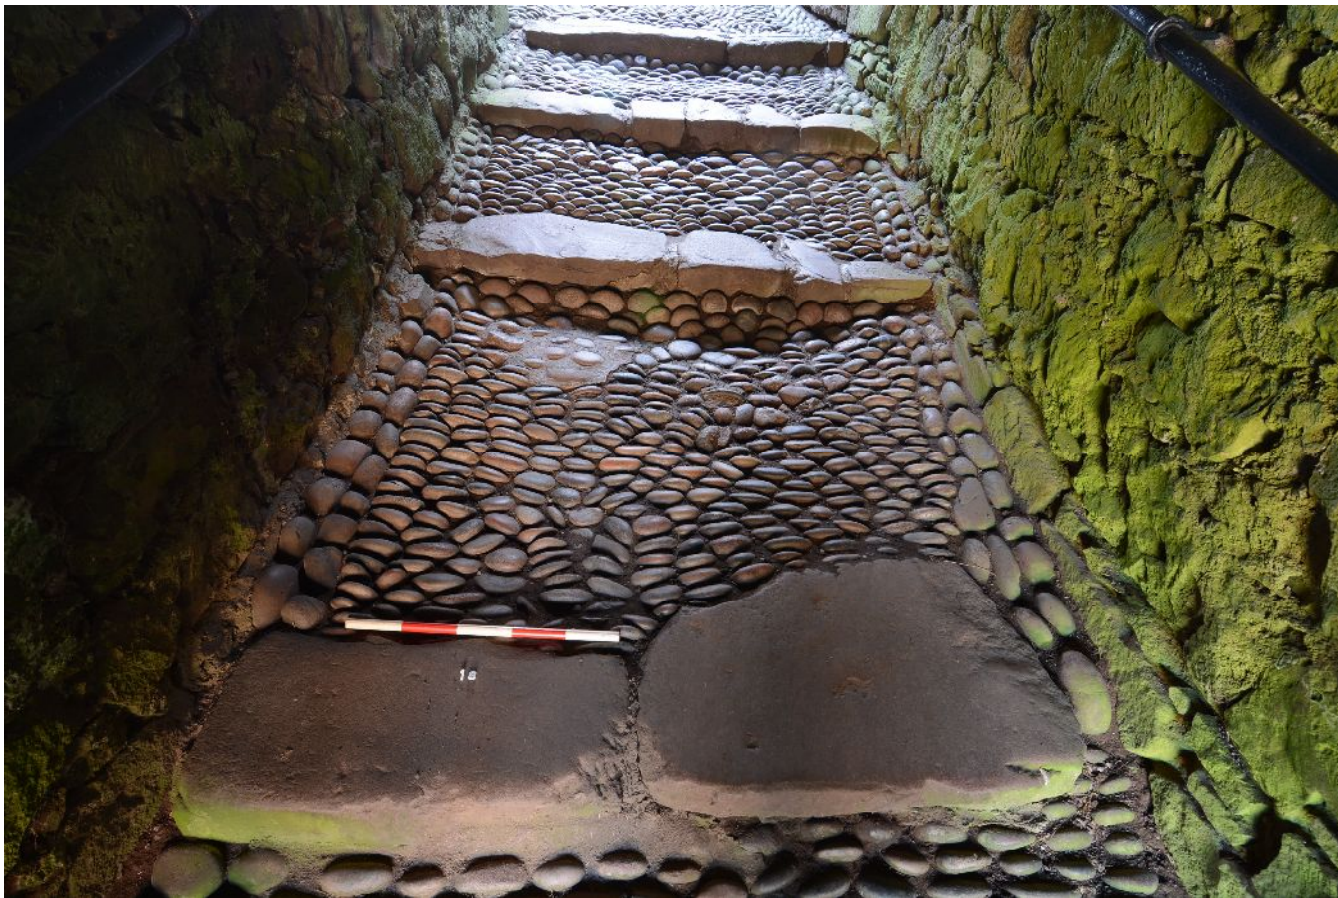
Illus 27 Step 18

Width across path	1.64m
Depth along path	1.60m
Rise from previous step	100mm

Small cobbles set on edge with only a slight indication of a pattern surviving. Both sides are bordered by two rows of larger pebbles laid parallel to the walls. The front of the tread is formed of two flat worn slabs.

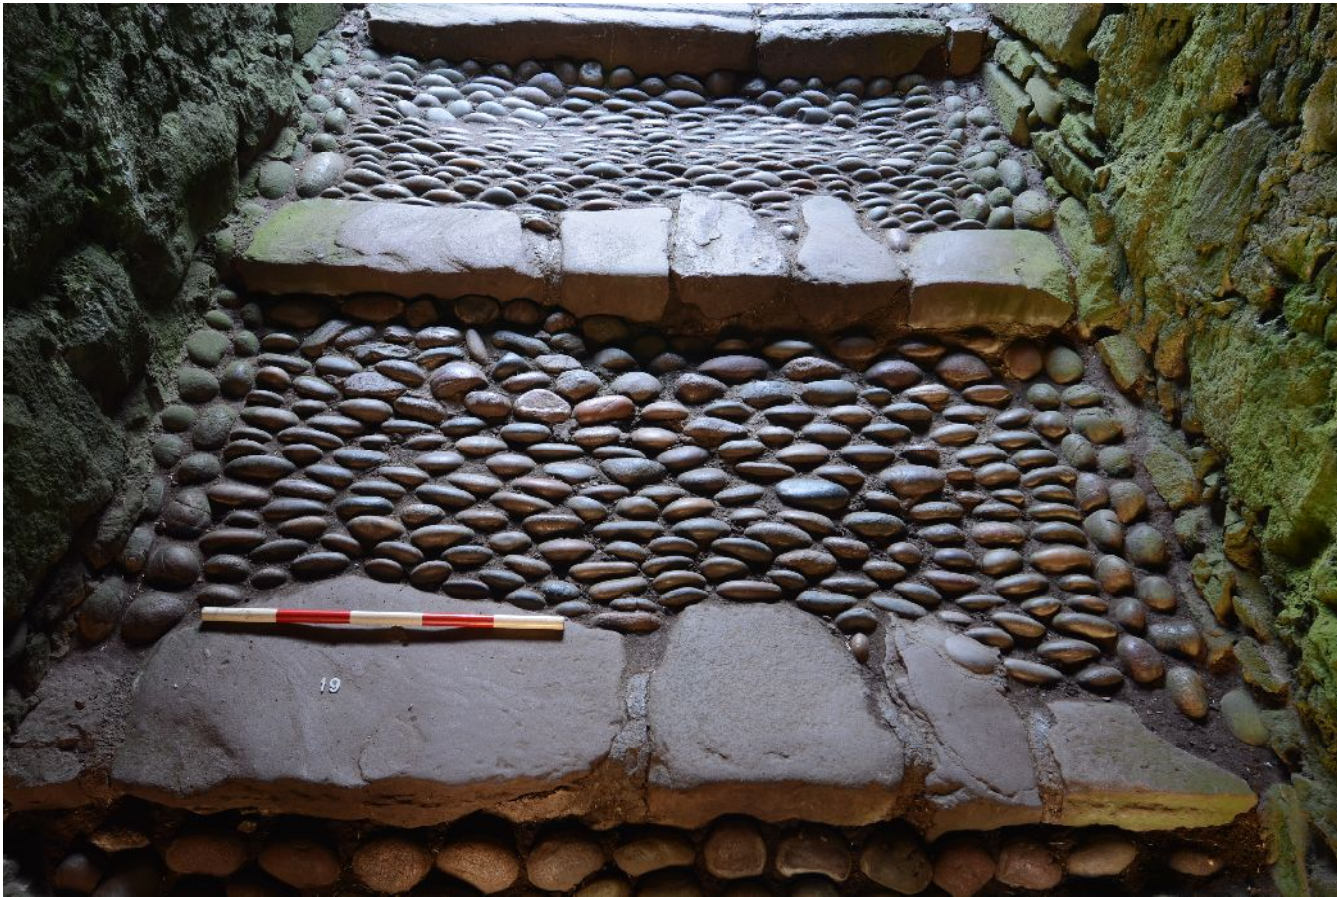
Illus 28 Step 19

Width across path	1.68m
Depth along path	0.97m
Rise from previous step	110mm

Small cobbles set on edge with some disturbance and replacement at the back of the step. Both sides bordered by two rows of larger pebbles set parallel to walls. The front of the tread is edges by flat irregular slabs.

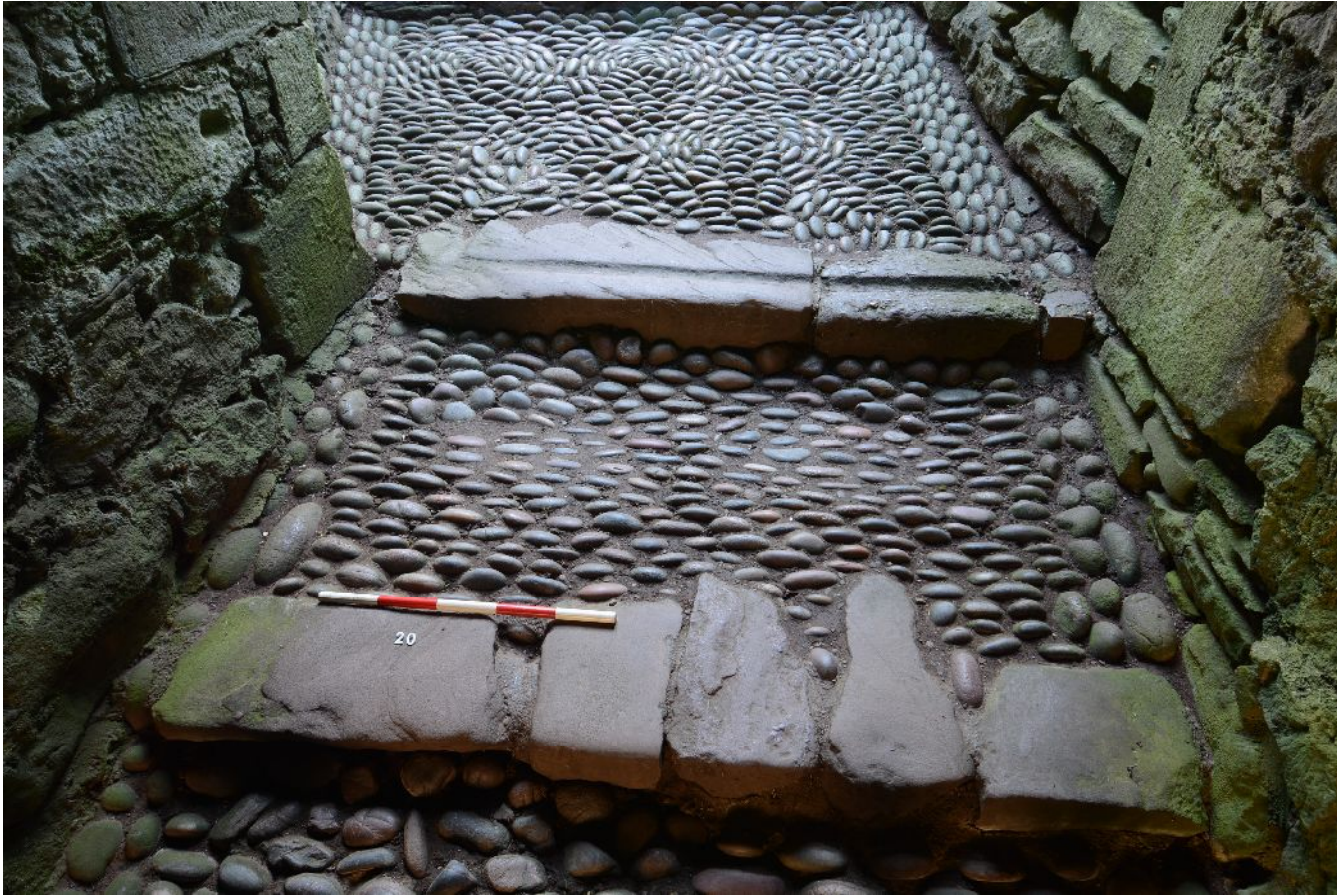
Illus 29 Step 20

Width across path	1.60m
Depth along path	1.01m
Rise from previous step	120mm

Small cobbles set on edge with no obvious pattern. Larger pebbles had been used on both RHS and LHS to form a border running parallel with the walls. The front of the tread is edged by flat irregular slabs.

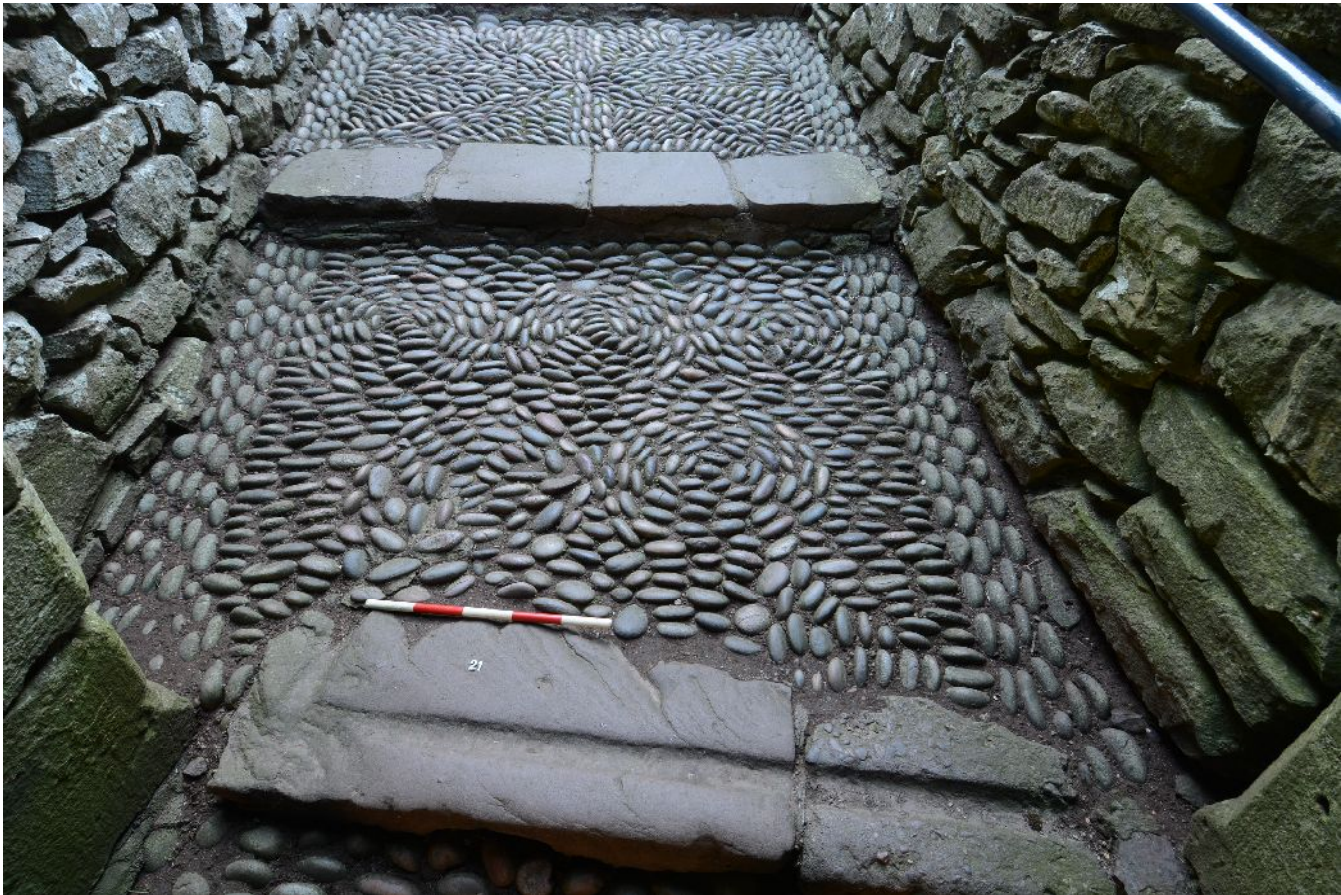
Illus 30 Step 21

Width across path	1.98m
Depth along path	1.76m
Rise from previous step	150mm

The cobbles in this section between Step 21 and 26 include a number of patterns and give an almost carpet-like impression.

Small cobbles set on edge forming a pattern of five circular discs, three at the uphill end of the step and two in front. Both the RHS and LHS of the step are bordered by four to five lines of cobbles running parallel to the walls. The front of the tread comprises two large dressed slabs with a groove along the upper faces; these form the sill of another door at this point.

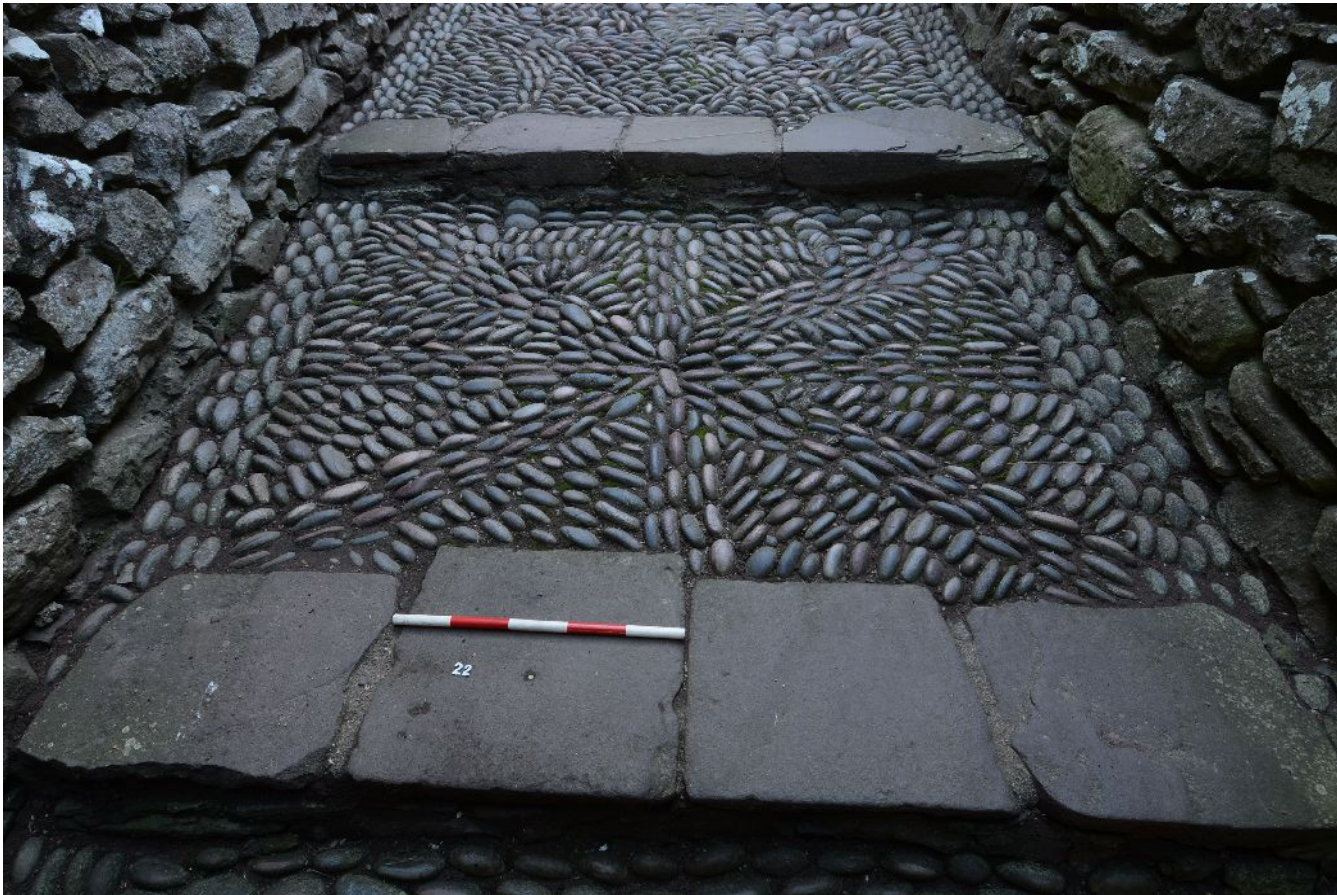
Illus 31 Step 22

Width across path	2.14m
Depth along path	1.73m
Rise from previous step	150mm

Small cobbles set on edge to form superimposed cross and St Andrew's cross. The stones have been chosen by colour and this is normally interpreted as representing the Union Jack flag. This is one of the most undamaged steps.

Both the RHS and LHS of the step are bordered by four lines of cobbles running parallel to the walls. The front of the tread is formed of four flat dressed stones.

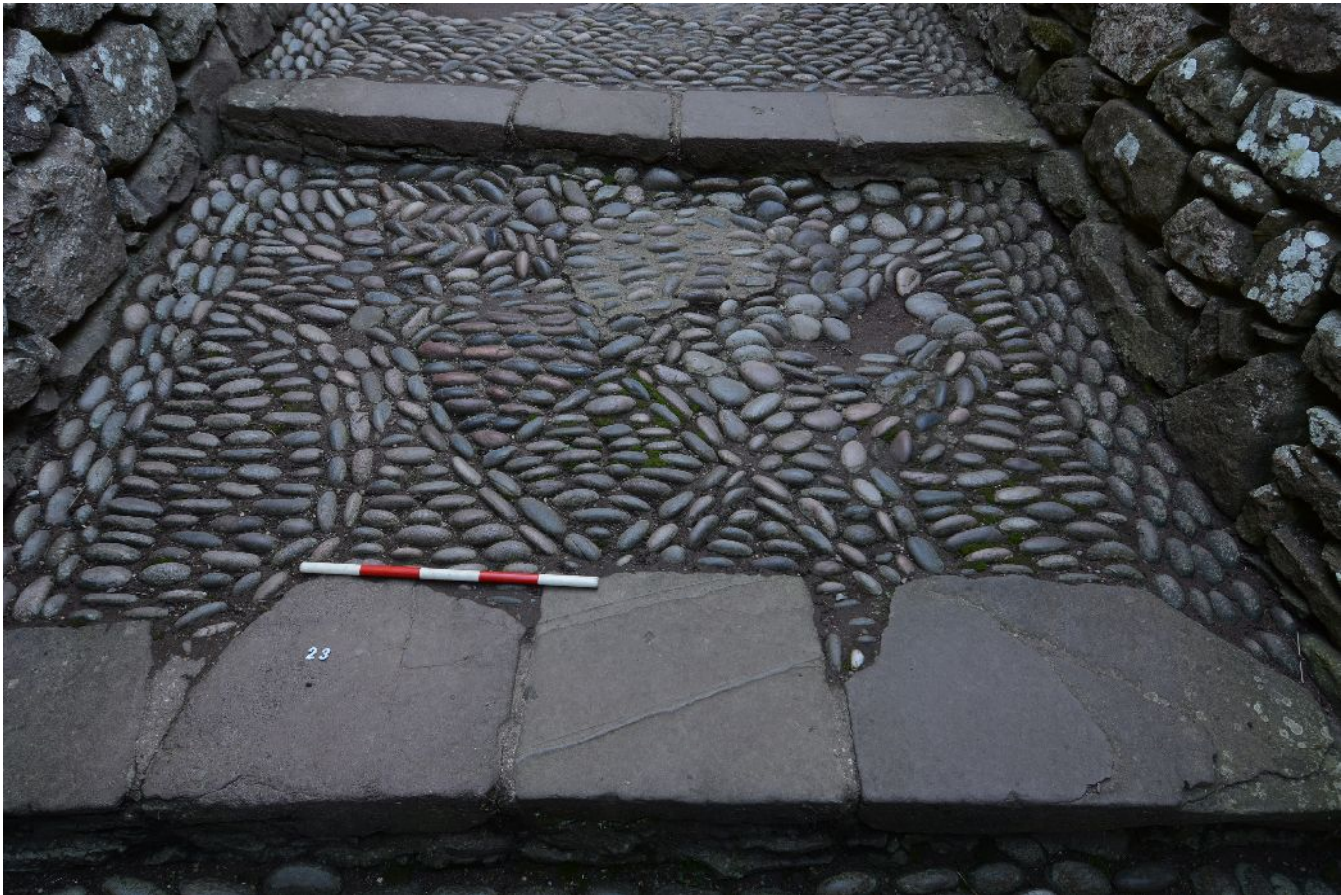
Illus 32 Step 23

Width across path	2.14m
Depth along path	1.66m
Rise from previous step	170mm

Small cobbles set on edge to form a pattern with curved and lozenge patterns, possibly around a central shield shape. However the back RHS of the cobbling has been damaged and the pattern is confused as a result.

Both the RHS and LHS of the step are bordered by four lines of cobbles running parallel to the walls. The front of the tread is formed of four flat dressed stones.

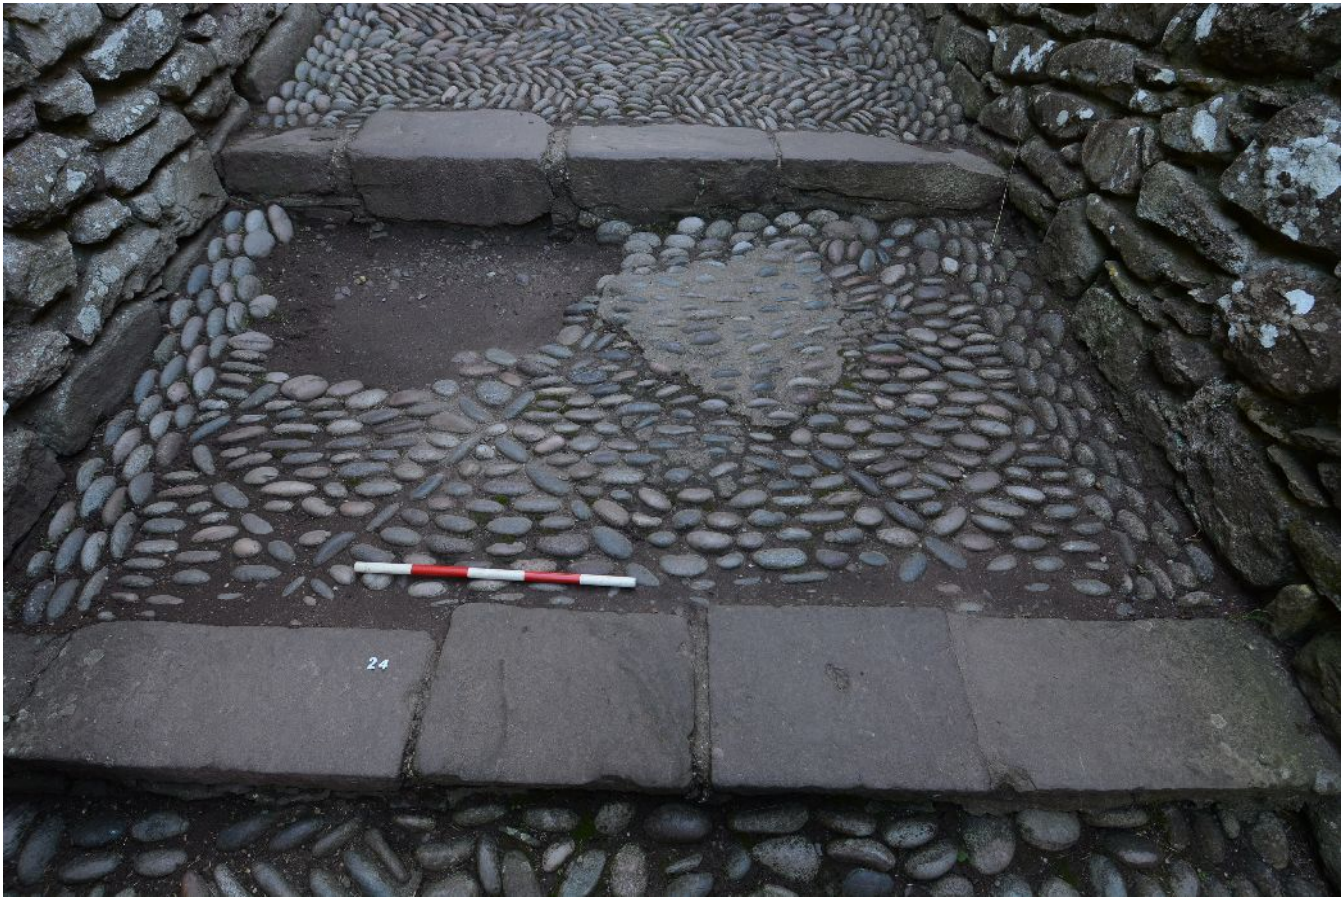
Illus 33 Step 24

Width across path	2.17m
Depth along path	1.55m
Rise from previous step	100mm

Small cobbles set on edge with a pattern of lines forming three diamond shapes across the width of the step.

Both the RHS and LHS of the step are bordered by four lines of cobbles running parallel to the walls. The front of the tread is formed of four flat dressed stones.

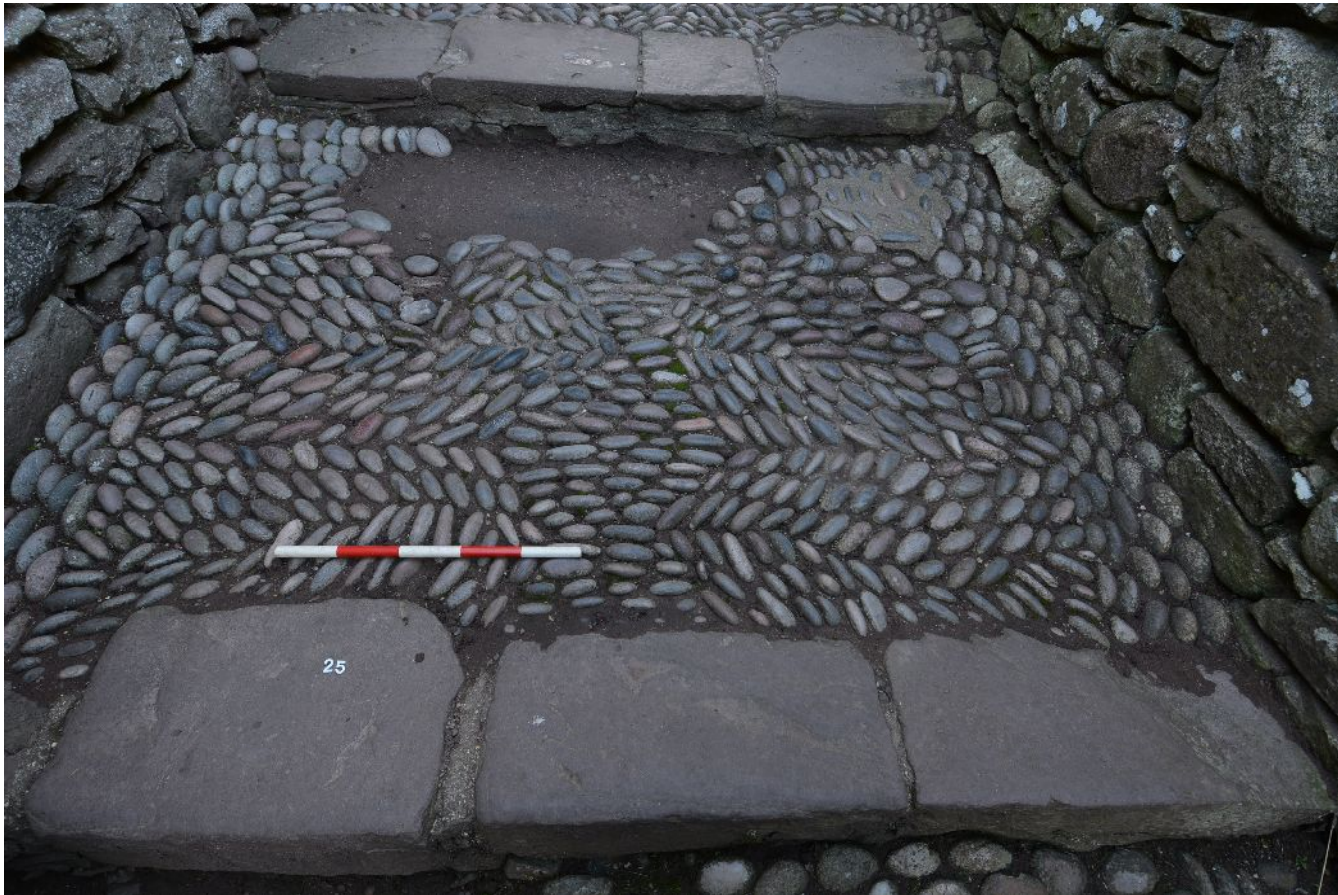
Illus 34 Step 25

Width across path	2.18m
Depth along path	1.72m
Rise from previous step	200mm

Small cobbles set on edge to form a pattern but damage to the centre and the back of the step makes the design hard to interpret.

Both the RHS and LHS of the step are bordered by four to five lines of cobbles running parallel to the walls. The front of the tread is formed of three flat dressed stones.

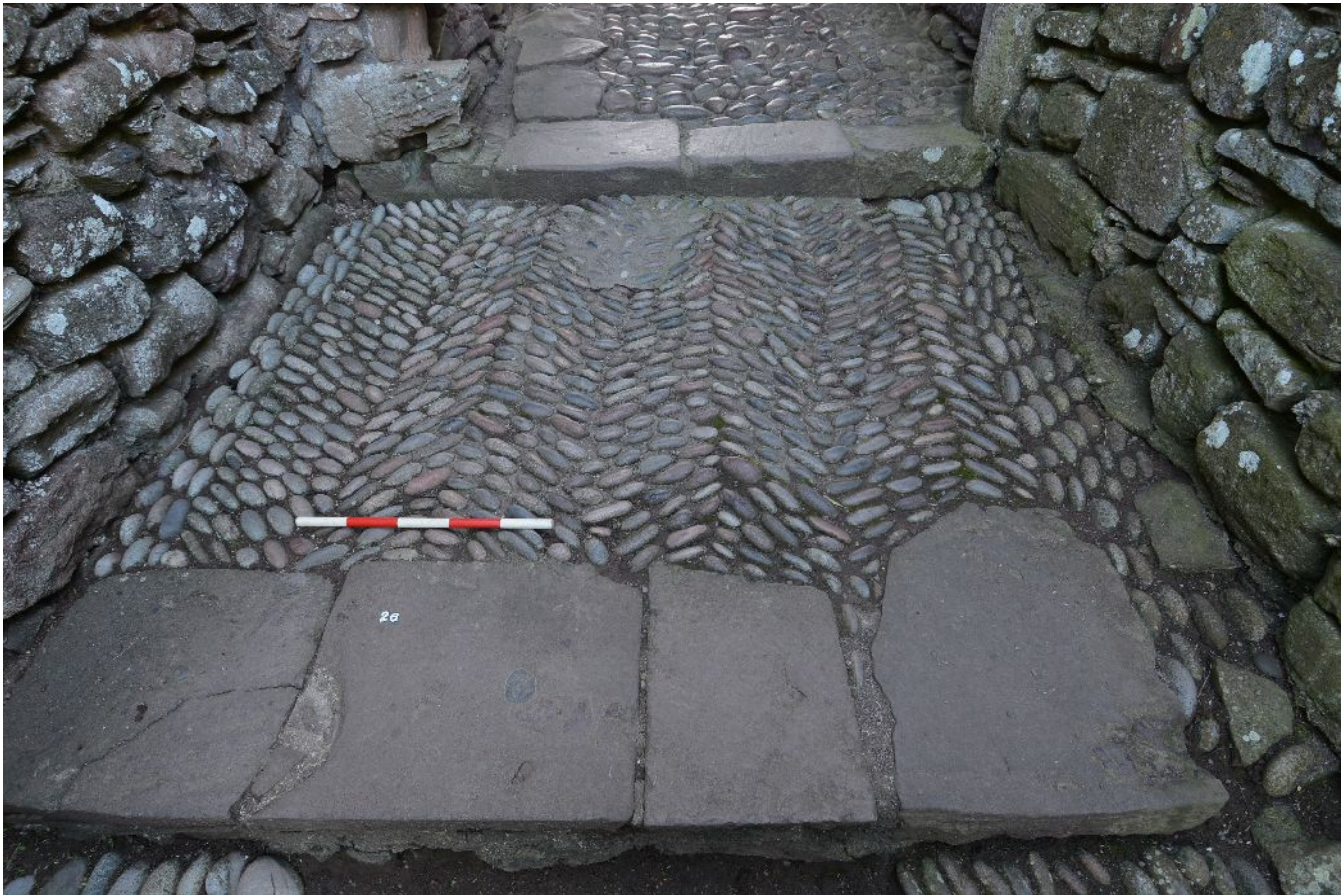
Illus 35 Step 26

Width across path	2.10m
Depth along path	1.84m
Rise from previous step	170mm

Small cobbles set on edge to form a herringbone pattern. Although completely level, the design gives a strong impression of gullies. This is another of the more undamaged steps with only slight damage at the back of the step.

Both the RHS and LHS of the step are bordered by three to four lines of cobbles running parallel to the walls. The front of the tread is formed of four flat dressed stones.

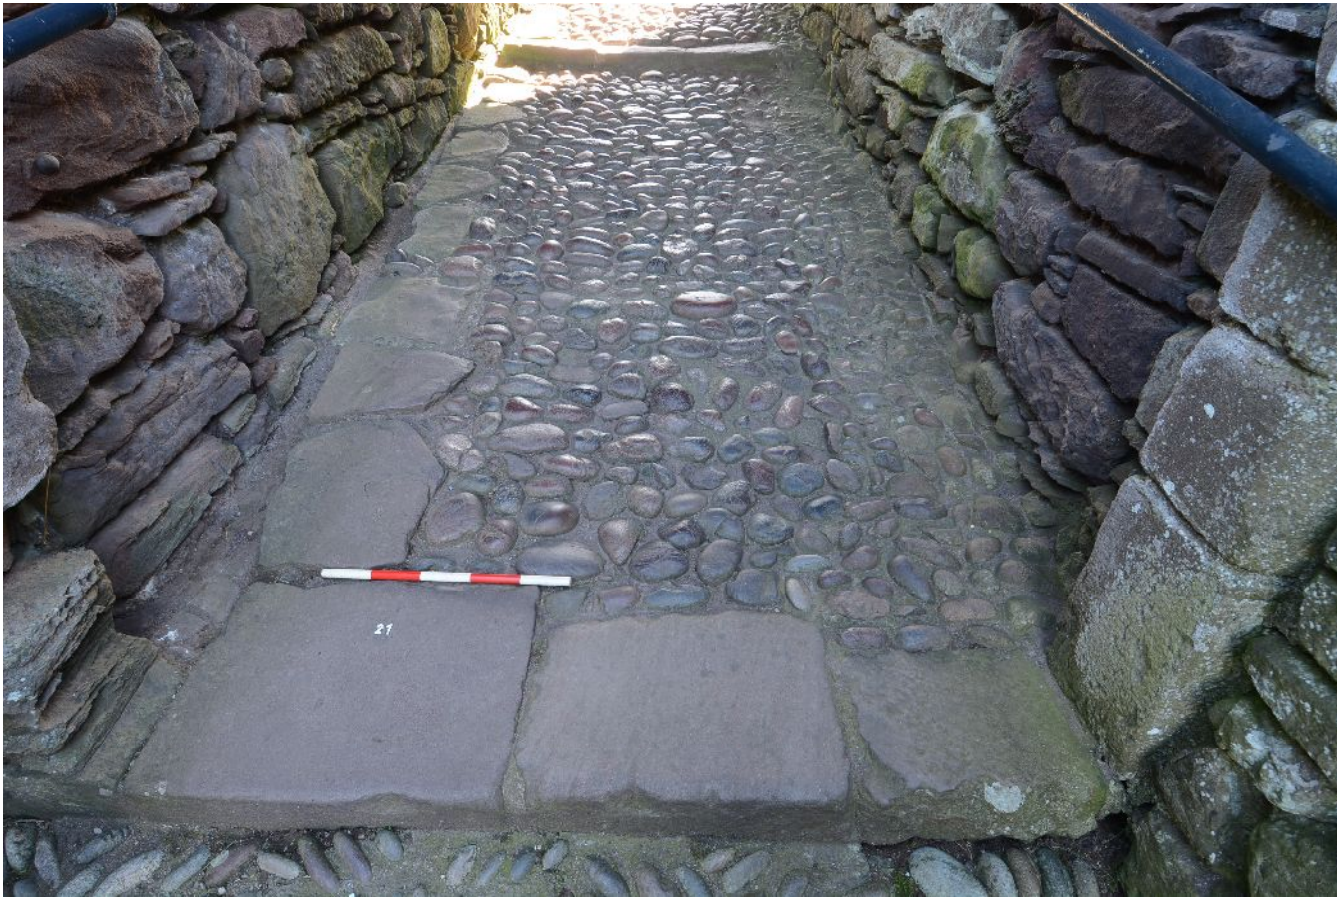
Illus 36 Step 27

Width across path	1.77m
Depth along path	4.09m
Rise from previous step	100mm

Large cobbles set in a random arrangement with large irregular slabs along the LHS edge.

The front of the tread is formed of three flat dressed slabs.

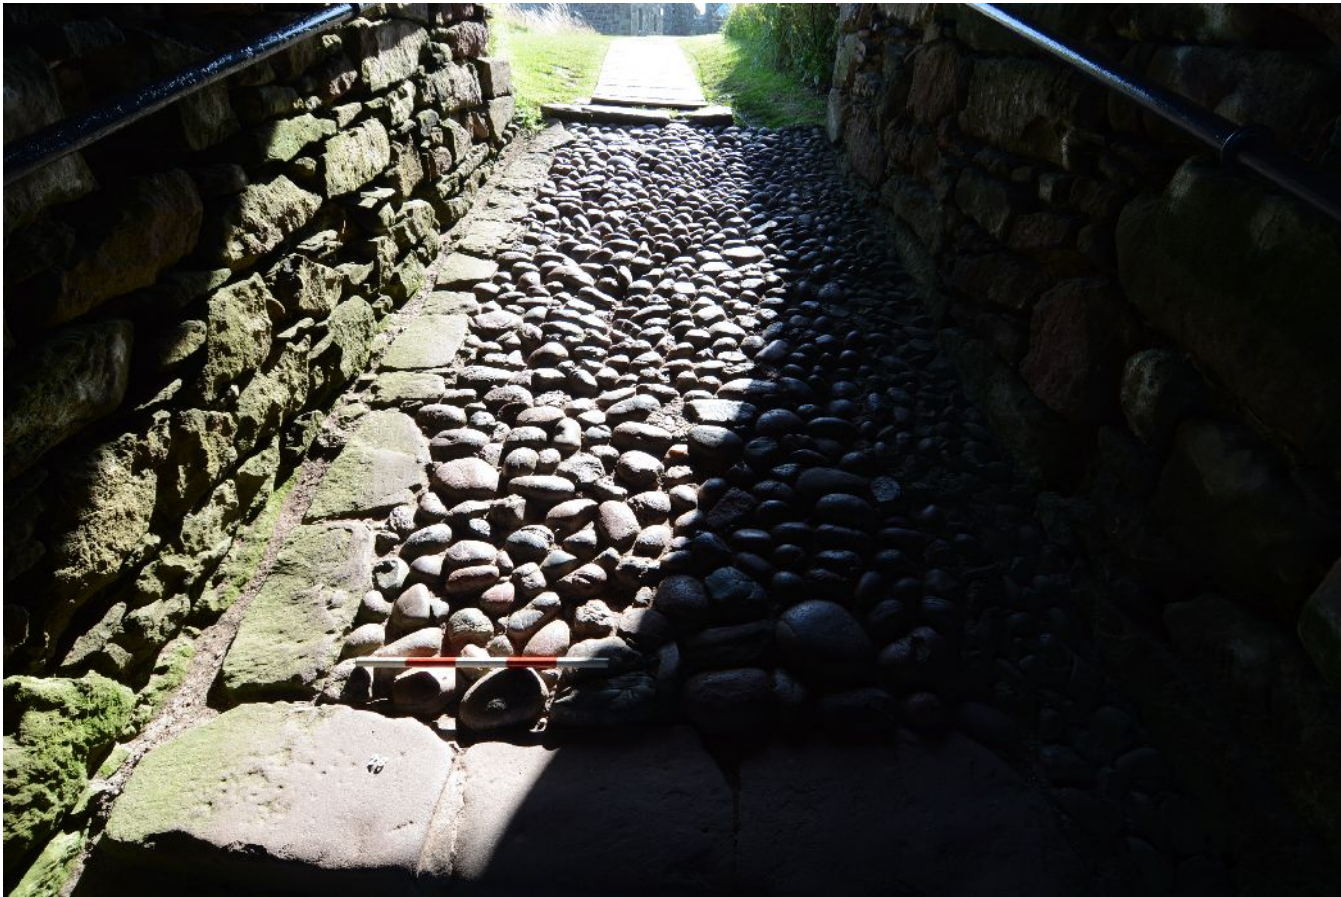
Illus 37 Step 28

Width across path	1.78m
Depth along path	4.22m
Rise from previous step	700mm

Large cobbles set in a random arrangement with large irregular slabs along the LHS edge.

The front of the tread is formed of three flat dressed slabs.

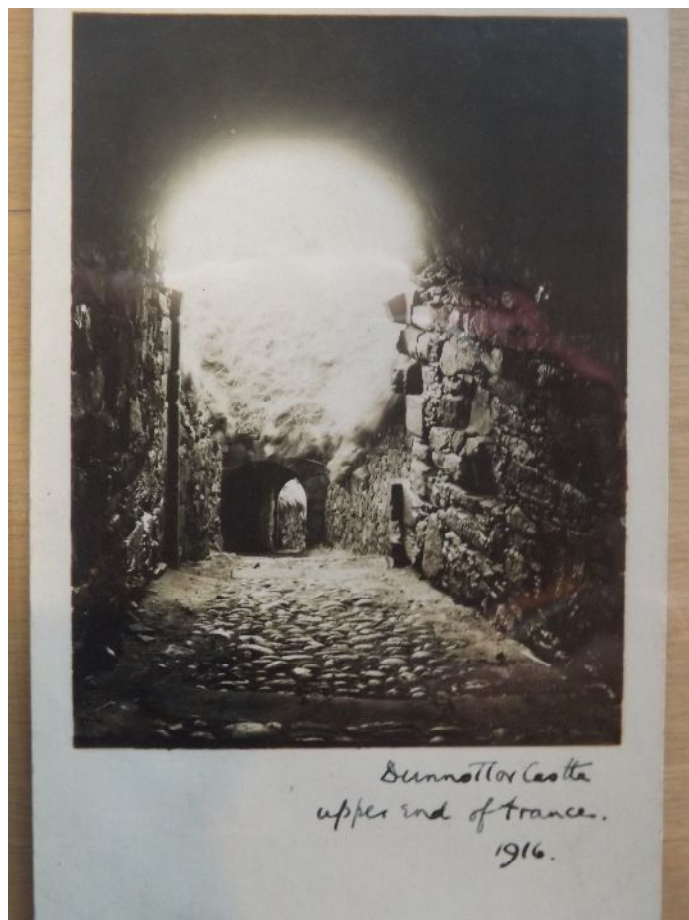
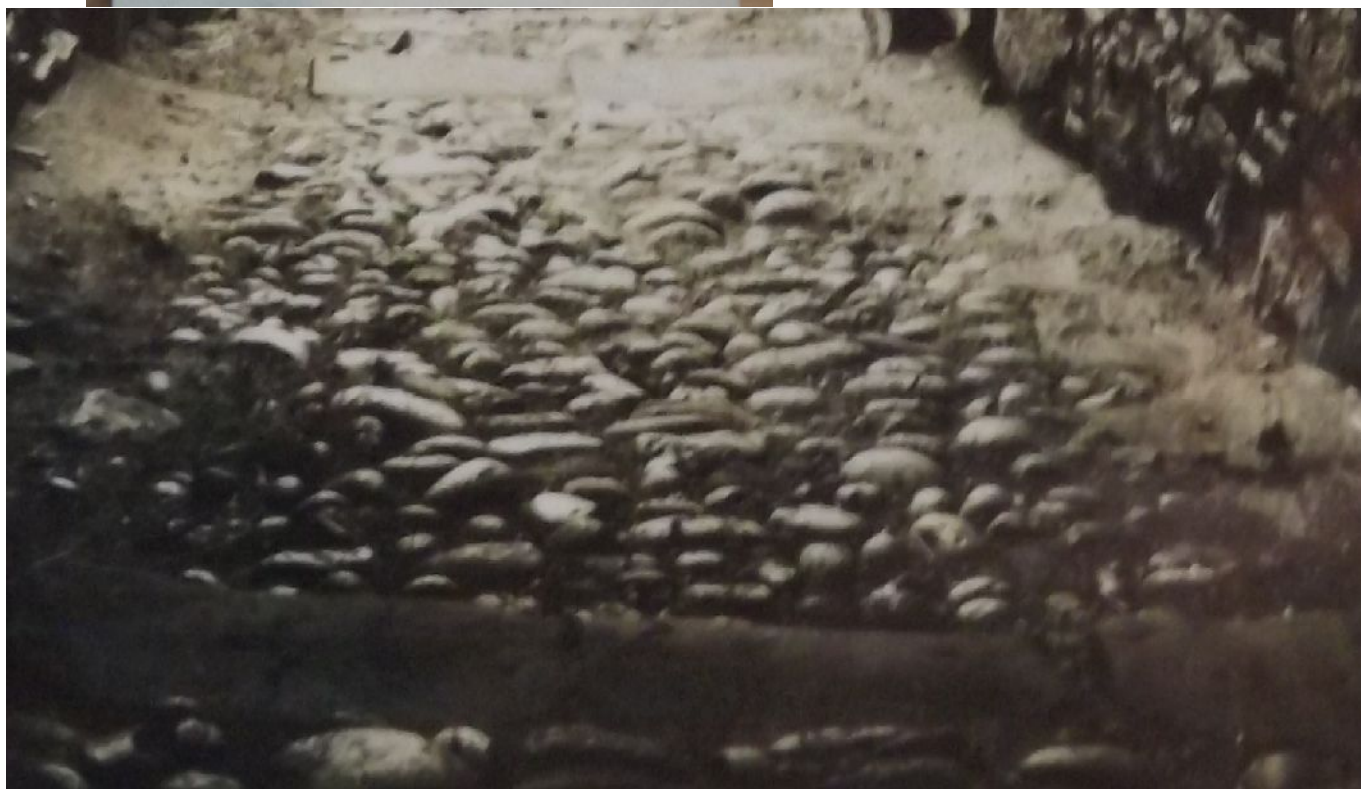
Illus 38 1916 photograph of Step 27 and detail of cobbles (HES Dunnottar file 1916-5)

Steps 27 and 28 also have larger cobbles but a photograph dated to 1916 (HES 1916-5) (Illus 38) appears to show these large, randomly placed cobbles were in place prior to the 1925 works. It is likely that individual stones may have been replaced or re-bedded as necessary over the years but it should be noted that the edging stones and the slab drains along the wall lines were in place at that time and should be retained.
