Lion's Den Lintols, Striling Castle

Archaeological Monitoring & Dendrochronological Assessment Survey

Written Scheme of Investigation

AOC 26813-59

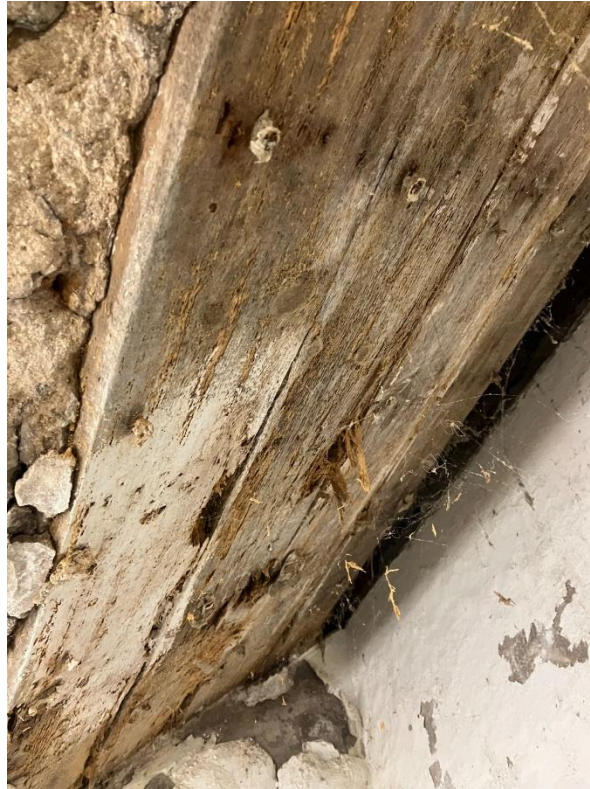
In the West range of the Palace, at vault level, wooden lintols in four locations have been identified as requiring replacement, as decay has led to them having no structural integrity, and there is a short bearing at the ends. The timber lintols above the steps in area B.11 (Fig 1) are bowing and have significant rot (Fig 2), and the lintols above the windows W:B.18, W:B.19 and W:B.20 in B.12 are also deteriorated (Fig 3).

Fig 2. Image of the timber lintols in B.11. Decay is visible and the poor condition is evident. Photograph taken by Lewis Brunton.

The lintols have been propped and the area above barriered off to avoid loading. Removal of the decayed lintols and replacement with concrete lintols has been proposed. The extent of these repair works means the age and significance of the timbers and surrounding masonry need to be taken into consideration.

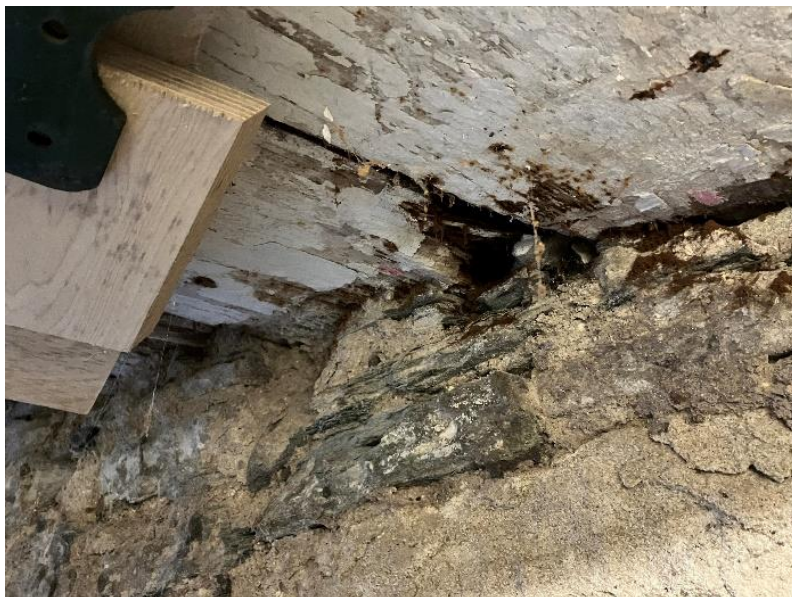
Fig 3. Timber lintols in B.12. This wood is spongy to the touch and decay has been principally at the ends of the timber, leaving the bearing very short.

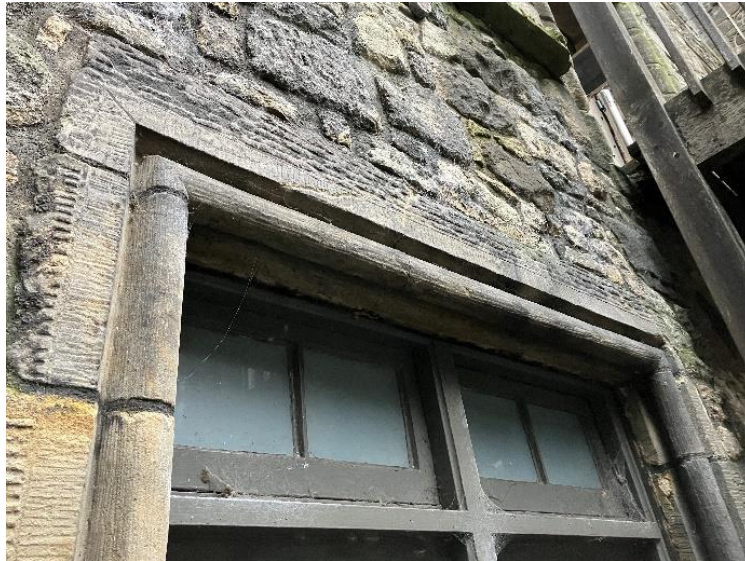
In addition, the external stone lintol to W:B.19 has a vertical crack in the centre (Fig 4). The proposed repair is the insertion of a 10mm thick bronze bar in the mortar joint below the lintol, with 150mm bearing on either side.

Fig 4. W:B.19. A vertical crack is visible near the centre of the stone lintol.

The stone lintol above W:B.19 is likely to date to the mid- to late-19th century, based on close architectural similarity with the additions by Robert Billings to the King's Old Building.

As the proposed stabilisation to the stone lintol at W:B.19 retains the lintol in situ, the proposed method would not be conspicuous so minimises physical and visual impact, while allowing for retention of historic masonry and contributing towards longer term conservation of the building as a whole.
