Lock 11 Dunardry

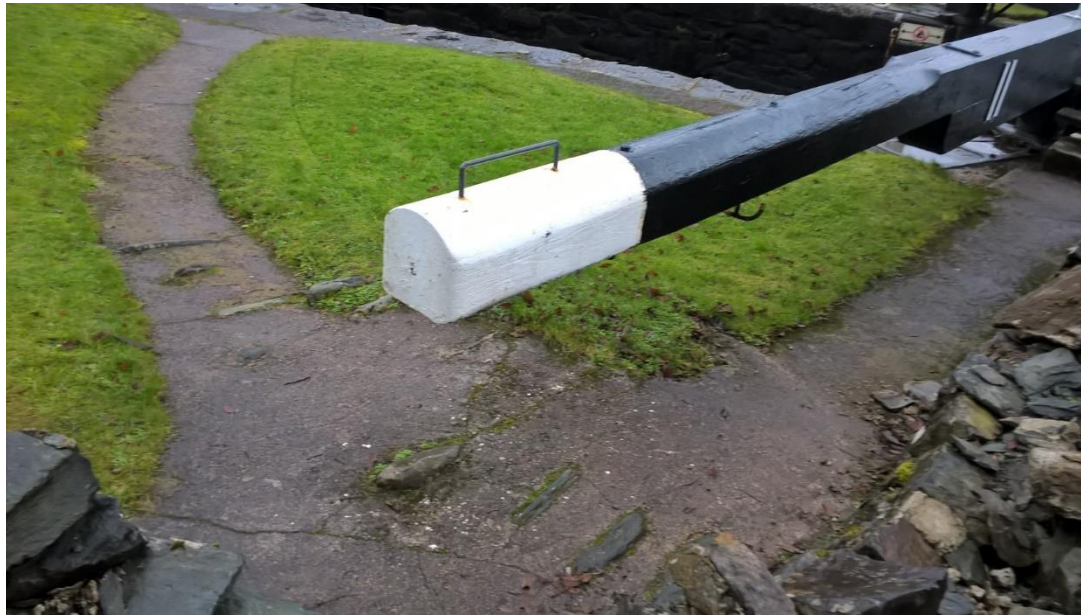
Picture showing existing stone and concrete quadrants.

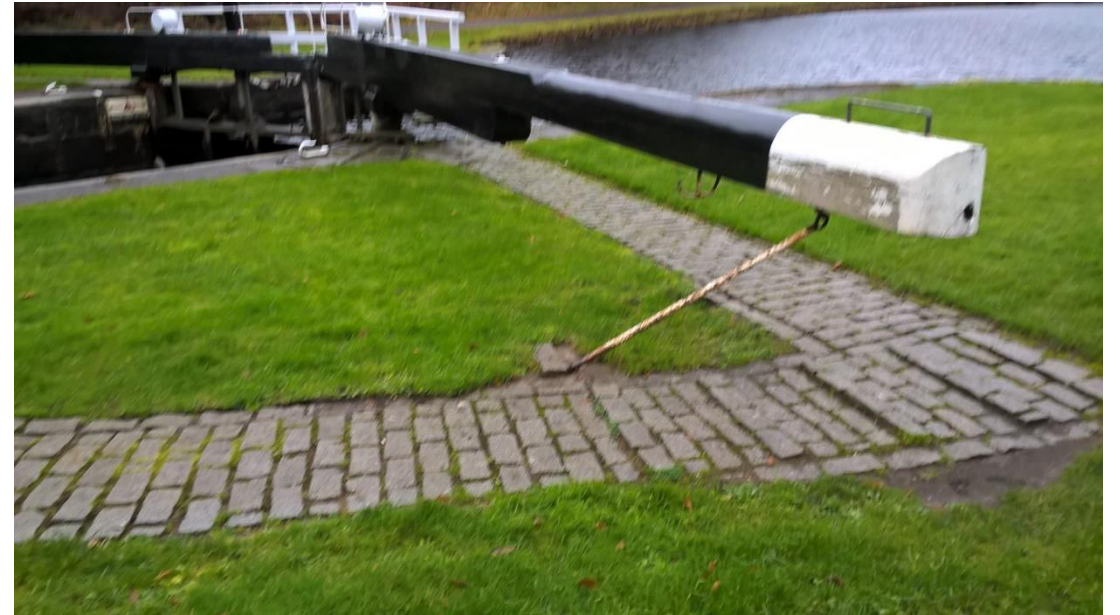
Picture showing typical Crinan Canal planned quadrants using granite setts.

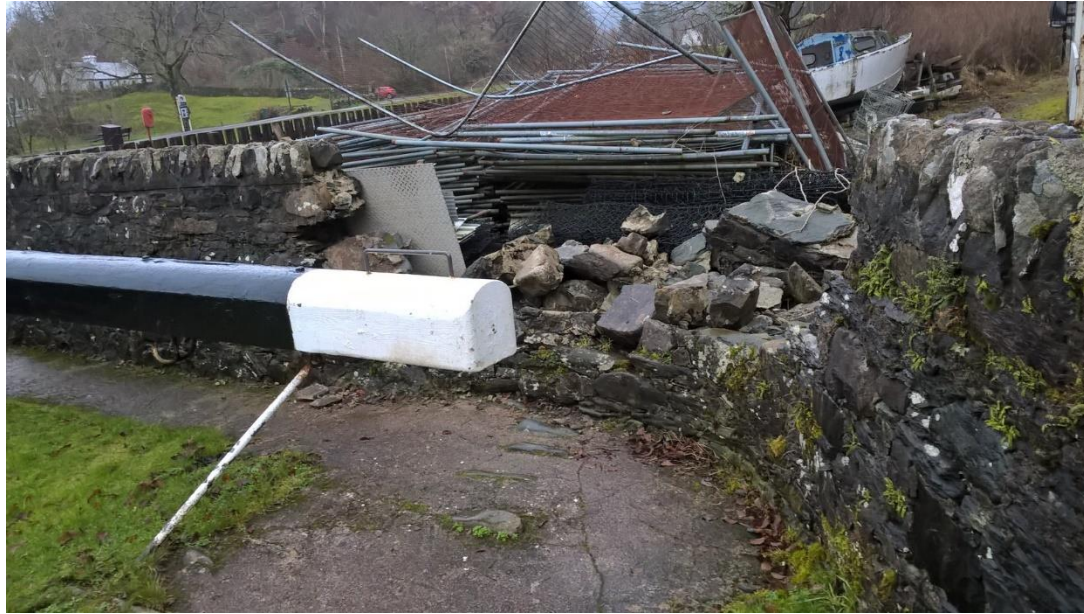
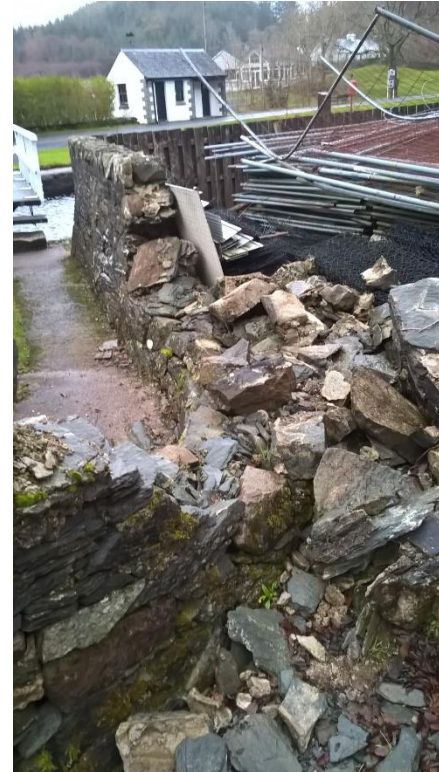
Pictures showing collapsed wall at Lock 11 to be rebuilt like for like.

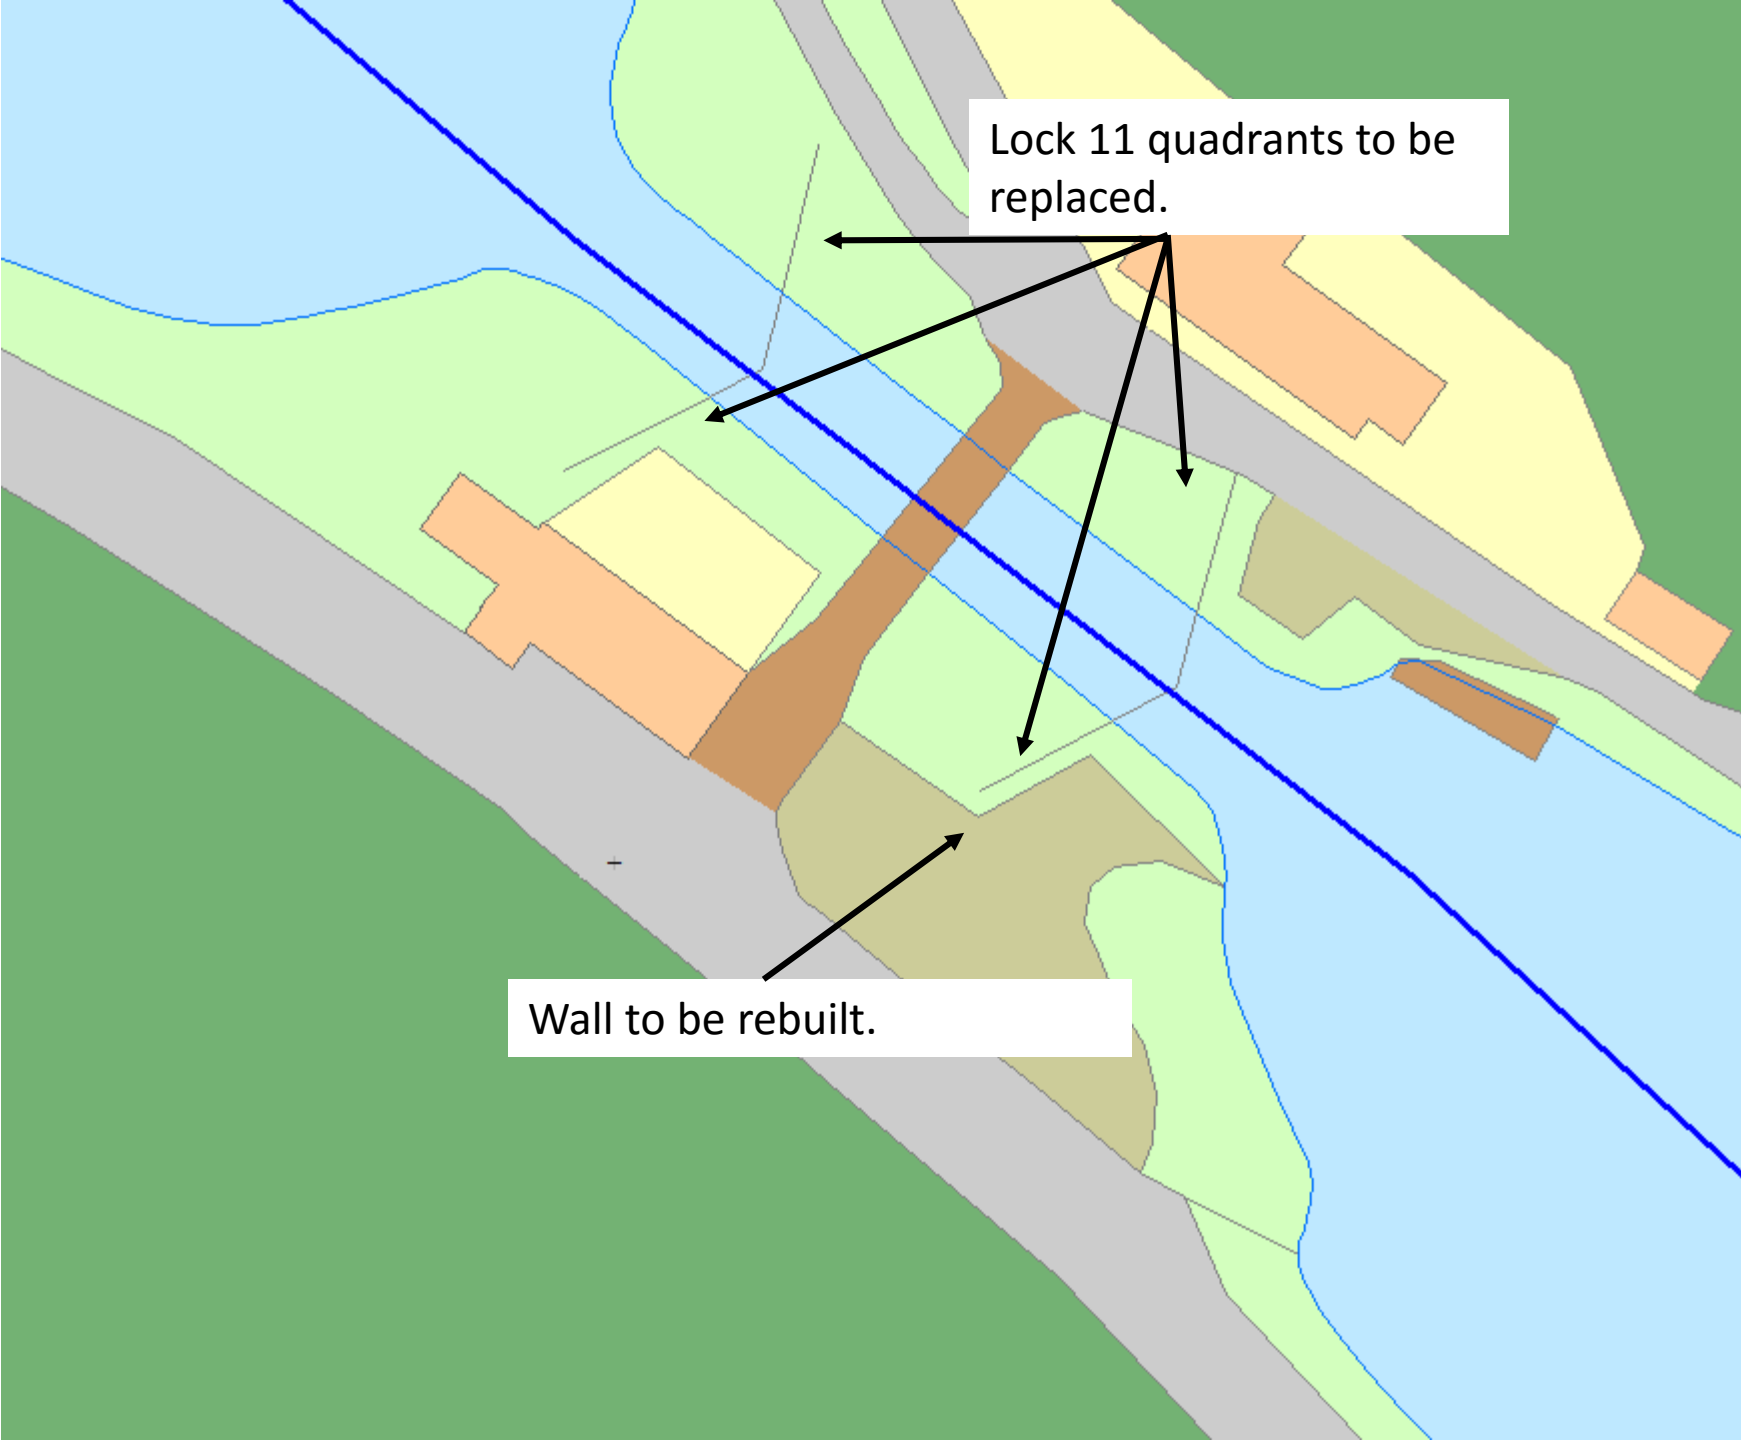
Lock 11 quadrants to be replaced.
