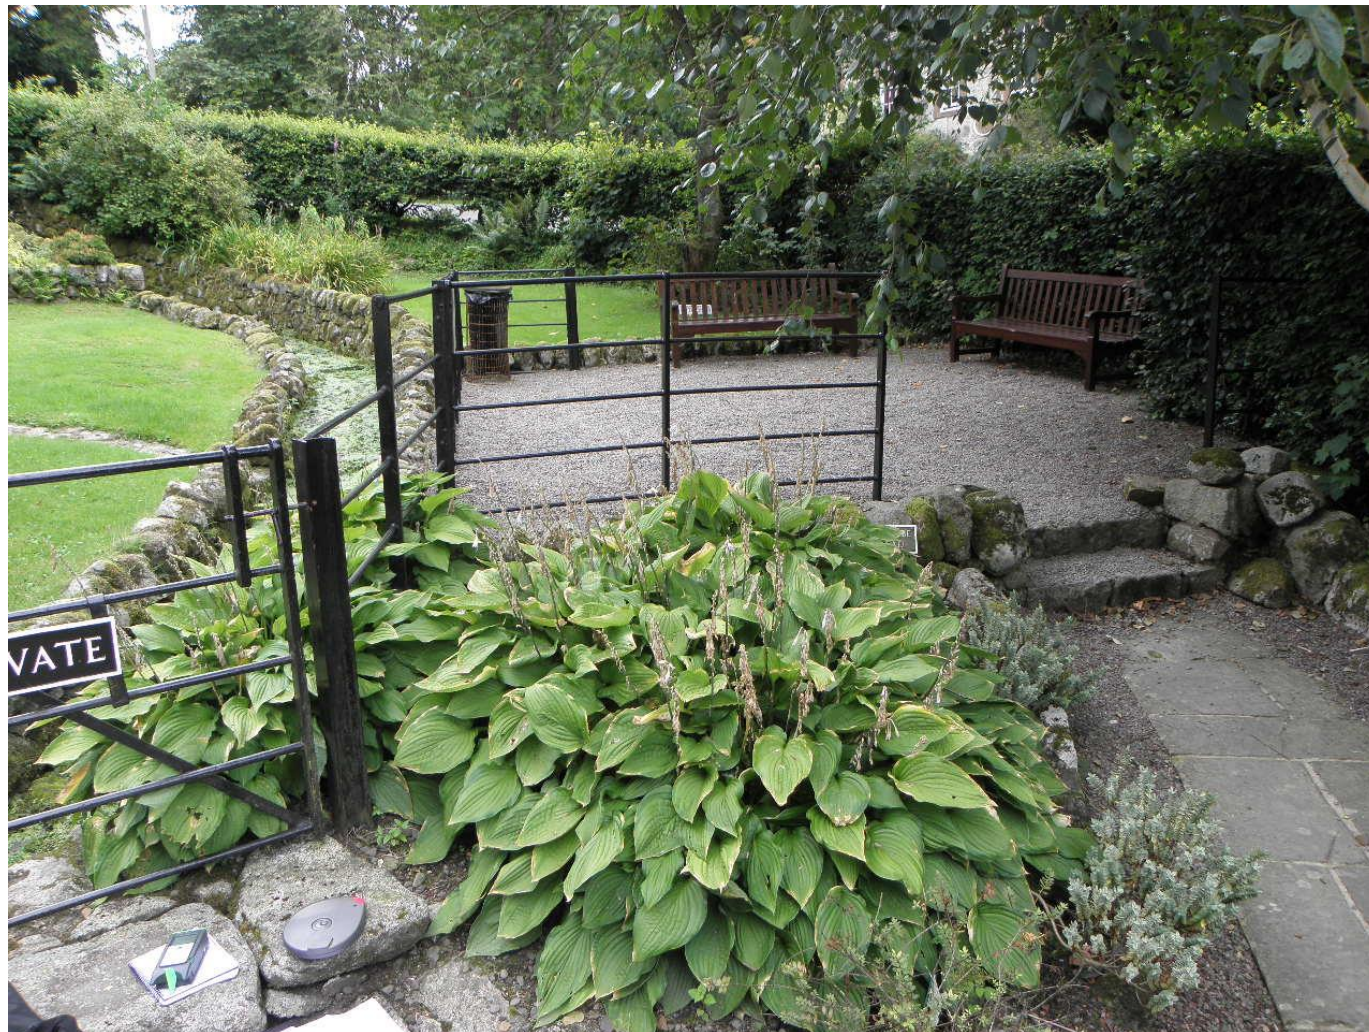
1. General view of garden area adjacent to west of Mill building before hedge was breached. The rubble wall and steps creating the gravelled viewing area terrace and estate railings are all 1980s or later in date.

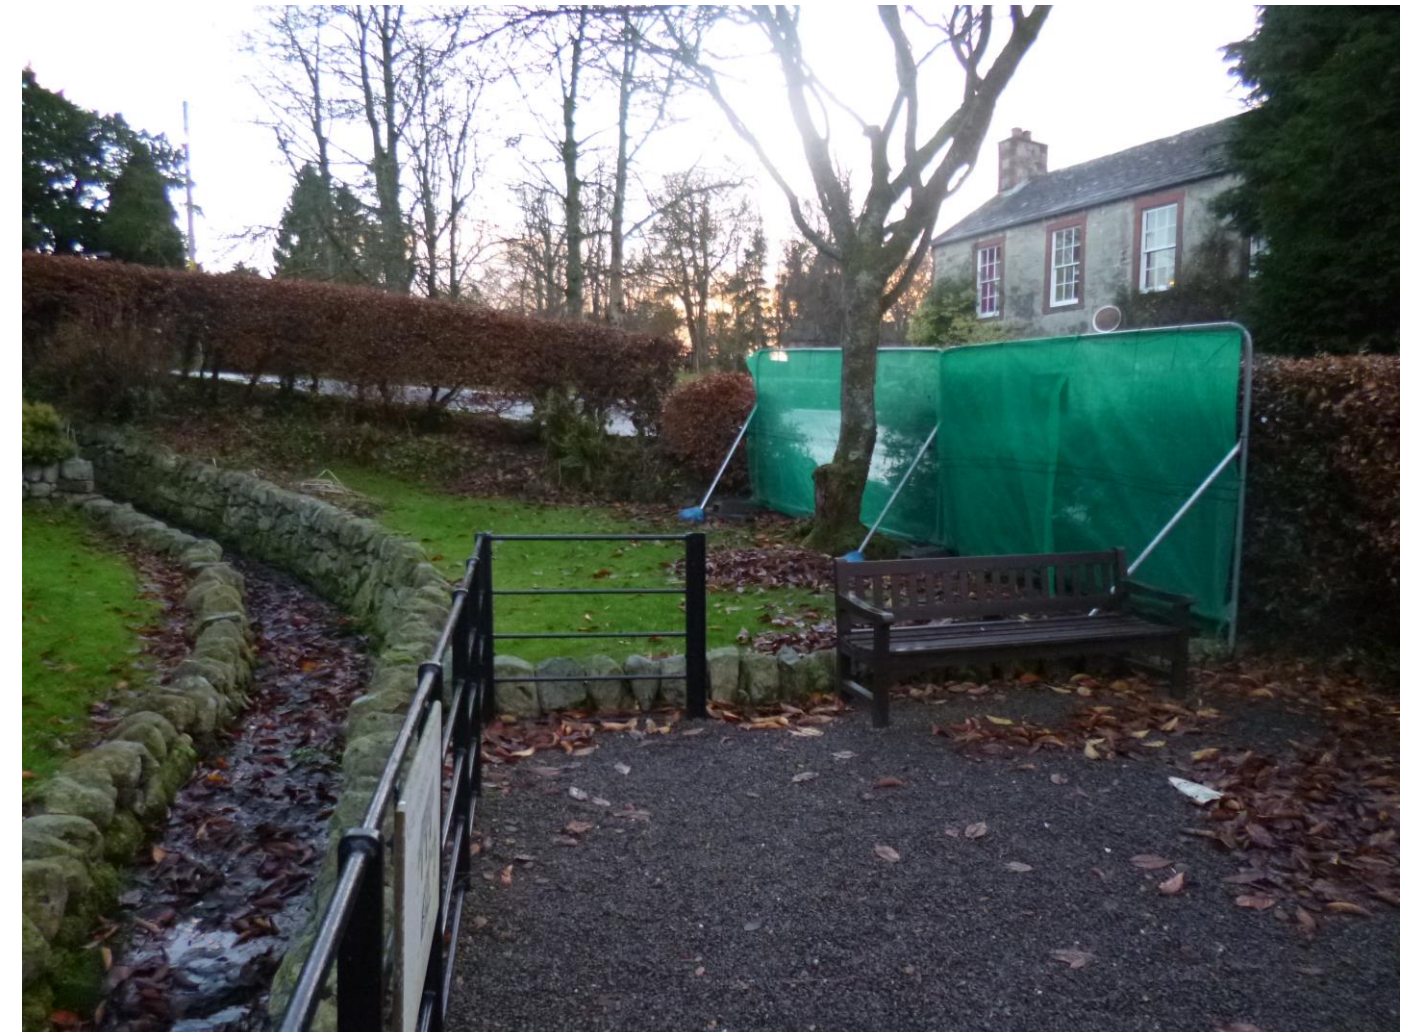
11. View of garden area adjacent to west of Mill building showing breached hedge, damaged cherry tree and area where ground would be reprofiled under submitted proposals.
