# Caisteal Bharraich, Tongue Supporting Statement

February 2016

Caisteal Bharraich  
1467J  
Ben Loyal Estate  
Sutherland

Groves-Raines Architects Ltd.  
with:  
David Narro Associates  
Structural Engineer  
Morham & Brotchie  
QS  
CFA Archaeology  
Archaeologist

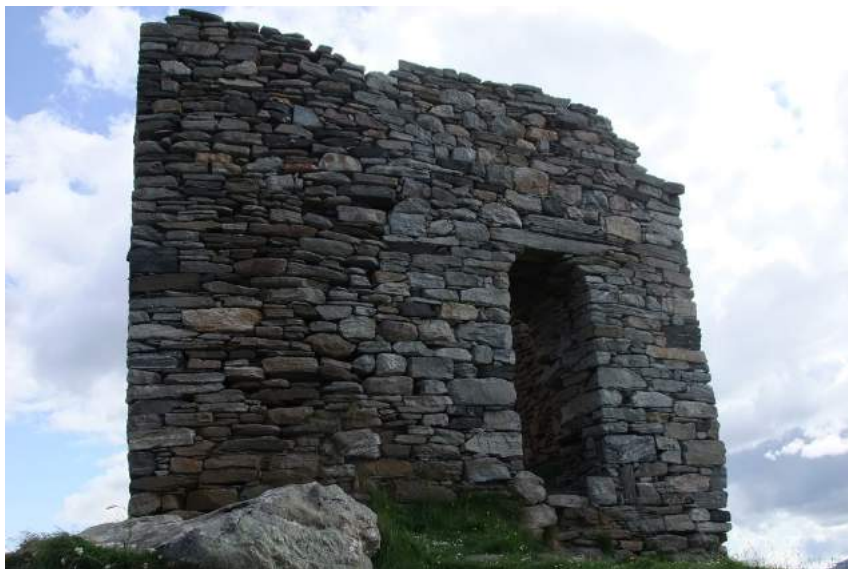
Fig. 9: North wall

North elevation - This wall contains an external door opening with corbelled head. The sill of this opening is well above the current external ground level, and heavily eroded so that it is impossible to confirm the original internal floor level. To the east side of the door there is a change in the masonry following a roughly vertical line; the stones are smaller, flatter and darker than to the east.

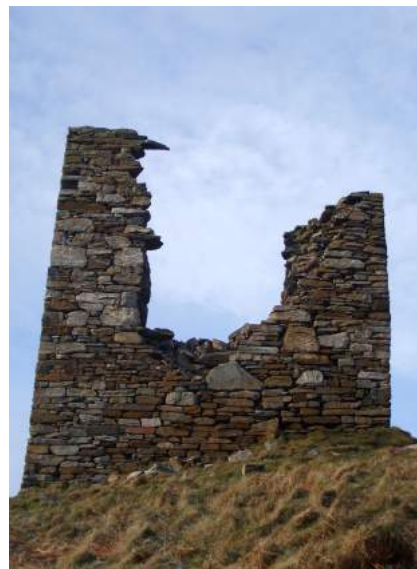
Fig. 10: East wall

East elevation - The centre of the wall is the location of the recent collapse down to the internal floor level, with the rubble from the collapse mainly left inside the building. Several cantilevering stones have been left at high level and these are a danger. This is some evidence, in the form of what might be smooth jambs and perhaps stubs of a sill and lintel, to suggest that there was a window opening at first floor level, which has possibly contributed to the recent collapse. A mortar sample was taken from the area of collapse, and found to consist of lime mortar incorporating local beach sand

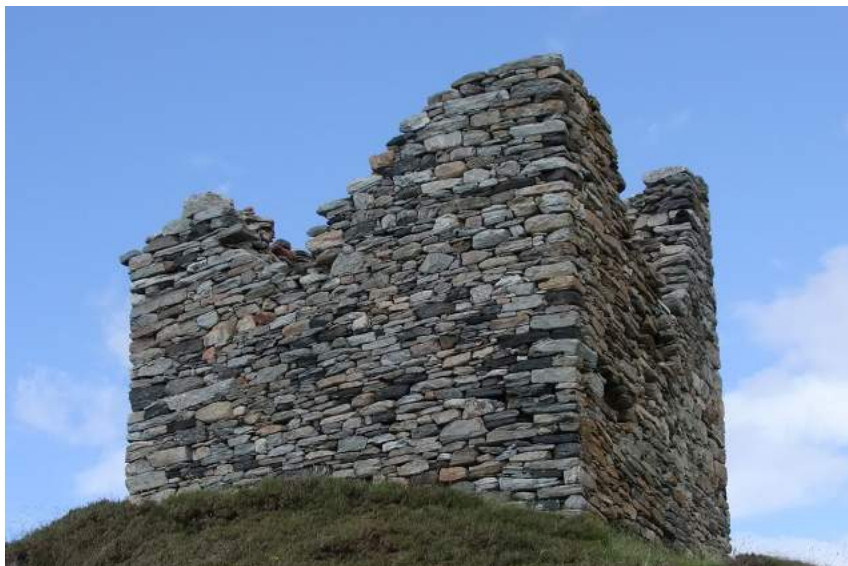
Fig. 11: West wall

West elevation - The centre of the west wall bows outwards, possibly as a result of mortar erosion within the wall. There is also some loose masonry at wallhead level.

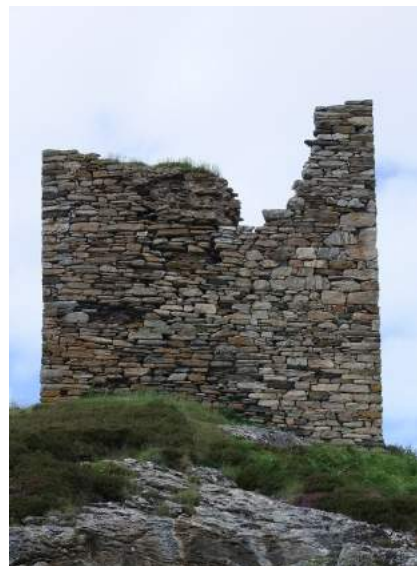
Fig. 12: South wall

South elevation - The centre of the south wall has experienced significant movement and there is now a large semi-vertical crack and pockets of missing facing stones exposing the wall core.

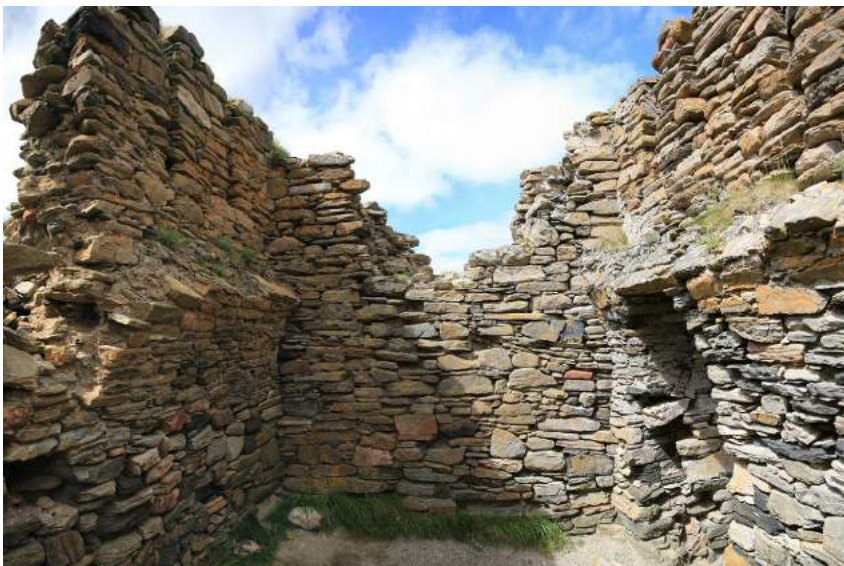
Fig. 13: Internal view looking West - showing remnants of vaulted ground floor and wall slots

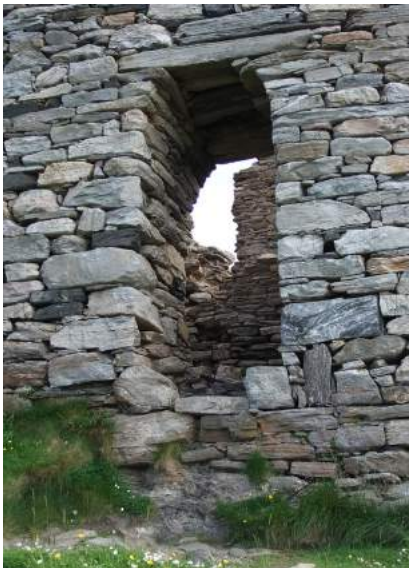
Fig. 17: View of North doorway

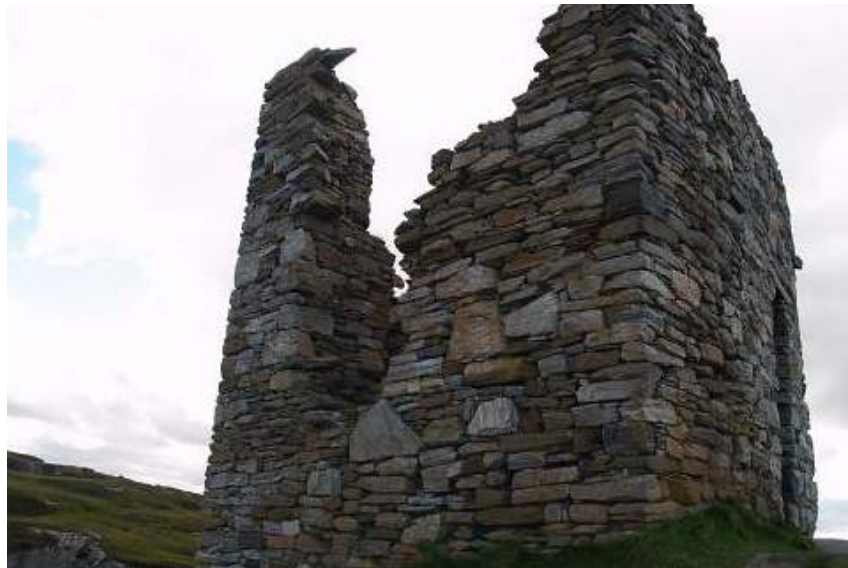
Fig. 18: View of East elevation before collapse of early 2015

4. Once the immediate work area is safe, the contractor is to go about the task of salvaging fallen stone. The contractor should refer to the provided photographs of the East Wall prior to collapse and attempt to find key facing stones. Prominent stones visible in the photos of pre-collapse should be numbered on the photos and matching stones found on site correspondingly numbered with chalk.

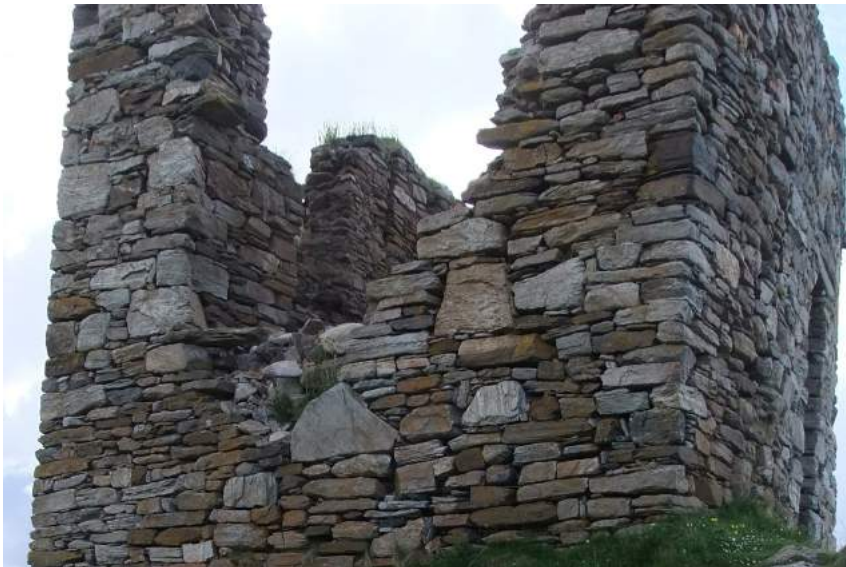
Fig.19: View of East elevation during 2015, following collapse

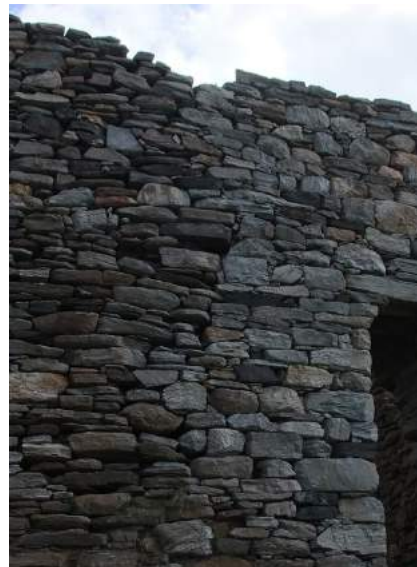
Fig. 20: View of North wall masonry change

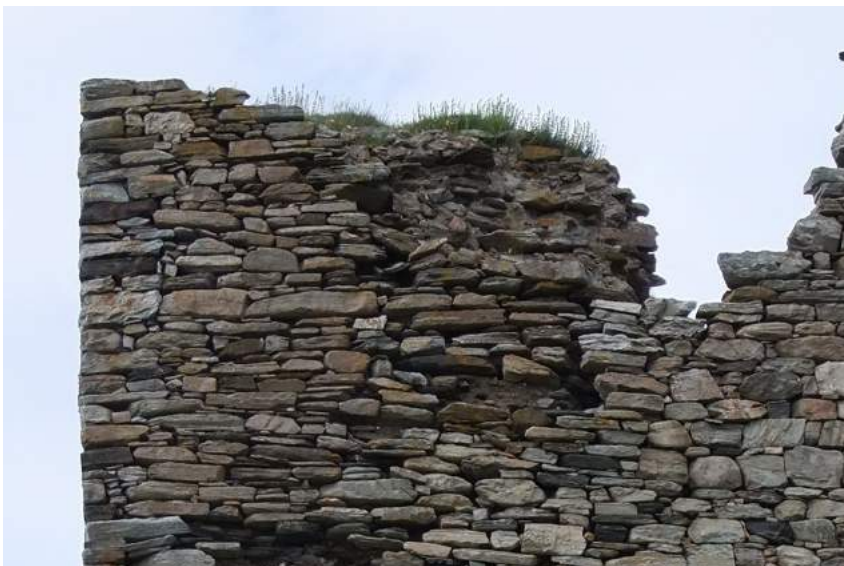
Fig. 21: View of South wall showing significant loss of facing stones

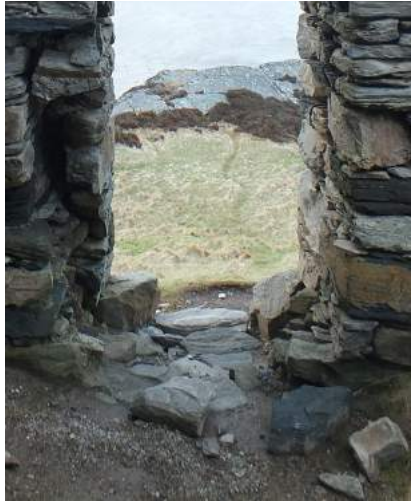
Fig. 23: View of North door threshold

At present, physical access is difficult and unsafe due to the c.1m climb up to the entrance doorway and the possibility of falls from heights. Damage is also occurring to the entrance doorway threshold and some other limited areas, possibly as a result of visitors clambering up and accidentally disturbing masonry. Information on the history of the site and the original form of the building is limited and currently provided by a single signboard with a simple illustration. These works would focus on increasing visitor access, safety and appreciation, again using the guiding principles of minimum intervention and reversibility, and would be integrated with the consolidation and repair works in order to reduce their impacts.

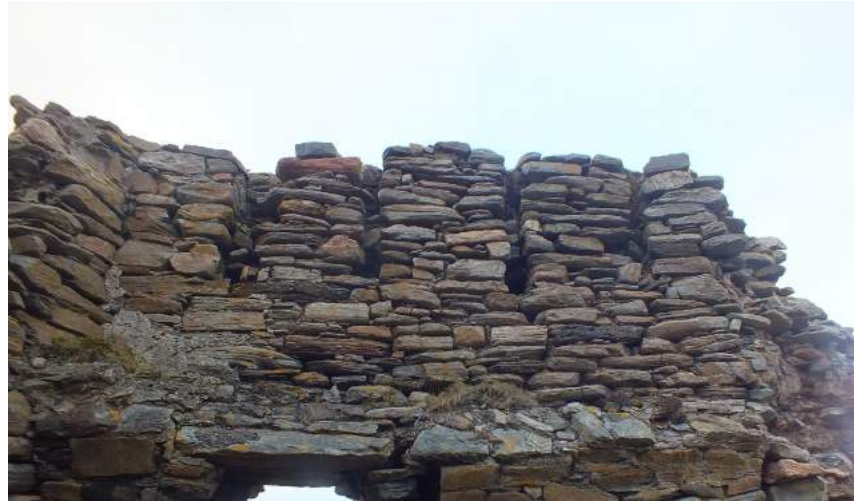
Fig. 24: view of wallhead slots on North elevation

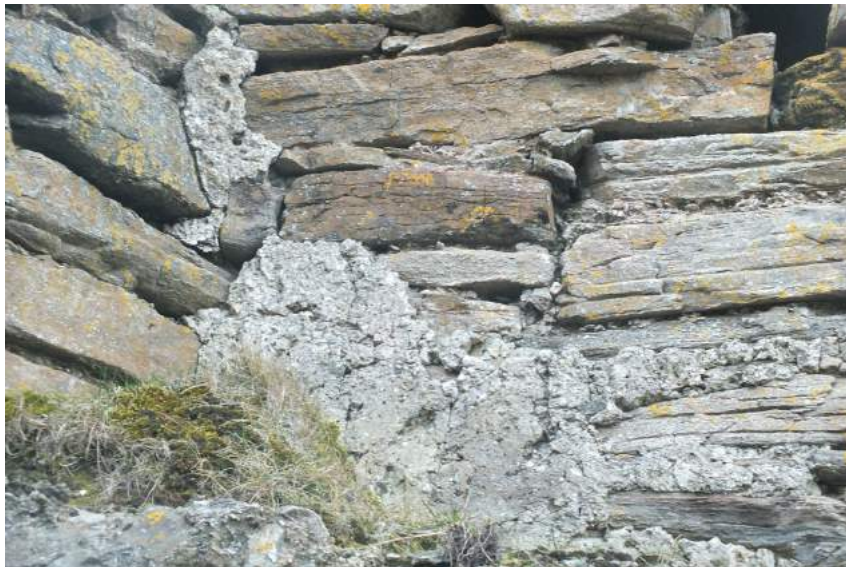
Fig. 23: Internal view of plaster remnants over North doorway

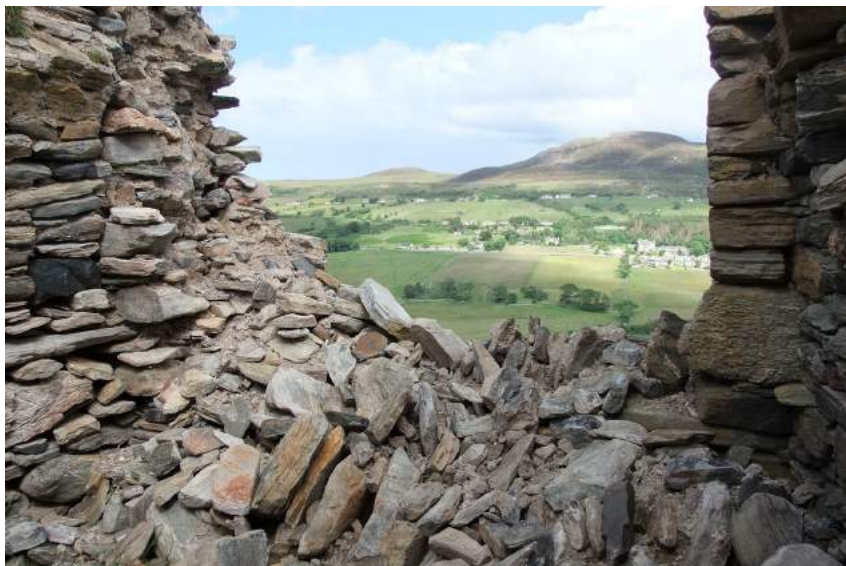
Fig. 25: Internal view of east elevation and area of recent collapse

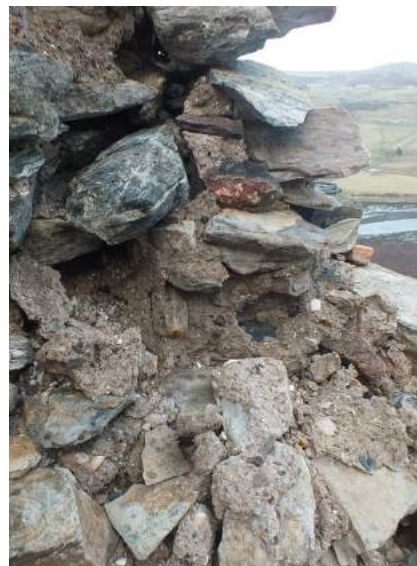
Fig. 26: Detail view of collapse area

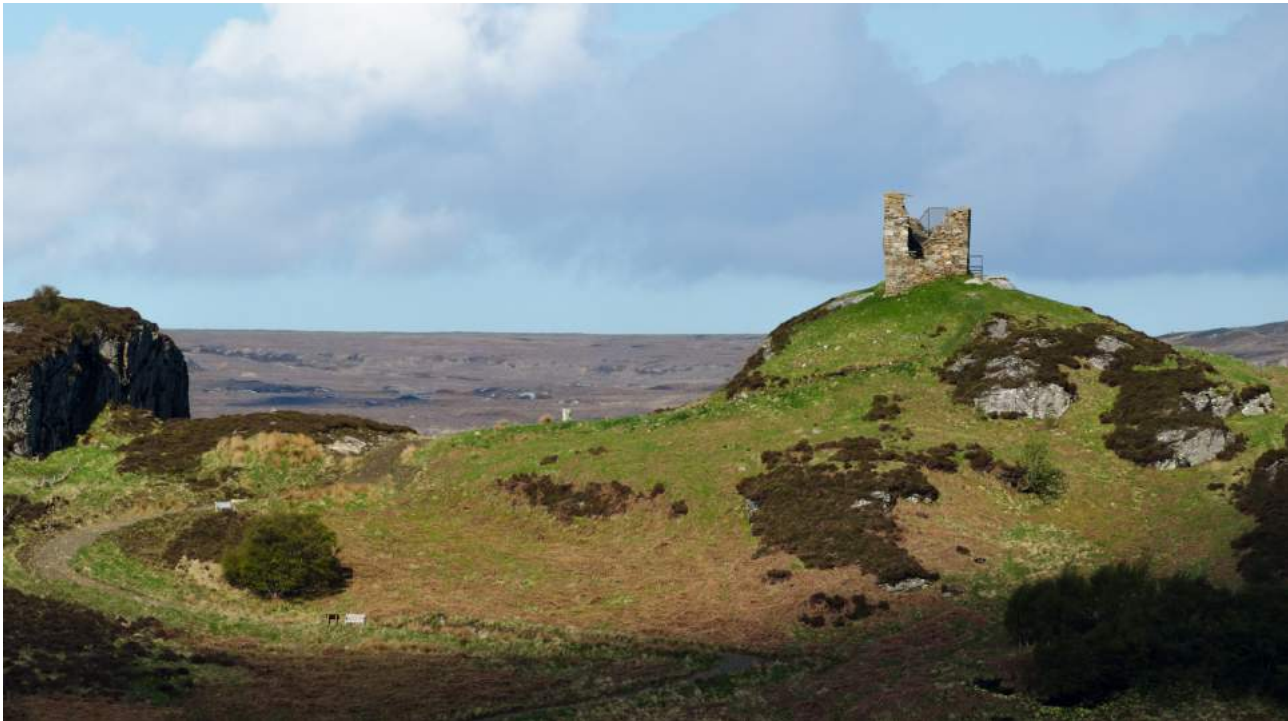
Fig. 28: Enlarged view of castle from approximately 1.2km away at Point A (see Fig. 34) with collage representation of proposed stair & viewing platform. Please note that this does not represent the view visible with the naked eye - refer to Fig.29.

Forming a new entrance stair and viewing platform with secure protective barriers and non-slip surfaces should help to improve safety, widen the range of people that could access the building and want to climb up to the site, and reduce instances of visitors climbing on the historic fabric and causing accidental damage. The interventions that are proposed would certainly add a new dimension to the visitor experience.

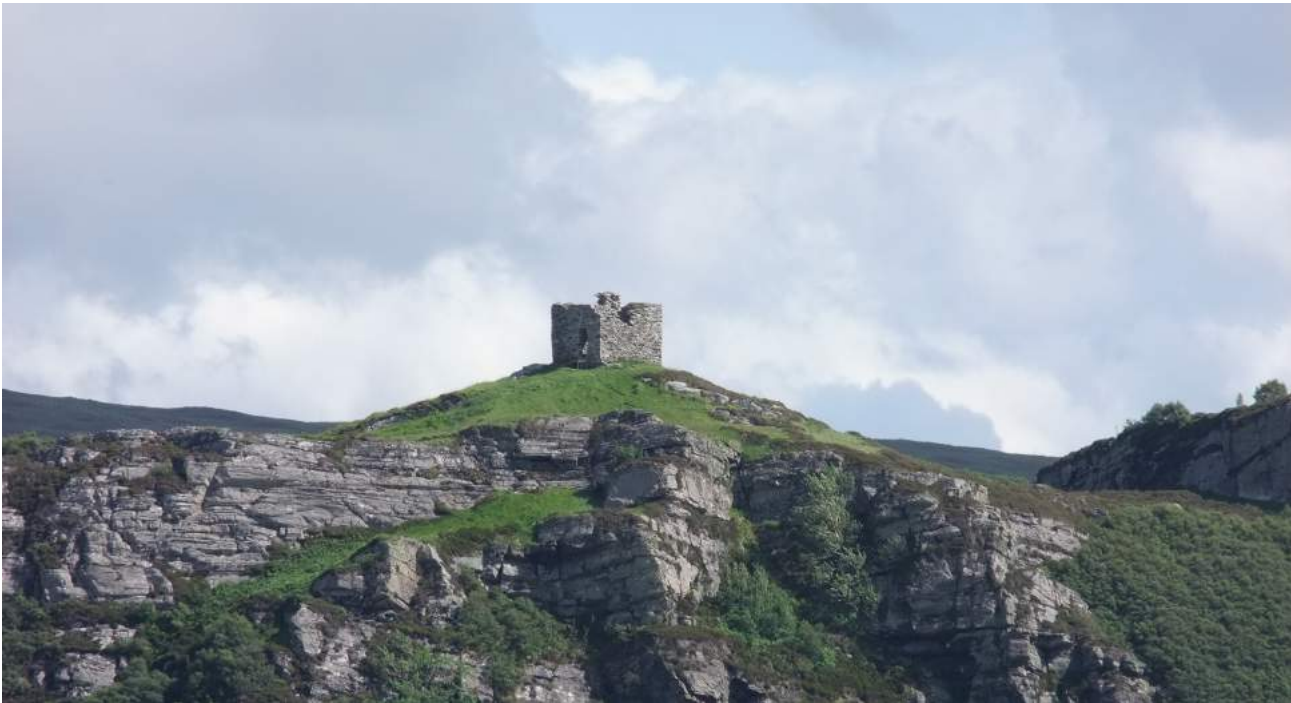
Fig. 32: Enlarged view of castle from Point C (see Fig. 34) showing proposed access steps at the entrance on the North elevation.

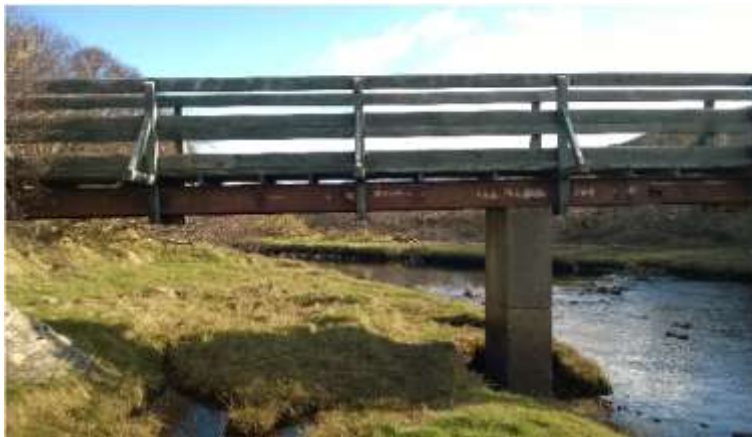
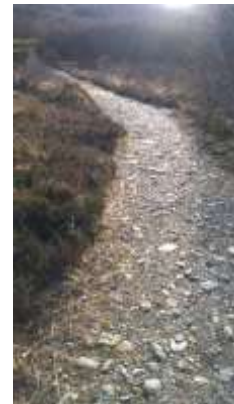
Photograph 1 & 2

Access to the site is somewhat limited. If a temporary bridge can be constructed then a quadbike & trailer (or similar) would be suitable. Fencing and controlled pedestrian gates will need to be removed temporarily for access.

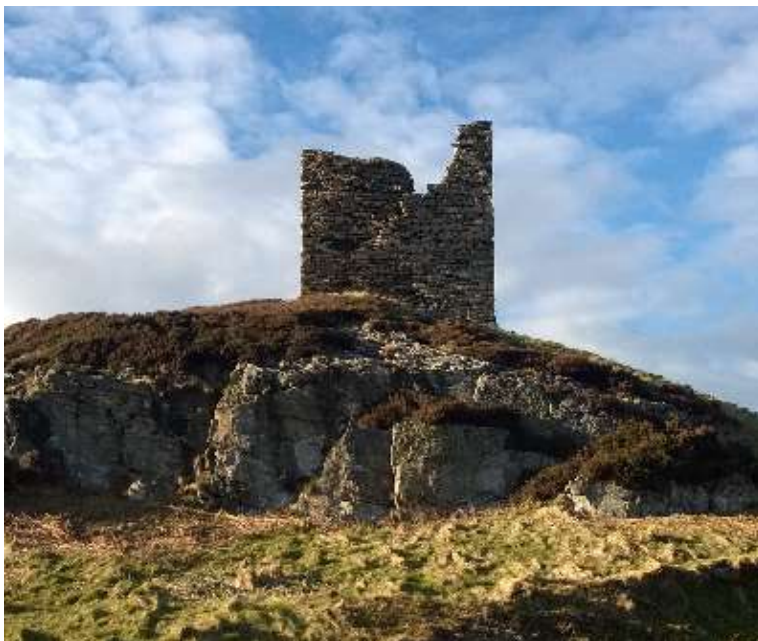
Photograph 3

The above photograph 3 shows the underlying bedrock as a metamorphic material, as expected of this location. The bedrock itself appears to be in good condition, no evidence of erosion that may affect the footing of the structure. During the consolidation works scaffolding is needed to be raised to support the facades and assist in the repair works. This scaffolding can be anchored into the bedrock, care must be taken around the west and northern areas due to the very steep topography.

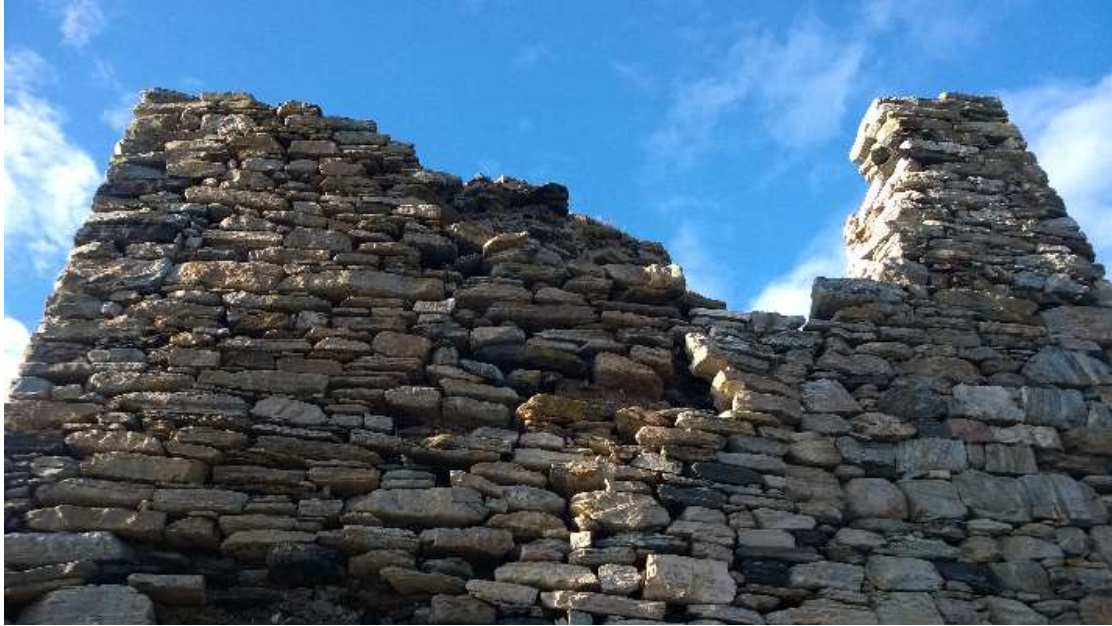
Photograph 4

The South elevation of the structure appears to initially be 2 separate leafs, however upon closer inspection it can be deduced this formation is due to significant movement within the centre of the wall panel. A series of pinning back facing stones to the core of the wall is required. Where this is not feasible the stones should be taken down and re-laid using a suitable mortar. Note that the relaying of the wall should be done to imitate the original courses. There is a pocket of stone missing due to weathering of the walls at the bottom left. This is seen in photograph 5 below.

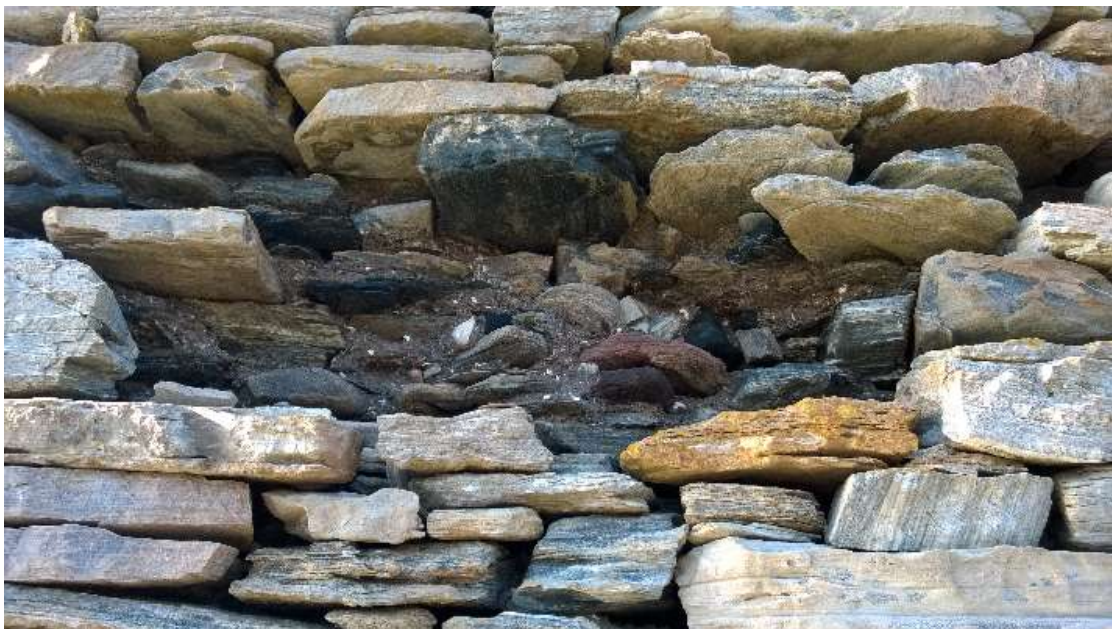
Photograph 5

The original mortar of the structure consists of a sand, shell and lime material typical for its location and age. This is seen in the above photograph. Due to the erosion of the mortar there is localised pocketing of the stones within the wall as seen on the Southern elevation. The core of the stones are still embedded suitably in the wall, a

packing exercise should be carried out to finish the face of the wall. Packing should be carried out sensitively, using the same stone where possible and a suitable lime mortar.

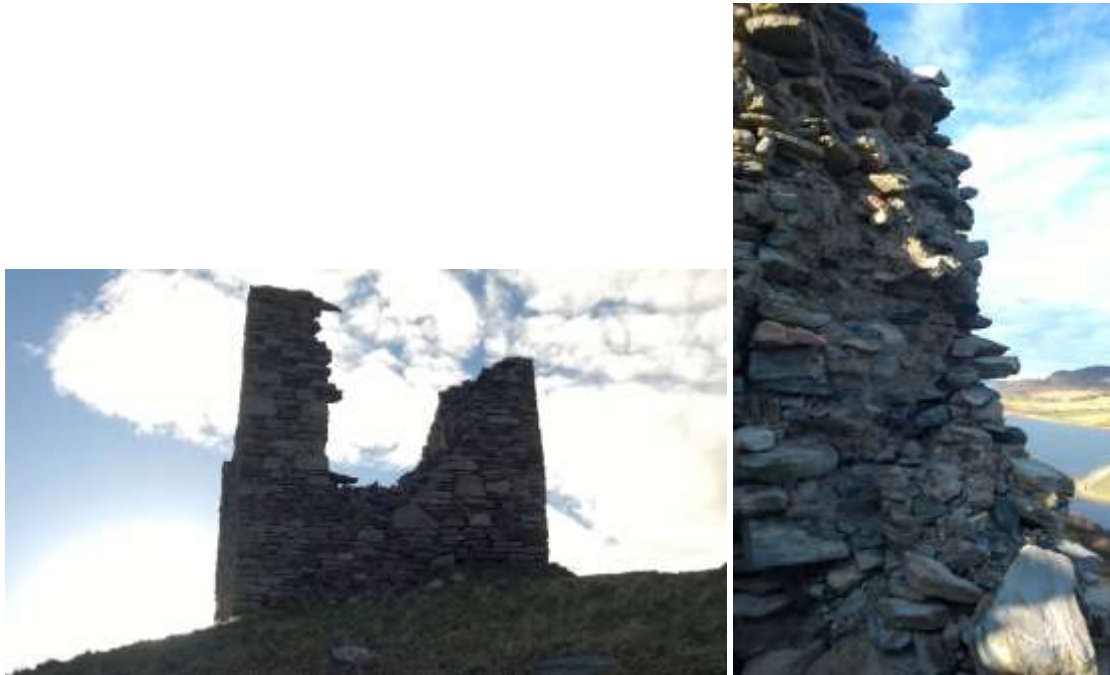
Photograph 6 & 7

The east elevation has an existing opening that has collapsed. It was highlighted that this elevation was the location of the recent collapse to the Northern, right hand side, of the elevation. The exposed rock face in photo 7 shows the recent collapse in 2005. There are still some stones that appear to be unstable at the southern side of the east elevation that should be taken down or re-laid to ensure stability of the elements. This should be considered for all wall heads for the castle. A soft copping such as turf should be considered to assist in keeping the inner walls dry.

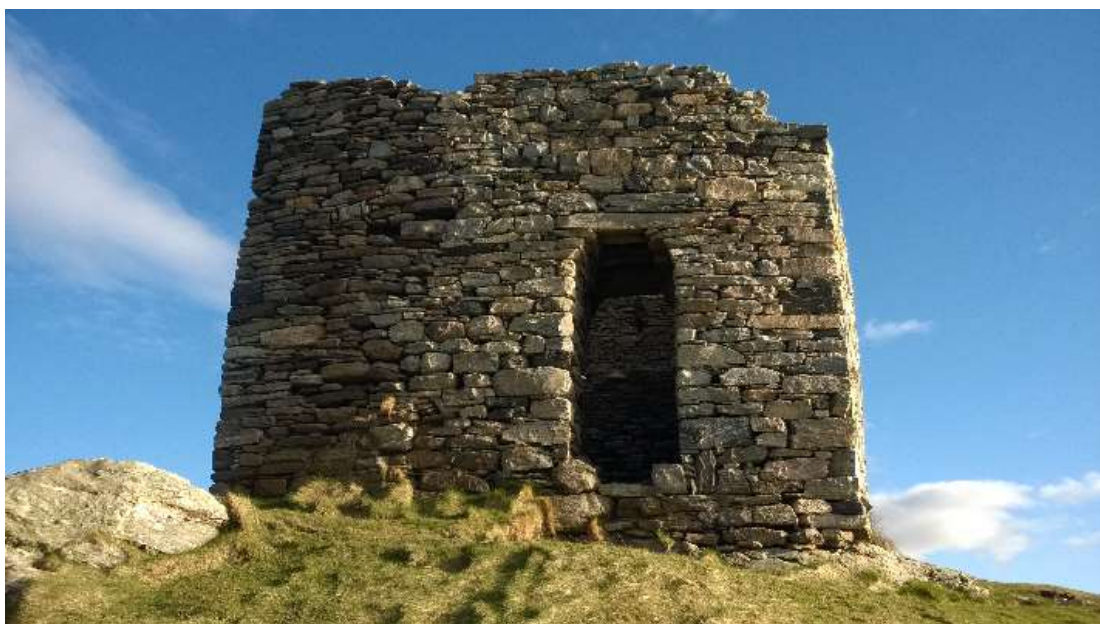
Photograph 8

The north elevation again shows signs of rebuild externally in that the lay of stone varies on the right hand side from that of the original lay of the left. There appears to be no significant movement however the mortar is again deteriorated and on this face there is some plant growth within the lower courses of the wall. Sensitive removal of vegetation should be carried out. Repointing the wall with a suitable mortar to ensure stability is recommended.

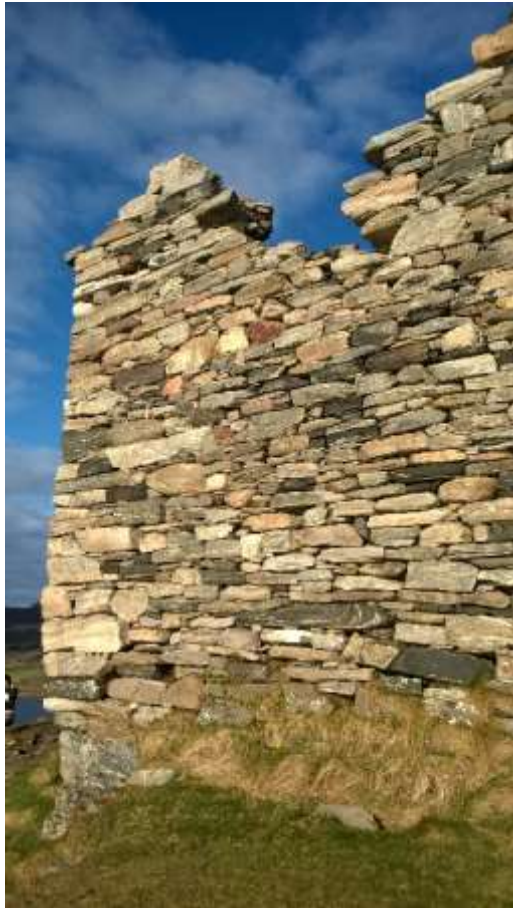
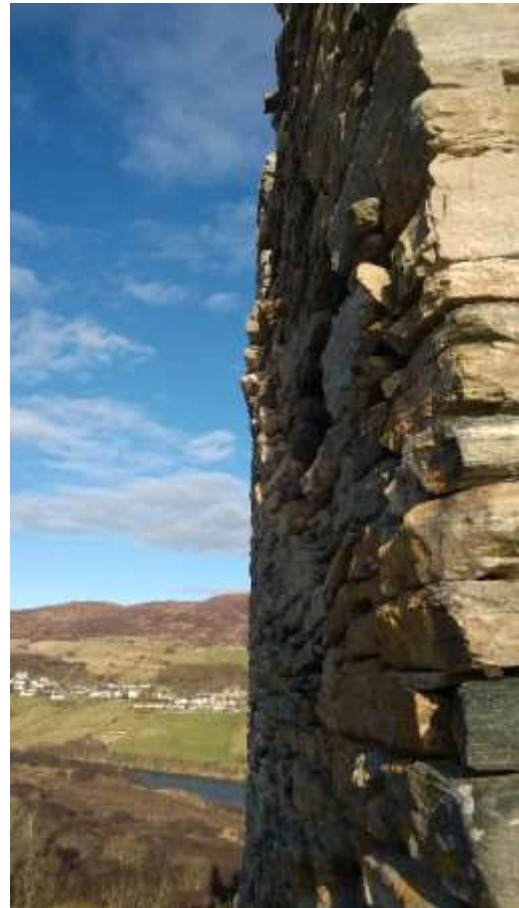
Photograph 9 &amp; 10

The west face of the wall shows signs of movement in the wall, in particular bulging at the middle. This movement may be caused by the internal structure no longer giving stability and the mortar eroding allowing for movement within the facing stones. An exercise of repointing with a suitable lime mortar will somewhat consolidate the structure.

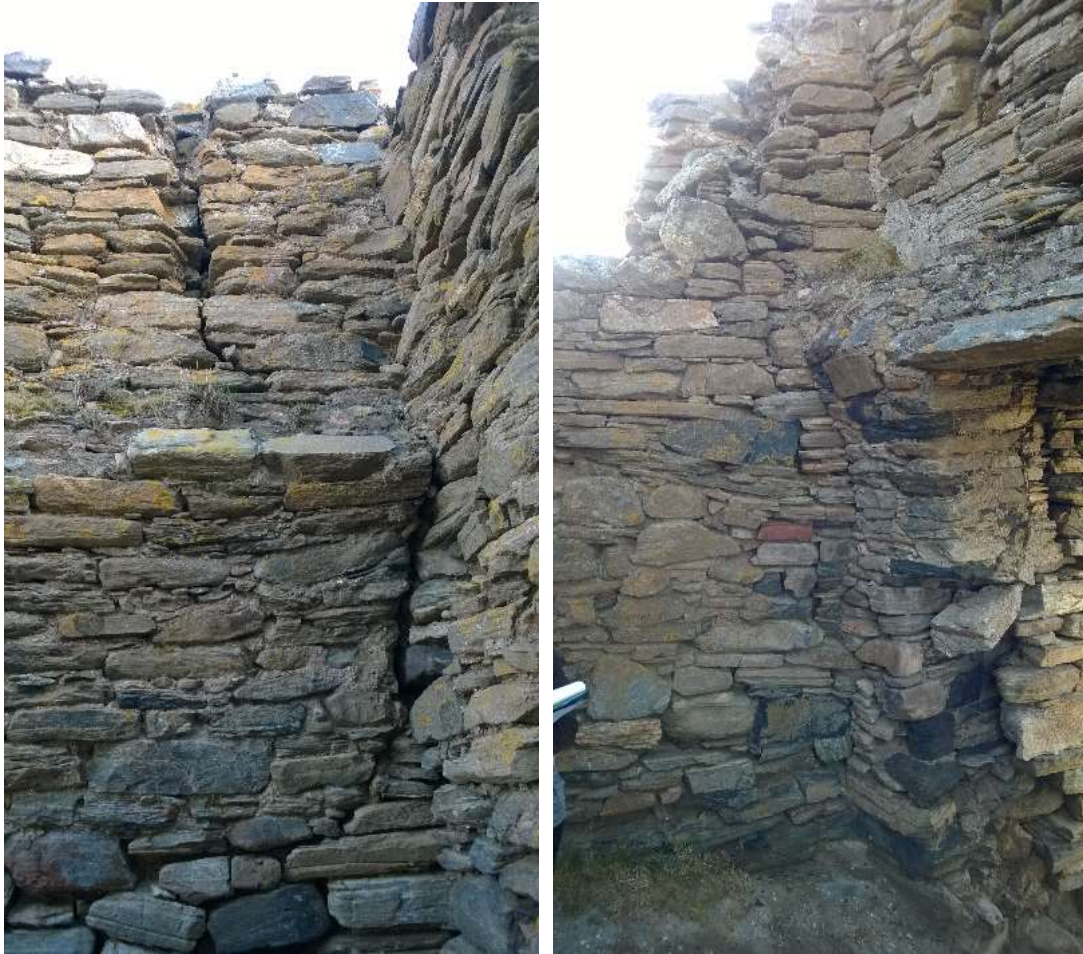
Photograph 11 & 12

The internal face of the southern elevation is shown on the left hand side, the internal face of the north and west elevation on the right hand side. Both photos show evidence of the vaulted ceiling internally as shown above extensive cracking may have formed from uneven collapse of the vault, creating a pull on the wall. Due to the history and what it currently represents this is not an area we would want to rebuild unless necessary. A pinning exercise should be carried out to stabilise the remains of the vaulted ceiling.

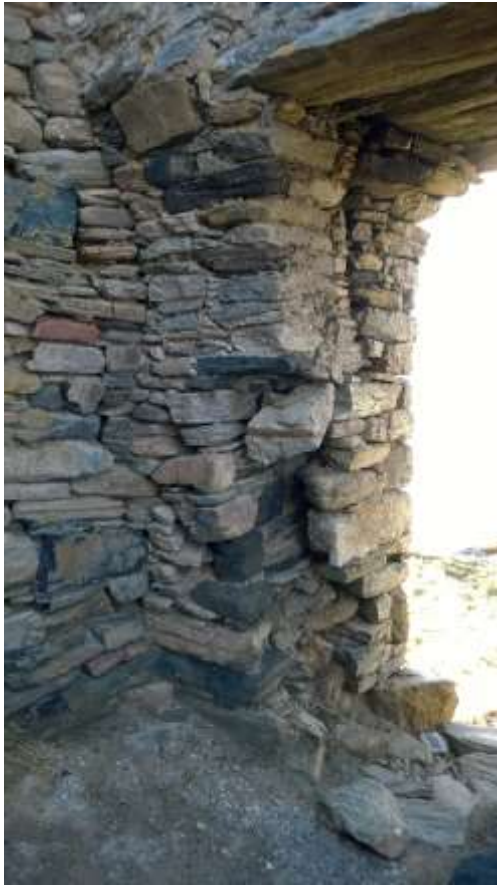
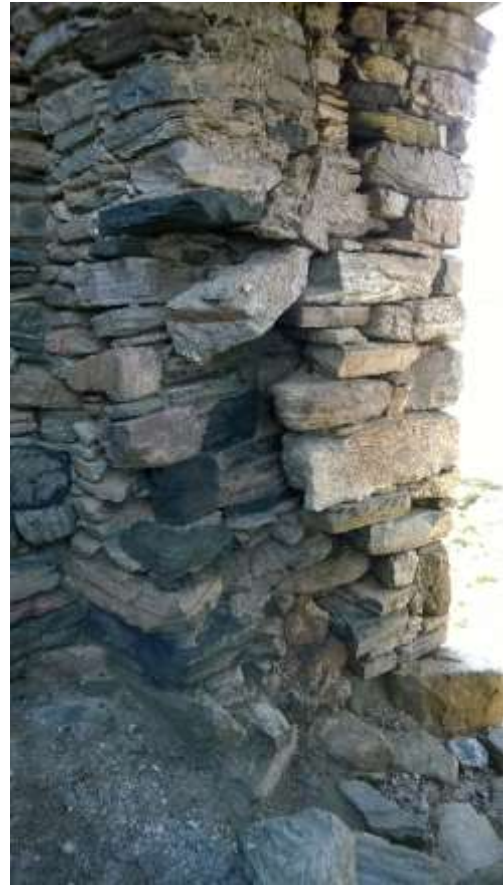
Photograph 13 & 14

The opening on the north face has weathered to an extent that the mortar is eroded and the larger stones framing the opening have become loose and fallen. The consolidation works should include temporary propping of the structure whilst the loose stones are removed, the existing structure is repointed and the frame is re-laid all with a lime mortar to suit.

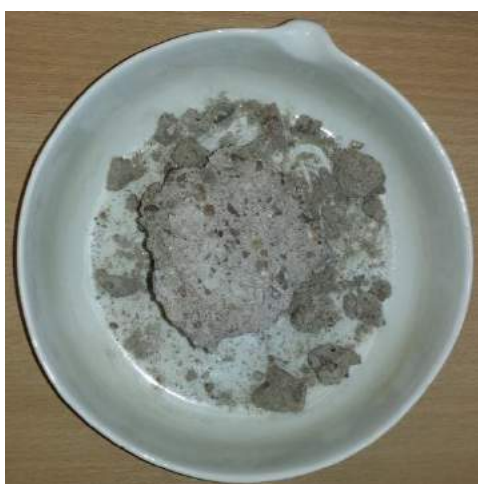
Plate 1. The total sample received (dish c.160mm diameter).

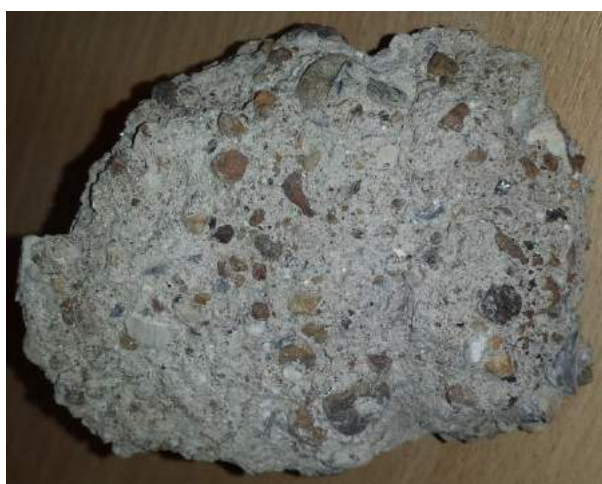
Plate 2. A freshly broken face of the sample at higher magnification highlighting the visible aggregate; composed of large shell fragments, lime inclusions, coal fragments, lithic fragments and quartz grains.
