# Application for Scheduled Monument Consent for the North Burial Ground at Glasgow Cathedral – August 2016

This summary of proposed works will support the **Application for Scheduled Monument Consent** by identifying the extent of the restorations required and show the location of the works detailed in the enclosed **Works and Site Information for the Restoration of the Cathedral North Burial Ground** by means of annotated pictures.

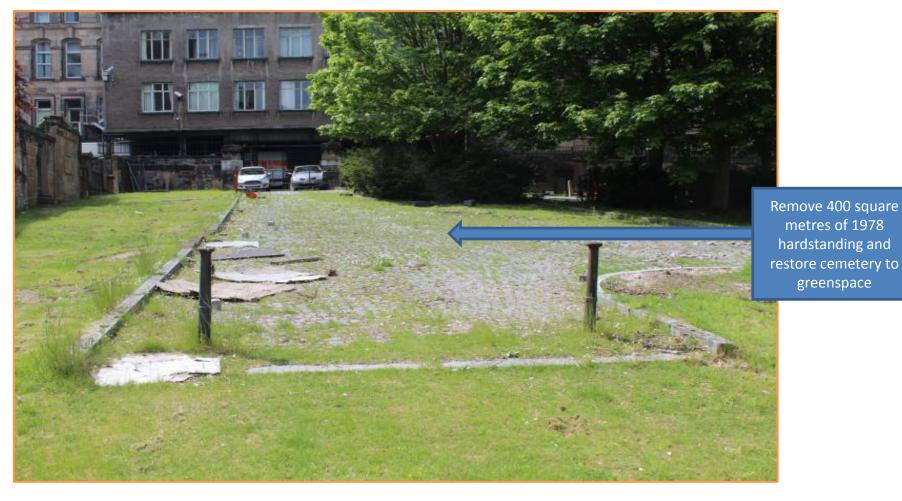
# **Recover 400 square metres of Original Cemetery Greenspace**

This proposal will remove two redundant car parks, recover 400 square metres of the original cemetery and help with our stated intention to recreate a garden cemetery on this site. The sets and car parks were a 1978 intervention when three small car parks were built in this lovely cemetery.. A) At the Southwest entrance to the garden the contractor has to break out the granite sett / cubes for an area of some 30 metres x an average of 8 metres - being 240 square metres of hardstanding and remove the cubes to the safety of a LES store in the Necropolis. The contractor will lift 80 metres of kerbing and move this to the Necropolis. The contractor will then soil and seed the area with grass. The contractor will then remove the existing boom gate and install two ornate hanging posts and a heritage gate supplied FOC by the Client. B) At the North West corner of the gardens the contractor has to break out the granite sett / cubes for an area of some 20 metres an average of 8 metres - being 160 square metres and remove the cubes to the safety of a LES store in the Necropolis. The contractor will then lift 60 metres of kerbing and move this to the Necropolis. The contractor will then soil and seed the area with grass. The contractor will then install two ornate heritage bollards supplied FOC by the Client.

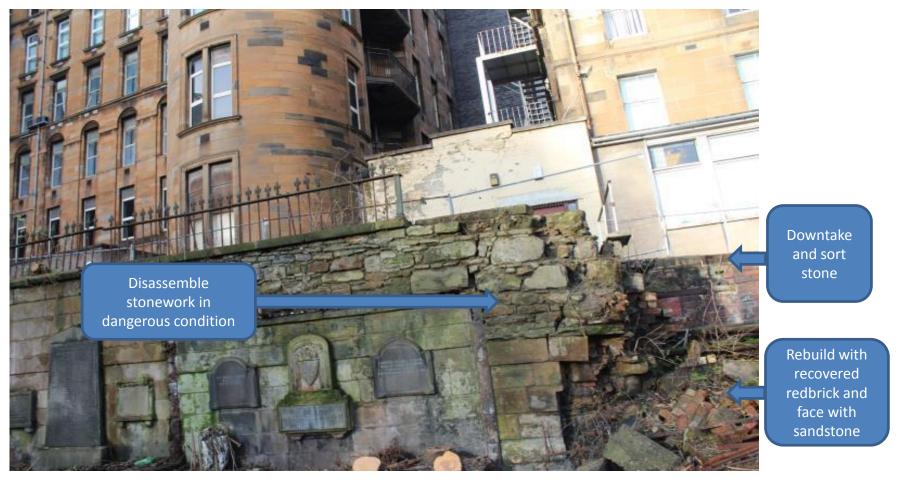
#### Restoration of 15 metre section of North retaining wall.

Being a section of retaining wall which exhibits an alarming bulge. This complete section requires to be downtaken and the stone sorted, then rebuilt after construction of a concrete foundation (15 metres long x 1 metre wide and 0.5 metre deep) This 7.5 cubic metre found to be strengthened by reinforced mesh. The contractor will then rebuild 15 metre x 4 metres of new or recovered redbrick (being 60 square meters of red brick) and then face the wall with 15 metres x 4 metres of recovered sandstone (being 60 square metres of sandstone). This section will be pinned to the hospital with non-ferrous fixings. Lime mortars must be used on both red brick and sandstone cladding. Memorial tablets should be returned to their original location. It is assumed that 90% of the stone can be recovered and re-used and a provision of 10% allowed for new brick and sandstone.

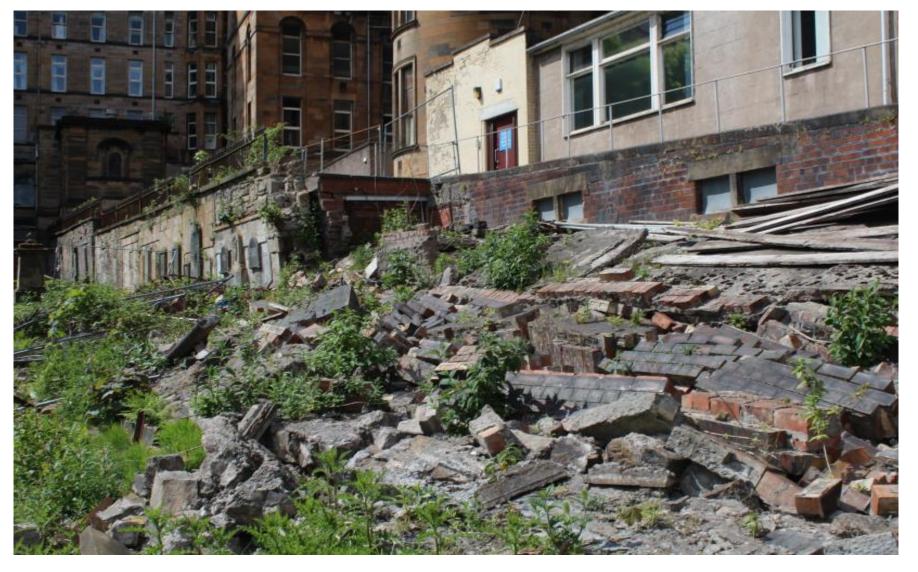
The Restoration of the Fallen Section of the North Retaining Wall (being 20 metres long x an average 4 metres high)

**Being the Restoration of the Fallen Section** - 20 metres of collapsed section of wall and walkway requires completely rebuilt. This damaged section has major Heath and Safety implications

- The contractor will lift and sort approximately 64 cubic metres of fallen stone from the completely collapsed section of the retaining wall- being 20 metres in length x 4 metres high x 0.8 metres in width. Some 21 metres x 2 metres wide x 0.75 thick granolithic concrete (approximately 31 cubic metres) must be broken up and removed from site.

- The contractor will construct a concrete foundation (20 metres long x 1 metre wide and 0.5 metre deep) This ten cubic metre found to be strengthened by reinforced mesh.

- The contractor will rebuild 20 metres x 4 metre new or recovered redbrick being 80 square metres. Lime mortars must be used. It is assumed that 90% of the stone can be recovered and re-used and a provision of 10% allowed for new sandstone.

- The contractor will rebuild 20 metres x 4 metre new or recovered rubble wall with sandstone facing (being 80 square metres). Lime mortars must be used. Memorial tablets should be returned to their original location. It is assumed that 90% of the stone can be recovered and re-used and a provision of 10% allowed for new sandstone.

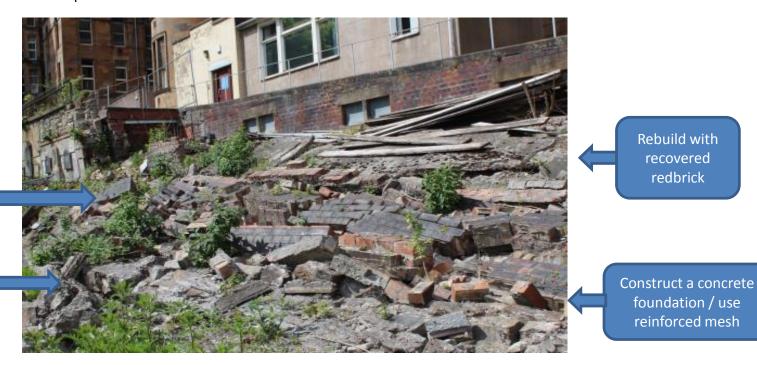
#### Requirements for the repair of the completely collapsed section of the retaining wall.

Rebuild with

sandstone facing

Lift and Sort

Rubble

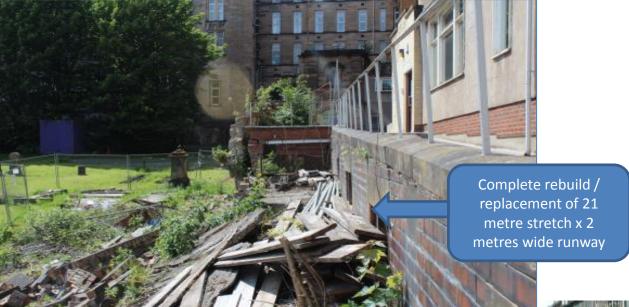
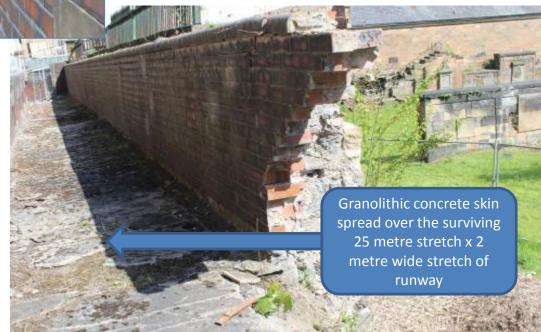
# The Restoration of Concrete Walkway on Hospital Side (being 21 metres long x an average 2 metres wide)

Restoration of Concrete Walkway on Hospital Side - The contractor will restore the concrete walkway on the hospital side. This will involve a complete rebuild / replacement of 21 metre stretch x 2 metres wide runway. The contractor will then establish the safety of the surviving stretch of runway and if acceptable then a granolithic concrete skin spread over the surviving 25 metre stretch x 2 metre wide stretch of runway. The contractor will ensure that the existing drain system works and water runs away safely.

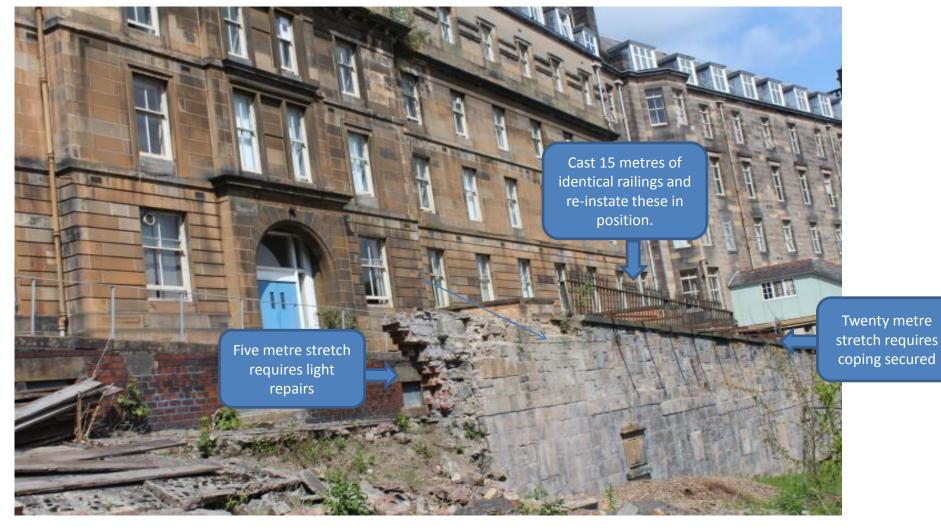
### The Restoration of the final section of North retaining wall (being 25 metres long x an average 4 metres high)

Restoration of the final section of retaining wall - being the 25 metres stretch where the laundry meets the corner with the nurses quarter. The first five metres have missing cope and require light repairs, the condition of the next 20 metres stretch is fine; the contractor will carry out a light pick and point and also check / secure some 20 metres of coping. The contractor will then remove barbed wire and stanchions/ post arrangements for securing barbed wire. The contractor will clean and paint the cast iron railings. Some 25 metres are missing of which 10 metres are in a Council store. The contractor will recover these and re-instate them. The contractor will cast 15 metres of identical railings and re-instate these in position.

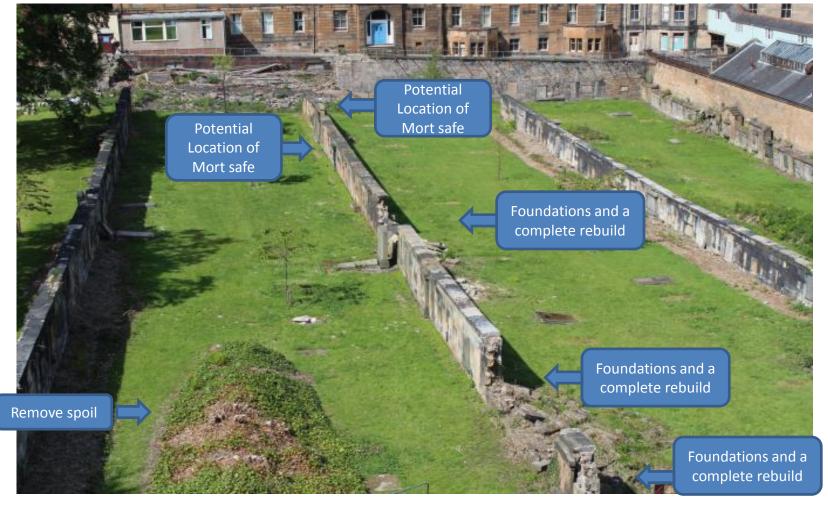
### Restoration of the middle free standing wall (being 78 metres long x an average 2.10 metres high)

Restoration of the middle of the three free standing walls. This wall is in poor condition. It stands 2.10 metres high and is 78 metres long. 36% of the wall requires urgent attention. Approximately 22% has already collapsed, needs foundations, then to be completely rebuilt. Another 14% is listing. The two listing sections require to be secured / propped by the introduction of two mock heritage mort cages - made up of 3 mild steel panels 2 metres wide x 1.8 metres high. The contractor will then install the aforementioned mort safes as props / support systems for the two listing stretches of this walling. - Each panel to be supported by three augured holes 600x150mm in-situ C25 concrete. The contractor will replace 20 linear metres of coping with new stone to match the existing sandstone and copy any existing numbering - to be carved into replacement coping by a stone mason.

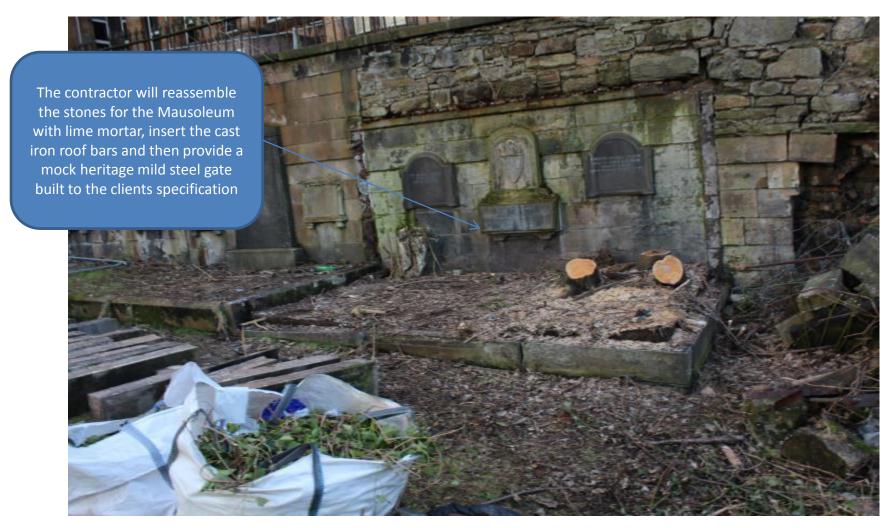
#### The Reconstruction of the Maxwell Graham Mausoleum.

This small mausoleum was disassembled on health and safety grounds in late 2015. The stones for the mausoleum are laid out and numbered in front of the Maxwell Graham wall tablets - as are the cast iron bars from the roof. Once the 22 metre long collapsed section of the retaining wall is repaired, the contractor will reassemble the stones for the Mausoleum with lime mortar, insert the cast iron roof bars and then provide a mock heritage mild steel gate built to the clients specification. All tree stumps shall be ground out from base.
