## Supplementary information relating to Scheduled Monument Consent Applications:

Cullicudden, church and burial ground - Relocation of gravestones to Gun Munro Mausoleum 201602120  
St Michaels Church, Kirkton - Relocation of gravestone to Gun Munro Mausoleum 201602118

Dr Jim Mackay, Chairman, The Kirkmichael Trust 21 August 2016

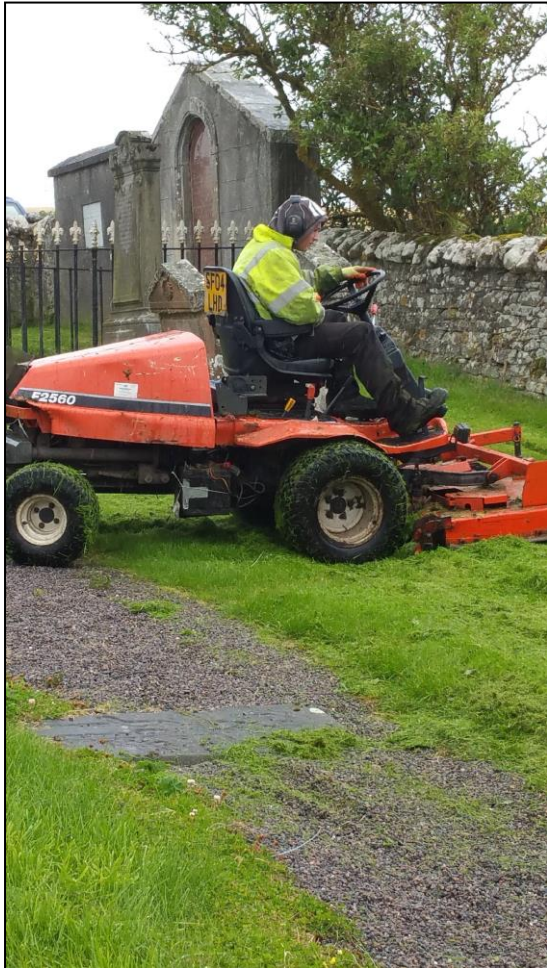
On left:

Mowing machine carrying out regular damage to the stones in Old Cullicudden, including Medieval cross stone "A" seen on path; it is raining, and the rain exposure since these stones were recorded by RCAHMS has also caused serious deterioration.

Date of picture: 19 August 2016

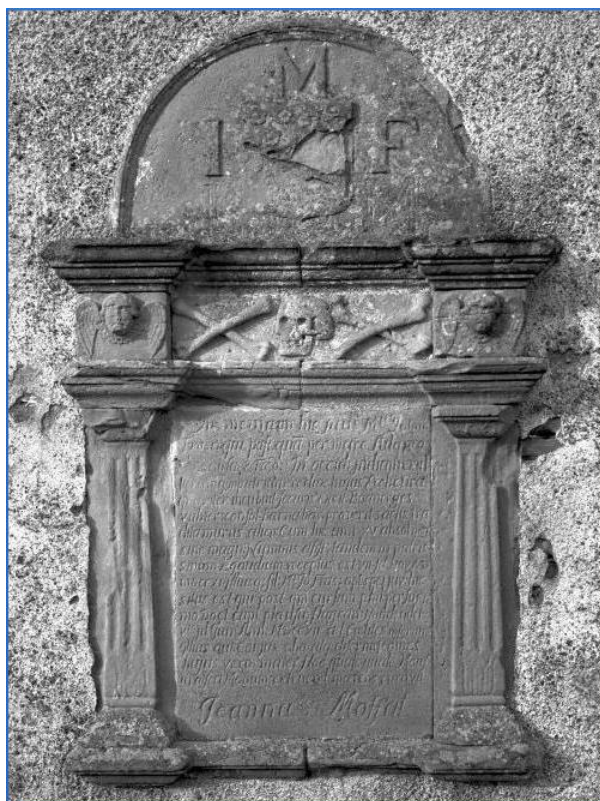
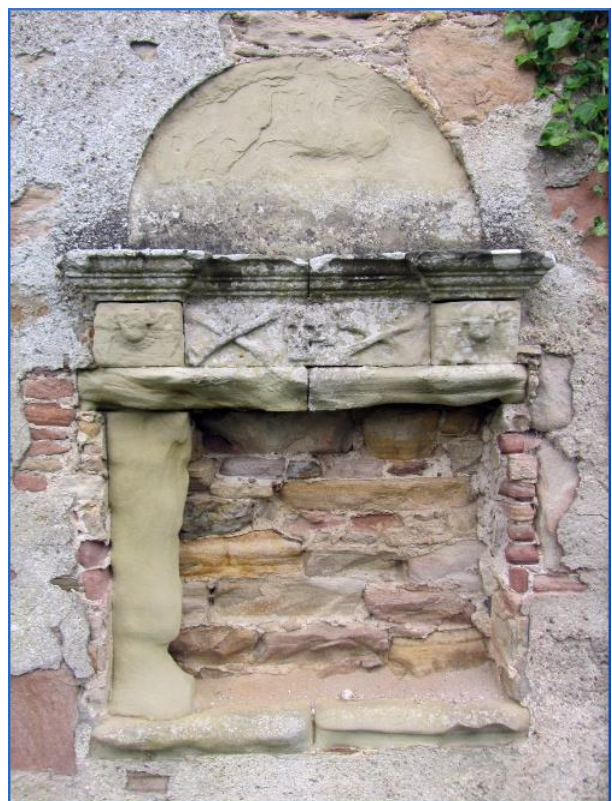
Below:

The Kirkmichael Trust visited Alness kirkyard on 14 August 2016 to view a memorial (the Master John Fraser memorial Canmore SC 400215) that has similar features to one at Kirkmichael (the Urquhart of Braelangwell memorial). It had been photographed by RCAHMS in, we believe, the 1950s or 1960s. We were concerned to see that weather exposure had resulted in almost complete loss of features, and the Trust is determined that the same should not happen with the Resolis stones in Kirkmichael and Old Cullicudden.

Date of picture: 14 August 2016
