## BALVAIRD CASTLE – ARMORIAL PANELS

A condition survey on these panels was carried out in 2012 by Christa Gerdwilkner which I have attached onto this report as it covers the relevant conservation issues of the panels .

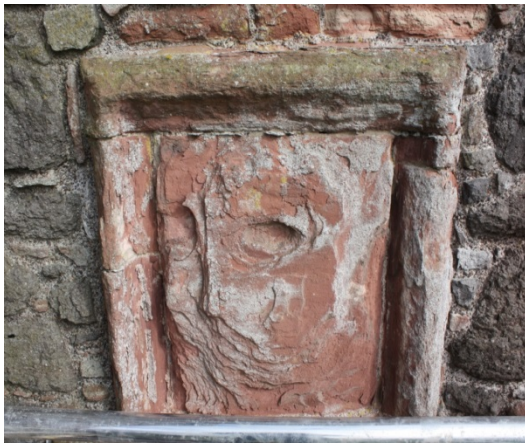
fig:1

2012

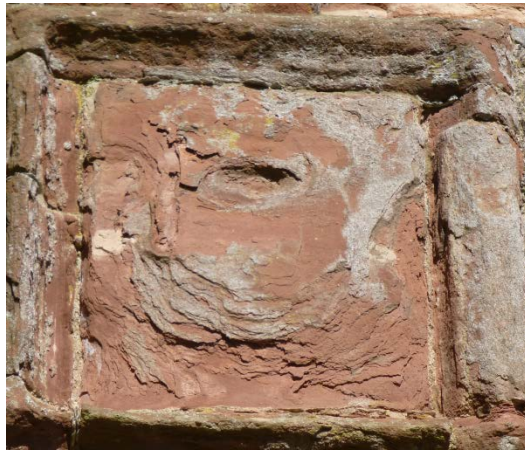
fig:2

2015

The loss of material on this panel seems to be mainly on the left hand side , at the bottom corner and mid-way up the panel . Some of the delaminated edges have opened slightly and there is evidence of some open fractures on the surrounding moulding .

In line with the 2012 report and conclusion, long term conservation of these panels , taking into consideration the use of an alkoxy silane could be problematic. However we can hopefully slow down the further deterioration of the panels by injecting behind the laminating sections with a solution of Paraloid B72 at 5% to try and stabilise the substrate and then edge point the laminated sections with a colour matched acrylic mortar . Again it must be pointed out that this will work on a short term bases but due to the condition of the substrate will only stabilise the panels for a limited time .

These repairs should be carried out as soon as possible , preferably before the onset of heavy frosts and inclement weather .

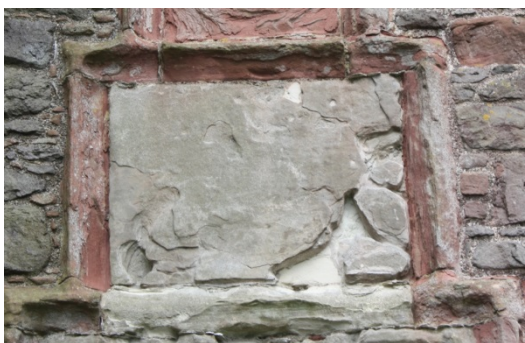
fig:3

2012

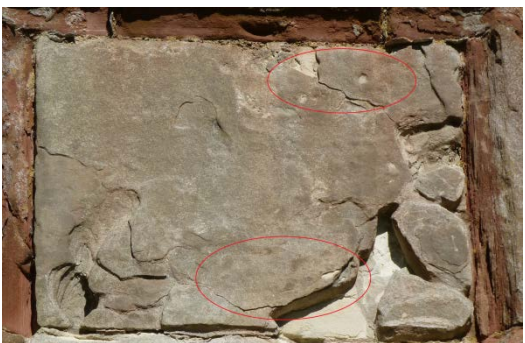
fig:4

2015

There does not seem to be any significant loss of materials on this panel since 2012 , but the areas highlighted in red circles on the 2015 picture above are of most concern.(fig:4) These two areas have fissures which are open and will allow moisture in over the winter months especially, with freeze thaw action this might result in more loss of material come springtime .Again here the surrounding moulding is showing more signs of delamination .

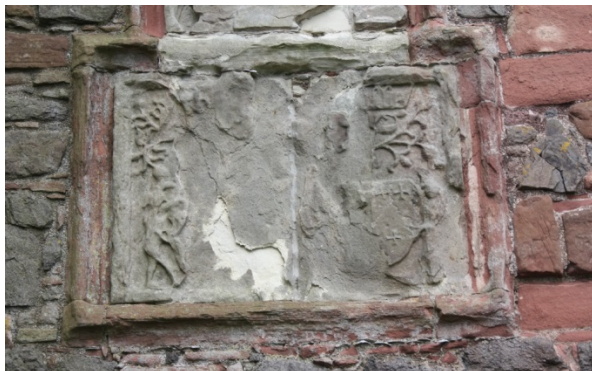
fig:5

2012

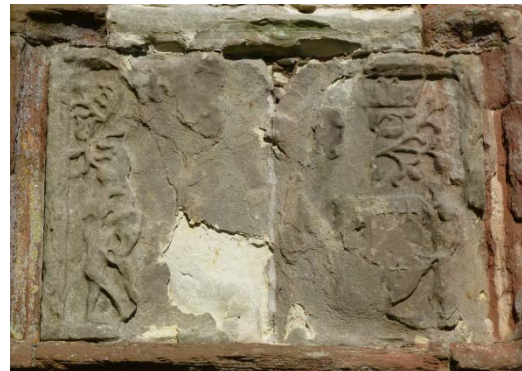
fig:6

2015

This panel shows most signs of loss of material as you can see from the pictures above . This loss of materials has left an open edge which again will let in moisture especially over the winter months . The central parts of this panel look extremely fragile and more loss of material will occur if left untreated .
