Clickimin
Proposal for new grounds maintenance and site presentation plan

This document outlines the proposal for a new ground maintenance plan for Clickimin, changes to the existing presentation of the site and the rationale behind the proposed changes. The plan has arisen out of discussions with the District Architect over long term issues with management and maintenance of the site. This document should be read alongside the attached annotated site plan.

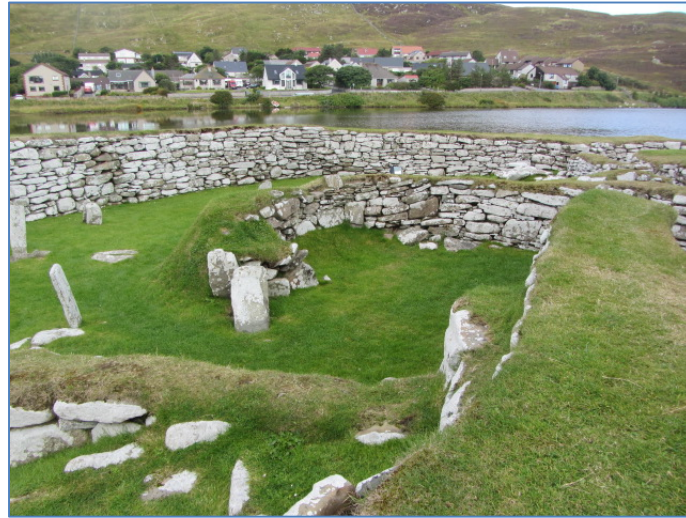
Fig 1. Grassed interior of 'Hut I'.

There is inconsistency in the way in which interiors of structures are presented at Clickimin. The broch/wheelhouse interior is gravelled, but elsewhere the interiors of structures are grassed. Furthermore, very little survives of some structures, or they overlap/are overlapped by structures of other phases making the plan of individual structures difficult to determine and to present to the public.

A new regime is proposed to bring consistency to the presentation and management of the structures at Clickimin. For a number of the structures, where only fragmentary traces survive, the exposed stones will be left as at present, in situ with turf cover around. The interiors of more complete, or clearly defined, structures will be gravel covered – the gravel will be distinct from exterior pathways and modern paths. This involves the removal of turf and levelling of the underlying surface in three of the prehistoric dwellings to the west of the broch. The ground

disturbance will involve no more than removal of turf and levelling of topsoil to a depth of no greater than 100mm. The affected areas are marked on the accompanying plan.

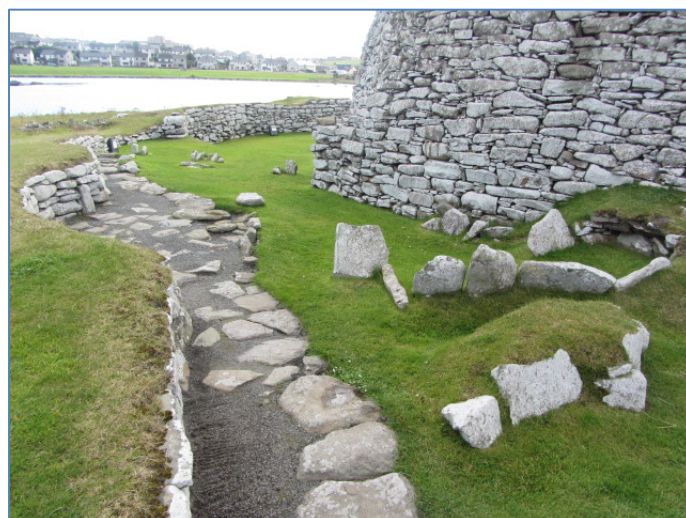
Fig 2. 'Exterior' paving to the north of the broch.

In the paved areas around the west and north of the earlier dwelling, the paving will be retained, with vegetation removed by hand as necessary. As above, this work will involve minor ground disturbance, as the paving stones will be lifted to remove vegetation and to level the ground below, with up to a maximum of 100mm excavated to provide a suitable foundation, before relaying and filling voids with fine gravel where required. Care will be taken to ensure that the paving stones are re-laid in the same locations as before, as far as this is possible. The same treatment is proposed for paving within hearths and structures, where shown on plan.

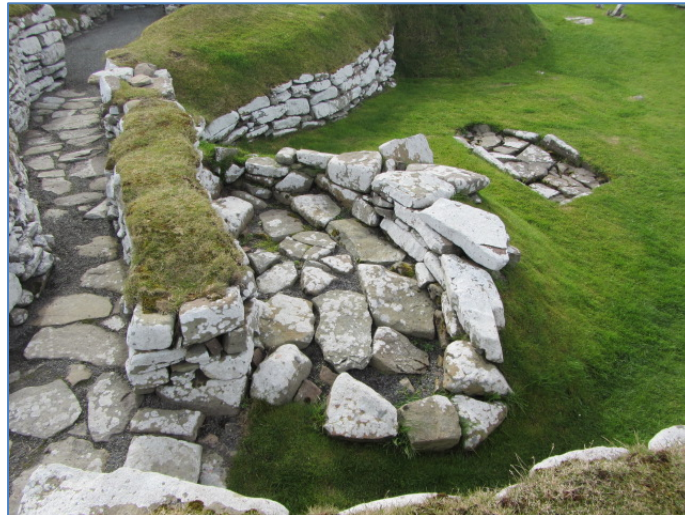
Fig 3. Paved area within structure adjacent to path and 'Bronze Age' structure.

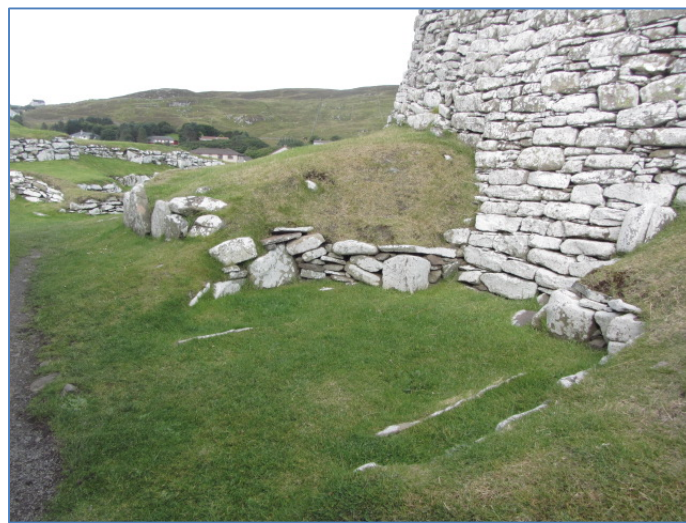
Fig 4. Hut structure to rear of blockhouse and eroded route (on left hand side).

The area to the rear and west of the blockhouse is suffering from visitor erosion which has in places completely eroded grass cover. The areas of exposed earth are not only unsightly, but if

the erosion is left unmanaged it could lead to the loss or degradation of the archaeological resource.

It is proposed that grass bars are installed in the area to the west, immediately behind the blockhouse, to reinforce the ground and reduce the risk of further erosion, while allowing for drainage. Strips of Caithness flagstone approximately 50mm wide and 100mm deep will be laid widthways across the affected area of grass – the lengths will be cut to fit the area. There will be some ground disturbance for the installation of the grass bars but this should not extend to greater than 150mm.

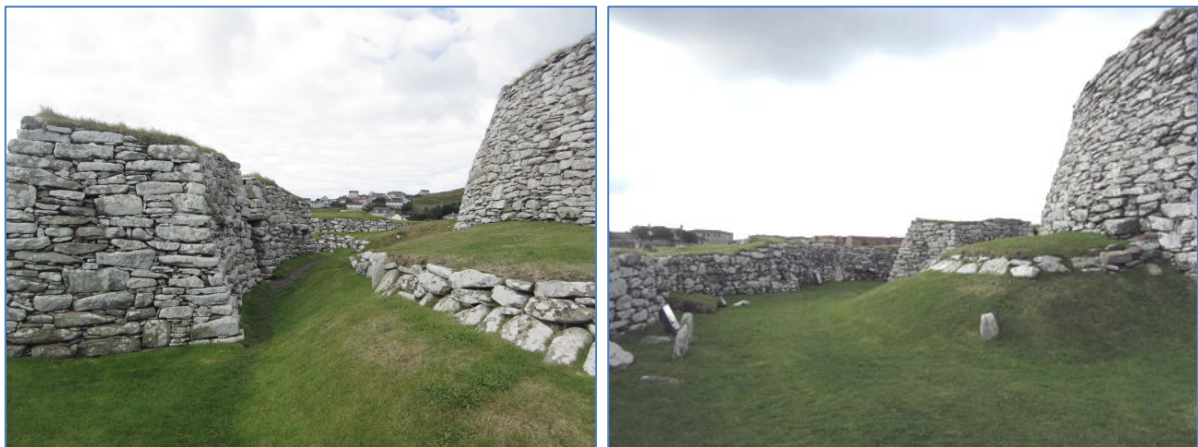
Figs 5 & 6. Area to the rear and north-east of the blockhouse, with the inner ringwork and grass bank.

The area to the rear and east of the blockhouse, abutting the ‘inner ringwork’ is also becoming worn, though erosion is less of a problem here as present. The condition of this area will be monitored and if the area of erosion worsens, proposals will be developed to reinforce the ground and reinstate turf – this would form a separate SMC application in due course.

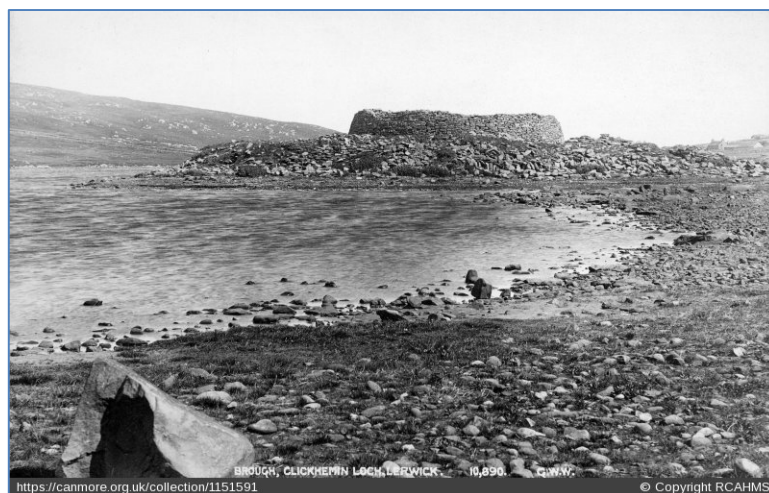
Fig 1. Clickimin c. 1890.

The site also has a complex recent history, with a considerable amount of antiquarian investigation, stone robbing and vandalism, reconstruction and consolidation since at least the early 19th century. Research by Shetland Amenity Trust's archivist, Brian Smith, has shed light on the extent of alteration, repair and reconstruction at the site during the 19th and early 20th century². It was in a ruinous condition in the early 19th century and contemporary sources suggest it was robbed for stone. The site was surveyed by Dryden in 1855 and again in 1866 – comparison between these two sketches provides evidence for some consolidation and rebuilding following excavation by the Shetland Literary and Scientific Society. However, sources from the later 19th century suggest that neglect and vandalism continued after this early attempt at consolidation.

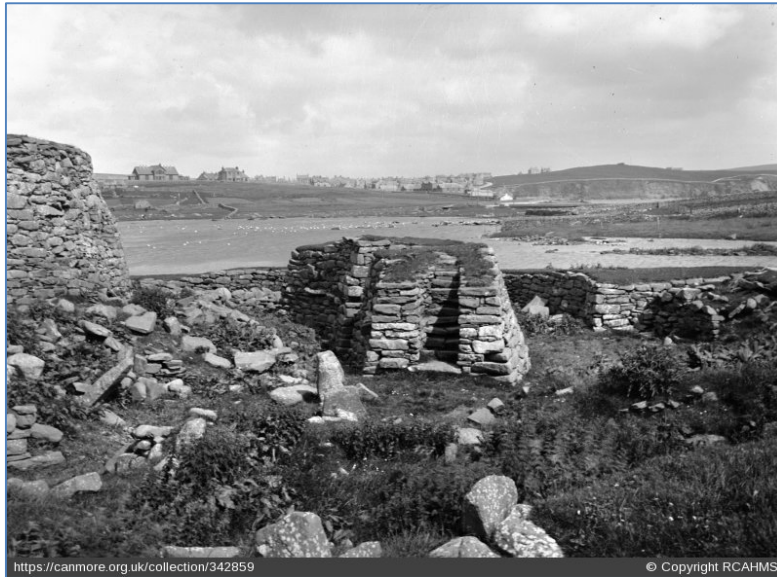
Fig 2. Clickimin prior to 1950's excavation and reconstruction.

Clickimin was one of the first sites to be protected under the Ancient Monuments Protection Act in 1882 and was came into guardianship in 1888. Since then it has undergone a number of other phases of consolidation, reconstruction and excavation: between 1907 – 1910 when work focused on repairing the drystone masonry and stabilising entrances, passages and staircases within the broch and the broch interior and entrance through the ring wall were cleared; in the 1930's the interiors were cleared of debris, vegetation was cleared and the drystone structures were again consolidated; in 1958 further consolidation work was carried out on the ring wall.

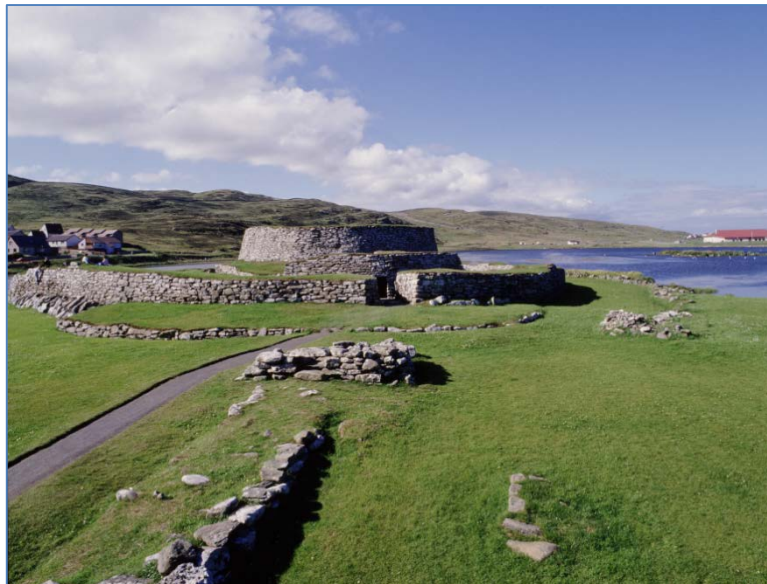
Fig 3. Clickimin today, following excavation, reconstruction and consolidation.
