Stirling Castle – James IV Arch Masonry Works Application for Scheduled Monument Consent

Prepared by: Tom Gaze, District Architect, Historic Environment Scotland
May 2016

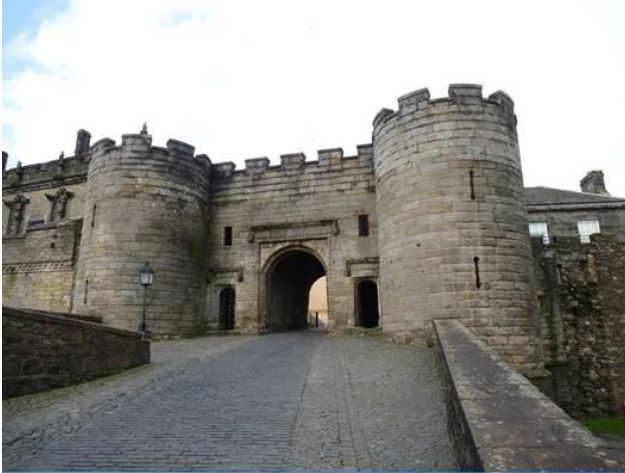
(Fig 1)

Open joints had been identified to the later upper masonry courses of the monument during audits of Stirling Castle (fig1). A phase of repointing works to the parapet was added to the planned works programmes, subject to securing the funding for a scaffold to access this area of high level masonry.

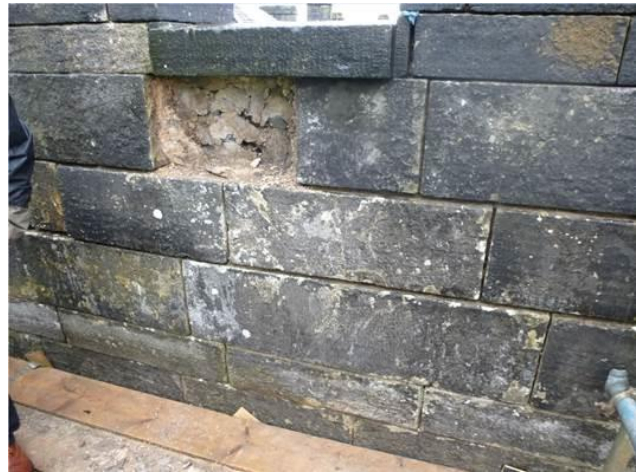
(Fig 2)

Funding was achieved in 2015/16 financial year, for a limited scaffold to urgently address a blocked rainwater pipe associated with the drainage of the tower's artillery battlement. Upon access, the adjacent open joints in the masonry were inspected in more detail and displacement of the masonry was quickly discovered. Isolated stones were found to be loose on their bed and easily dislodged (fig 2).

From this, it was suspected that there may be wider problem of the later military ashlar facing-courses being insufficiently tied through to the rubble inner wall of the parapet, in isolated areas. Moisture and frost cycles in the wall core via the open joints seemed to have compounded the problem resulting in the weakening of areas of masonry.
