Corgarff Castle Reharling of outer wall

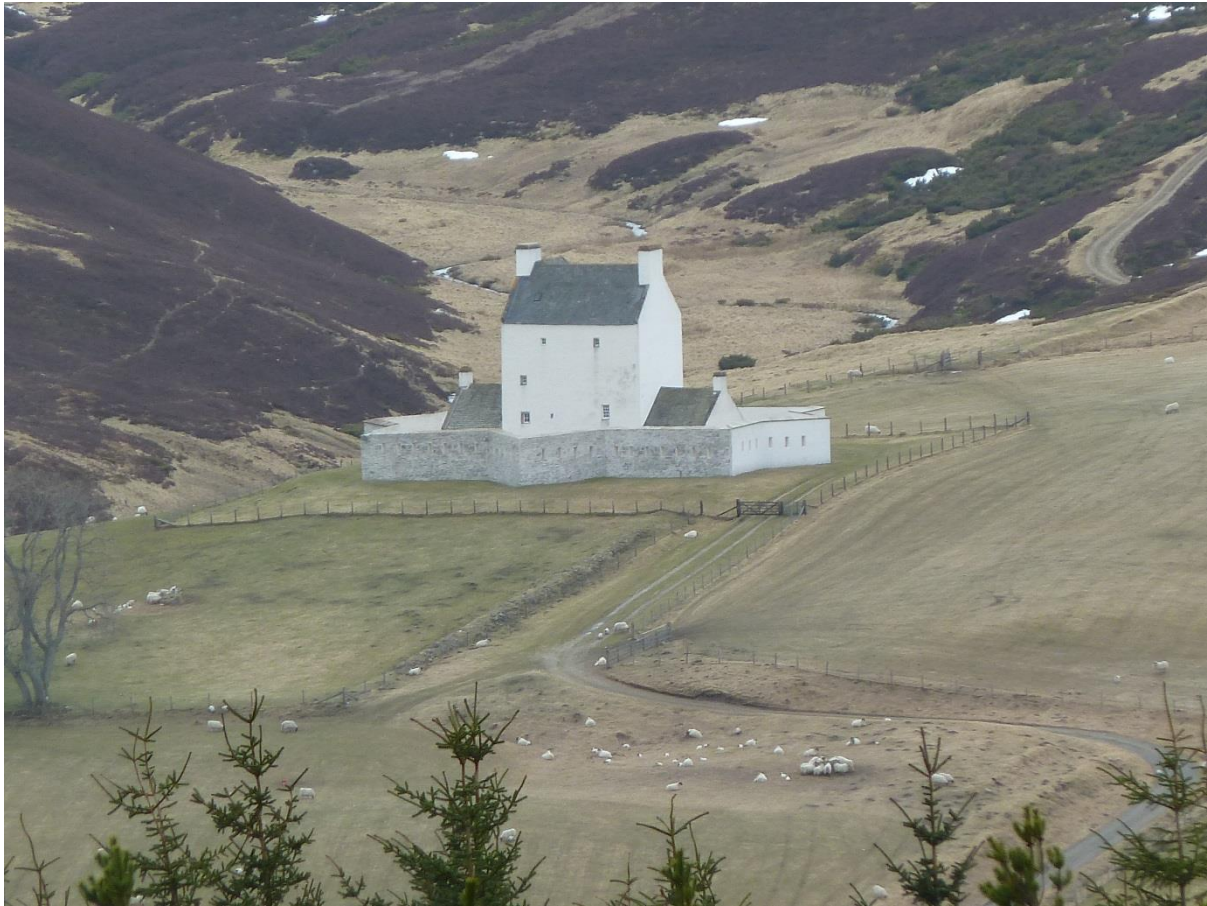
Corgarff Castle from the North showing the hall to reharl and renew copes

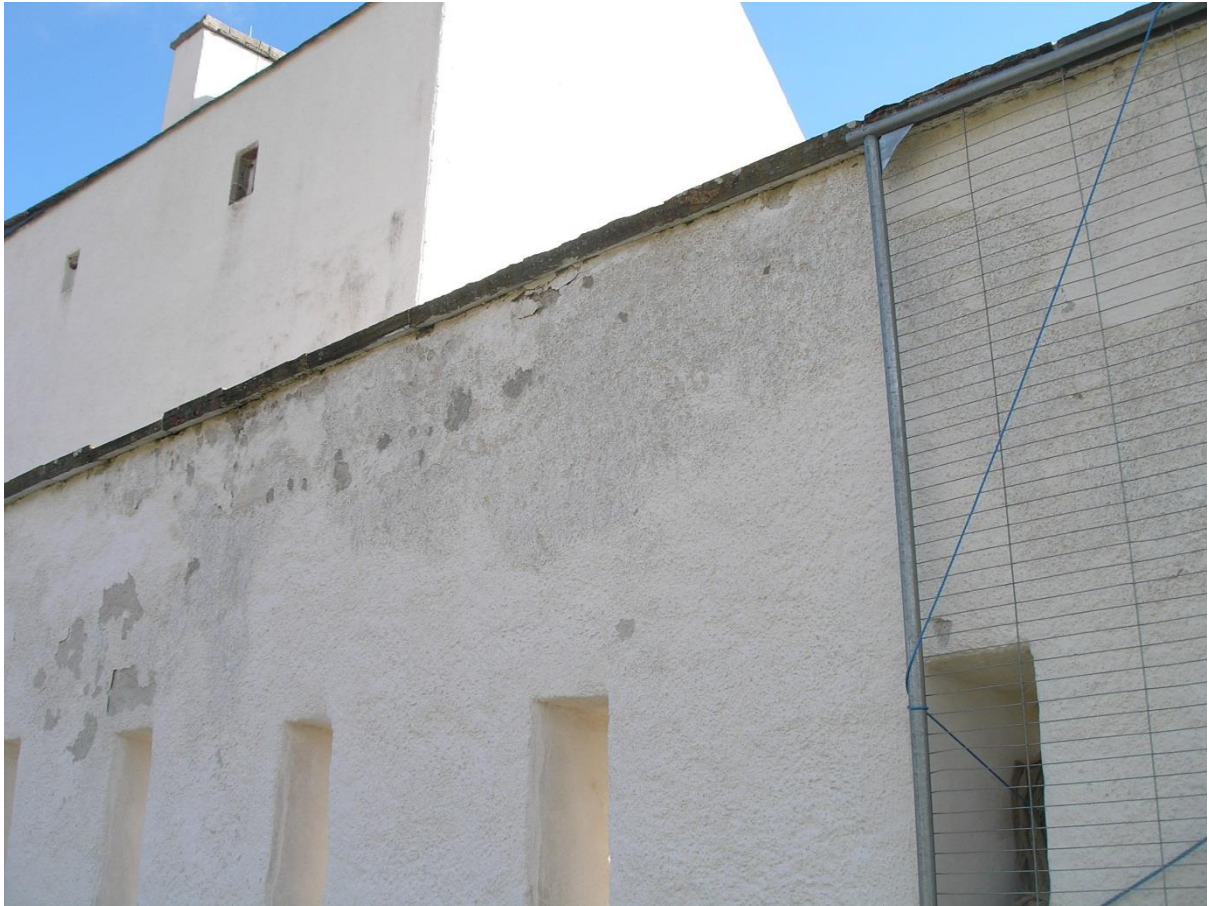
The failing harl to the north wall before its removal in 2011, note delaminating old copes.

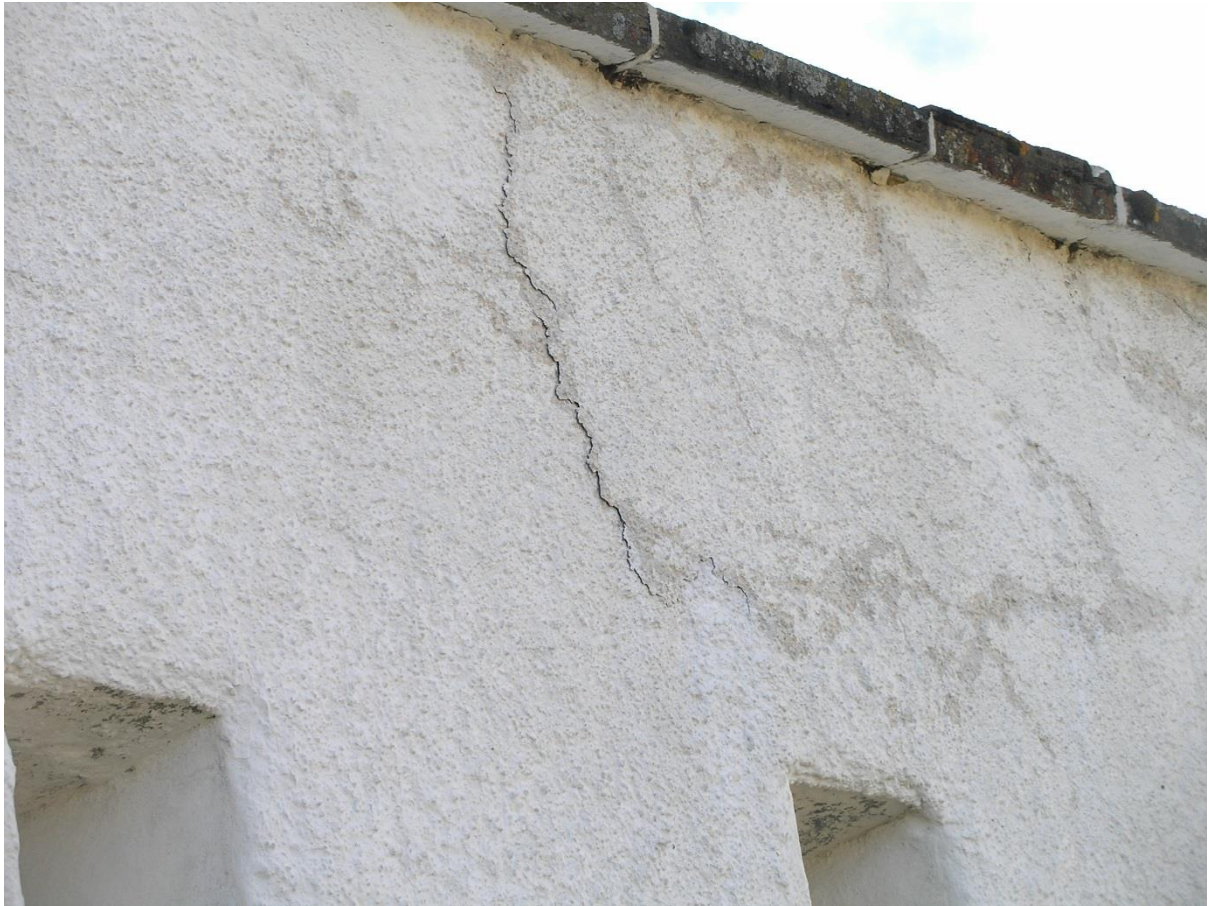
The failing harl to the north wall before its removal in 2011, note delaminating old copes.
