## **Bothwell Castle latrine tower, consolidation and repair works**

### **ENVIRONMENTAL IMPACT STATEMENT**

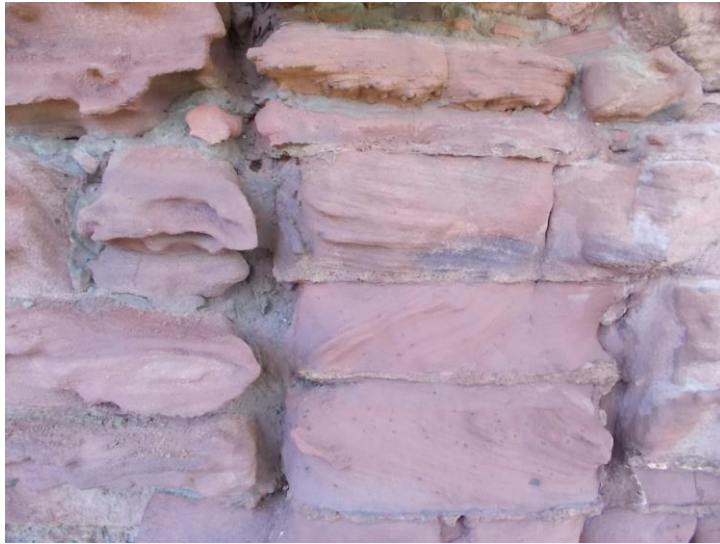
Detail of eroded stonework, probably representing early 20<sup>th</sup>-century repairs

Although extensive in terms of indenting, the proposed works are likely to represent the minimum necessary to consolidate and conserve the structure of the latrine tower, ensuring its future survival. Although some loss of original fabric is anticipated, the form of the structure will be preserved, and, in general terms, the original stones likely to be affected do not include significant architectural forms; rather they are examples of facing stonework of which many examples will survive in the wider structure. It will be important to record

The greater part of the proposed indenting will affect stone repairs introduced in the 1920s-30s. This is significant in terms of the more recent history of the castle and its conservation, but of lesser significance than the original stonework. Once again, it is important that all replacement is recorded carefully.

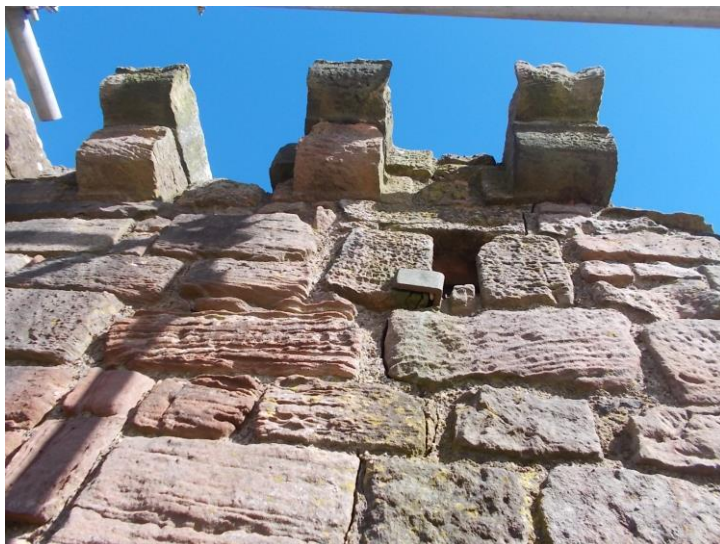
Architectural details at the wallhead. An opportunity can be taken to examine these during the works.

I would recommend that an opportunity is taken to examine the latrine tower's masonry archaeologically while the scaffolding is in place, particularly to examine and further our understanding of any phasing or alterations at the upper levels of the structure. This work would be undertaken under the terms of the archaeological call-off contract managed by CNR.
