BOTHWELL CASTLE  
PROJECT LATRINE TOWER CONSOLIDATION WORKS  
IDENTIFIED ORIGINAL STONES FROM 1899 PHOTOGRAPH

| PROJECT DRAWING NUMBER | | 90038-150714-002A | |

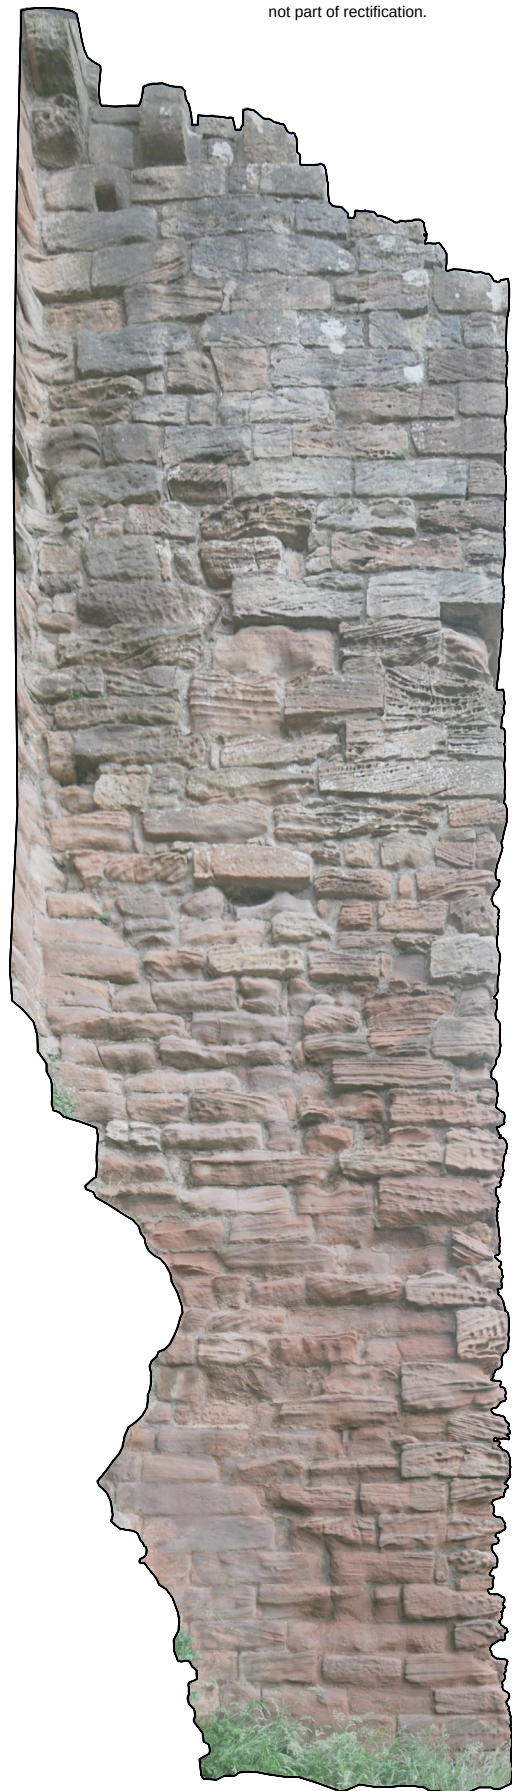
LATRINE TOWER - WEST ELEVATION  
(not visible in 1899 photograph)

\*NOTE: Projecting corbels are not part of rectification.

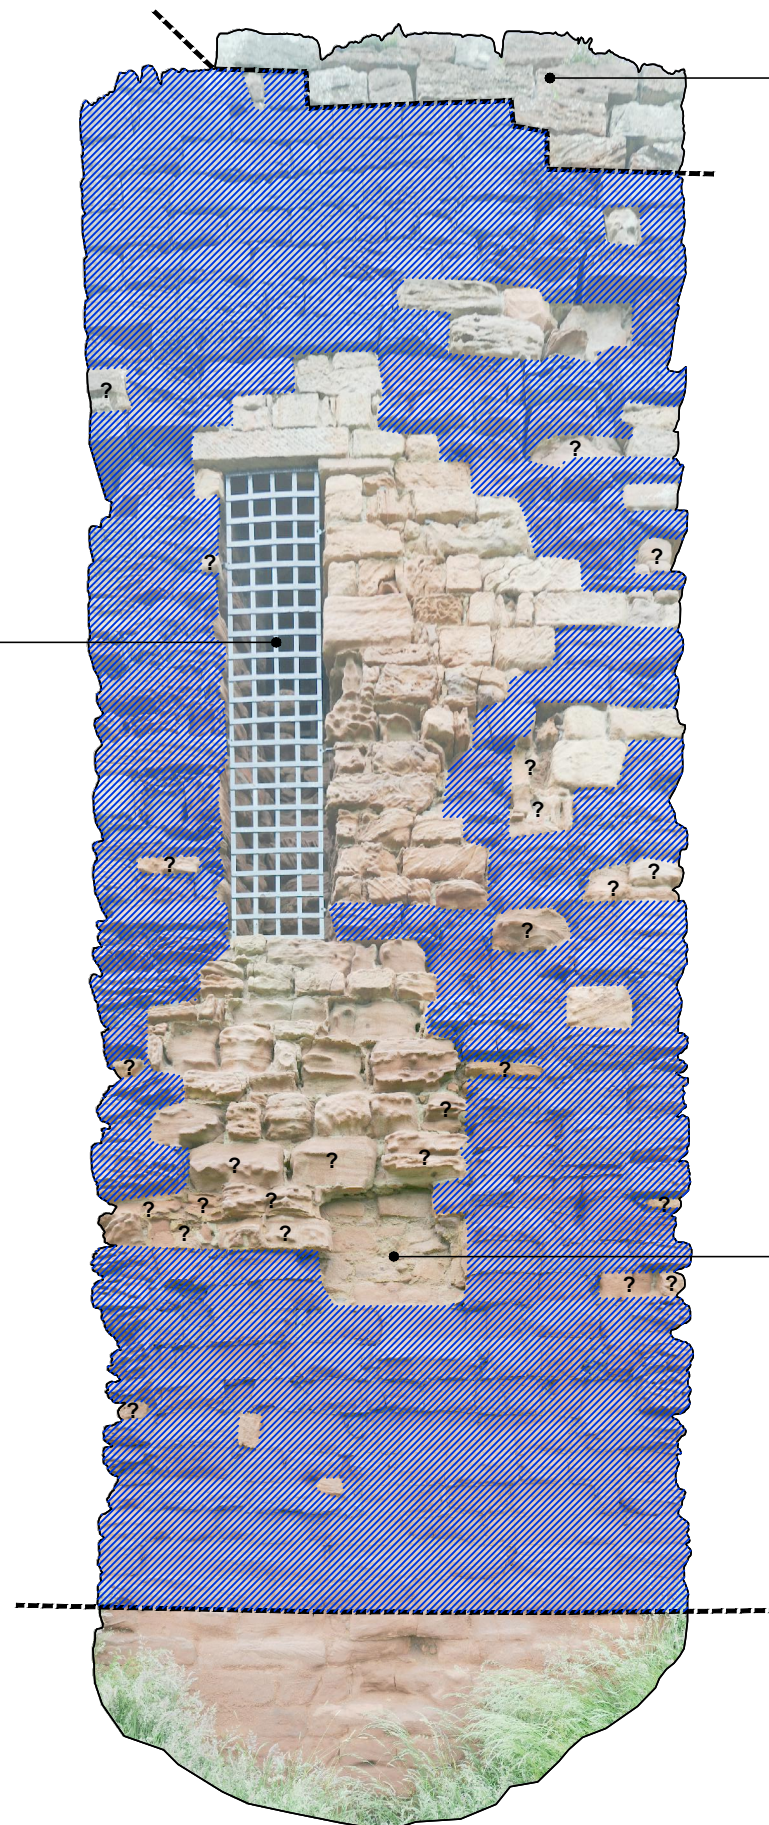
LATRINE TOWER - SOUTH ELEVATION

Opening previously consolidated as simple vertical slot though 1899 photo suggests this is not historically correct.

This area of stones is out of frame on the photograph.

This area of now missing facing stones is present on the 1899 photograph.

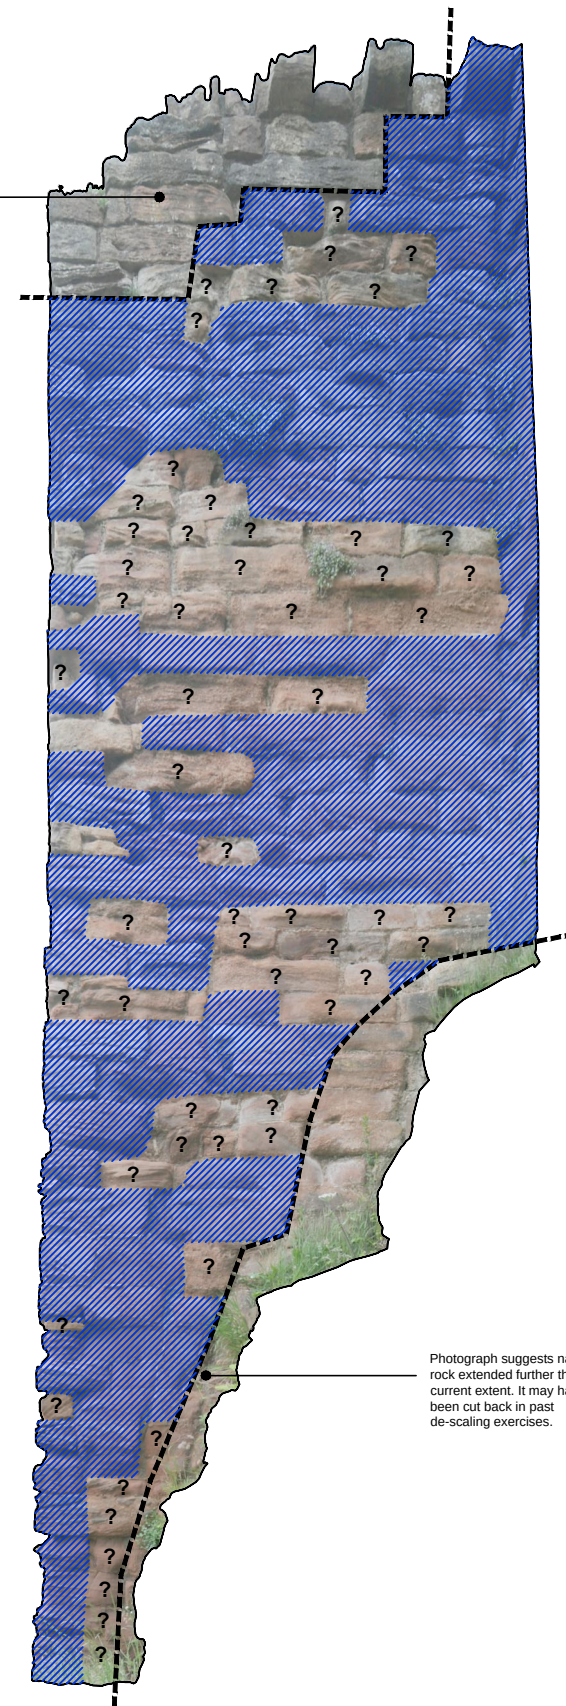
LATRINE TOWER - EAST ELEVATION

\*NOTE: Projecting corbels are not part of rectification.

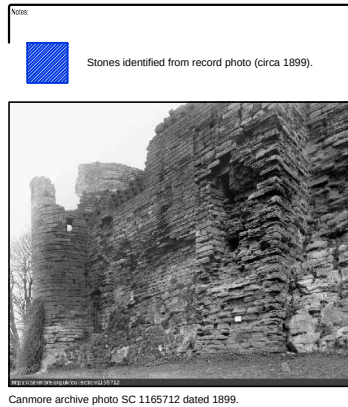
Stones marked with a "?" are ones which are difficult to determine whether they are present in the photograph or not. This may be due to erosion to these stones making them difficult to identify, or indented stones of a different shape.
