# Turnberry Castle and Lighthouse

## Summary Report of Archaeological Works Undertaken on Western Terrace

By Steven Black, Northlight Heritage, 10<sup>th</sup> May 2016

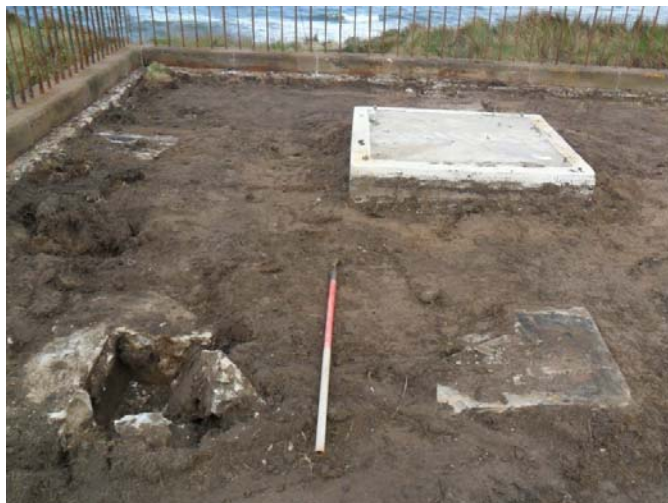
Plate 1: Examples of concrete and stone blocks uncovered beneath the topsoil in the Western Terrace (large, raised, square white block at top right is the former flag pole base).

Immediately beneath the topsoil remains relating to the use of the area as part of the operational lighthouse were present (Plate 1). This included three dressed stone blocks running north to south down the inside of the western wall/fence line. These were very similar to those found during previous evaluation on the eastern side of the lighthouse (Black, 2015), which related to a boundary fence running down the northern side of the access road into the lighthouse. This suggests the three stones could relate to a former fence line on the western side of the enclosed terrace. A total of four small square concrete footings and two irregular and small concrete bases were also uncovered, the latter relating to a former washing line.

The controlled stripping of turf and topsoil over the western terrace revealed features relating to the lighthouse but nothing obviously older than this or material of a nature which would be likely to be adversely affected by any proposed paving scheme.

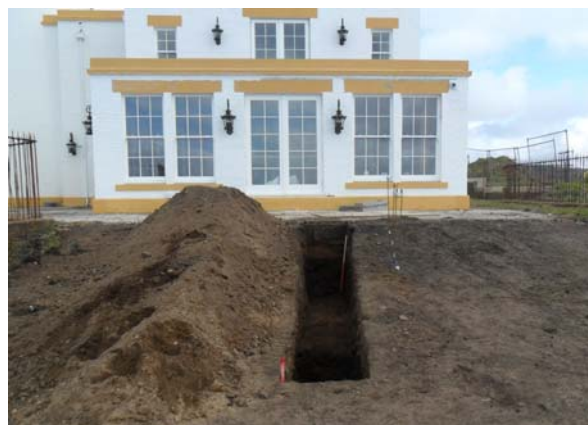
At the eastern side of the western terrace the previous evaluation trench, originally excavated in 2008, was re-excavated in order to provide a current assessment of the deposits in this area. The location of the previous trench corresponded approximately to the location of the new stairway (Plate 2).

The re-excavation of the backfill revealed a trench measuring 6.20 m E-W by 0.80 m N-S. The trench backfill was fully removed which resulted in a trench 0.80 m in depth with two deeper slots at either end, each measuring 2 m by 0.8 m and extending to a depth of 1.2 m.

Plate 2: Re-excavated 2008 evaluation trench

The re-excavation of the 2008 evaluation trench has shown that no obviously significant archaeological layers exist within the upper levels where the deposits appear to relate to lighthouse activity.

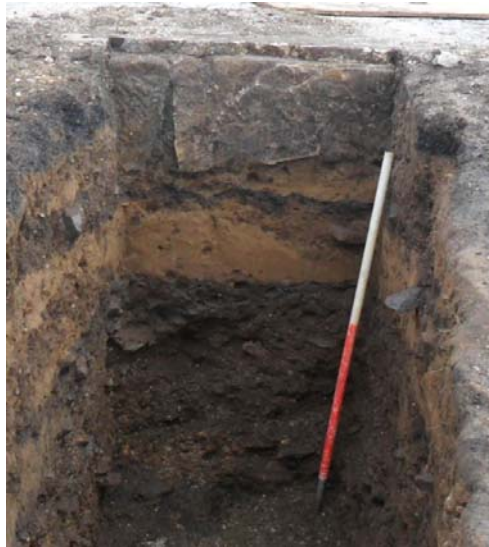
The eastern end of the trench contained seven deposits (001-007) all of which comprised sand with varying amounts of stone and gravel inclusions (Plate 3). The exception to this was a deposit of black silty ash (001) which was only present in a very small patch at the surface of the eastern trench extent.

The western end of the trench was capped by a dark brown sand deposit (004) which varied in depth from 0.1 m to 0.36 m and contained frequent angular stone inclusions along with yellow/brown brick and sandstone fragments. Beneath this lay three layers of sand (009, 016 & 012). The upper deposit (009) comprised 0.10 m of sterile mid-brown sand while the subsequent two deposits (016 & 012) comprised dark brown sand with occasional small rounded stone inclusions up to 0.04 m in size. The latter two sand deposits (016 & 012) were very similar and difficult to distinguish from each other with (016) existing to 0.45 m in depth and lying over (012) which extended to the base of the trench.

Plate 3: West facing section of 2008 evaluation trench

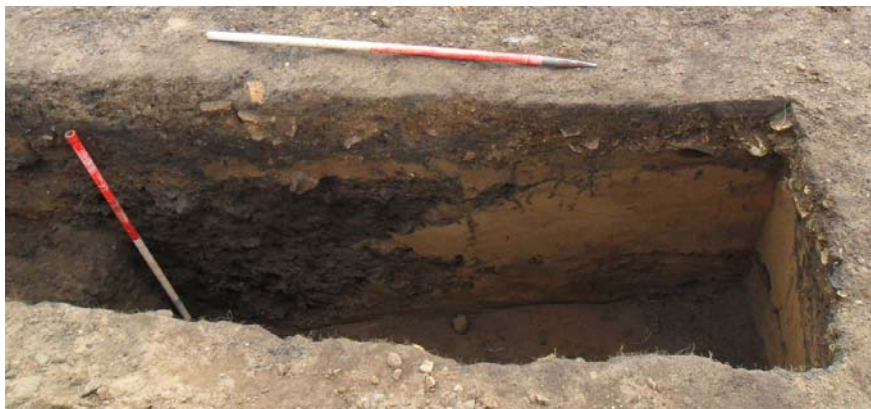
A likely archaeological feature [014] appeared to cut into sand deposit (016). The cut was only partially revealed in section but, where visible, appeared to have a gradual break of slope at the top and very shallow slightly concave sides (Plate 4). The cut was filled by a single fill comprising a moderately compacted very dark brown/black sand with abundant angular stone inclusions (010).

Plate 4: North facing section of 2008 evaluation trench showing possible cuts [014 & 015]

The base of cut [014] was not distinct or obvious in section due to it truncating a lower feature containing an almost identical fill (Plate 4). The lower feature [015] exhibited a similar profile to the upper feature [014] and appeared to be of similar dimensions. The lower feature [015], which was cut into sand deposit (012) contained a single fill comprising a moderately compacted very dark brown/black sand with abundant angular stone inclusions (013).

To the east of these two features [014 & 015] and lying between sand deposits (012 & 016) lay a small band of dark brown sand and gravel (011).

Likely archaeological deposits and features were uncovered at the western end of the trench, the most obvious two being cut features [014 & 015]. Given the absence of any artefactual material being recovered and the narrow confines of the previous evaluation trench it was not possible to fully characterise these features or their associated deposits. It was, therefore, also not possible to fully confirm whether they related to the lighthouse or some prior episode of activity.

The removal of the 0.4 m either side of the previous evaluation trench during the extended evaluation was confined to layers above the potential archaeology. However, the extent of the extended evaluation resulted in excavation to within approximately 0.1 m of the top of the uppermost possible feature [014]. Further excavation was not undertaken in accordance with the conditions of the Scheduled Monument Consent dated 26<sup>th</sup> April 2016. It is considered that, if excavation is limited to this same depth, there will be no disturbance of archaeological deposits which might exist, however, consideration should be given to an appropriate archaeological mitigation for all remaining investigation works to ensure that the archaeological resource is fully protected.

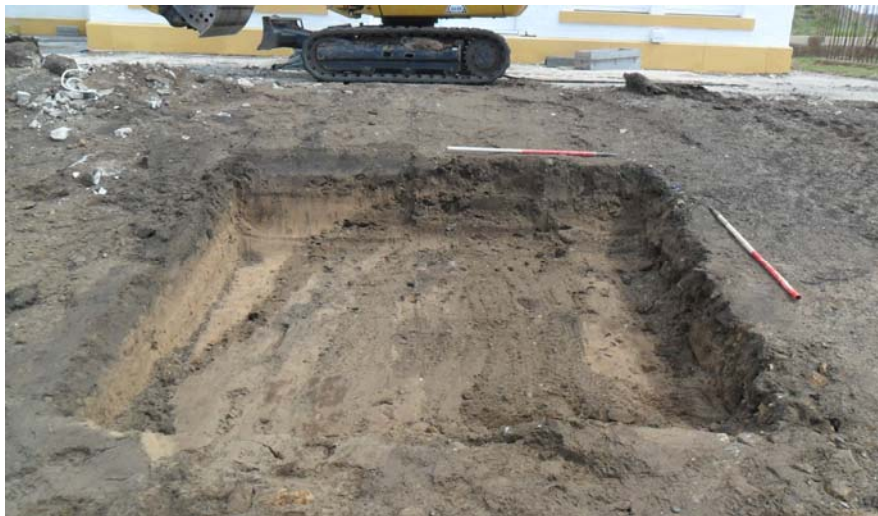
Once the 2008 evaluation trench had been fully recorded it was carefully backfilled to the post-topsoil strip ground level. The area covered by the previous evaluation trench was then expanded linearly to the north and south creating a trench measuring 4 m E-W by 3 m N-S (Plate 5) and comprising a cross-section of the proposed stair position. Depth was restricted to 0.4 m below ground level, being the maximum likely to be required for formation of the staircase using shallow pad foundations.

The trench was excavated through deposits (002-004 & 009) which were interpreted as disturbance, levelling or made ground associated with the lighthouse. No artefacts or potential archaeological deposits were noted during the course of the excavation.

Plate 5: Extended Evaluation
