**ELLON CASTLE GARDEN**  
**ABERDEENSHIRE**  
**Historic Garden Survey**

Carried out July-August 2016  
by  
**Murray Archaeological Services Ltd**

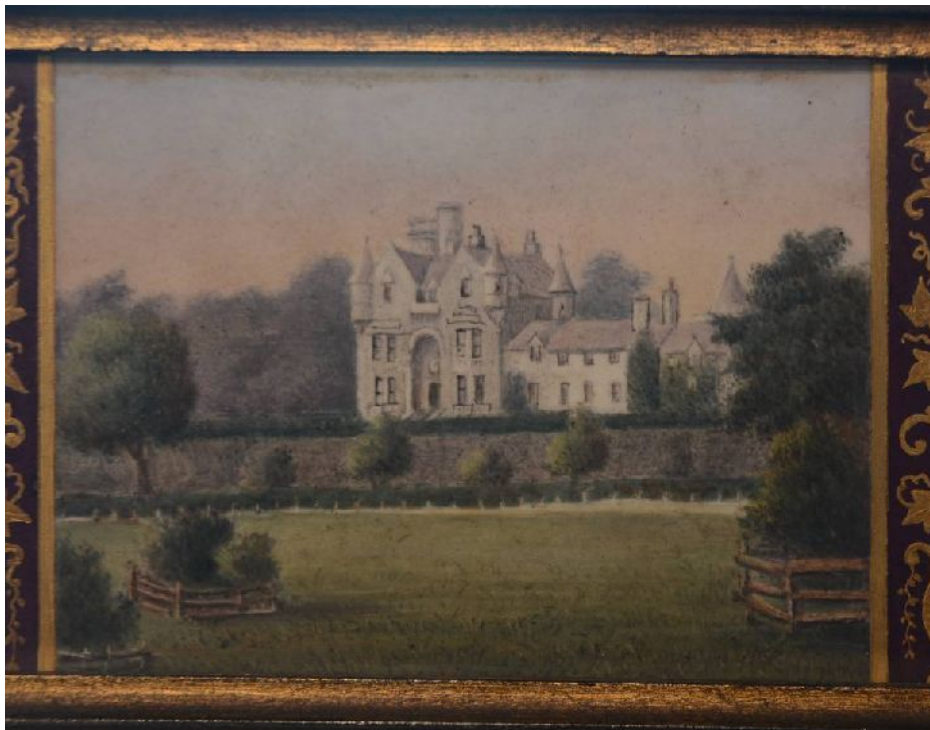
**Illus 3 The new castle of Ellon built 1851. painting c 1870s on enameled box Haddo House (Photograph MAS Ltd courtesy of the Marquess of Aberdeen)**

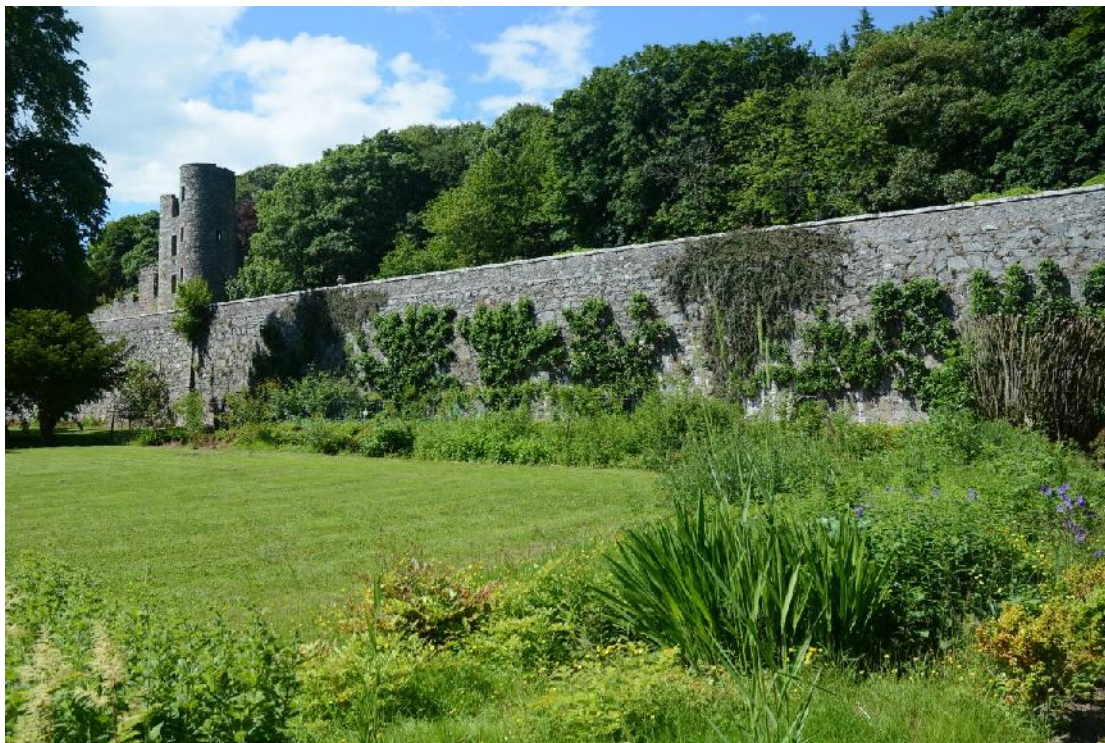
**Illus 19 N wall E of Garden House, looking W**

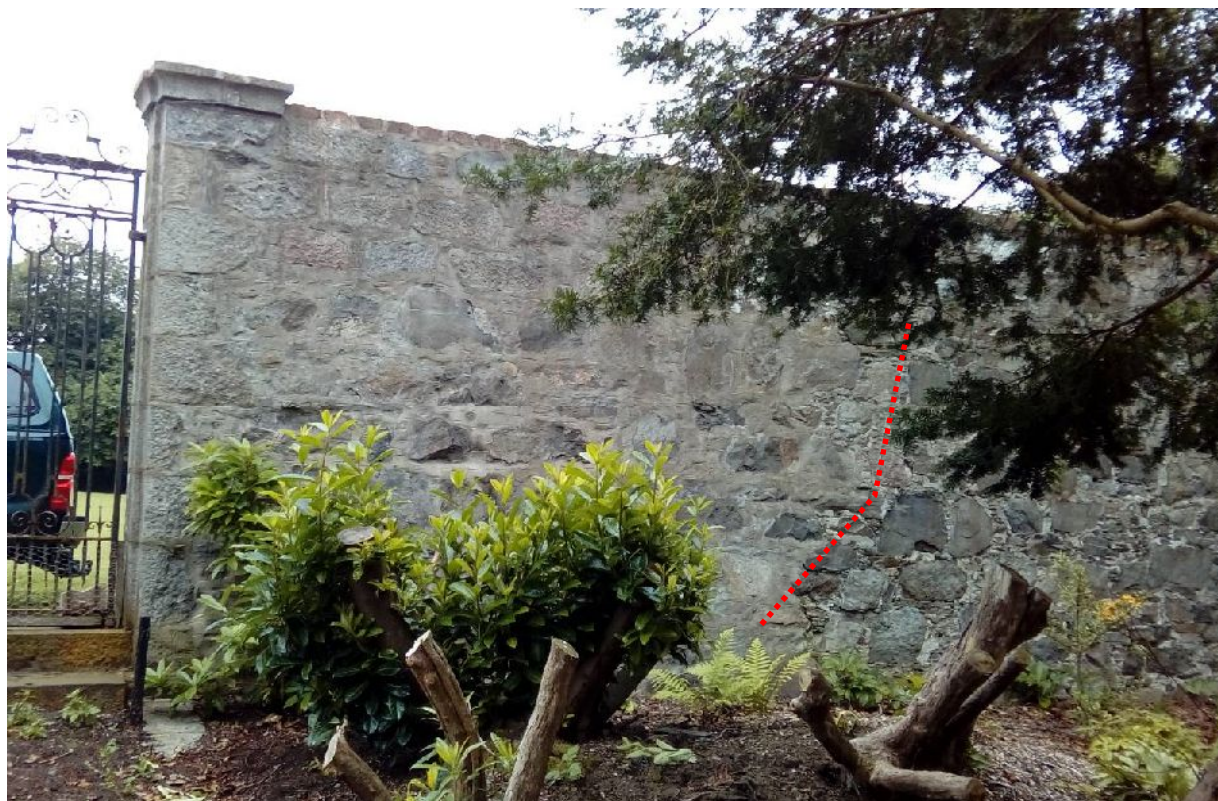
**Illus 25 S wall W of central gate. Red line indicates break in construction**

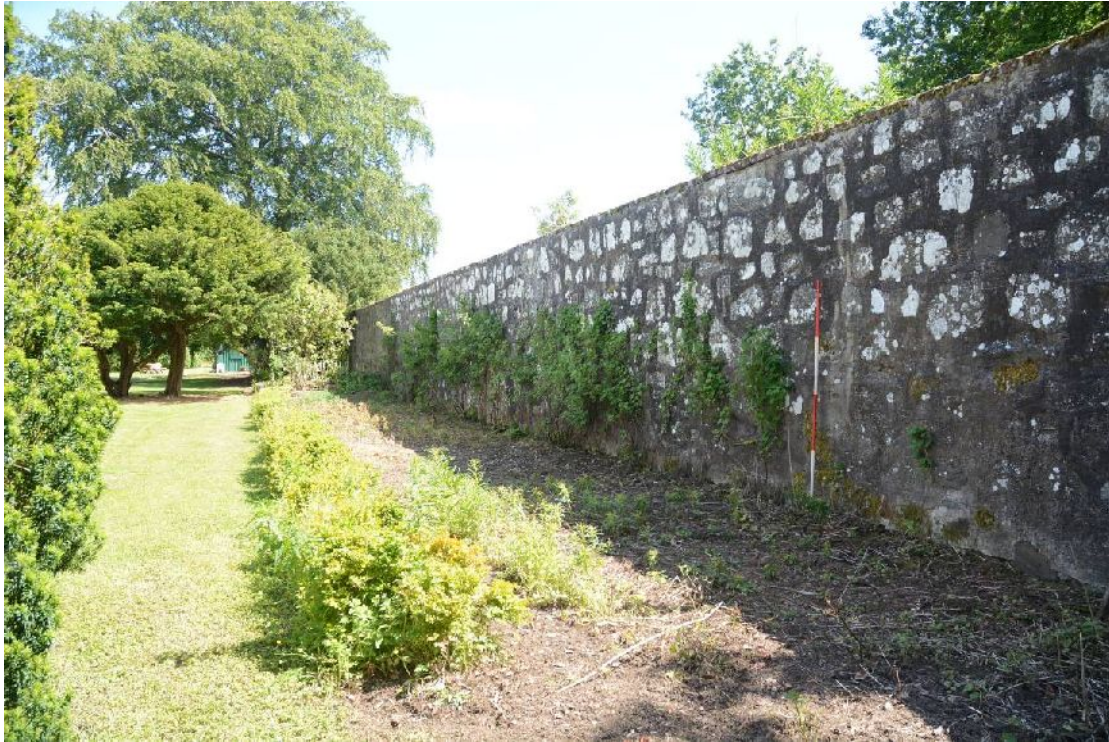
**Illus 26** W end of S wall, looking E

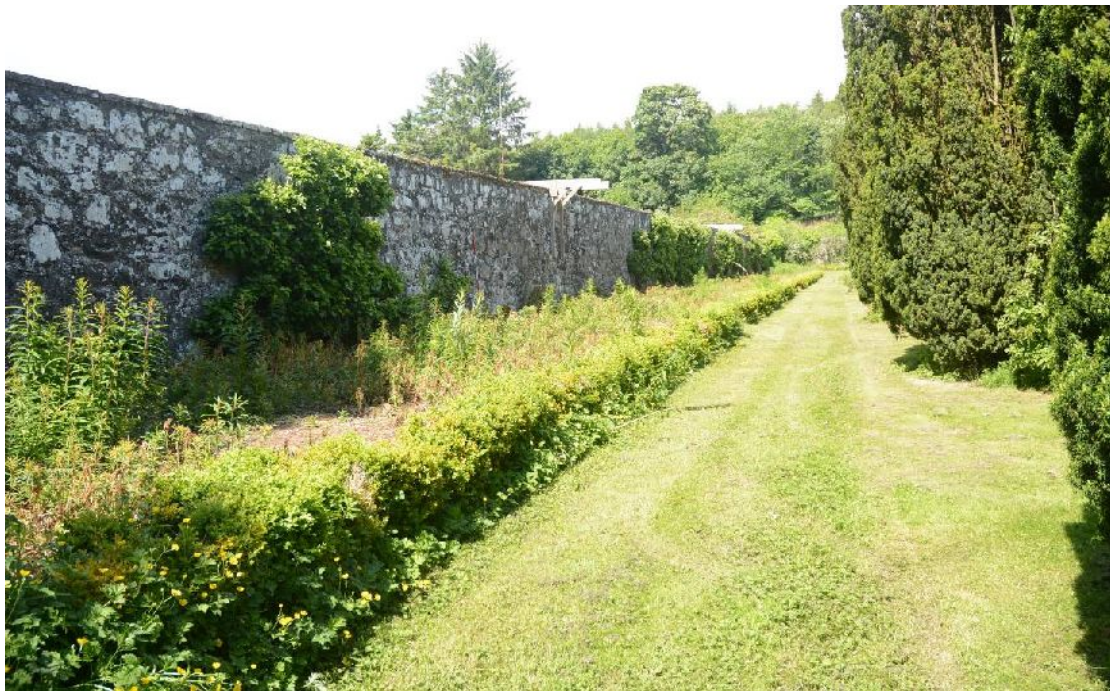
**Illus 33 W wall looking N**

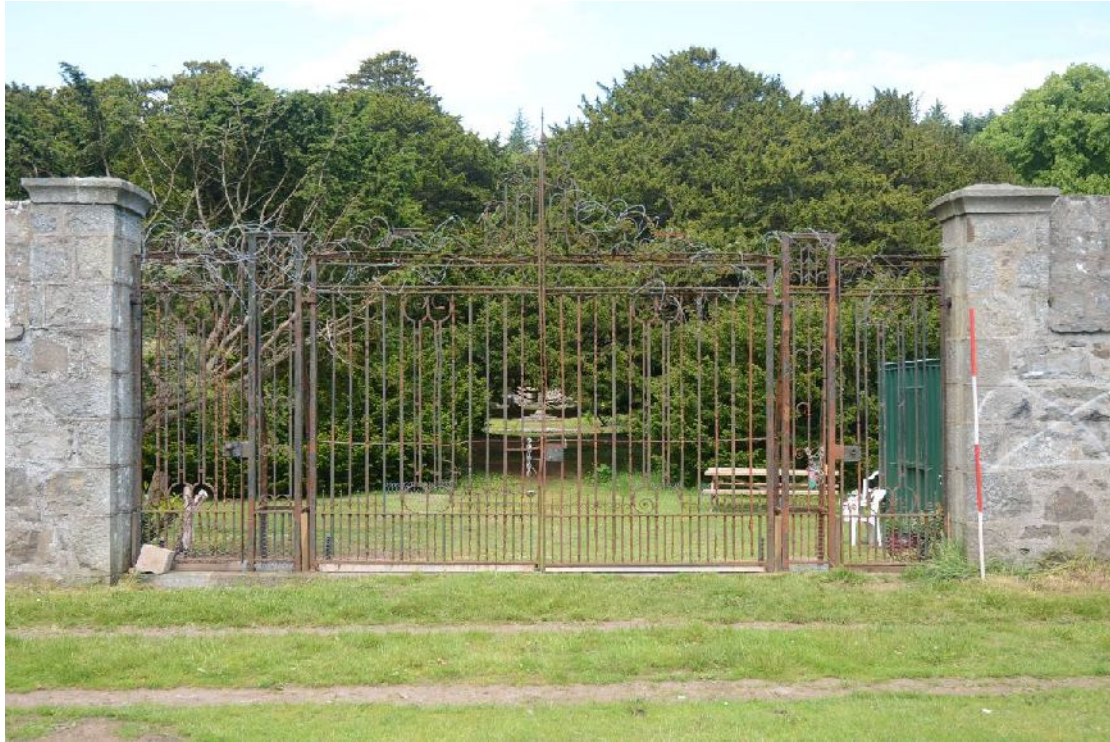
**Illus 46 Gate 14 externally from Deer Park**

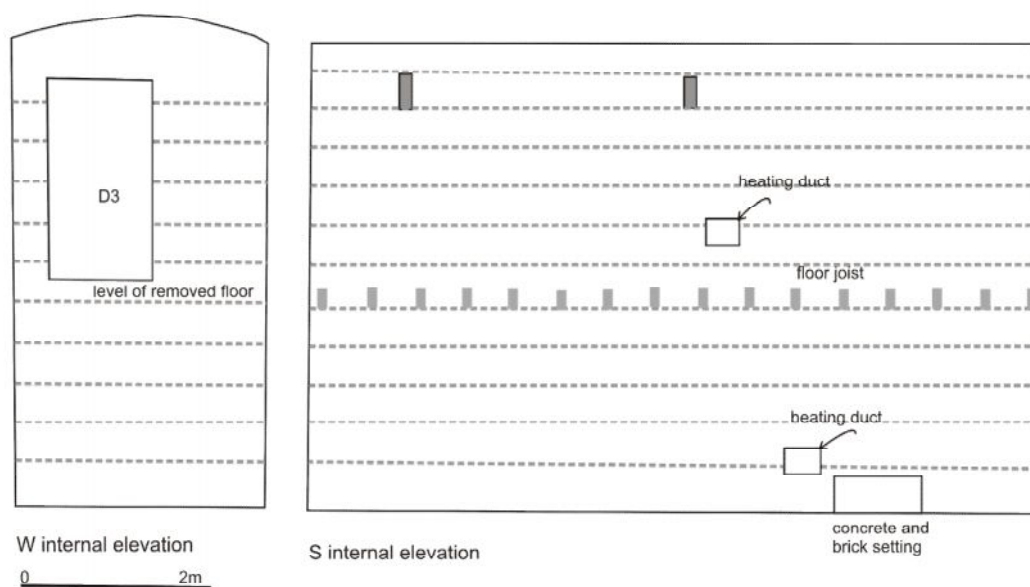
**Illus 59 Internal elevations of Garden House. The dotted lines are c 50mm wide bands of grey cement- possibly showing where shelves have been removed.**

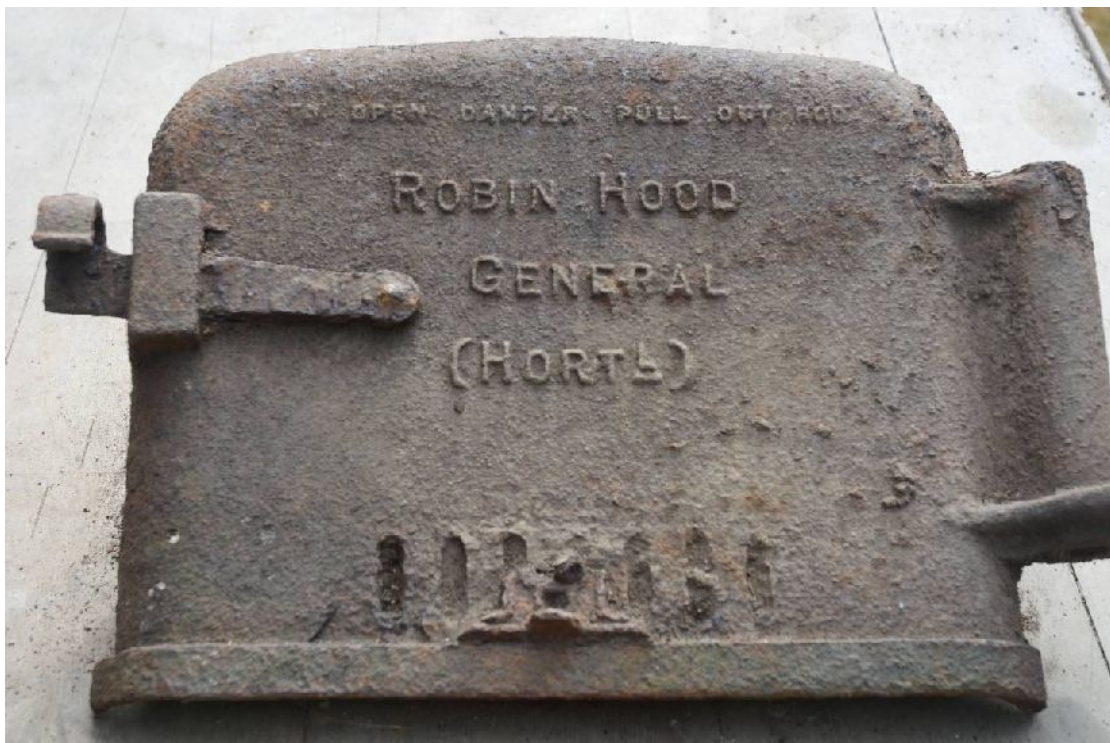
**Illus 60 Boiler cover found in garden house**

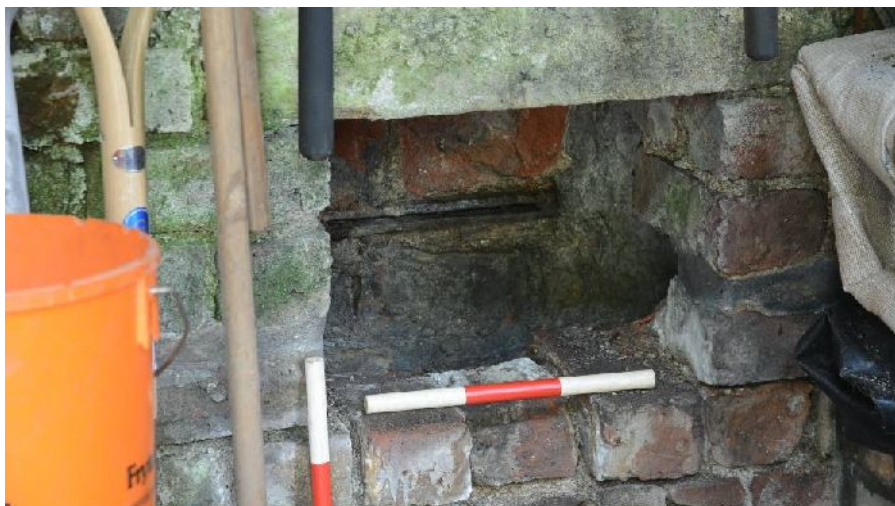
**Illus 61 Detail of lower vent in N wall. The grooved metal bar at back may have held a shutter to direct the hot air either sideways or upwards**

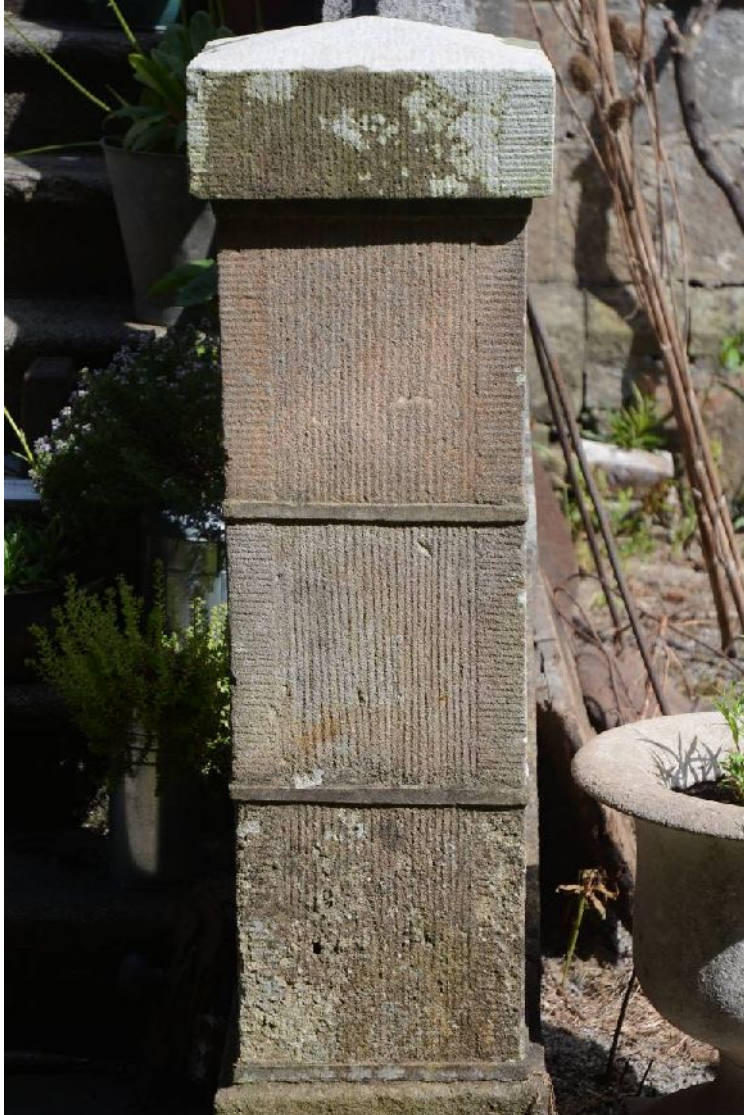
**Illus 68** E side of steps. Detail of dressing on stonework of pillar

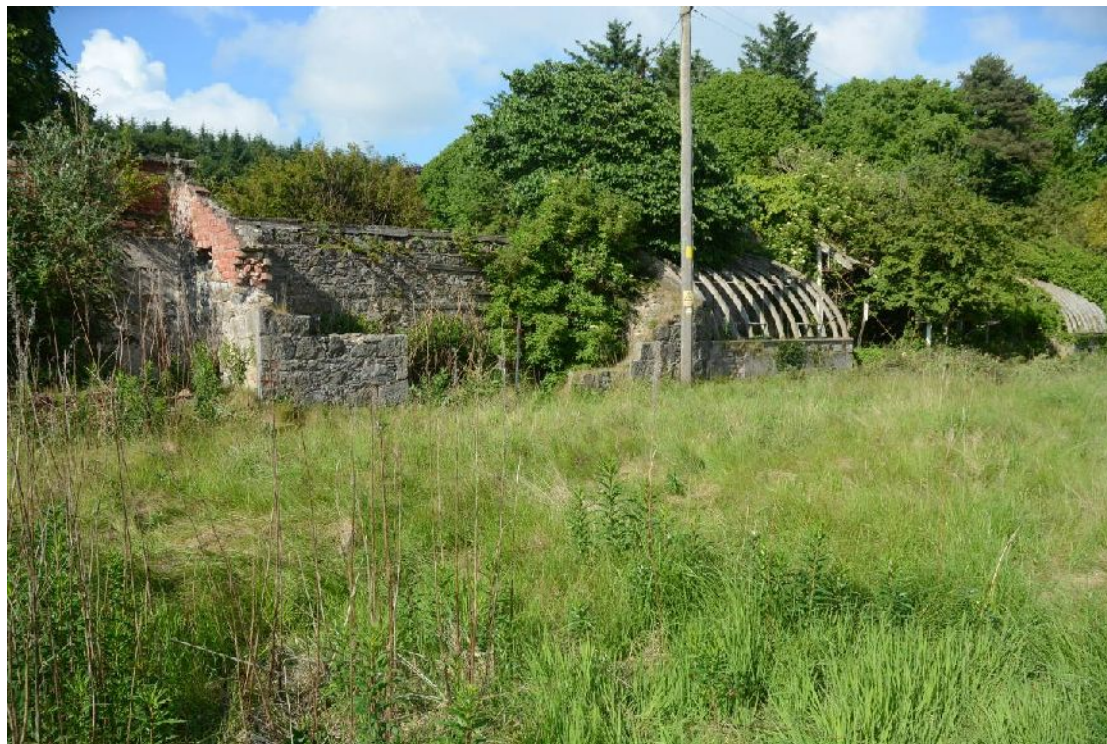
**Illus 75 View of greenhouses from L to R: 24,25,26,27,28**

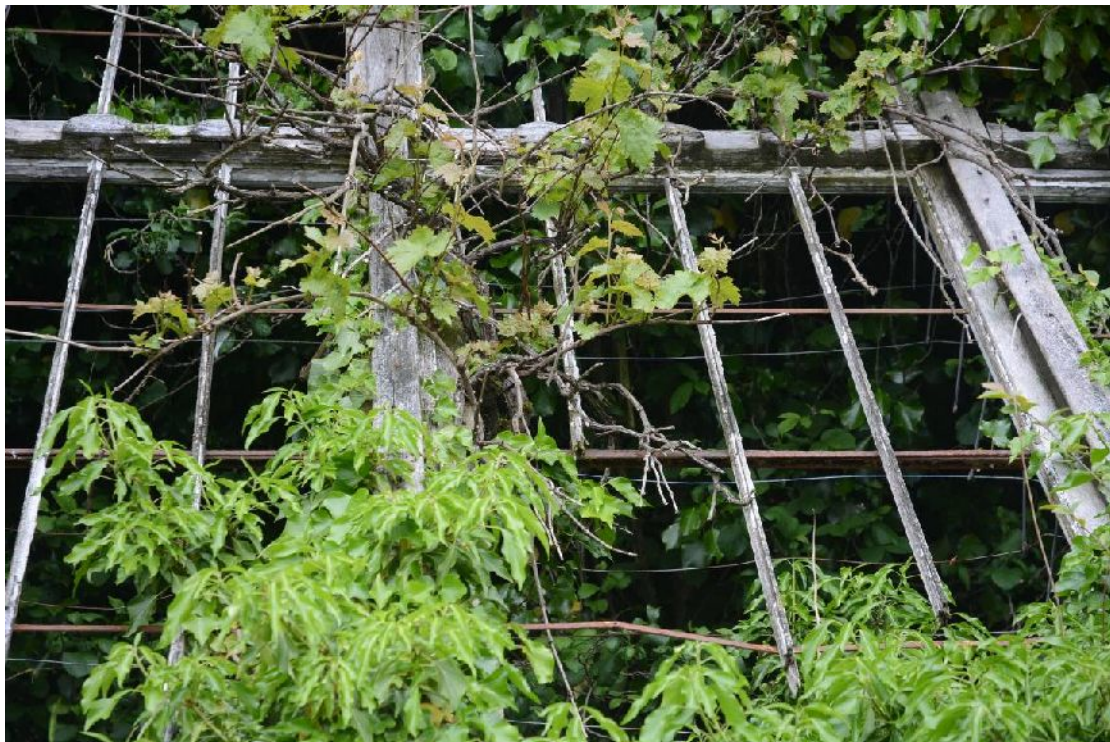
**Illus 82 Greenhouse (27). Live vine surviving.**

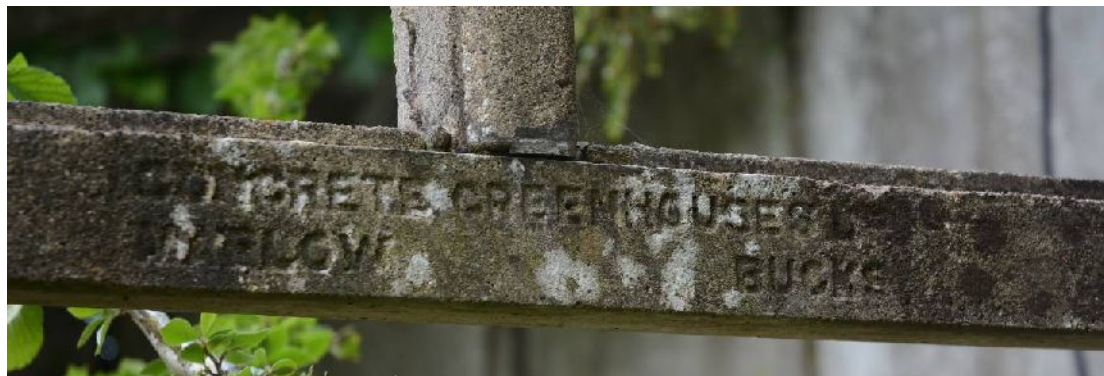
**Illus 83 Greenhouse 26. Maker's name on door lintel**

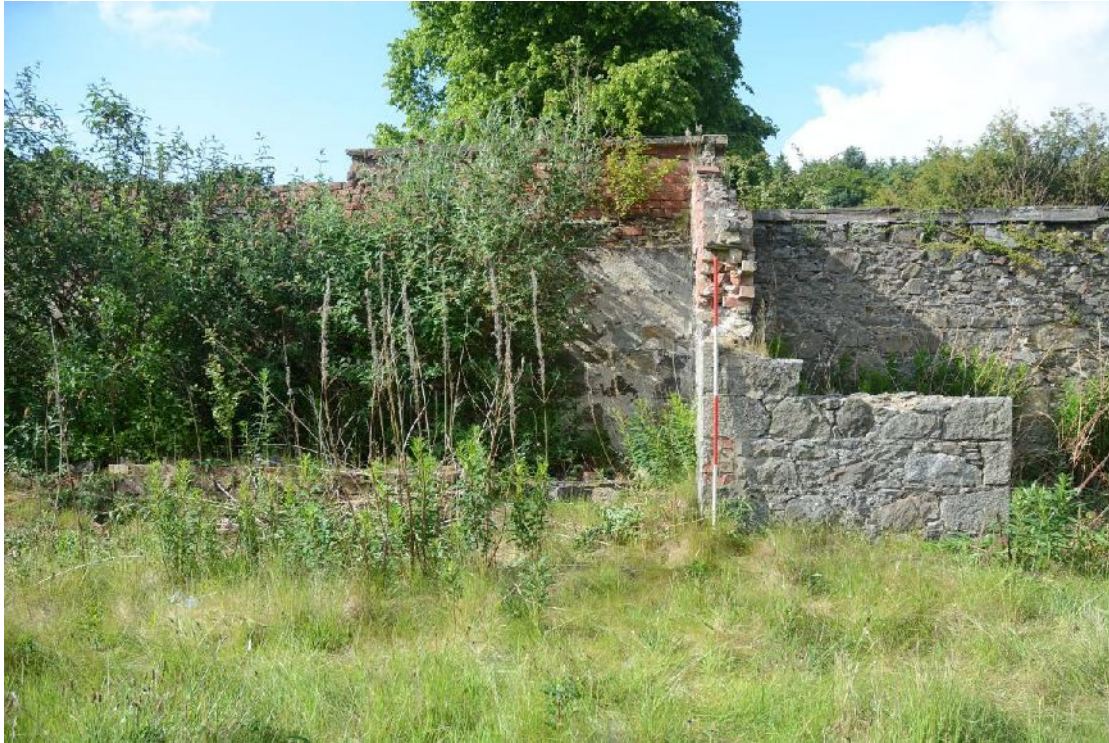
**Illus 95 General view of building 24 from the S.**

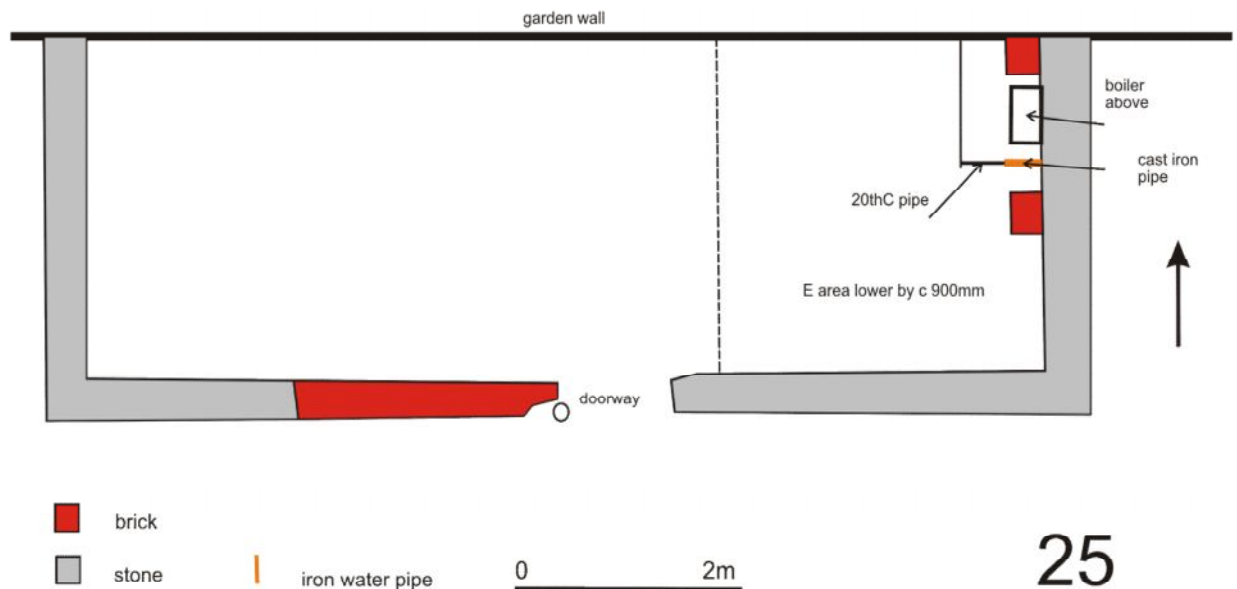
Illus 97 Boiler House 25

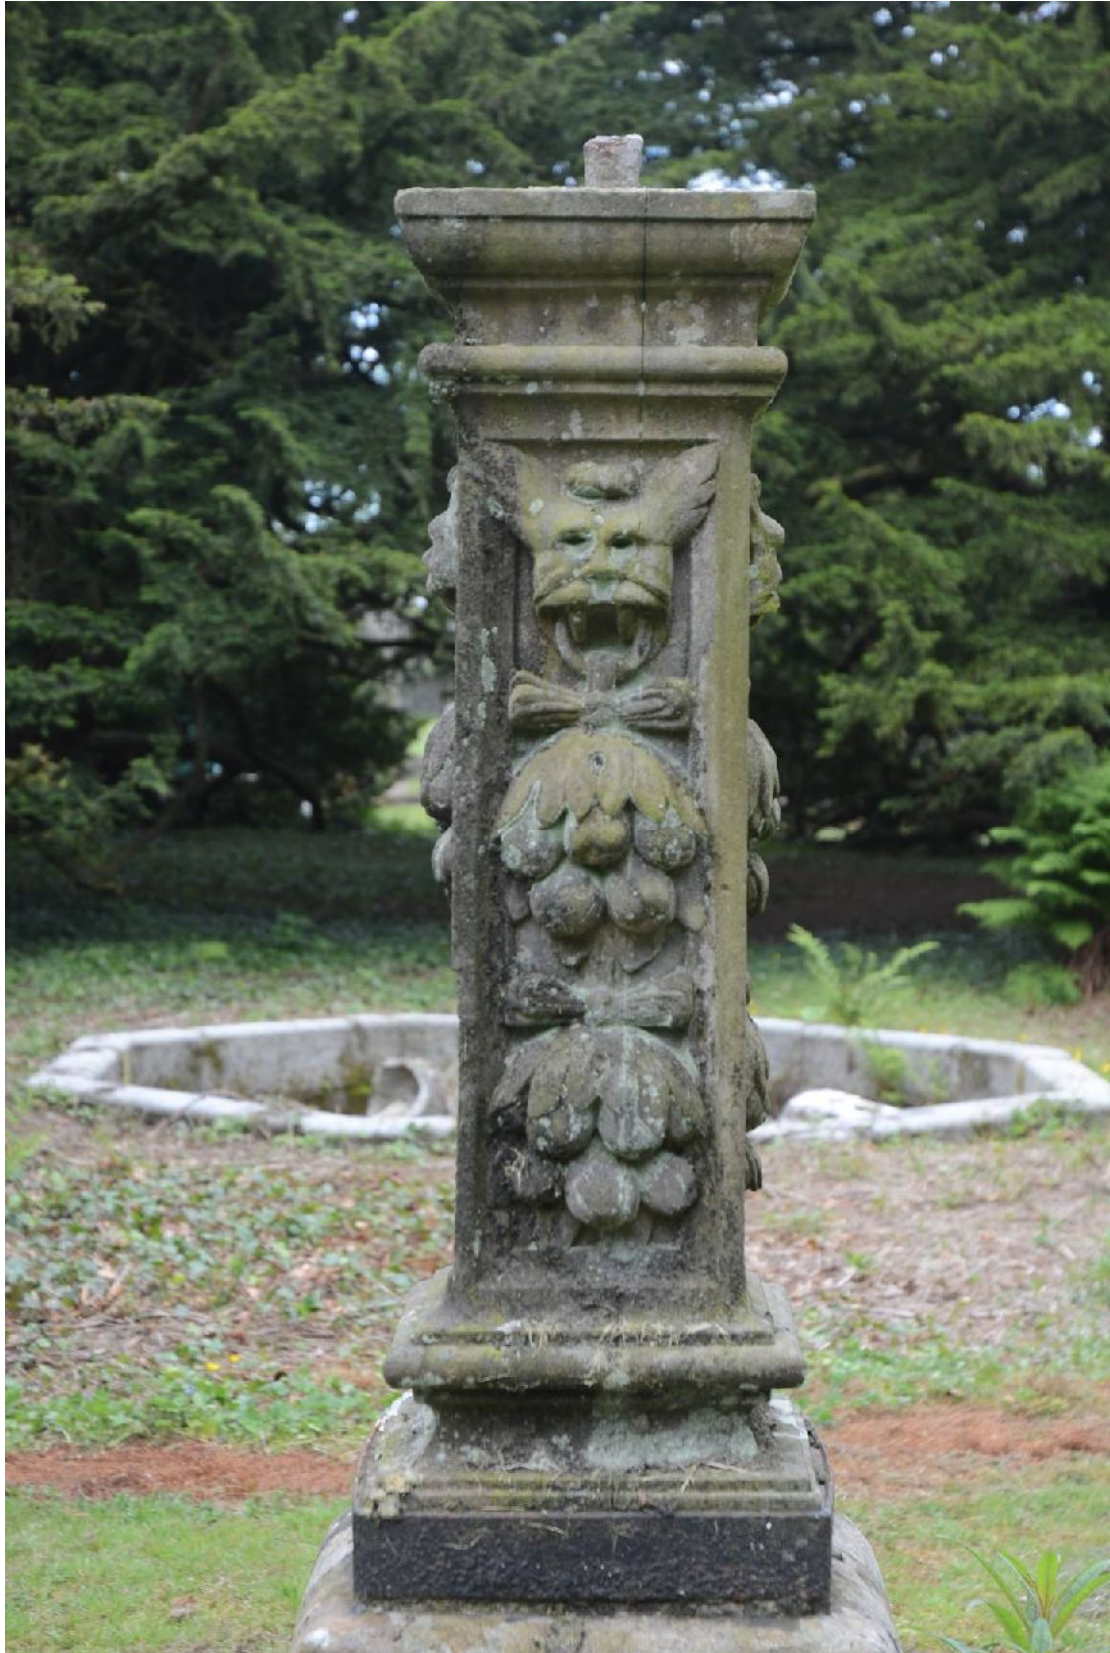
**Illus 107 Detail of the N face of the column of the central sundial (9)**

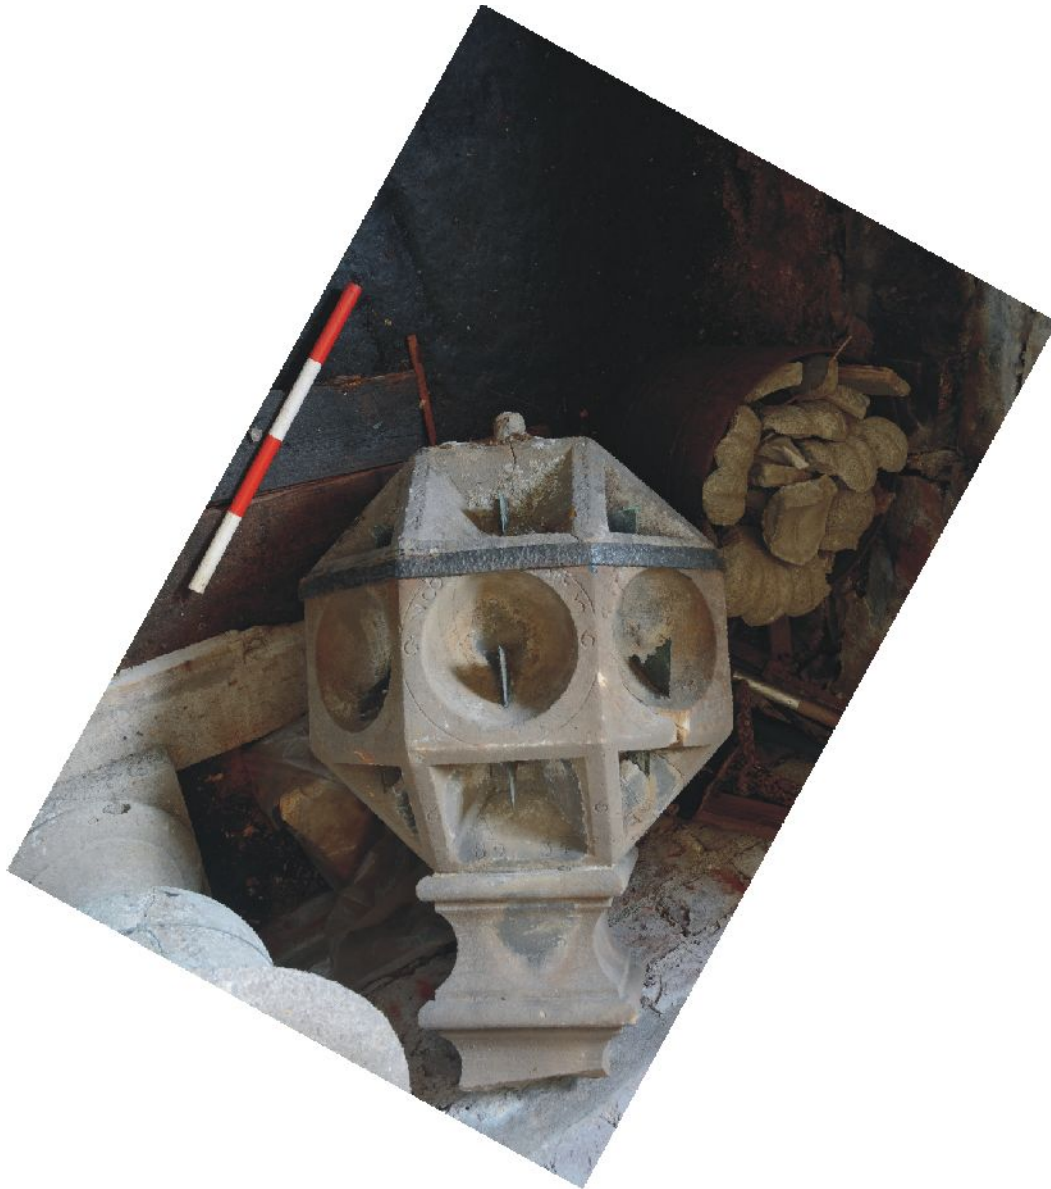
**Illus 108 Sundial (9) with gnomens as photographed in storage in Garden House 2016**

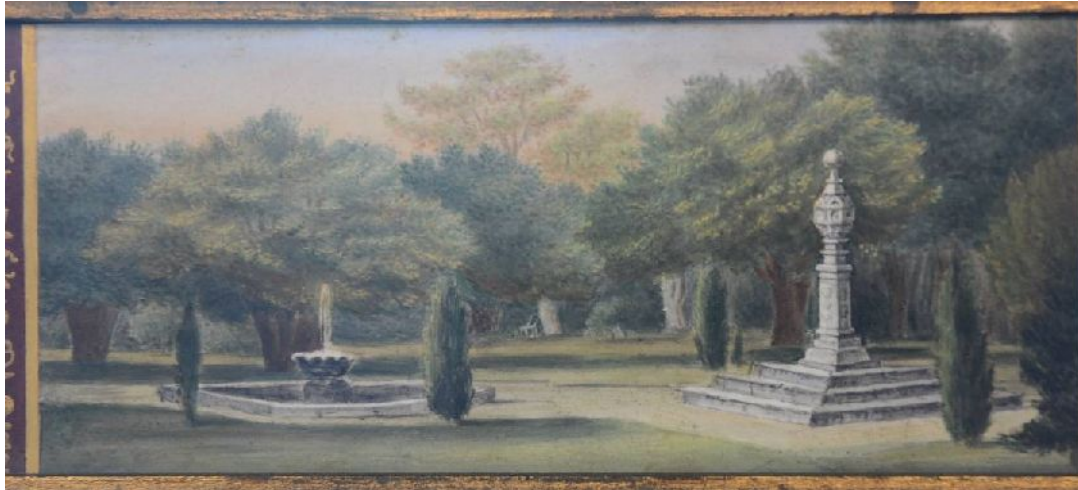
**Illus 117 Fountain and central sundial 1870s on enameled box Haddo House (Photograph MAS Ltd courtesy of the Marquess of Aberdeen). Note the increased size of the small conifers beside the fountain and sundial.**

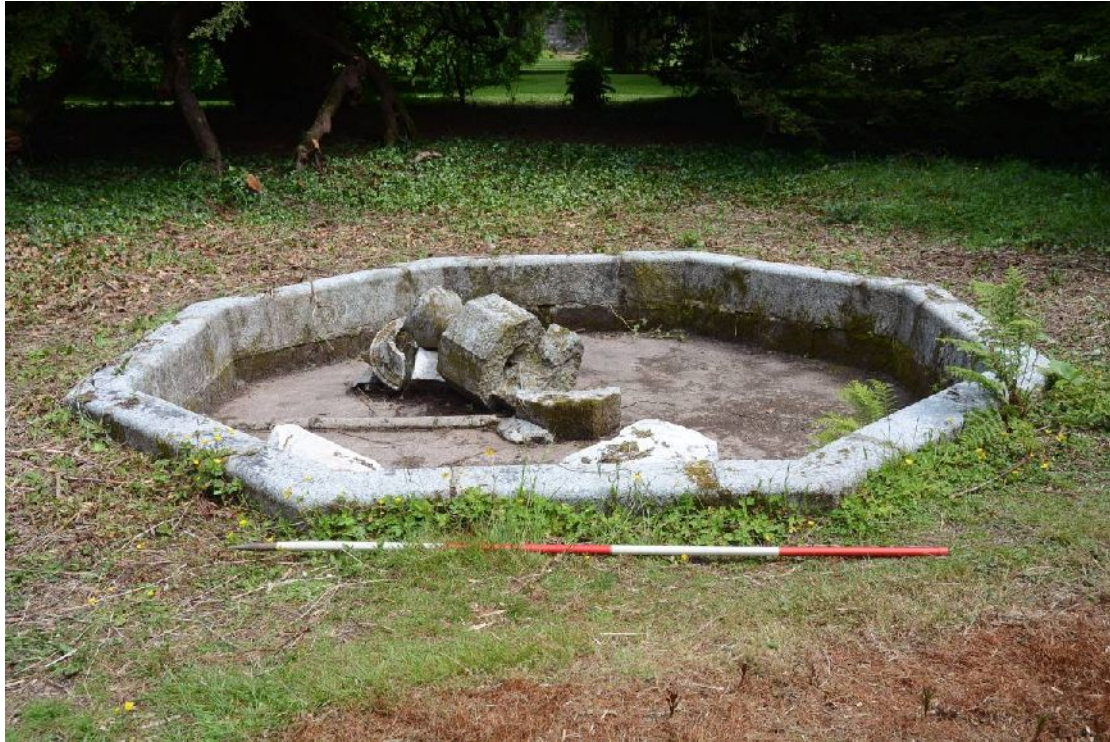
**Illus 118 Fountain (8) in 2016, looking S**

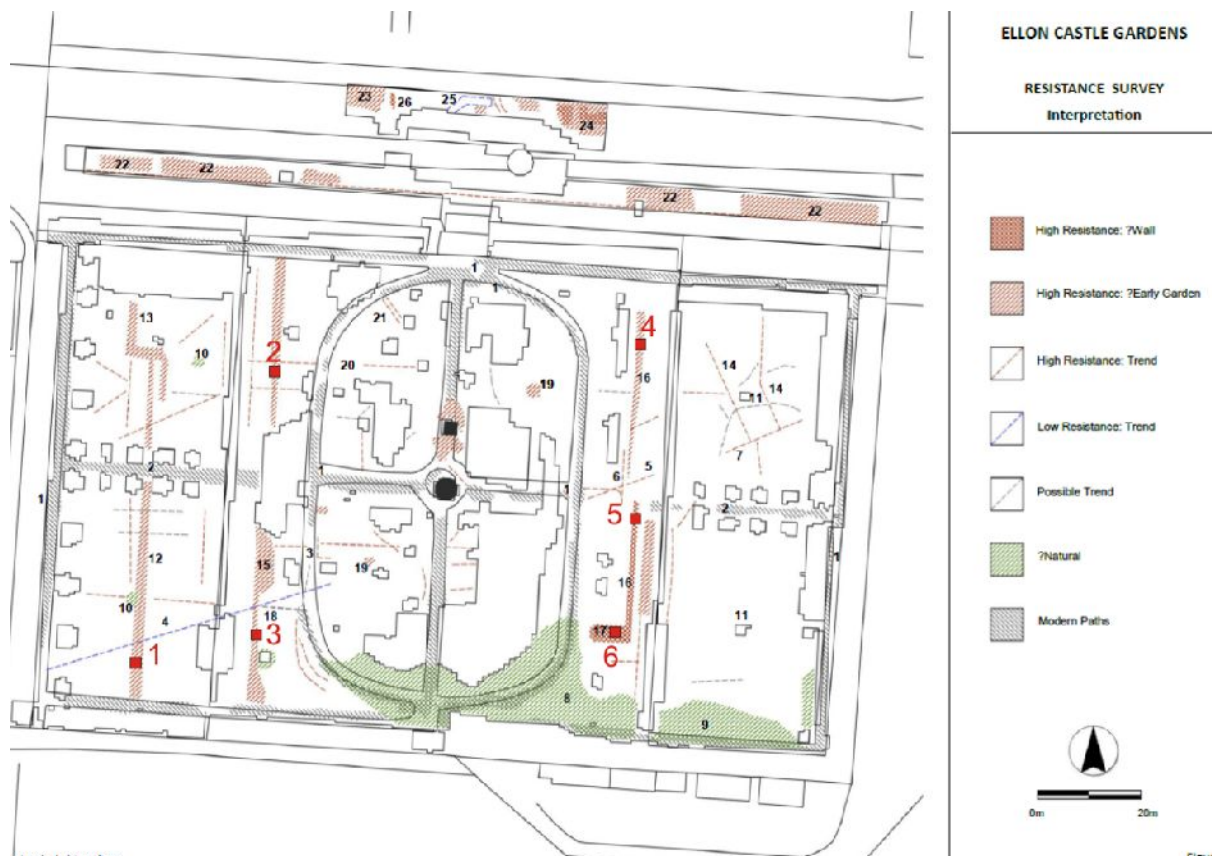
**Illus 141** Interpreted results of geophysical survey (Ovenden 2016, fig 8) with suggested test pits shown in red with red numbers 1-6.
