Scottish Medieval Castles & Chapels C-14 Project

Preliminary mortar & masonry Survey of Kinclaven Castle, Perthshire

SC14-KCP-PRE-01

Site	Kinclaven Castle, Perthshire
NGR	NO 1581 3773
Document reference	SC14-KCP-PRE-01
Document type	Preliminary report
Subject	Preliminary mortar and masonry survey
Survey Date	03/10/2016.
Previous reports	No
Literature search	Ongoing
Fao	Historic Environment Scotland, XXXXXXXXXX
Compiled	M Thacker 24/10/2016

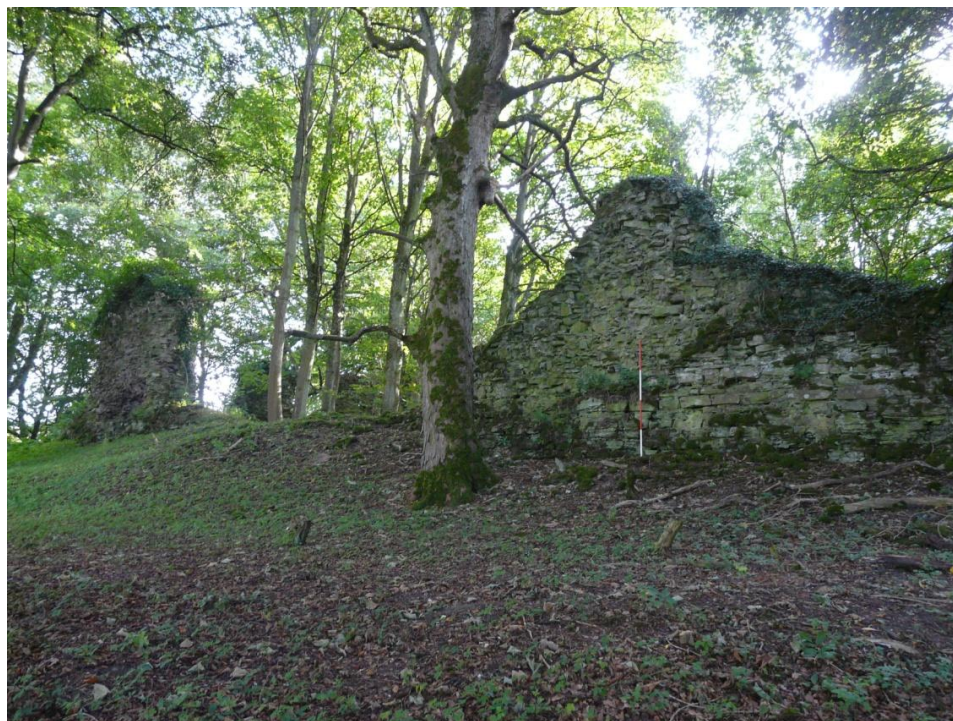
Figure 4 (above) - Kinclaven Castle; external face of surviving sections of north-east wall from north. Scale 500mm; photograph M. Thacker.

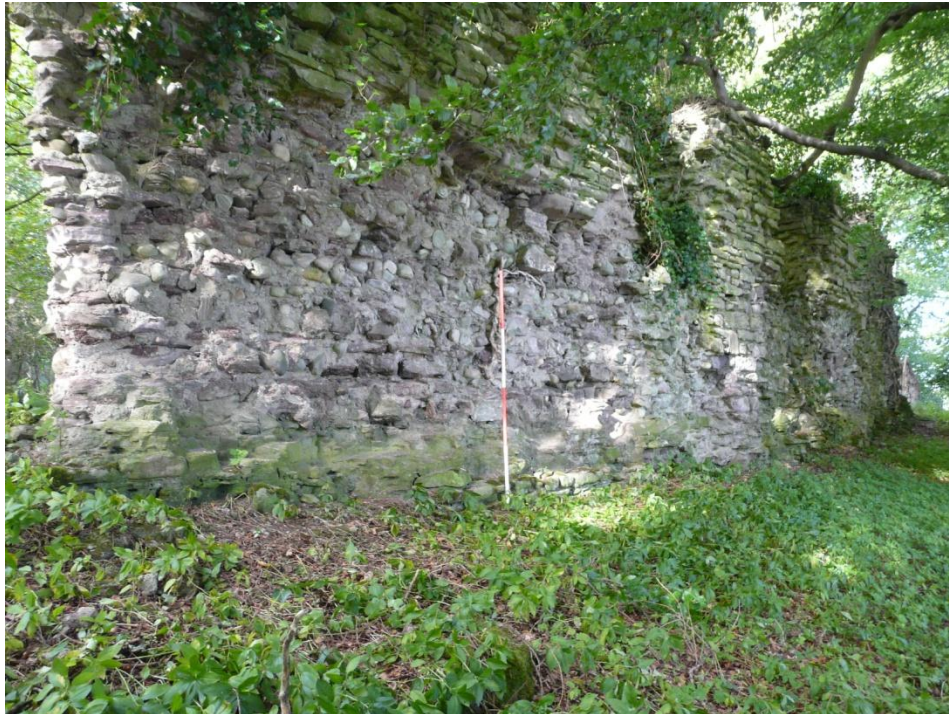
Figure 5 (above) – Kinclaven Castle; external face of south-east wall from the south. Scale 500mm; photograph M. Thacker.

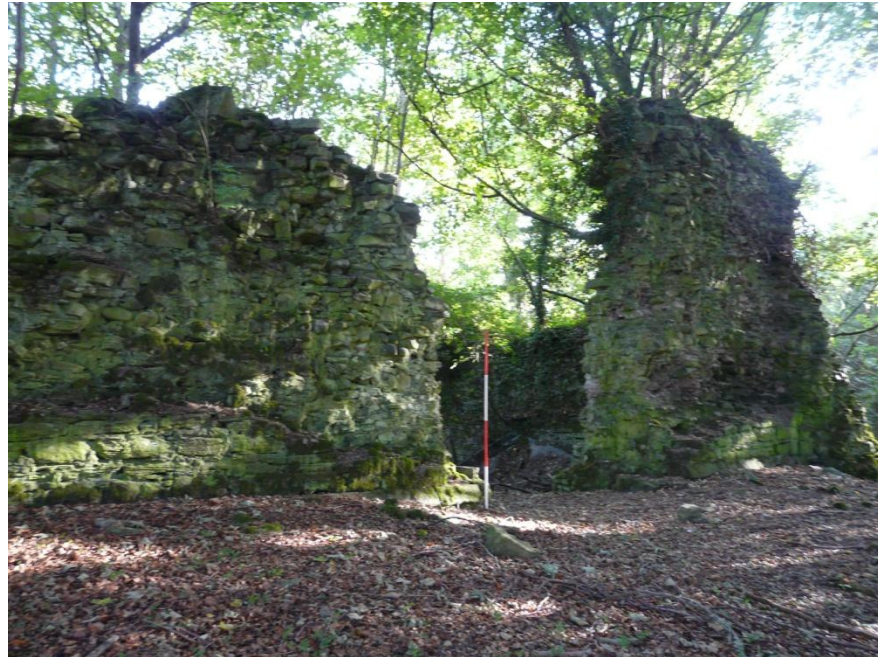
The walls are wider in the basal courses, and a 150mm deep splay of finely dressed sandstone (of irregular lengths) survives at the west end of the north-west wall. This basal levelling plinth appears to be of the same sandstone as the general wall faces, and no evidence for this feature was noted internally.

Figure 7 (above) – Kinclaven Castle; external face of west end of north-west wall, including the remains of main entranceway. Scale 500mm; photograph M. Thacker.

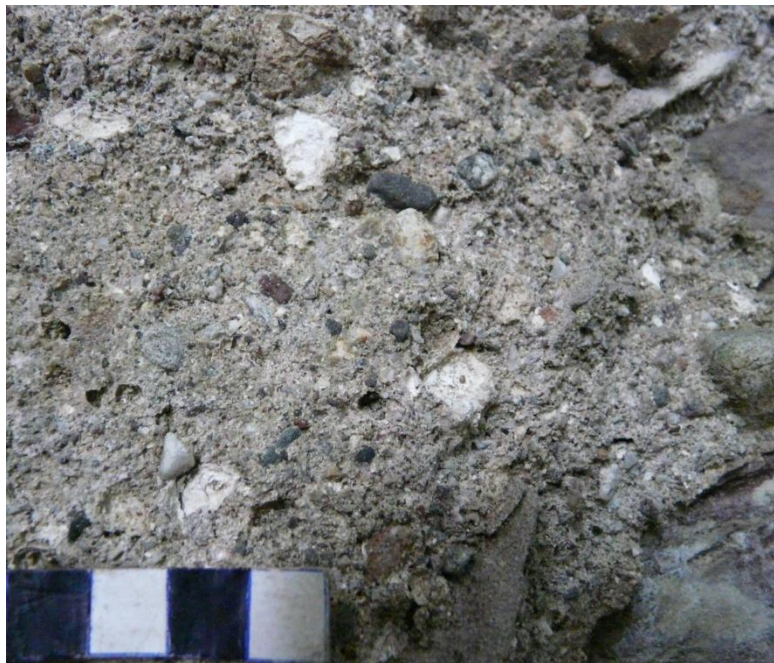
Carbonate kiln-relicts: This is a limestone-lime containing a high concentration and range of heated limestone kiln-relicts, which are angular to rounded, white to buff-brown and generally grade to 10mm diameter.

Added-temper: This mortar is lithic-tempered and contains quartz-rich sands, gravels and stones; often very rounded but including all shapes to angular; generally grading up to 15mm but including clasts up to 30mm.

Figure 8 (above) – Kinclaven Castle; core mortar of south-east wall clearly displaying large angular and white probable limestone kiln-relict clasts, and rounded lithic temper inclusions. Scale 10mm; photograph M. Thacker.
