Scottish Medieval Castles & Chapels C-14 Project

Preliminary mortar & masonry Survey of Castle Roy, Strathspey

SC14-CRS-PRE-01

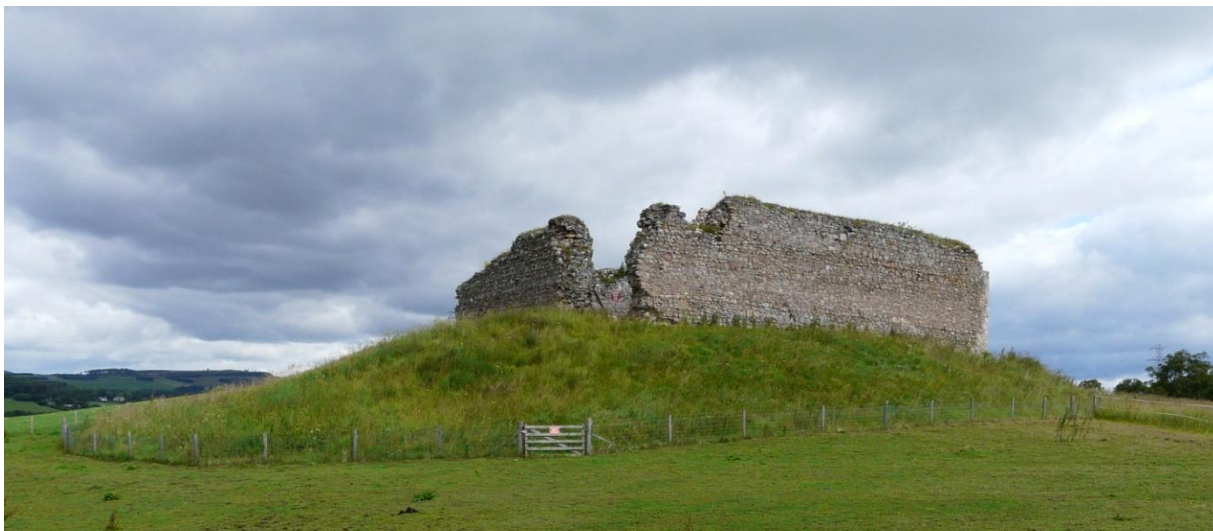
Figure 4 – From the south Castle Roy appears to be located atop a prominent mound. This view also shows the large breach and adjacent exposed wall cores at the south corner of the enclosure. No Scale; photograph M. Thacker.

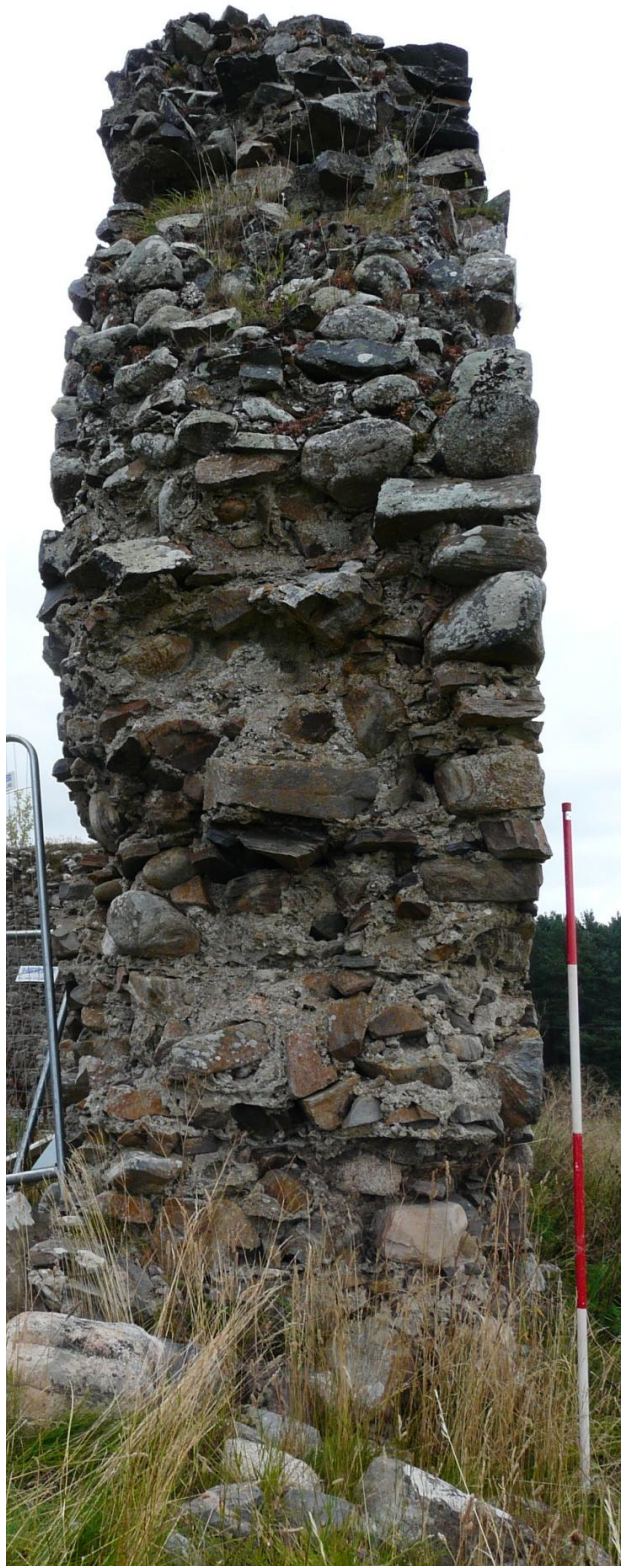
Figure 5 – Full face-core-face cross-section of south-east wall visible and accessible from breach in south corner. Note large volumes of core mortar. Scale 500mm; photograph M. Thacker.

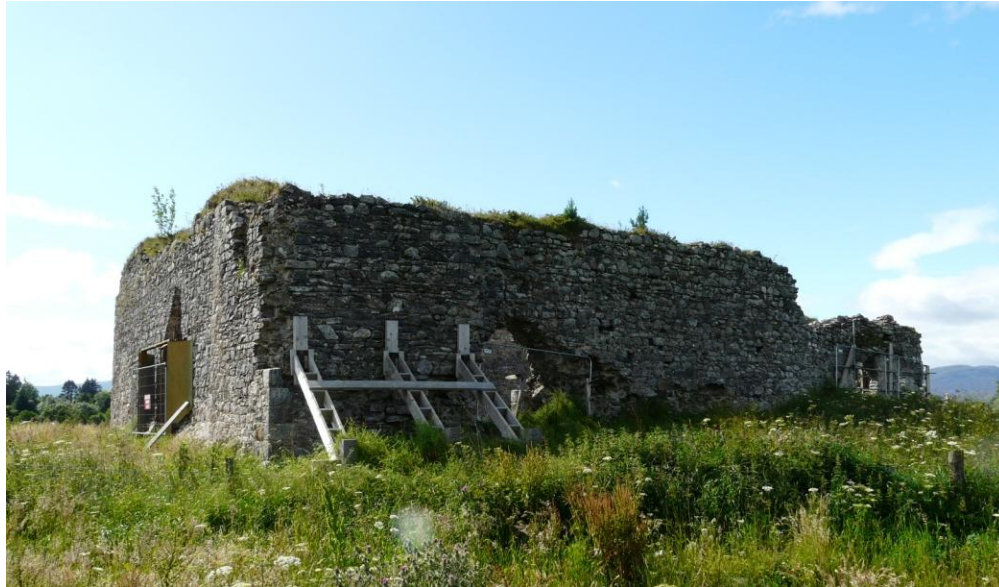
Figure 6 – Castle Roy from the north-north-west. Note north-east and north-west arch-headed entrances, exposed wall core at lower levels and around postern of the north-west wall, and some recent consolidation and temporary buttressing of northern tower. No Scale; photograph M. Thacker.

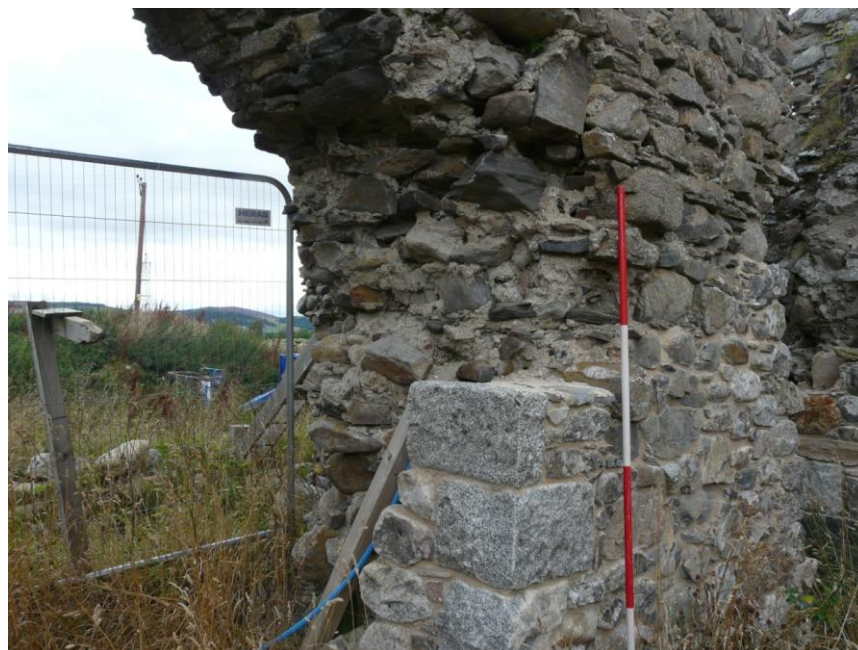
Figure 7 – Exposed primary core rubble of the north jamb of the north-west postern entrance, with some recent consolidation and re-facing of the internal face and jamb. Scale 500mm; photograph M. Thacker.

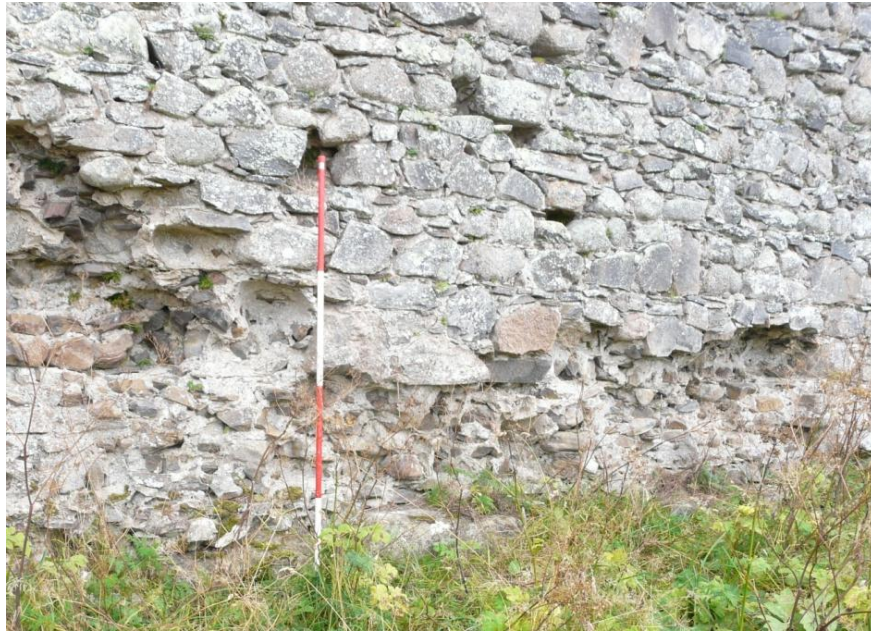
Figure 8 – Visible core rubble and constructional mortar exposed by missing face stone in external face of the north-west wall. Scale 500mm; photograph M. Thacker.

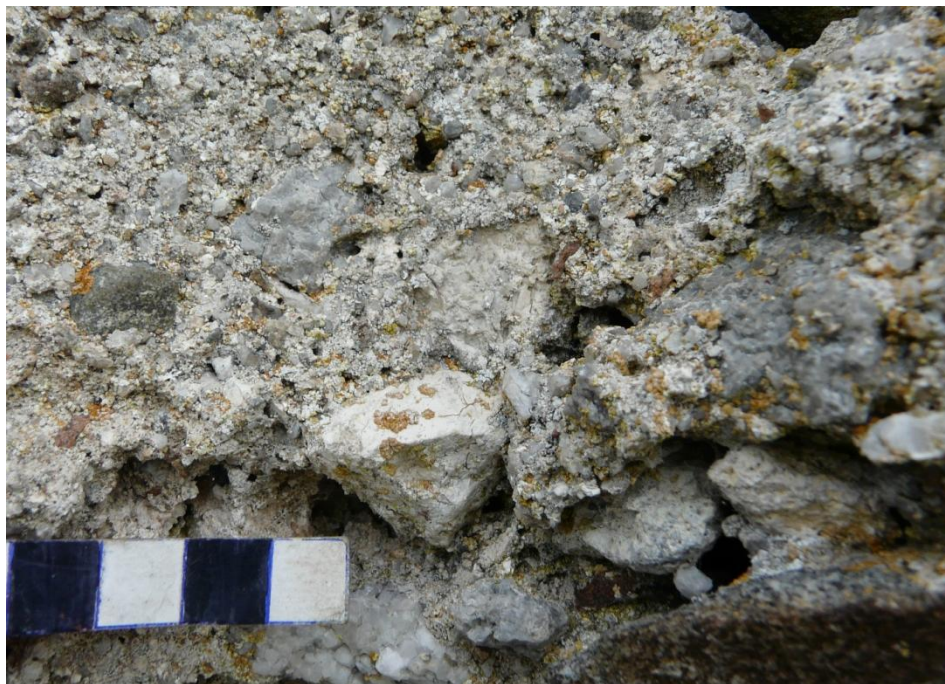
Carbonate kiln-relicts: The primary mortar at castle Roy is a limestone-lime which contains a very high concentration of blue-grey to yellow, angular to rounded, polycrystalline, probable limestone kiln-relicts to 40 x 30 x 20 and larger.

Figure 9 – Core mortar within the south-west wall of Castle Roy. Note high concentration of large angular probable heated limestone kiln-relicts. Scale 10mm; photograph M. Thacker.
