**Goldenhill Park, Clydebank:  
Archaeological Investigation for  
Access Improvement**

Data Structure Report

issued 30<sup>th</sup> January 2017

on behalf of West Dunbartonshire Council

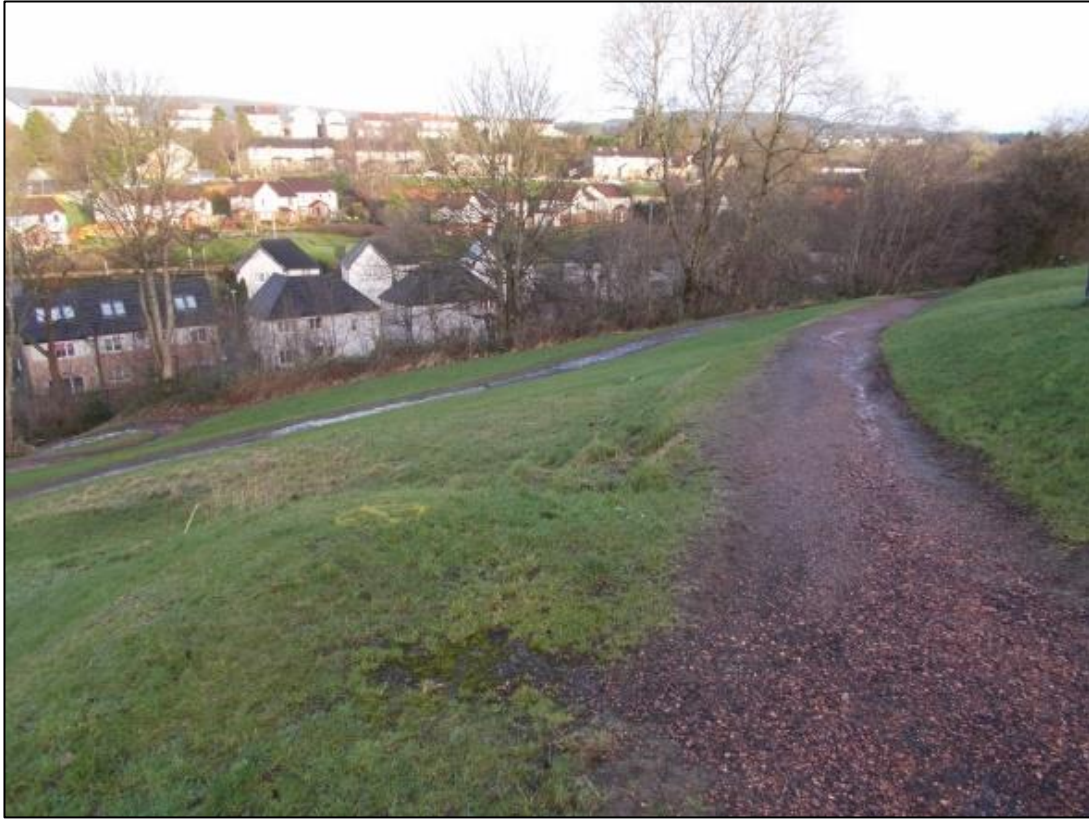
18. Test Pit **2** examined the mound adjacent to the path network and the steps at the top of the 'slide'. This showed that under a skim of topsoil (002) was buried path fabric (001) of some 200mm thickness. Beneath this was very compact clay (007) that was sufficiently robust as to prevent deeper hand excavation than 550mm depth.

Figure 2a: Path falling past upper platform of 'slide' to be tested by TP 2, steps to rear

27. Test Pit **2** is at another location that is depicted on the scheduling document map as a path, at the top of the 'slide'. This was confirmed by the path fabric exposed under another skim of topsoil. The very compact clay (007) that underlay this is dissimilar to the subsoil located anywhere else in the test pits; suggesting it is redeposited material - potentially cast material from excavation immediately downslope – that would have formed the topography to mirror and support the slide. This strongly suggests that the landform at this location is artificial and generated by landscaping within the park.

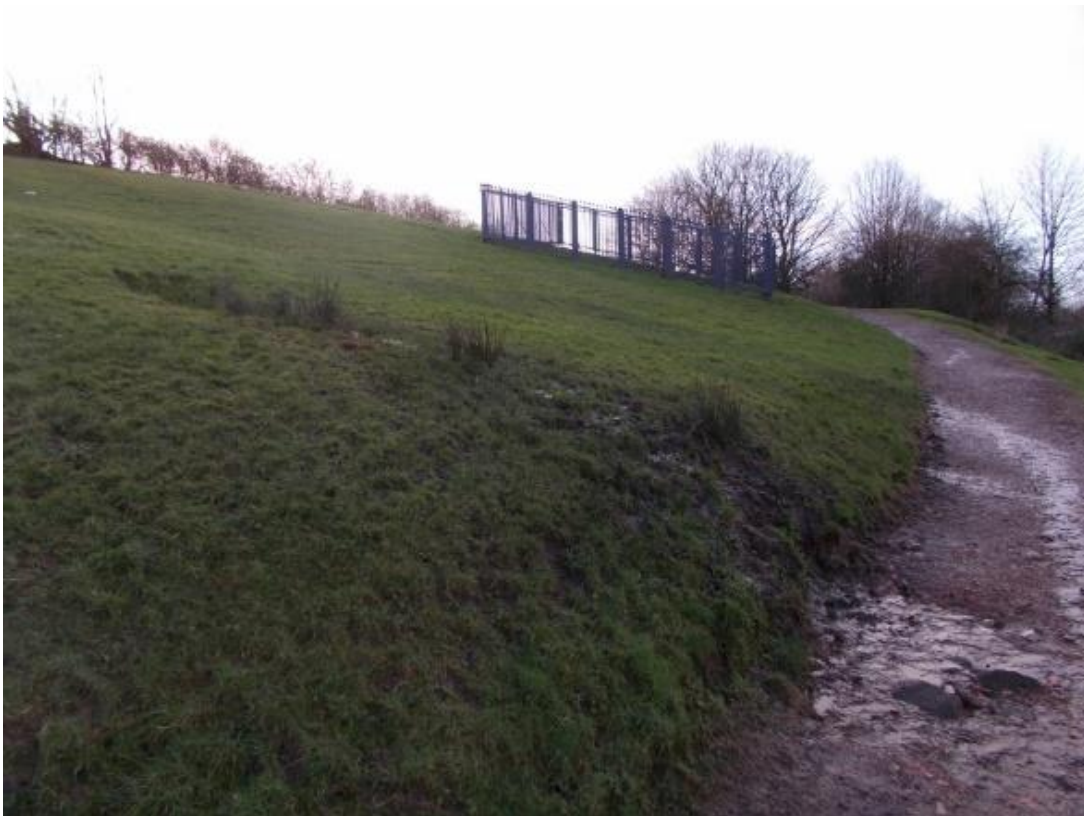
16. Five test pits (Test Pits **1** to **5**) were excavated off the path network to address other specific improvement issues.
17. Test Pit **1** sought to clarify the origin of the water that appeared as a 'spring' upslope of the path network. Excavation immediately upslope of the spring exposed a ceramic tile drain (006) within a cut (005) aligned roughly SE to NW. Subsoil (003) at this location was 300mm below the surface.

Figure 2b: Spring emerging onto pathway to be tested by TP 1

28. Similar landscaping and park management is evident from the shallow field drain exposed in Test Pit **1**, the source of the water emerging as a 'spring' adjacent to the path network. This field drain, a modern extruded ceramic drain, is most likely twentieth century in origin and presumably drains part of the ditch complex to the fore of the fort and fortlet. Its shallow run strongly suggests that this is a park rather than agricultural drain.

29. The drain presumably extended further W and the 'spring' is the result of a failure of that downhill section of the drain. The renewal of the drain downslope, under the path network, before discharging should have a low potential for archaeological impact. Consideration should be given to ensuring any overland flow of discharged water not having the potential to initiate erosion. This drain is already presumably dewatering the ditch complex, as such the impact on the characteristics of these ditch fill sediments should not alter through the renewal of the downslope element of the drain (as the field drain is discharging now, but in an unmanaged way).

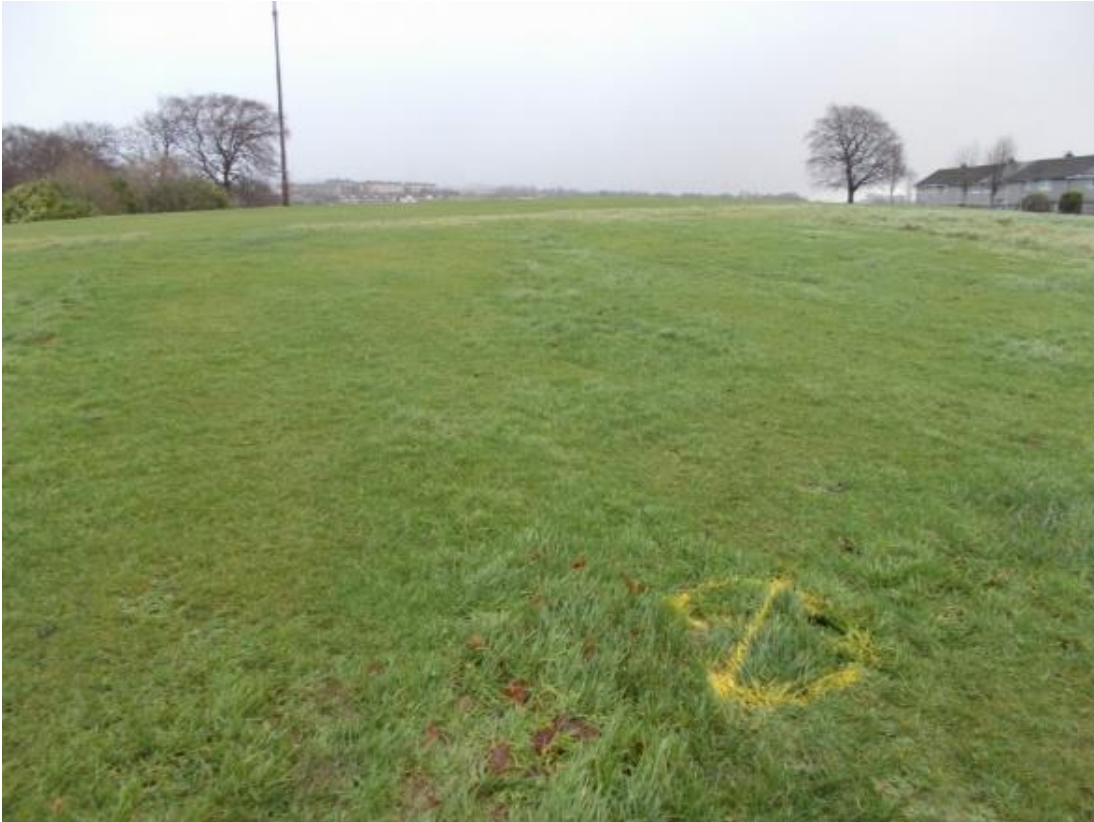
20. Finally, Test Pit **5** assessed a proposed location for an interpretation sign, within the Roman fortlet. Some 220mm of topsoil (002) was excavated revealing an intermittent layer of cobbling or metalling material (008). As a clear structural layer, excavation ceased at this upper surface.

21. Four sherds of pottery <1> were recovered from the topsoil within Test Pit **5**. One sherd <1.1> is a heavily abraded Samian ware rim sherd, with a light orange-brown body colour and fine, well rounded inclusions. The remaining three sherds are orange-brown coarseware with gritty sub-angular inclusions. One sherd <1.4> is a fragment of rim, sub-angular in profile, and one side is blackened by heat to a dark grey colour. The pottery appears consistent with finds recovered from the previous excavation conducted by Robertson (1957).

Figure 3a: Location for TP 5 within Fortlet from W

34. Test Pit **5** was also located within the centre of the fortlet, an area also investigated by Robertson (1957, 23): ‘*Trenching within the fortlet revealed gravelled or cobbled surfaces at many points*’. The exposure of a comparable surface at a depth of 220mm shows that this surface was not removed by Robertson and remains the first significant archaeological horizon within this portion of the scheduled monument. The recovery of abraded pottery sherds from the topsoil over this surface highlights that all topsoil on the site has the potential to contain *ex situ* archaeological material.

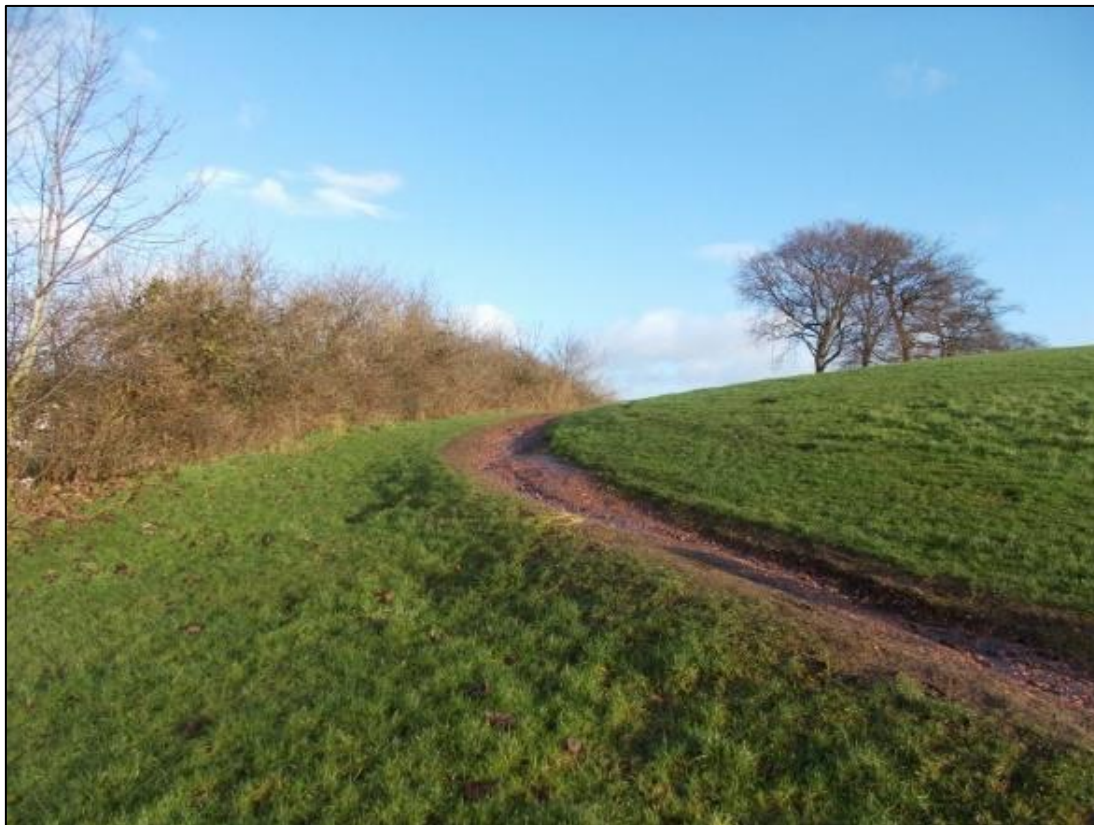
19. Test Pits **3** and **4** were both placed on the upslope side of the hedge, with the aim of assessing the higher ground level at this point (relative to the downslope side of the hedge). Both test pits exposed topsoil (002) of around 300mm depth overlying the subsoil (003).

Figure 3b: Pathway from SW on corner of Annexe with Hedge to left (NW) on ditch

32. As such the test pits on the upslope side of the hedge (Test Pits **3** and **4**) fall within the berm, which at other locations have been shown to have a gravelled surface present. That these test pits showed a soil profile consistent with that in other test pits around the scheduled monument, a topsoil of 300mm depth over subsoil, suggests this characteristic of the berm is not present here. Further, the lack of any overdeepened soils supports the hedge being planted on a pre-existing topographic feature rather than creating one through its presence – which further supports Robertson’s interpretation as to the location of the elements of the Annexe.

33. Any programme to remove this hedge must consider the importance of the topographic feature which is a significant aspect of the Scheduled Monument. Further, consideration must be given to the hedge growing within the upper portion of the Annexe ditch and across the line of the Antonine Wall.

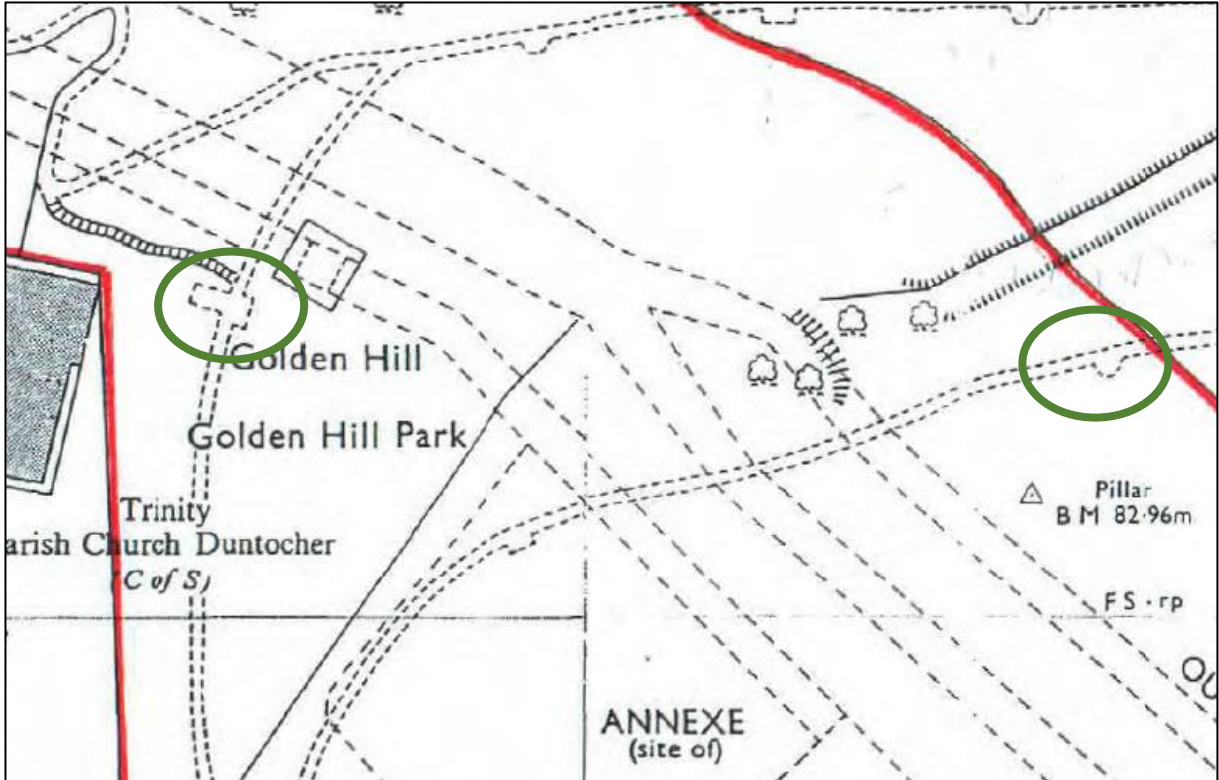
Figure 4a: Extract from scheduling document with circles (green) for former path areas

26. The examination of the upslope lip (see TP **I**) at a location where a bench is proposed showed the presence of path fabric overlain by a topsoil skim. The scheduling document (Figure 4a) shows that the area around TP **I** has consistently been depicted as part of the path network – presumably a small terrace cut for a bench. The re-exposure of the path fabric and the installation of a bench along with any necessary resurfacing should have no archaeological impact.

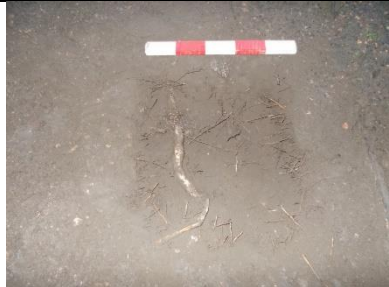
Test Pit	Heritage Sensitivity	NGR	Location Detail	Target Depth	Description	Image
a	Wall crossing	NS 49414 72768	In path fabric, avoiding tree roots	100mm	Excavated to 100mm wholly within path fabric (001). Dense roots and rootlets.

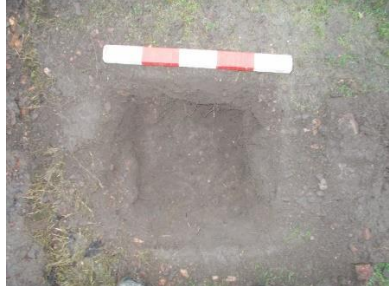
b	Ditch crossing	NS 49439 72772	Downslope lip adjacent to path fabric	300mm	Topsoil (002) upto 300mm deep (E side) overlay (W side) path fabric (001) at 100mm and subsoil (003) in centre of TP at 200mm depth. Subsoil dipped out of TP to E.

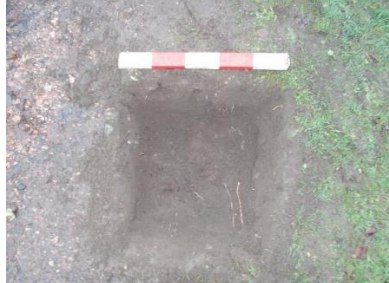
c	Wall crossing	NS 49431 72760	Downslope lip adjacent to path fabric	300mm	After removal of shallow spread of path fabric (001) from SE edge TP, balance of TP removed only topsoil (002) to 300mm depth.

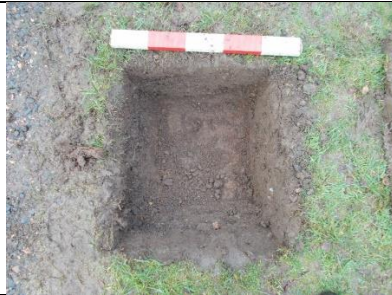
d	Wall crossing	NS 49439 72756	Downslope lip adjacent to path fabric	300mm	Topsoil (002) upto 295mm deep with subsoil (003) under.

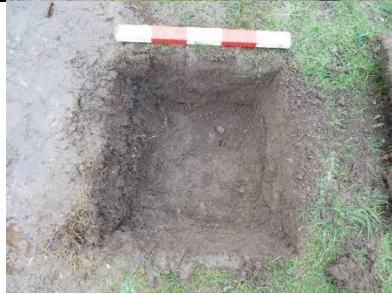
e	Ditch crossing	NS 49457 72764	Downslope lip adjacent to path fabric	300mm	Topsoil (002) upto 296mm deep with subsoil (003) under.

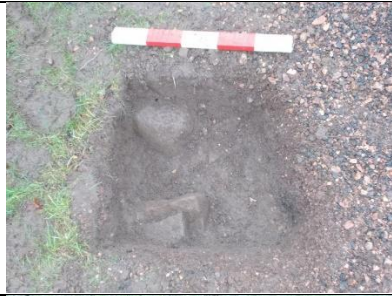
f	Ditch crossing	NS 49466 72760	Downslope lip adjacent to path fabric	300mm	Topsoil (002) some 290 to 300mm deep in majority of TP, with upper surface of subsoil (003) exposed across most of bed of TP. At W edge exposed series of sub-angular stones (004) within (002).

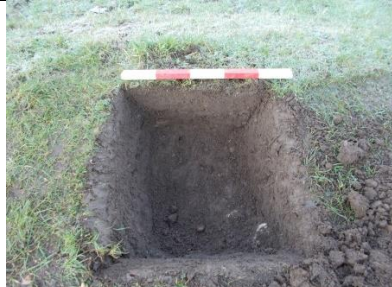
g	Wall crossing	NS 49457 72747	Downslope lip adjacent to path fabric	300mm	Topsoil (002) upto 300mm deep with upper surface of subsoil (003) exposed at base.

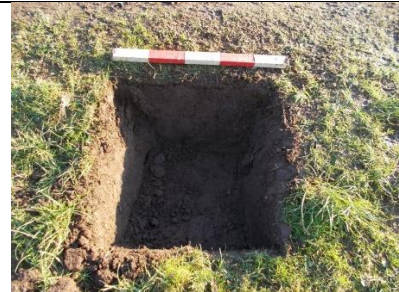
h	Ditch crossing (Annexe)	NS 49462 72675	Downslope lip adjacent to path fabric	300mm	Excavated to 300mm wholly within topsoil (002).

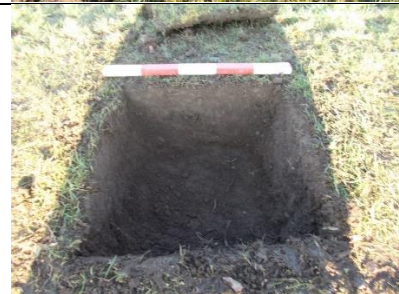
i	Wall crossing	NS 49503 72715	Downslope lip adjacent to path fabric	300mm	Topsoil (002) upto 295mm deep with subsoil (003) under.

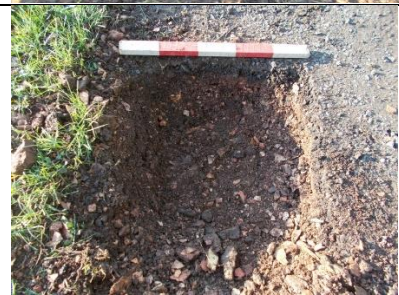
j	Ditch crossing	NS 49518 72717	In path fabric	100mm	Excavated to 100mm within path fabric (001).

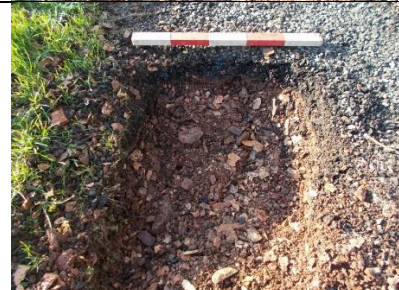
k	Ditch crossing	NS 49536 72722	In path fabric	100mm	Excavated to 100mm within path fabric (001).

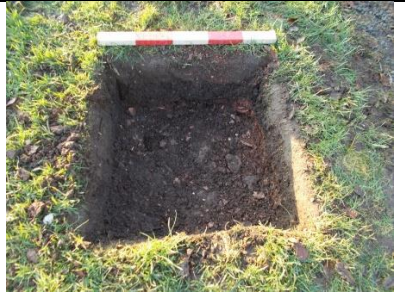
I	Other	NS 49563 72730	Upslope lip adjacent to path fabric	300mm	Topsoil (002) some 150mm deep overlay buried path fabric (001) that was excavated to 200mm depth.

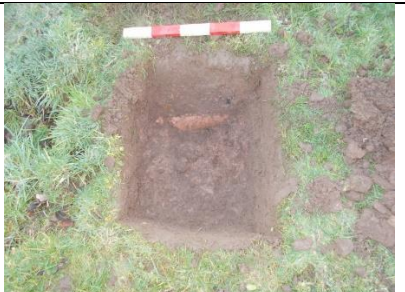
Test Pit	Location	NGR	Target	Description	Image
1	Spring or field drain	NS 49478 72763	To immediate SE of emerging flow of water, that then flows NW onto path to determine whether this is a field drain/culvert emerging.	Topsoil (002) some 300mm deep overlay subsoil (003). The cut (005) for ceramic tile drain (006) was exposed on the N edge of the TP. The tile drain ran roughly SE to NW, downslope towards 'spring'.

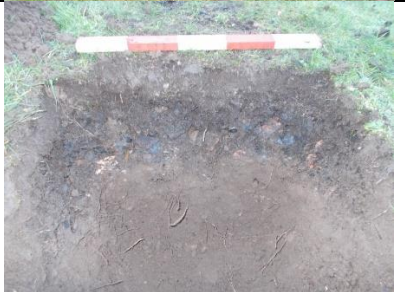
2	Step Removal	NS 49452 72739	In mound to immediate NW of path and to SW of top of steps, to characterise material that formed top mound of children's slide	Topsoil (002) some 150mm deep overlay path fabric (001) that was 200 to 300mm in depth. This in turn capped compact clay (007) that was excavated to overall maximum depth of 0.55m

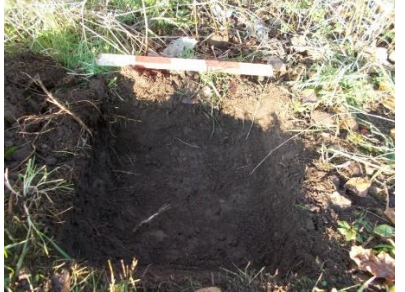
3	Hedge Removal	NS 49499 72733	To immediate rear of hedge in accumulated/retained material that should overlie the NW berm of the Annexe to characterise this material.	Topsoil (002) upto 280mm deep with subsoil (003) under.

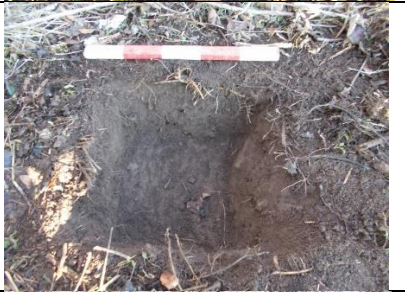
4	Hedge Removal	NS 49482 72713	To immediate rear of hedge in accumulated/retained material that should overlie the NW berm of the Annexe to characterise this material.	Topsoil (002) upto 280mm deep with subsoil (003) under.

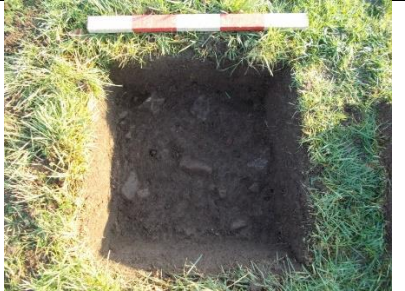
5	Signage Location	NS 49531 72668	Location within fortlet/forts to assess potential to introduce signage within core of (reinstated) site.	Topsoil (002) some 220mm deep overlay probable metalling material (008) that covered base of TP. Four sherds of pottery <001> recovered from Topsoil (002)
