MONUMENT	ST BRIDGETS KIRK
PROJECT	Window to South Elevation

HISTORIC ENVIRONMENT SCOTLAND | ÀRAINNEACHD EACHDRAIDHEIL ALBA

PROJECT DRAWING NUMBER		
SCALE	1:10 @ A3	ARCHITECT DMBorthwick
DATE	Jan '2017	DRAWN BY BTPringle
ARCHIVE NUMBER	365/266/076

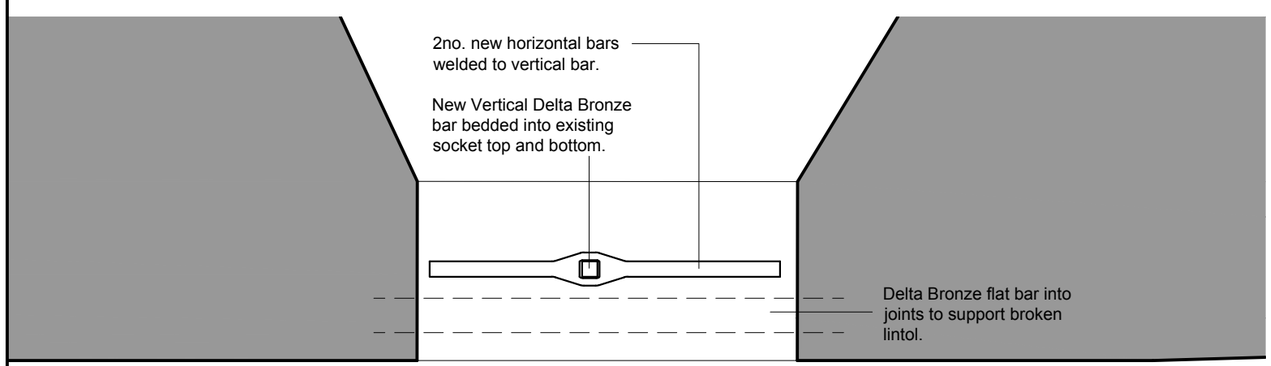
Front Elevation (1:10)

Delta Bronze flat bar into joints to support broken lintol.

New Vertical Delta Bronze bar bedded into existing socket.

2no. new horizontal bars welded to vertical bar.

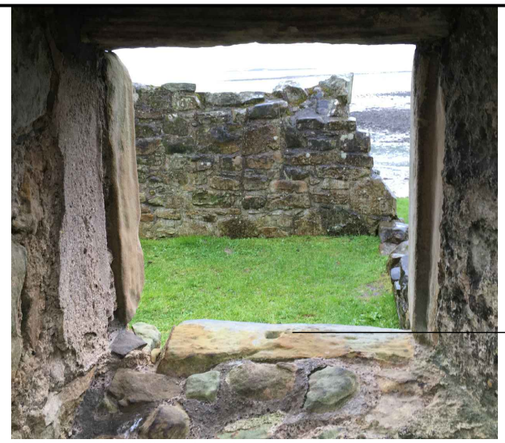
Photo from inside if window showing socket.

New Vertical Delta Bronze bar bedded into existing sockets in sill and lintol.
